# **Laboratory and Field Evaluation of In-Place Asphalt Recycling Technologies for Small Airfield Repair**

Mariely Mejías-Santiago, William D. Carruth,  
Jeffrey C. Petermann, and Dean H. Hitzelberger

June 2013

Final report

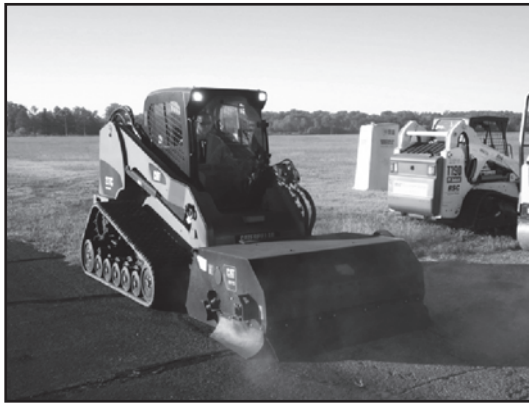
Due to the extensive raveling and loose aggregate on the apron surface, the entire site was swept using a skid steer-mounted broom attachment (Figure 33). The sweeping effort collected most of the loose material for offsite disposal. Removing debris from the pavement surface was important to prevent aggregate with little or no bonded asphalt from being included in the rejuvenation process. Uncoated aggregates in the final asphalt mix reduced the net asphalt content and ultimately decrease final performance of the repair. The removal of this debris also allowed the infrared heat to permeate directly into the existing asphalt layer, rather than being absorbed into the surface area of the loose aggregates. This increased overall heating efficiency and decreased time needed for sufficient heating. A photo of the loose material recovered from the repair site (Figure 34) illustrates the magnitude of site deterioration as well as the severity of overlay erosion and wear.

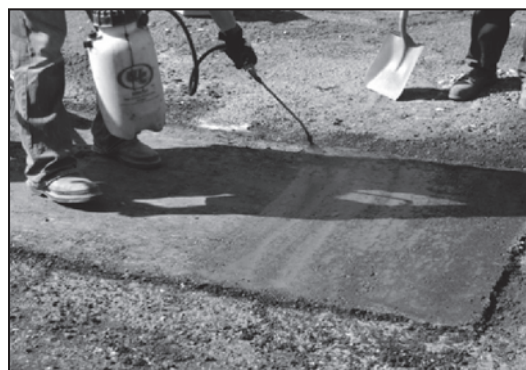
Figure 56. Typical rejuvenator application to mitigate surface cracking.

sprayer and applied lightly to the repair surface (Figure 56). The rejuvenator was allowed to penetrate the surface and become tacky before the roller was used to compact one final time. This effort was completed without vibration to prevent additional cracks from forming. When completed, the repair surface was again inspected visually, and the technique had sealed many of the visible cracks.

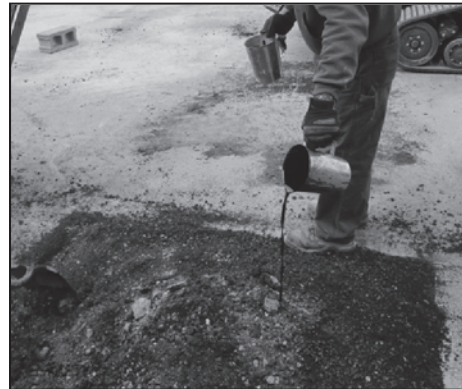
The remaining RAP material needed was weighed in 5-gal buckets, emptied on the stockpile cold and pushed into the void using a skid steer and bucket. The heater was then placed over the repair area to slowly bring the cold RAP to temperature. To avoid scorching the surface material, the heater was periodically removed and the processor was used to mix the mass. Once the RAP had reached an average internal temperature of 250°F, the heater was removed, and the cement and rejuvenator dosages were added as seen in Figure 61 and Figure 62. The cement was added first. The RAP was then processed again to ensure a homogeneous mixture.

Figure 62. Rejuvenator addition to PHP-4.

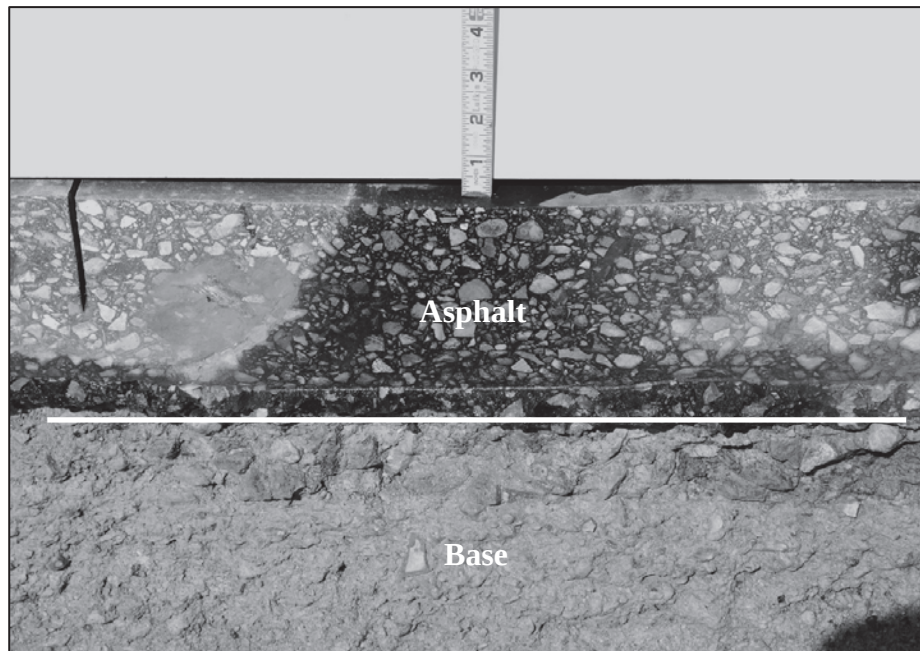
Figures 75 to 76 show the trenched cross-section view of repairs at the ERDC test site after failure. The white lines delineate the boundary between the asphalt and base layers. Shear deformation was not evident in the asphalt pavement, and no deformation was observed at the bottom of the asphalt layer. Therefore, the small amount of deformation observed at the surface of the asphalt layer was attributed to compaction of the asphalt mix. The surrounding asphalt pavement rutted equal to or greater than all the repairs (except for PHP-4) as shown in Figure 78.

Figure 75. Repair PHP-1 trenched cross-section view post traffic.

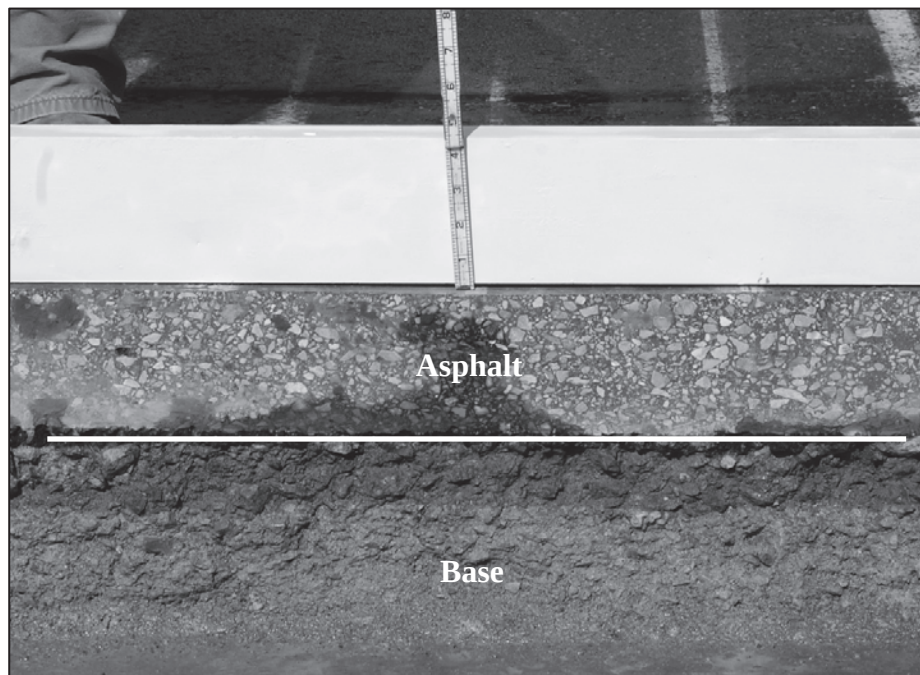
Figure 76. Repair PHP-2 trenched cross-section view post traffic.

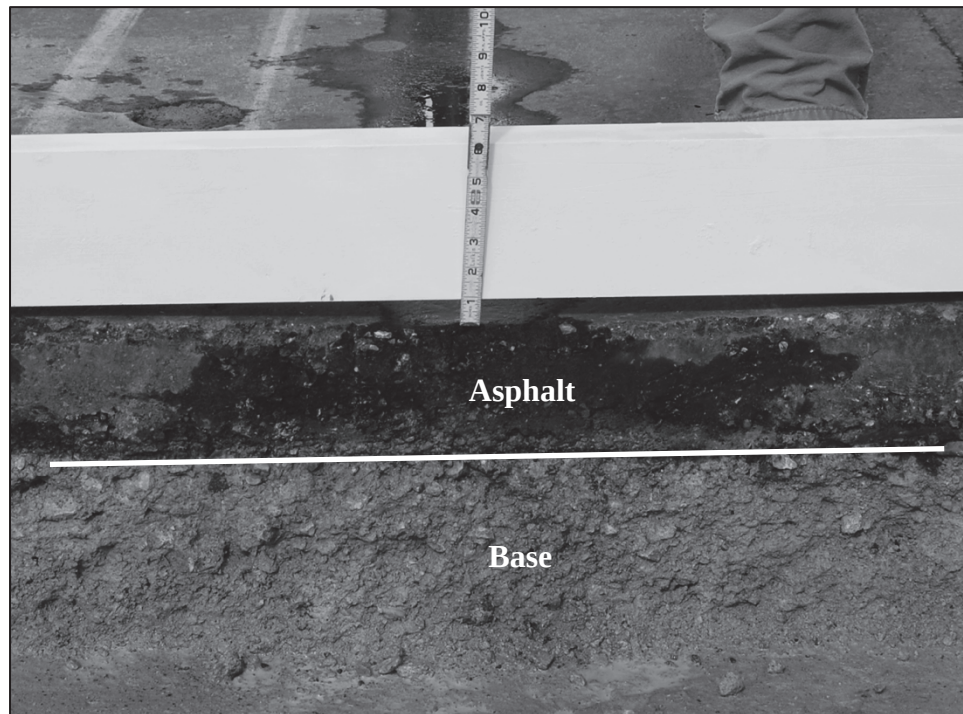
Figure 77. Repair PHP-3 trenched cross-section view post traffic.

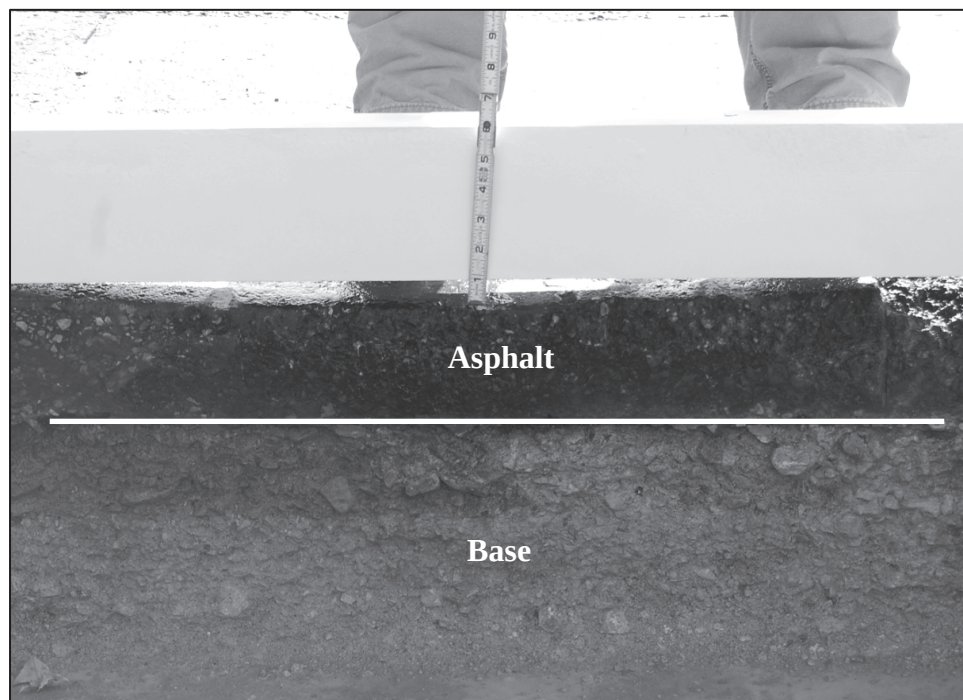
**Figure 79. Trenched cross-section view of original asphalt pavement between repairs PHP-1 and PHP-2 post traffic.**

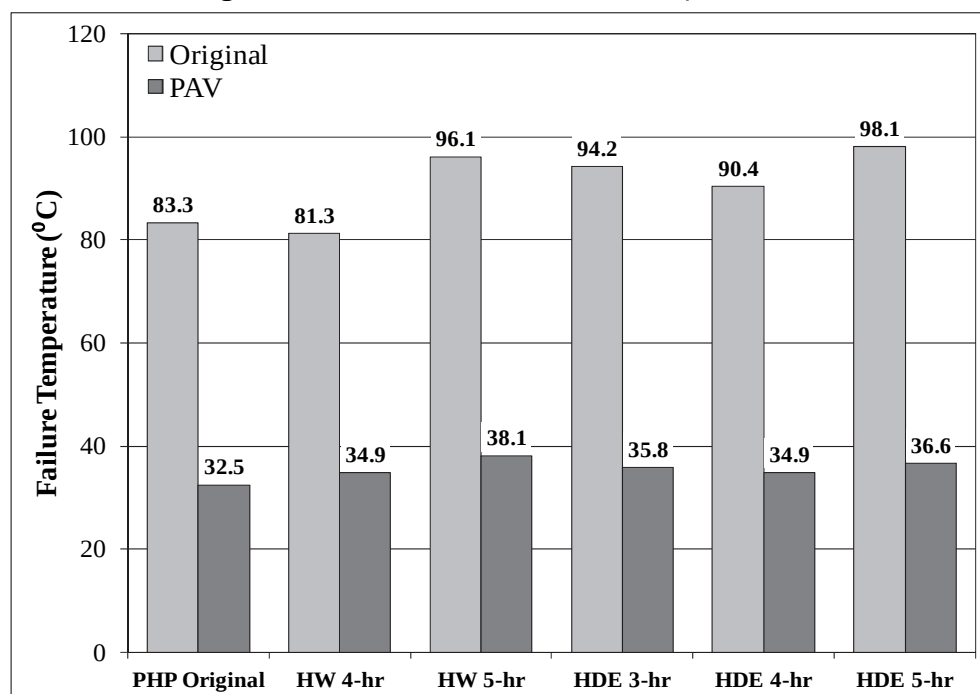
Superpave performance grade binder specifications were used to analyze the DSR data (1.0 kPa minimum for original binder and 5,000 kPa max for PAV aged binder). The failure temperatures from each sample for the original binder and the PAV aged binder are shown in Figure 82, respectively. Higher failure temperatures indicate stiffer binder. As shown, the original binder from the ERDC Test Site and the HW 4-hr specimen failed at similar temperatures, while the HW 5-hr specimen failed at a much higher temperature than the PHP original binder. The failure temperature of the HDE-3-hr specimen was higher than the HDE 4-hr specimen, and both were higher than the original PHP binder. The HDE 5-hr specimen had a noticeably higher failure temperature than the original binder. Since

the HDE 4-hr specimen was aged for a longer period of time, the failure temperature of the HDE 4-hr specimen was expected to be higher than that of the HDE 3-hr specimen. The sampling procedure used is believed to have caused this result, since some of the softer material under the hardened asphalt surface may have been inadvertently obtained during sampling.

Figure 82. Oxidation test binder failure temperatures.

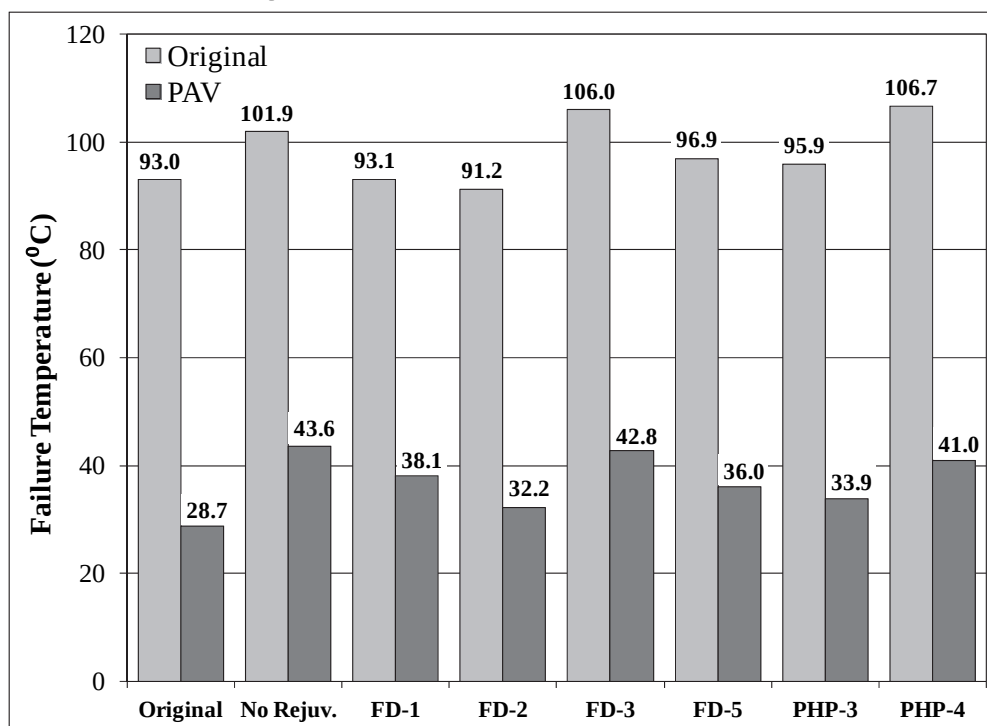
As shown in Figure 83, the binder extracted from the material that was heated but not rejuvenated had a higher failure temperature than the binder extracted from the original pavement. The stiffening of the binder indicated that a considerable amount of oxidation occurred during the heating of the original pavement before removal and rejuvenation. The PAV data suggest that if the removed material is not rejuvenated before compaction, the resulting repair could be more susceptible to performance problems.

Figure 83. Repair binder failure temperatures.

As shown in Figure 83, all original binder specimens extracted from the various repairs exhibited a lower failure temperature than the material that was not rejuvenated, except for FD-3 and PHP-4. Although nearly all of the original binder specimens had a lower failure temperature than the material that was not rejuvenated, only FD-2 and FD-3 showed lower stiffness values than the original pavement binder. However, binder extracted from the 2-in. overlay at the test location was extremely stiff, to the point that no DSR testing could be performed. Although no data could be collected, it is clear that any of the rejuvenated repairs would be an improvement compared to the existing, highly oxidized overlay at the test location. All of the PAV-aged binders had failure temperatures that were higher than the original pavement. The PAV data suggest that the expected long-term performance could be slightly reduced due to the recycling process when compared to the existing asphalt binder's elastic properties. However, as mentioned previously, the recycling process does appear to provide binder flexibility compared to the existing, highly oxidized overlay.
