# **Thule Air Base Airfield White Painting and Permafrost Investigation**

Phases I–IV

June 2013

Final report

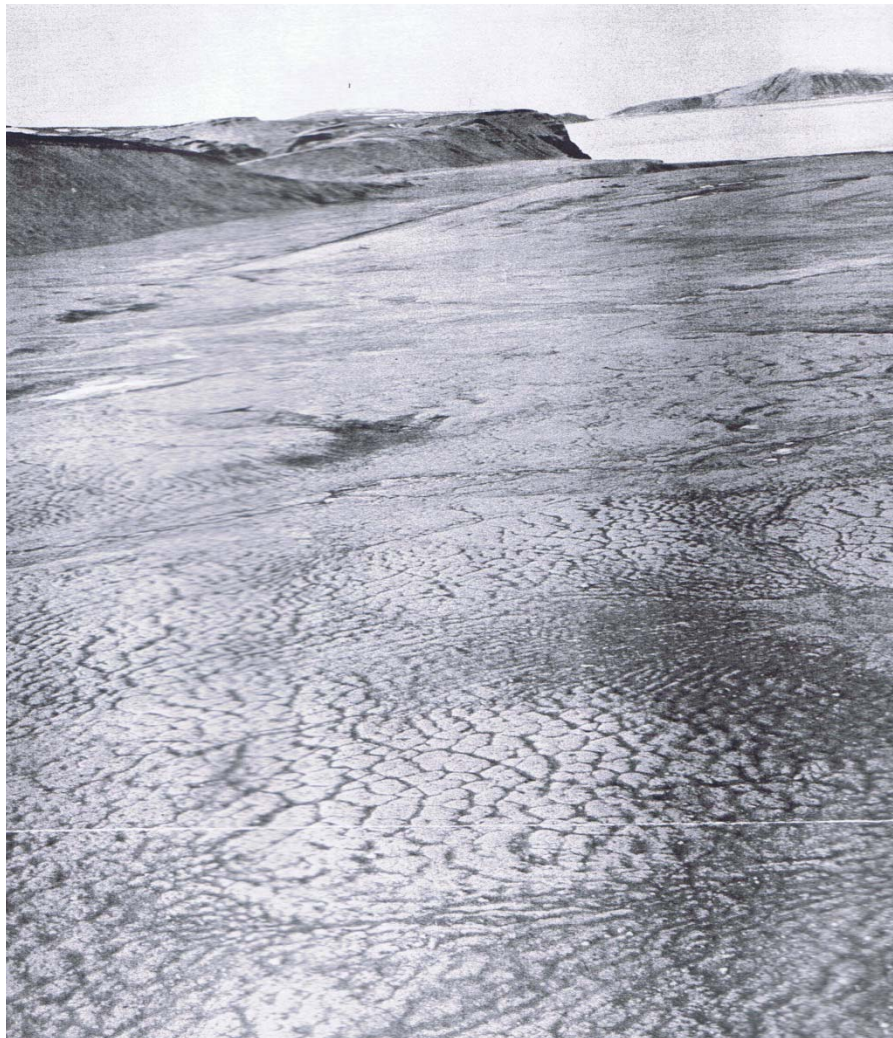
Figure 6. Aerial photo prior to Air Base construction looking southwest. The polygonal ice wedge networks are seen to extensively cover much of the valley.

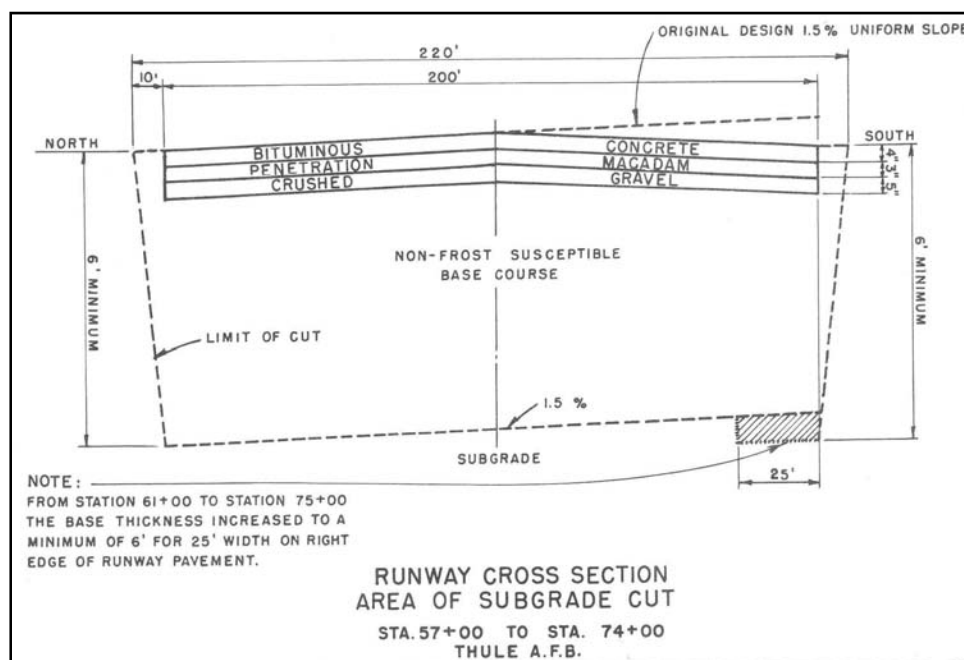
Figure 7. Cross section of the runway cut section from 57+00 to 74+00 showing initial design and mid-construction design change. The box excavation is also shown which was installed from 61+00 to 75+00 along the runway south limit (ACFEL 1955).

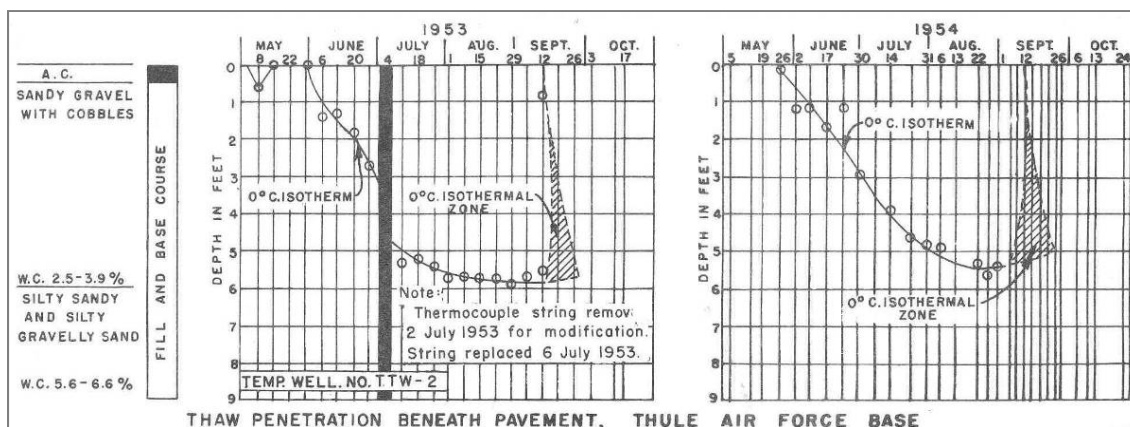
Plots of the depth of thaw under these two areas are compared for two seasons in Figures 9 and 10; the thaw depth was reduced by approximately 2 ft where the pavement was painted white. The thawing index for 1954 was greater than in 1953, but the deeper thaw in 1953 is attributed to heat introduction during excavation of the thermocouple strings, which were replaced in July 1953. Other investigators have confirmed these results (Berg and Aitken 1973). In a more recent study conducted at Kangerlussuaq, Greenland, Jorgensen and Ingeman-Nielsen (2008) used ground-penetrating radar to measure 2.6 ft of decreased thaw depth under white painted asphalt

Figure 9. Temperature profile for two seasons under a white painted asphalt surface (ACFEL 1955). Although 1954 had a higher thaw index, the 1953 thaw depth is deeper owing to excavation for a new temperature measurement string.

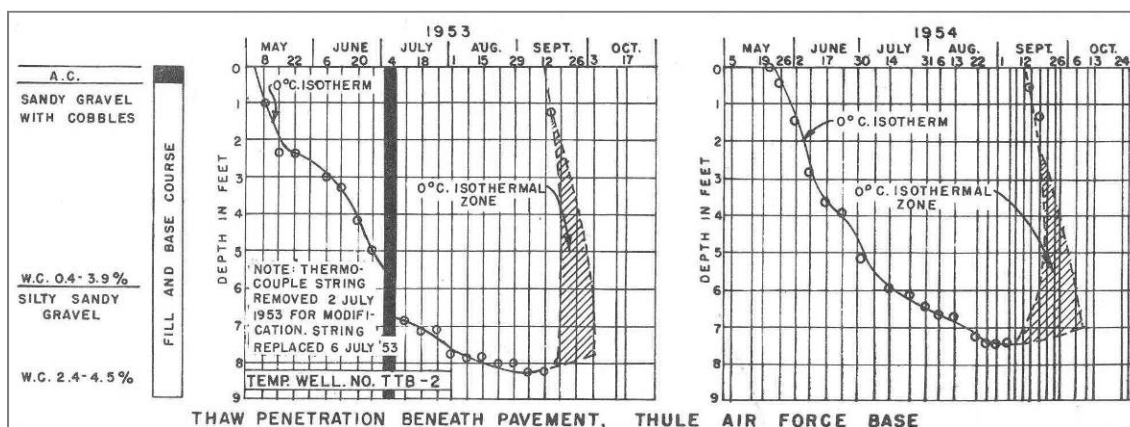
Figure 10. Temperature profile for two seasons under a non-painted asphalt surface (ACFEL 1955).

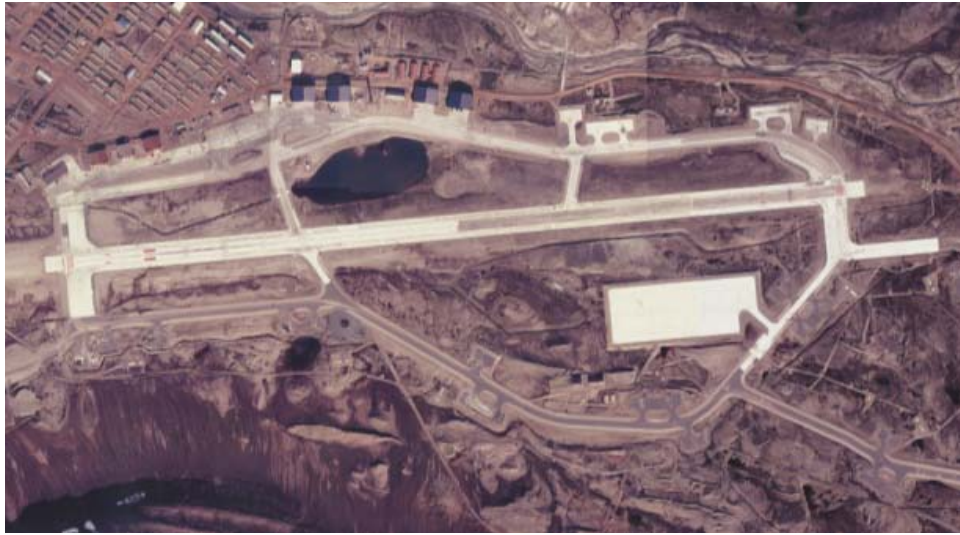
Figure 14. Undated photo of the airfield obtained from Thule personnel. The painting is in process during this photo. It is unknown if the dark pavement from approx. 50+00 to 100+00 is from wear or if milling or some other program is being conducted.

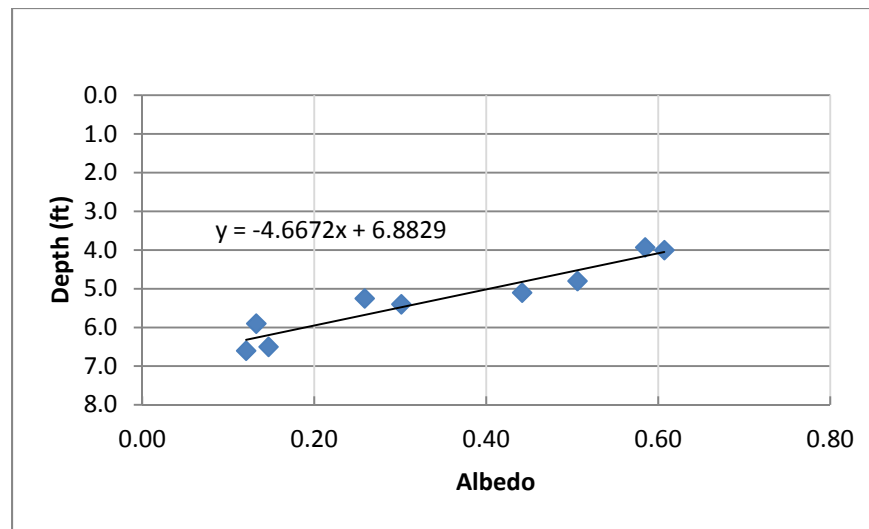
Figure 19. Albedo vs. thaw depth.

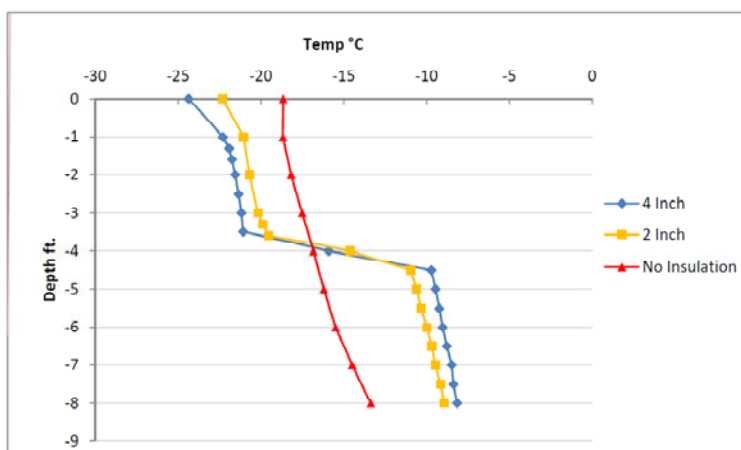
Figure 27. Insulation test measurement 1 April 2011. This plot demonstrates the thermal offset provided by 2- and 4-in. XPS insulation when the air is colder than the deeper subsurface.

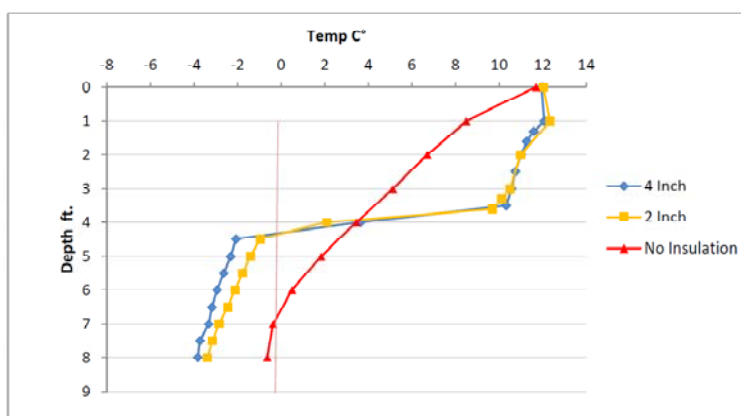
Figure 28. Insulation test measurement on 6 August 2011. This plot demonstrates the thermal offset provided by 2- and 4-in. XPS insulation when the air is warmer than the subsurface. The ultimate frost depth was held at the depth of the insulation. The summer of 2011 was the fourth warmest average air temperature recorded at the Air Base.

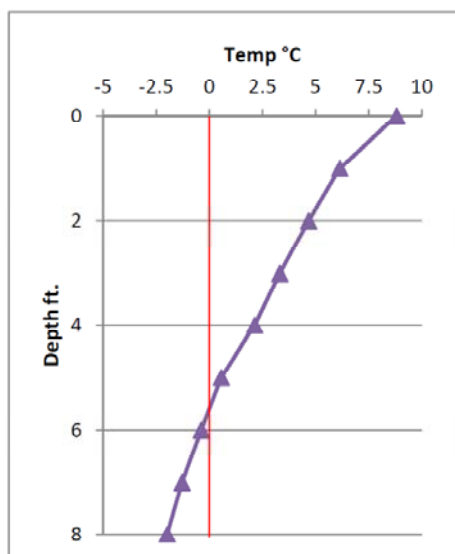
Figure 29. Subsurface temperatures measured at the “White Pavement” site. Measurement taken 11 August 2011 is the deepest thaw obtained for that summer. The albedo was 0.32 and the depth is almost 5.5 ft. This is consistent with the albedo vs. thaw depth presented in this report.

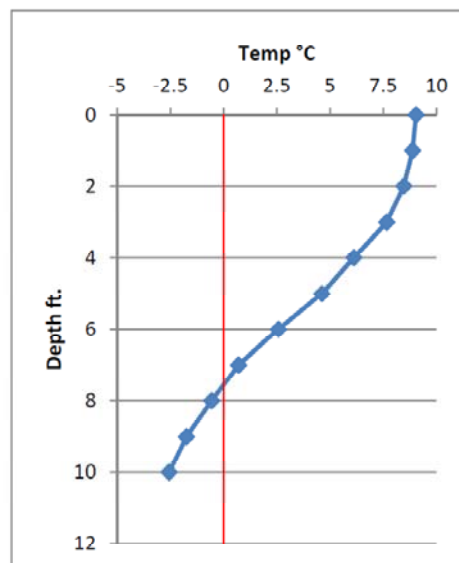
Figure 30. Subsurface temperatures measured at “Black Pavement” site. Measurement taken 11 August 2011 and is deepest thaw obtained for that summer, almost 7.5 ft, which is approximately 1 ft deeper than other measurements in natural colored pavement.

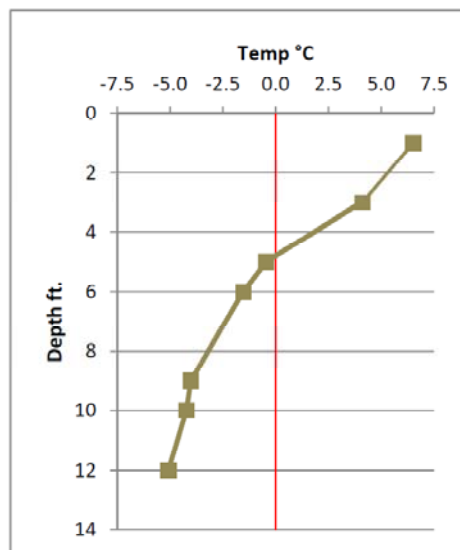
Figure 31. Subsurface temperatures at a permanent station in fill material near the Terminal Operations Building. Measurement was 1 August 2011 and is deepest the thaw obtained for that summer, almost 5 ft, which is consistent with borehole and test pit investigations, and the albedo vs. thaw depth measurements in fill material.

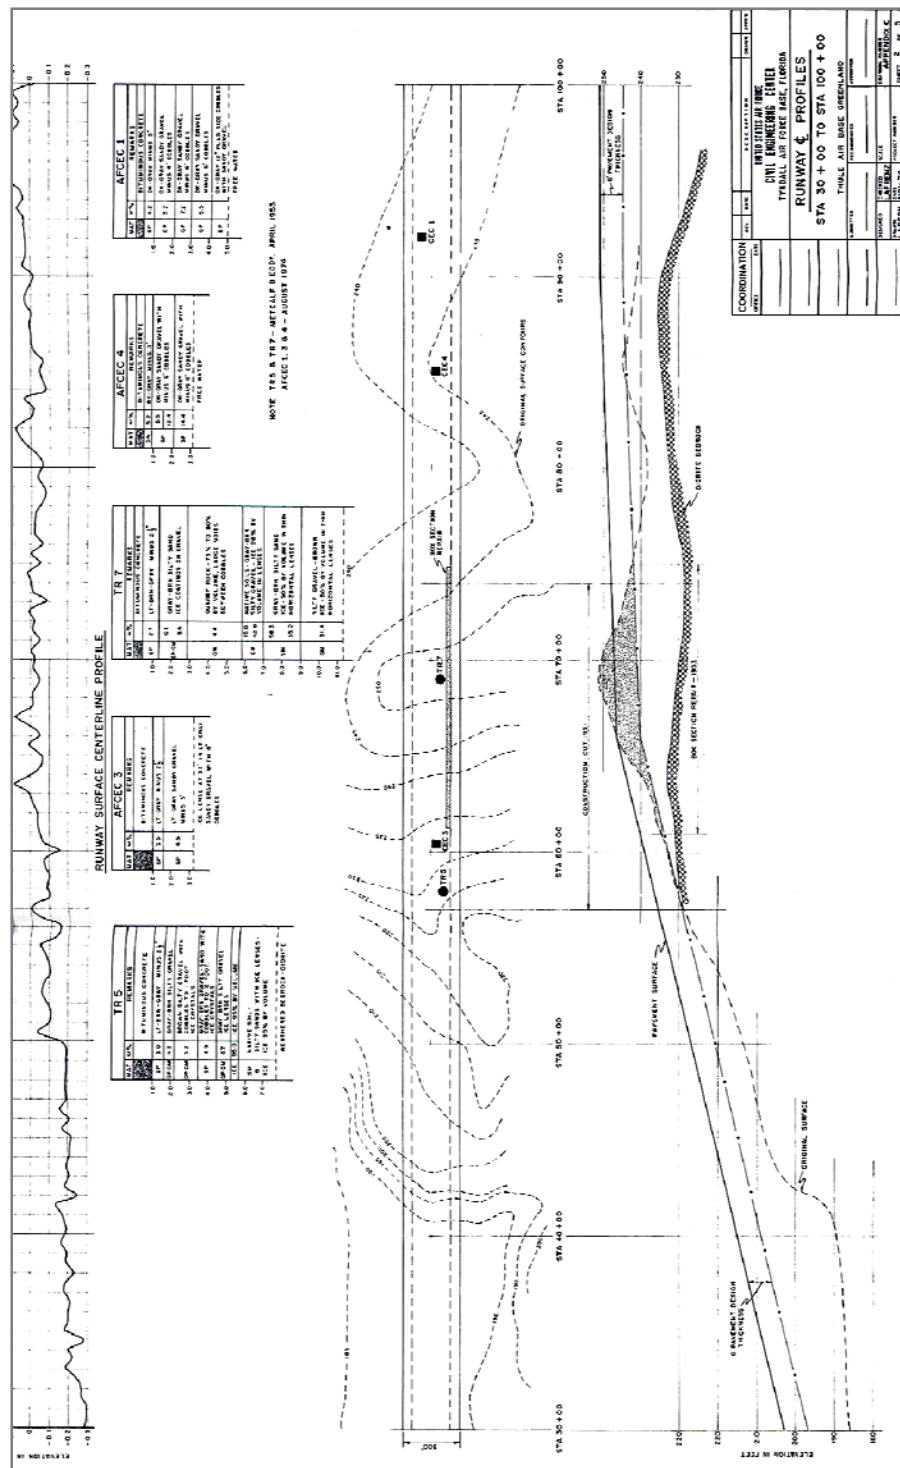
Figure 33. As-built plan provided in the AFCEC (1974) *Pavement Evaluation* report. The original surface before airfield construction is shown and is similar to the ACFEL (1955) report. These differ from the Metcalf & Eddy 1958 drainage report, which shows six cut sections.

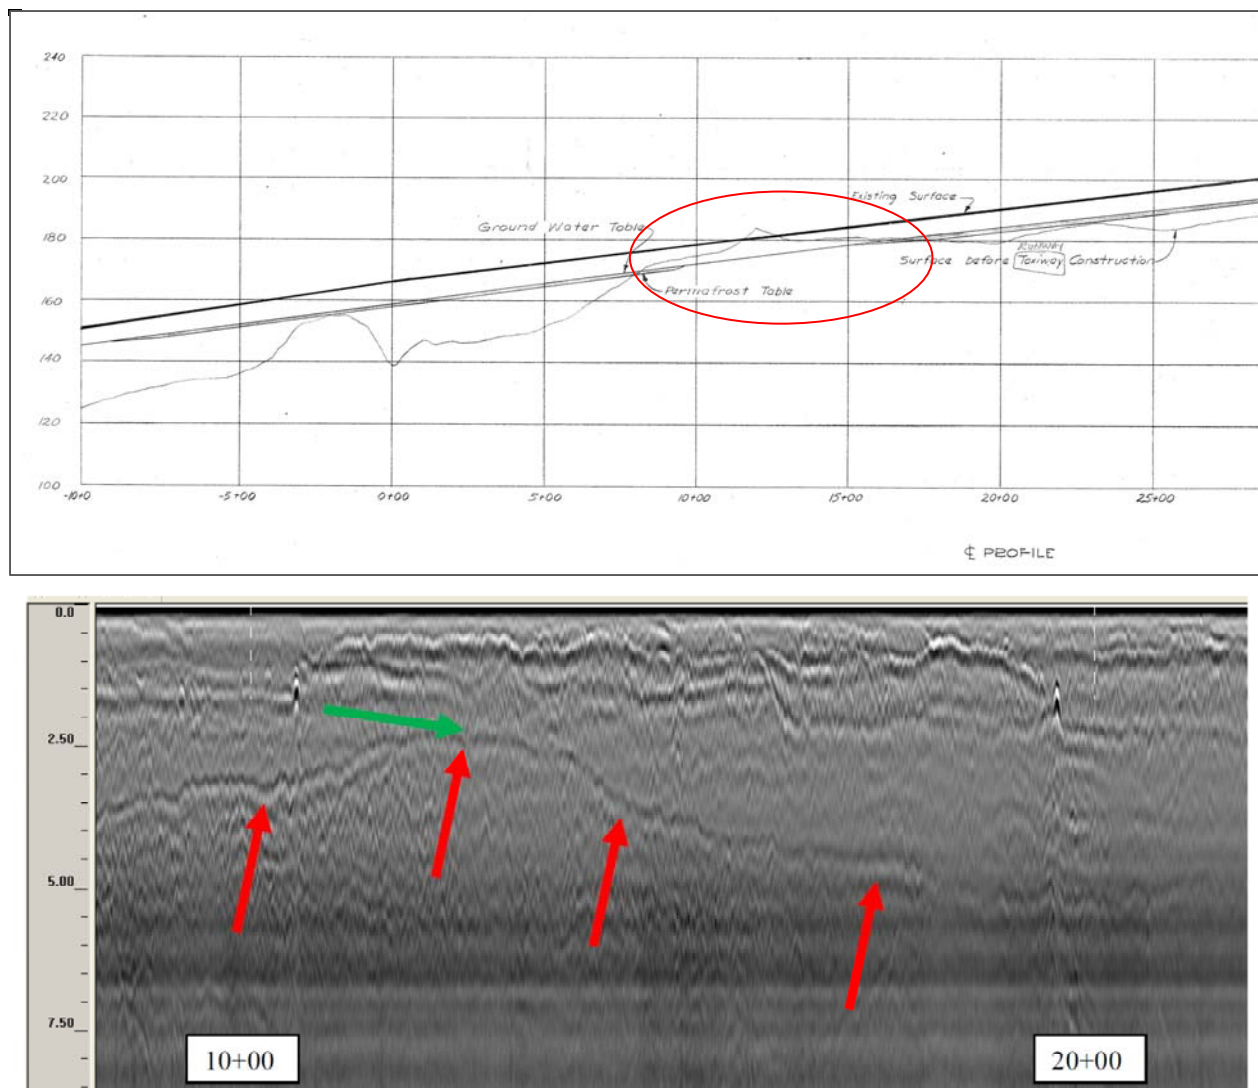
Figure 34. Top: a portion of the runway as-built provided by Metcalf & Eddy. A cut section is shown starting at 5+00 and ending at 17+00. The red oval indicates the location shown in the GPR image in the bottom figure, a portion of a radargram showing the subsurface between 8+00 and 22+00. Survey was taken on the right side of the runway between the centerline and the edge lighting. The rise in topography shown in top drawing is clearly seen at the red arrows. Green arrow indicates location where near surface ice-rich soil may exist at 8.2 ft depth.

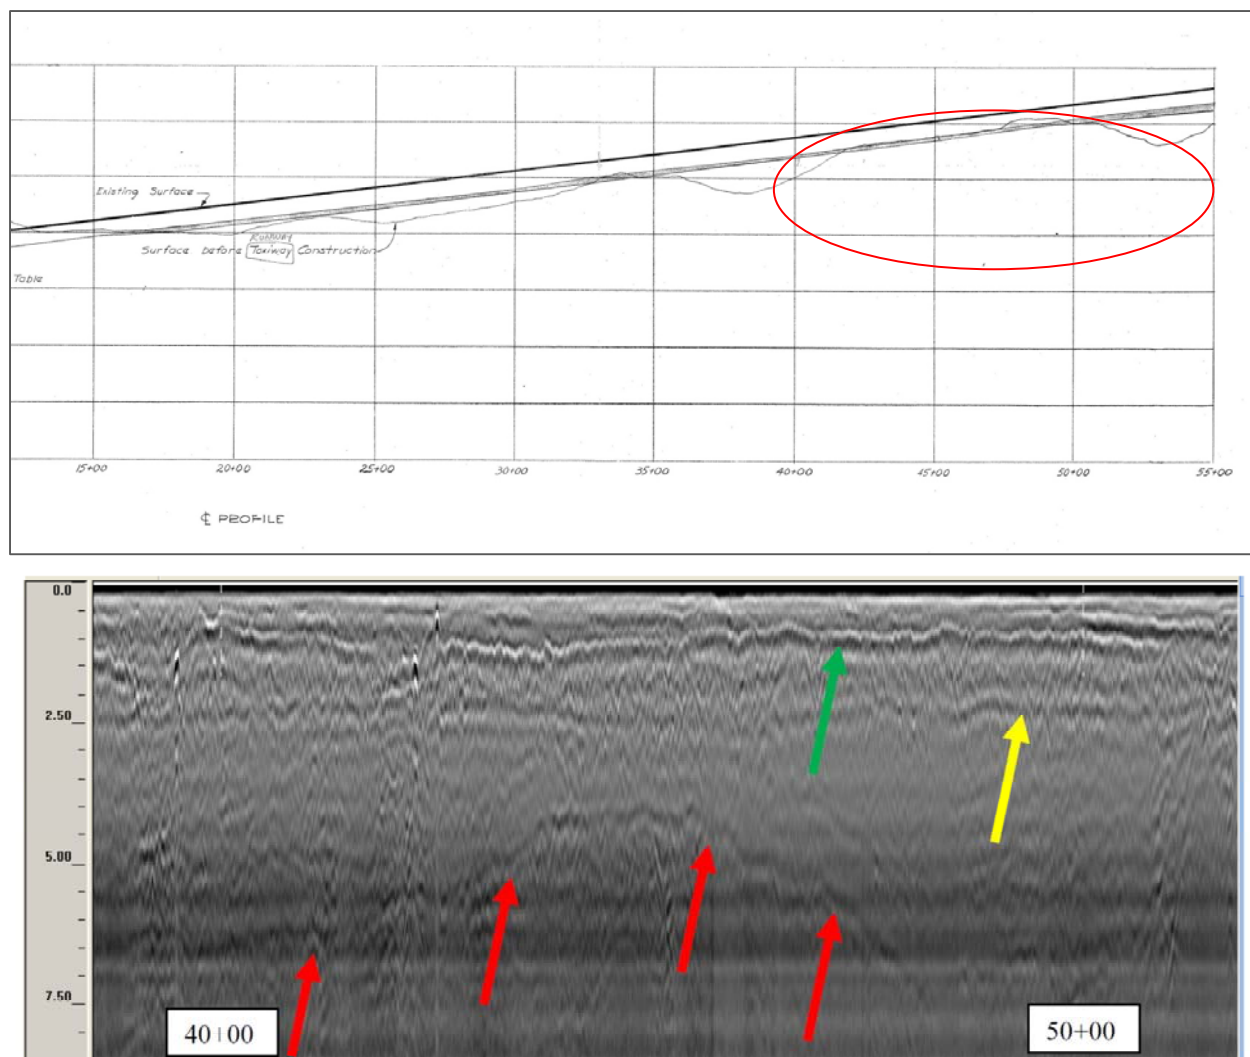
Figure 35. Top: portion of the runway as-built provided by Metcalf & Eddy. A cut section and near-cut section are shown starting at 42+00 and ending at 51+00. The red oval indicates the cut section shown in the bottom figure, a portion of a radargram showing the subsurface between 38+00 and 52+00. This survey was taken on the right side of the runway between the centerline and the edge lighting. The rise in topography shown in the top figure is marked by red arrows. The transitions to multiple lifts of coarser material for the asphalt base course (Fig. 7) are shown by the yellow arrow starting at approximately 8.0 ft. The green arrow indicates a visible strong reflector at the 3-ft depth and this most probably corresponds to the bottom extent of the 1992 repaving subgrade reworking.

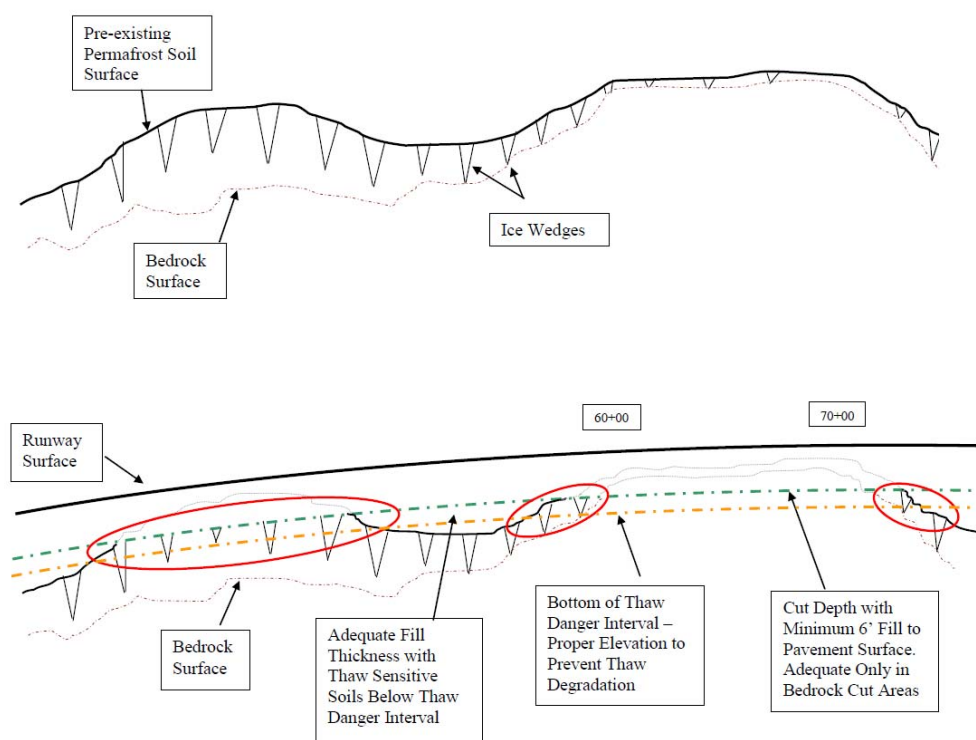
(late Pleistocene–early Holocene) and epigenetically frozen, it is assumed the massive ice occurs from the surface down 10 to 15 ft into the sediments. Locally, the wedge ice is much shallower where bedrock is shallow. This was confirmed with the field investigation.

The model is completed with the addition of the accurate cut-and-fill thicknesses over the top of the ice rich native soils. The cut and fill locations indicate where the massive ice and ice-rich soils may be close to the surface and in danger of thaw. As the fill thickness decreases, the native ice-rich terrain surface becomes closer to the man-made surface, within the thaw critical interval. Figure 36 illustrates this general concept. Therefore, if the cut was not substantially deep enough to excavate the entire near surface wedge ice, thaw danger is possible at the margins and surface of the cut areas. However, it is possible that, in some of the cut areas, where shallow bedrock existed, the massive ice was completely removed.

Figure 36. Permafrost terrain conceptual model created for the airfield.

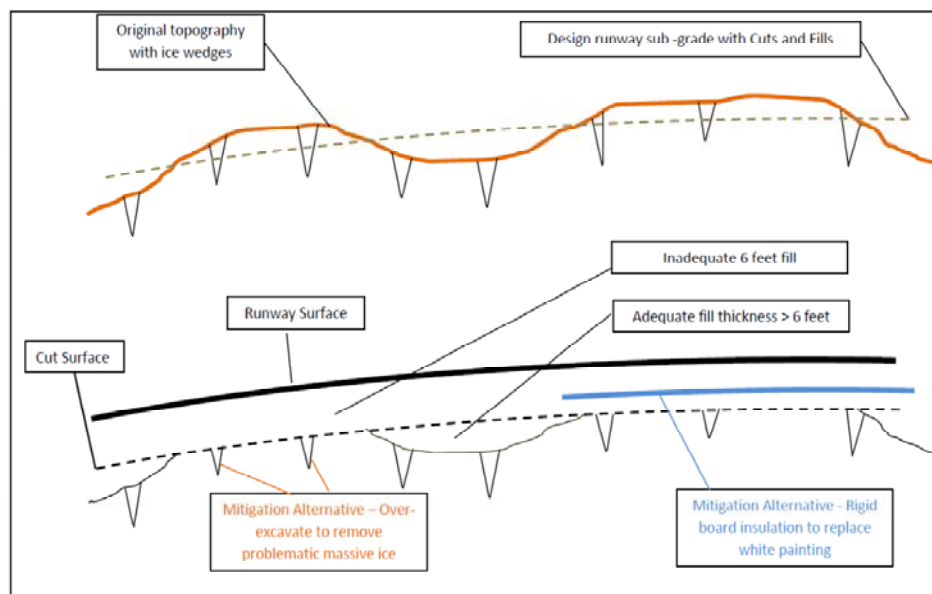
Figure 38. Thaw mitigation alternatives, over-excavation and insulation.

The effectiveness of installing XPS rigid board insulation at depth was discussed in section 4.5. The field test and computer thermal modeling demonstrated that this alternative will perform as required. Extruded polystyrene (XPS) is a closed cell material and will not be adversely affected by water. High compressive and flexural strength insulation, up to 100 psi and above, is available specifically for direct bury in a structural embankment. It has been shown to perform well under these conditions. A minimum installed thickness of 4 in. is adequate for the current climate and soil conditions, and will perform as needed if the mean annual air temperature (MAAT) increases by 2 to 3°C. For an anticipated climate change of up to 6 to 8°C, 6 in. of EXP will be required. Figure 38 illustrates the concept and installation of the XPS.

The insulation would be installed at the specified locations for thaw mitigation and at the depth of 4 ft below the finished subgrade. This depth is optimal for ensuring that subsurface groundwater does not flow at a shallower depth than it is now. It also eliminates the possible issues with differential heaving between the insulated section and the adjacent uninsulated sections. Preferably, 4- × 8-ft sheets would be used and each sheet must firmly abut the adjoining sheet. The following layers should be staggered to overlap the previous layer's joints by at least 1/3. Care must be taken with the size of the earth-moving equipment used to minimize fill material lift thickness so as to not shift or damage the XPS. The 4-ft-deep excavation for installing the insulation should not encounter massive ice.

However, if this were to happen, the opportunity should be taken to over-excavate the massive ice to the fullest extent possible to ensure problem areas are mitigated.

Removal of the massive ice in known areas can nearly eliminate the possibility of thaw degradation. Excavation of the subgrade soils to the bottom depth of the thaw critical interval, or 9 ft, would allow for visible identification of massive ice that then can be surgically removed to beyond the depth of the thaw critical interval. If over-excavation is prescribed for a localized area with known massive ice, the entire subgrade to the full depth of the excavation should be removed and replaced with clean, compacted fill material. The only known locations for shallow ice in the active runway are 58+00 to 64+00 (Table 2). Figure 38 also illustrates the concept of over-excavation.

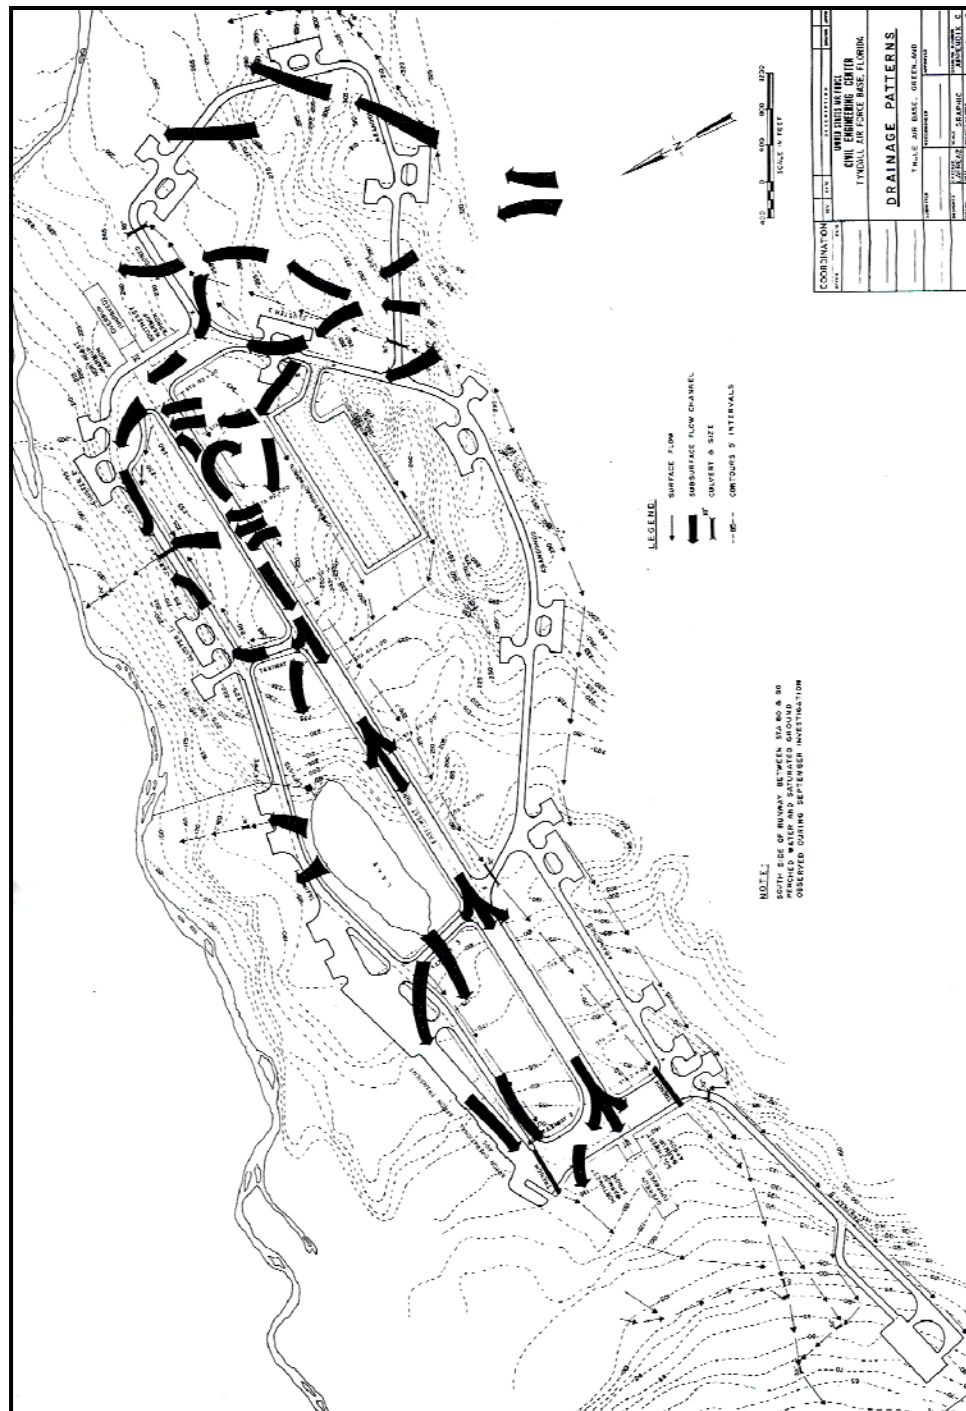
Previous dedicated drainage studies for the airfield (Metcalf & Eddy 1958; Berg 1976) have been conducted. These studies suggest that flow originates from the slopes of South Mountain, with contributions from the area in the direction of DET-1, and then enters the southeast area of the airfield, flowing across the South Loop Taxiway into the runway area. Both studies suggest that the runway and taxiway embankments act as preferential flow paths, and when flow encounters an embankment it migrates longitudinally under its centerline. The studies suggest that a majority of the flow eventually discharges out of the north side of the runway embankment at approximately 80+00 to flow through the culvert under Taxiway Alpha east of Taxiway Charlie (Fig. 39).

Figure 39. Surface water drainage paths and inferred subsurface drainage paths (AFCEC 1974).

Some flow continues to the west into Lake Eddy, under Taxiway Bravo and out under culverts to the west. In 1975, “bird baths” that had developed from 80+00 to 100+00 were suspected to be from groundwater weakened soils. Berg (1976) suggested white painting of this section of the runway; it

was done in 1977. Pavement overlay was done in 1977 and repaving in 1993 and this problem has not returned. The Metcalf & Eddy (1958) study suggests that a spring exists under station 85+00 of the runway with no explanation. A spring migrating through cold, continuous permafrost is very unlikely.

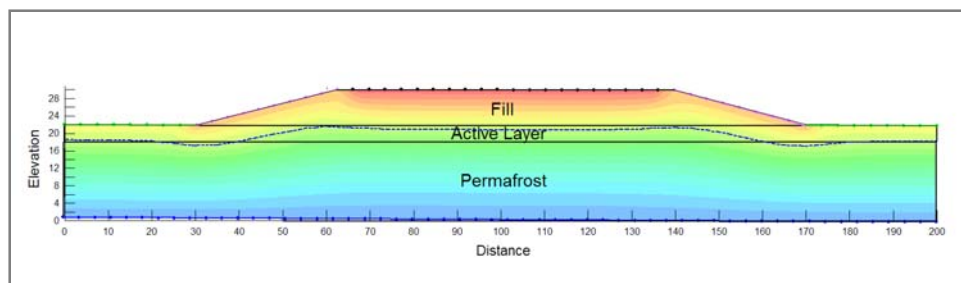
A finite element computer analysis was performed to see if subsurface water could possibly flow down the center of the airfield embankments. An idealized embankment was constructed with a 6-ft gravel fill section overlying a 4-ft active layer, these both in turn overlying an 18-ft thick permanently frozen till. Figure 40 shows that the swales at the transition from the embankment to the native soil grade would be the lowest elevation along the cross section. The top of the permafrost in the embankment will be at a higher elevation than the top of the permafrost in the native material adjacent to it, creating a damming effect that resists groundwater movement from one side of the embankment to the other. Therefore, a more realistic scenario than that suggested by the previous drainage reports is that lateral flow of groundwater under the runways and taxiways is altered or blocked, diverting the groundwater in complicated ways.

Figure 40. Numerical analysis of thaw depth in a 6-ft fill embankment constructed on natural grade. The colors represent end-of-analysis temperatures, with blue the coldest, and red the warmest. The depth of thaw after one season is represented by the blue dotted line. The raised permafrost table into the fill produces swales at the embankment toe and a damming effect that would prevent lateral flow of groundwater from shoulder to shoulder.

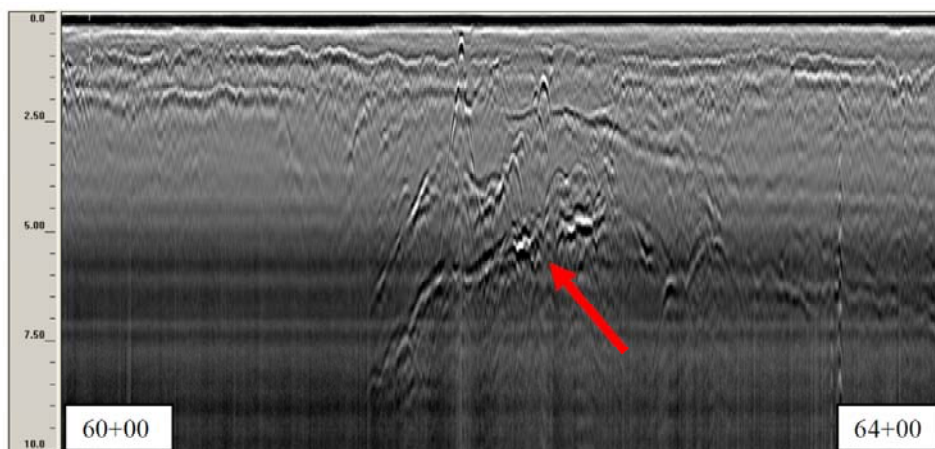
surface flow might now exist at this location under the runway to Lake Ed-  
dy. However, owing to the extreme climate at Thule, it is rather improb-  
able this flow is any deeper than the bottom of the seasonal frost. Also, sub-  
surface flow would pipe material from the embankment, most probably  
causing larger scale settlement at the surface, and this is not seen. The lo-  
cation at 63+00 corresponds to a relative low region within the very large  
cut made from 56+00 to 74+00. The GPR profiles image very sharply dip-  
ping reflectors in this area, and this also corresponds to the location of the  
depression at 62+00 to 63+00. (Fig. 43) The bottom of the highly conduc-  
tive region at 63+00 is 16 ft deep, and this corresponds with the depth of  
the reflectors in the GPR image at 16 ft.

Figure 43. GPR image showing from 60+00 to 64+00. Isolated reflectors are shown at ~63+00 at a depth of ~16 ft. The bright black-white-black reflectors (red arrow) are typical of the sedimentary bedrock reflections.
