## **Evaluation of Precast Panels for Airfield Pavement Repair**

Phase II: Results of Accelerated Pavement Testing

September 2013

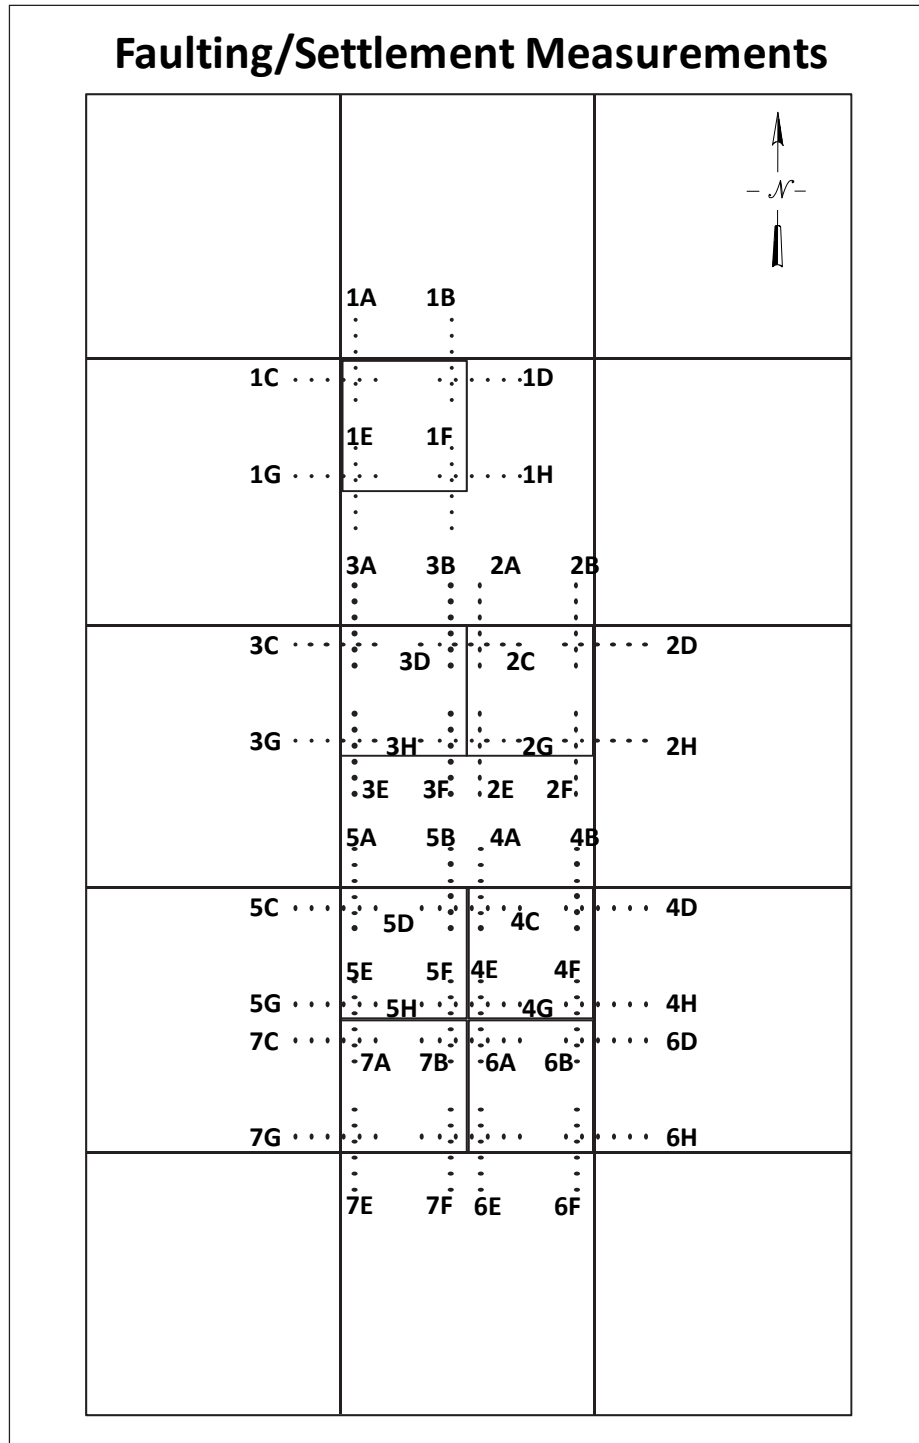
Figure 15. Locations of faulting and settlement measurements.

The peak elevation differences for each set of measurements are presented in Table 3. Negative differences represent changes in elevation due to settlement or loss of material. The data shows the panels moved very little during trafficking. None of the repairs had settlement or faulting in excess of 3.0 in., indicating that the panels did not fail due to roughness. The differences in elevation appear to be very minimal indicating that the flowable fill provided adequate support for the panels and that loss of subgrade support and excess material loss did not occur during trafficking. Additionally, the results show that the dowels provided successful load transfer across the transverse joints.

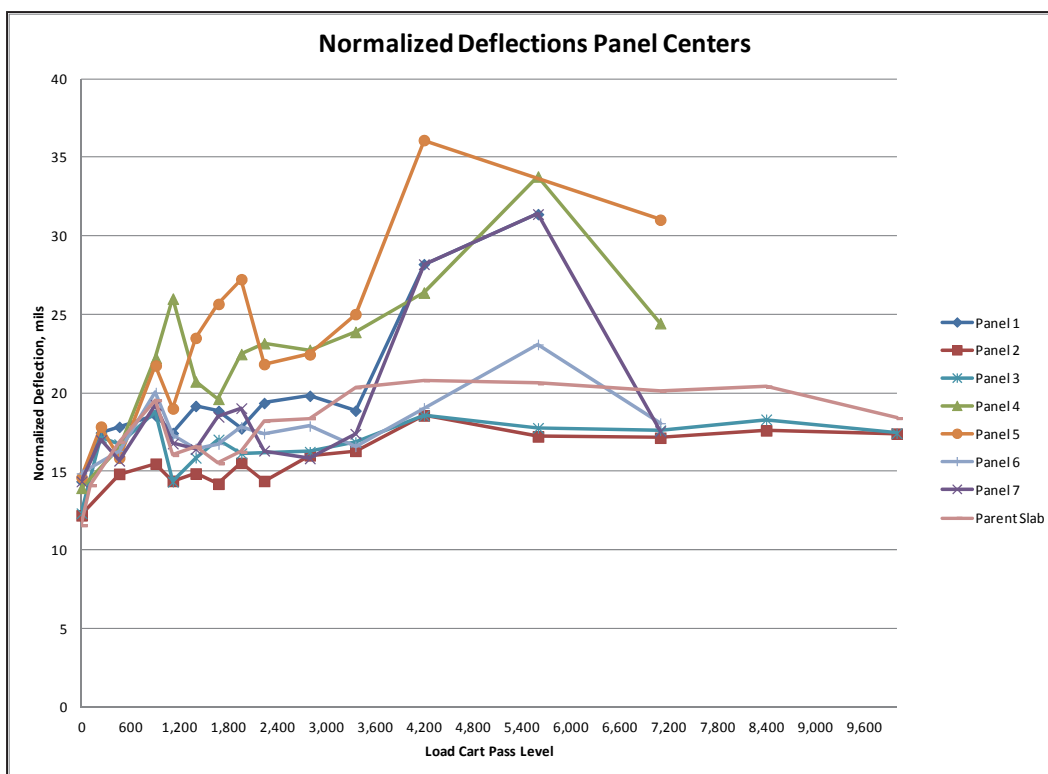
Figure 19. Normalized deflections for panels with traffic passes.

Center slab deflections recorded at the maximum HWD load level (measured at the first sensor) are presented in Figure 19. Deflections were normalized to a force of 50,000 lb to provide a comparison of the test data that varied in maximum force from approximately 39,000 to 57,500 lb. Normalized deflection values for each panel and pass level are also presented in Table 5. Figure 19 shows the general trend that as traffic applications increased, the deflections also increased for all repairs and adjacent pavement (parent PCC). This figure also shows that lower deflections were recorded for Panels 2 and 3 of Repair 2, slightly better than parent slab deflections. The highest deflections were recorded for Panel 1 of Repair 1 and Panels 4, 5, and 7, of Repair 3.

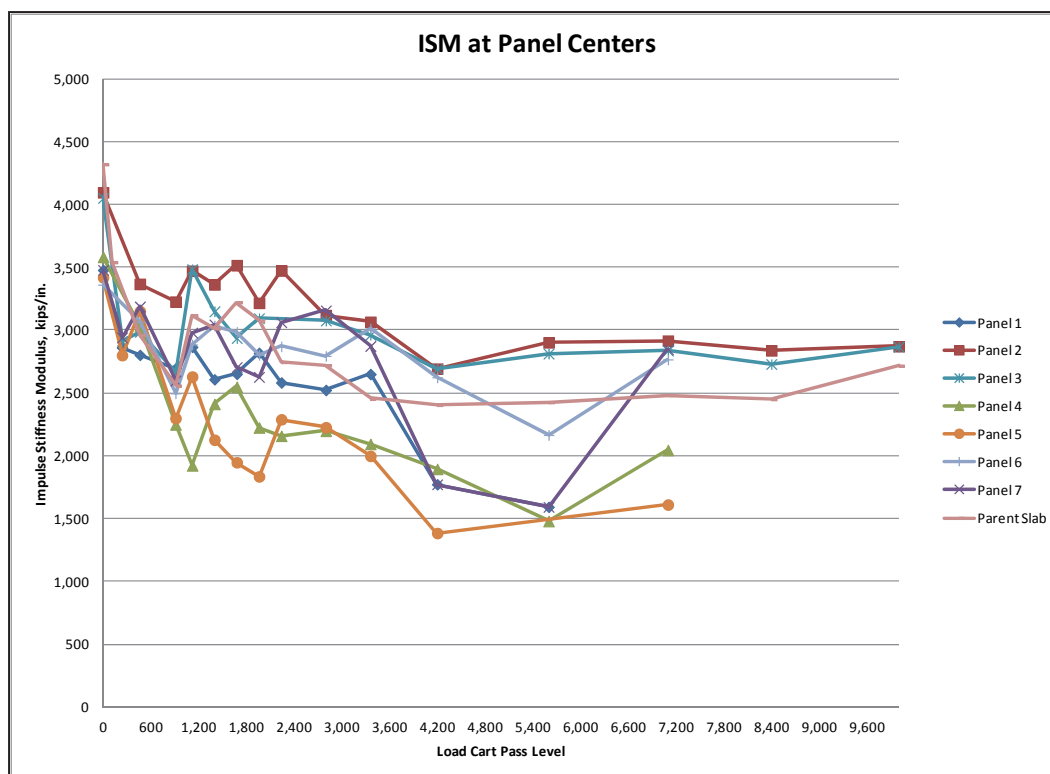
Figure 20. ISM versus load cart passes.

Figure 20 shows the ISM values with trafficking for all panels and a parent PCC slab. The figure shows that both the parent slab and the repairs lose strength over trafficking. This is expected as fatigue damage increases as loadings are applied. The ISM values for Panels 2 and 3 indicate that Repair 2 was the strongest of all repairs. The ISM values indicated that the weakest panels were Panel 1 (Repair 1) and Panels 5 and 6 (Repair 3) this could indicate that the flowable fill beneath these repairs was of lesser quality compared to Repair 2.

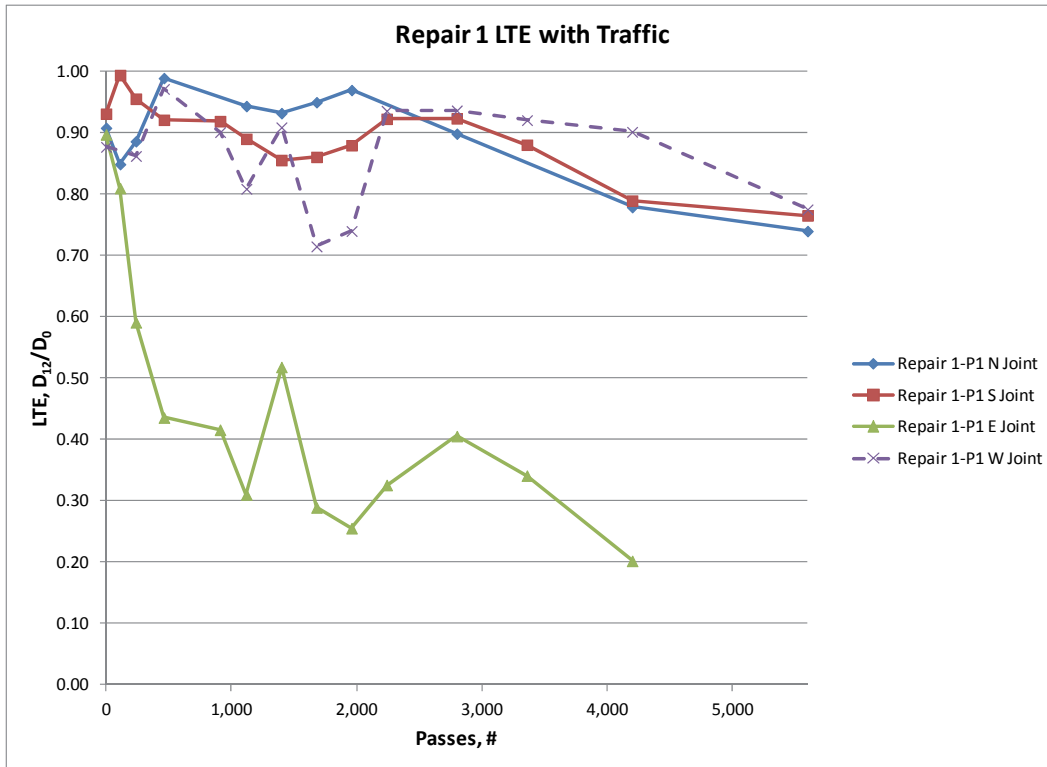
Figure 23. Load transfer efficiency for Repair 1 (Panel 1) with traffic.

For Repair 1, the E joint's LTE dropped rapidly after the initiation of traffic (90 percent before traffic to 20 percent at after 5,600 passes). This is not unexpected, as this was a longitudinal joint (no dowels). The high early LTE was attributed to the initial contact of the panel to the surrounding PCC during installation through temporary contact provided by flowable fill and rapid-setting grout used to seal around the panel and the dowel slots during field installation. During trafficking, the bond was weakened or destroyed due to the crushing of the material located in the narrow joint openings by traffic movement of the panel and PCC. While the individual LTE values varied during trafficking between the N and S joints, the maximum and minimum LTE values were very similar with 99 to 74 percent for the N joint compared to 99 to 77 percent for the S joint. These LTE measurements are above the minimum recommended threshold of 70 percent for transverse joints. The W joint performed similarly to the N and S joints with LTE ranging in the 90 percent and higher range to the 70 percent range, indicating that the joint may have experienced load transfer through contact of the panel and the parent PCC.

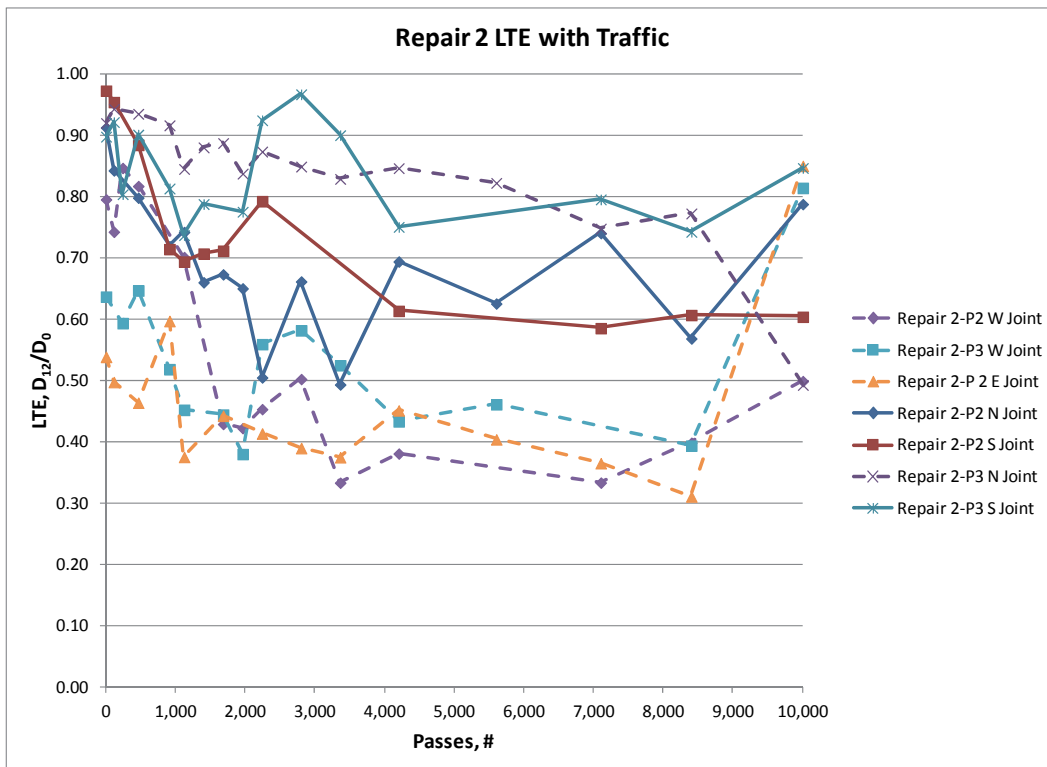
Figure 24. Load transfer efficiency for Repair 2 (Panels 2-3) with traffic.

For Repair 2, the N and S joints (transverse- doweled) had better LTE than the E and W joints (longitudinal- undoweled). Overall, the longitudinal joint between the panels (Panel 2 W joint (center)) performed worse than the other joints for this repair with a maximum LTE of 65 percent and minimum of 38 percent. Additionally, the LTE for this repair was poorer than for the single-panel Repair 1. This was attributed to the larger joint openings for this repair compared to Repair 1. The panel sizes were the same, but Repair 1 had a joint opening of approximately 0.375 in., while Repair 2 had joint openings of approximately 0.5 in. Panel 2 had a maximum LTE of 84 percent and minimum LTE of 62 percent for the N joint and 97 percent maximum and 59 percent minimum for the S joint. Panel 3 had a maximum LTE of 97 percent and minimum LTE of 75 percent for the N joint and 92 percent maximum and 80 percent minimum for the S joint. The E and W joints had similar values with Panel 3 W joint with a maximum of 64 percent and a minimum of 33 percent, while Panel 2's E joint had a maximum LTE of 60 percent and minimum of 37 percent. The transverse joints (N-S) with the exception of Panel 2's N and S joints were above the minimum 70 percent threshold.

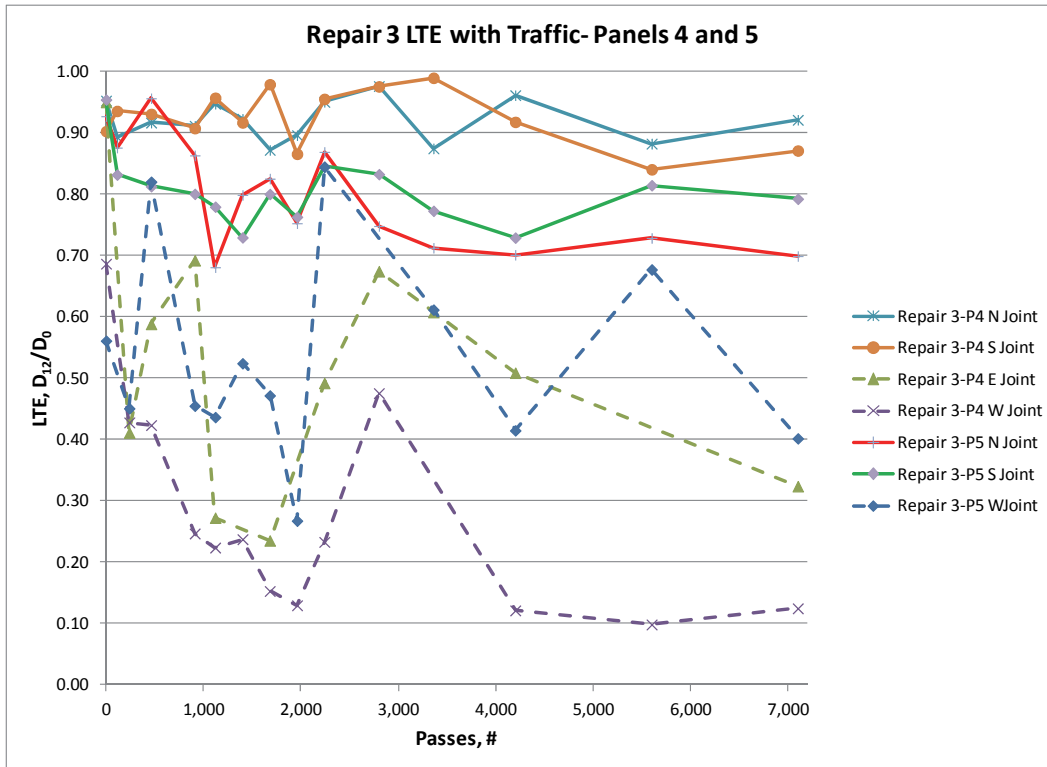
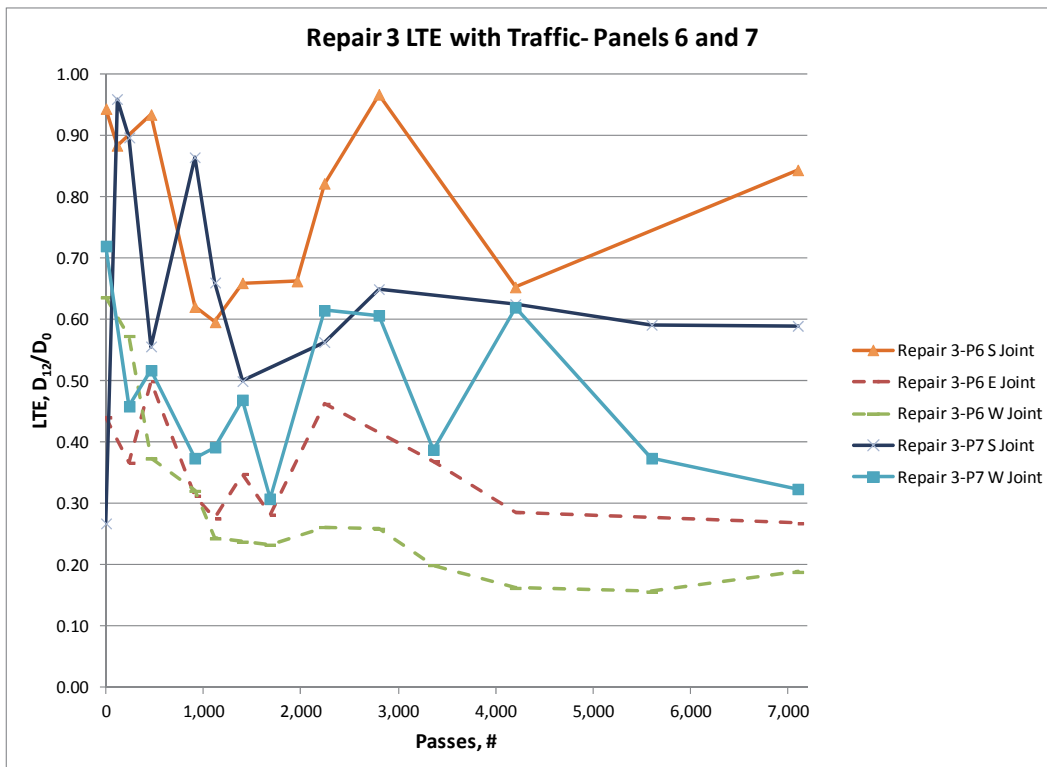
Figure 25. Load transfer efficiency for Repair 3 (Panels 4-5) with traffic.

For Repair 3, the center (longitudinal) joint between the panels had the lowest LTE compared to the other joints with initial values less than 70 percent and the lowest values of less than 20 percent after 5,600 passes. The N joints of Panels 4 and 6 performed similarly to each other with maximum LTE of 90 percent for Panel 4 and 97 percent for Panel 6, and a minimum LTE of 88 percent and 84 percent for the N joints of Panels 4 and 6, respectively. Panel 7 had the lowest LTE for its S joint with a minimum of 50 percent (below the minimum threshold). This could indicate loss of support on the S end. As with Repair 2, the longitudinal joints had poorer LTE than the transverse joints. The maximum LTE for the E joints were 90 percent for Panel 4 and 52 percent for Panel 6 with minimums of 51 percent and 28 percent, respectively. The W joints had LTE maximums of 82 percent for Panel 5 and 72 percent for Panel 7. The minimum LTE for the W joints of Panels 5 and 7 were 27 percent and 31 percent, respectively.

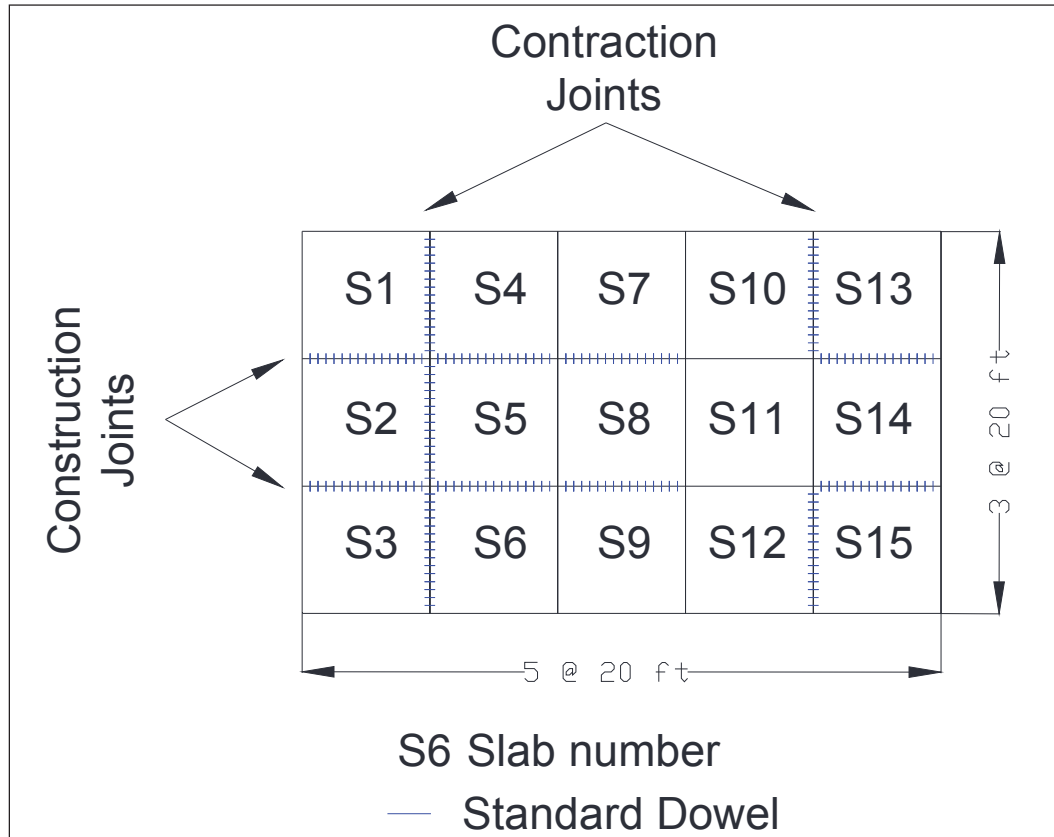
Figure 27. Dowel layout for precast slab test section.

For comparison, the LTE was calculated prior to traffic and after 10,000 passes on the parent slabs in locations shown previously in Figure 17. The majority of the slabs had LTE values greater than 70 percent prior to and after traffic with the exception of test locations 3, 10, and 11. These locations had LTE values well below the threshold level before and after traffic,

indicating that there was poor load transfer between slabs in these locations. These slabs were not doweled on the transverse joints, as shown in Figure 27.

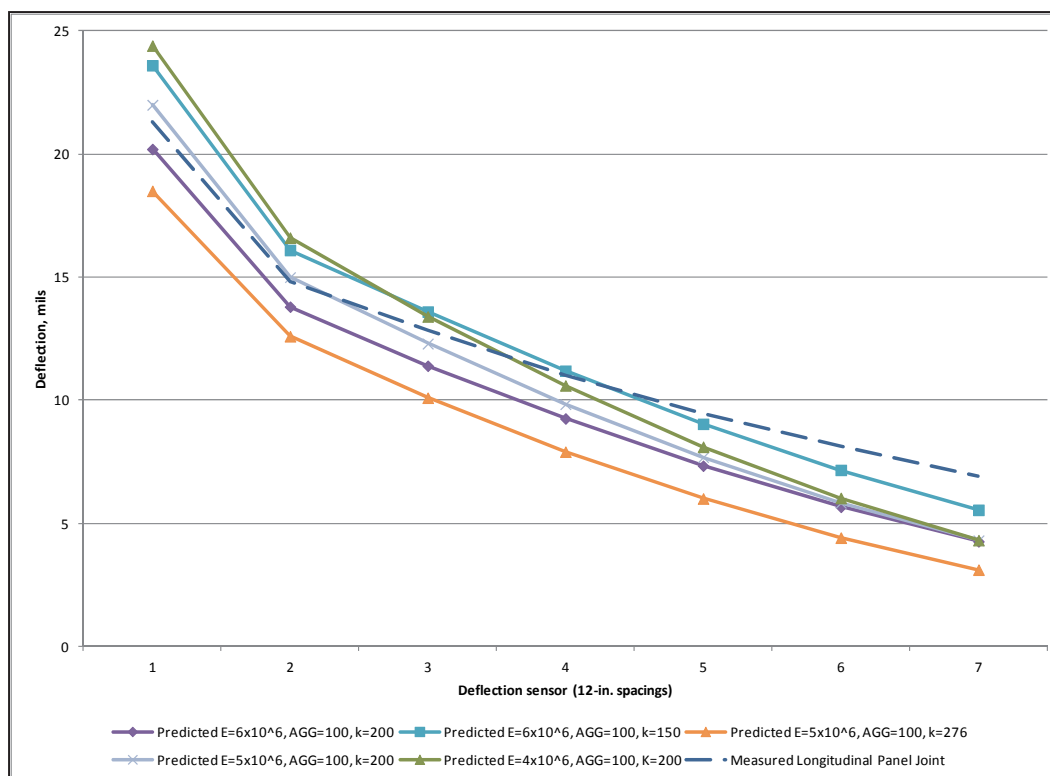
Figure 28. Predicted deflection basins for longitudinal joints prior to traffic.

The LTEs of the panels were predicted by simulating a joint load test using a Skarlatos rigid joint model. The model simulates two infinite slabs connected by a single joint of infinite length. The measured deflection basins for the panels were used to estimate the panel modulus of elasticity ( $E$ ), joint stiffness factor ( $JSF$ ) and modulus of subgrade reaction ( $k$ ) prior to traffic and at failure.  $AGG^*$  is a nondimensional stiffness of the joint. During the simulations,  $E$  was varied between 4 and 6 x 10<sup>6</sup> psi (reasonable range for PCC pavement), and the  $JSF$  was varied between 100 (excellent load transfer) to 0 (no load transfer).  $k$  was varied between 100 and 276 pci (the measured test section  $k$  value). Predicted deflection basins were compared to measured deflections for each joint type (transverse and longitudinal) to determine which modeled joint behavior(s) best reproduced the measured joint behaviors. A subset of the predicted deflection basins compared to the average longitudinal joint behavior of the repairs prior to traffic is presented in Figure 28.

While none of the simulated basins exactly matched the measured basins, the best predicted basins were obtained when  $E=5 \times 10^6$  psi,  $JSF=100$ , and  $k=200$  pci for the initial calculation of LTE on the transverse joints (prior to traffic). This high joint stiffness factor of 100 indicated high load transfer (>90 percent). For the longitudinal joints, the joint stiffness factor was reduced to 4 for the initial calculation of LTE. A joint stiffness factor of 4 is representative of good load transfer of approximately 70 percent.
