## **Demonstration of Corrosion-Resistant Fire Hydrant Retrofits For Military Installations**

Final Report on Project F09-AR12

Edgar Dean Smith, Mark D. Ginsberg, and Clint Wilson

October 2013

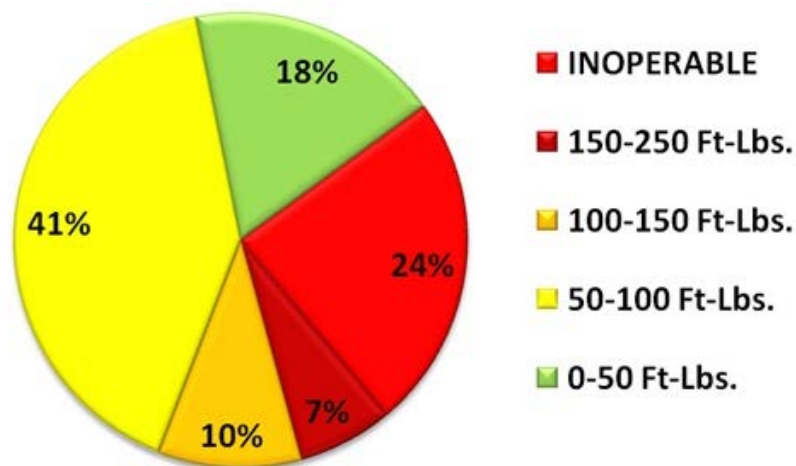
Figure 13. Torque needed to open each of the 90 fire hydrants before installing DATV kits.

These measurements were recorded before and after the installation of the DATV kits. The ideal torque required for an individual person to open a hydrant is 30–45 ft-lb. A hydrant was classified as inoperable if it required more than 250 ft-lb of torque to open. Although hydrants requiring less than 250 ft-lb were considered operable, hydrants needing more than 150 ft-lb of torque required the extra leverage provided by a cheater bar to operate. As previously noted, in most cases it required two or three people pressing applying force to a cheater bar to open an inoperable hydrant for servicing. Figure 13–Figure 15 illustrate the torque characteristics of the 90 hydrants evaluated.

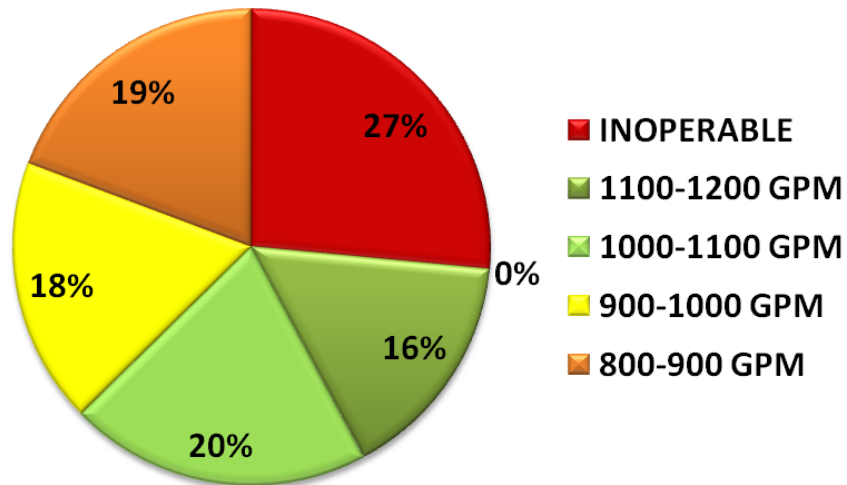
Figure 16. Volumetric flow through each hydrant model before installing a DATV kit.

The DATV kits are designed not to restrict any flow from the hydrants. In most cases, the shape of the barrel sleeve will reduce turbulent flow through the barrel and increase the flow rate. Upon completion of the DATV installation, all inoperable hydrants were returned to an operable status. The results are shown in Figure 16 and Figure 17. Static pressure

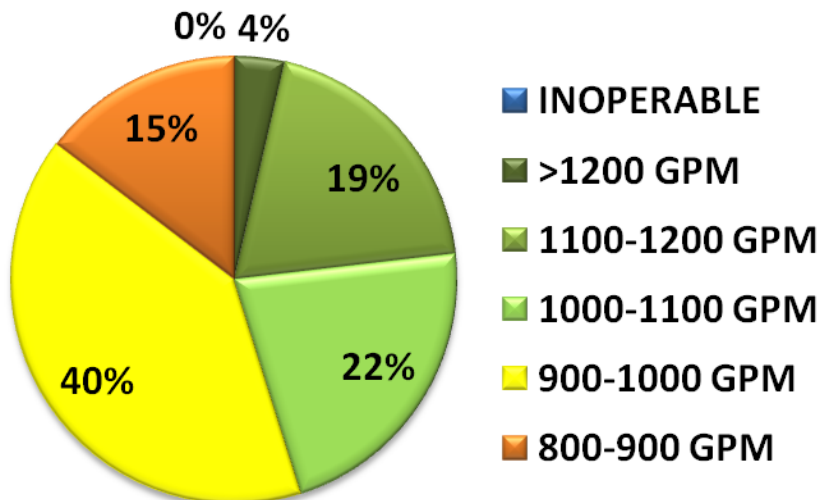
Figure 17. Volumetric flow through each hydrant model after installing a DATV kit.

was also recorded; as expected, it did not change with the installation of the DATV kits.

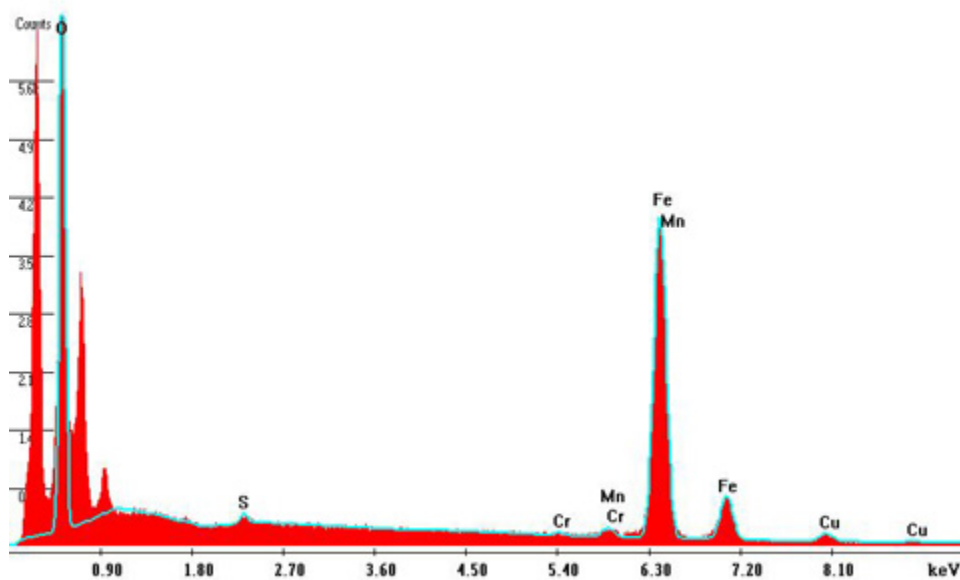
Figure D6. Plot of counts versus x-ray energy for the black powder from the valve stem under the copper sleeve.

Results of the water chemistry analysis indicated that the pH is neutral and that there is little risk of scaling related to calcium in the water. A visual inspection of the DATV components in 12 hydrants was made after 12 months in service. The stainless steel components of the DATV kit showed no signs of corrosion damage. The one cold-rolled valve stem that was inspected after 12 months—original manufacturer's equipment experimentally substituted for the standard DATV stainless stem—was found to be severely corroded in two places. In Appendix D, it is shown that the corrosion of the original stems is caused by dissimilar metal corrosion between the brass raceway for the O-rings and the cold rolled steel stem underneath.
