**Innovative Masking of Ferrous Inserts in Magnesium  
Aerospace Components Prior to Tagnite Anodization  
(v.1, Unlimited Release)**

**ARL-CR-716**

**July 2013**

**Technology Applications Group, Inc.  
810 S. 48th St.  
Grand Forks, ND 58201**

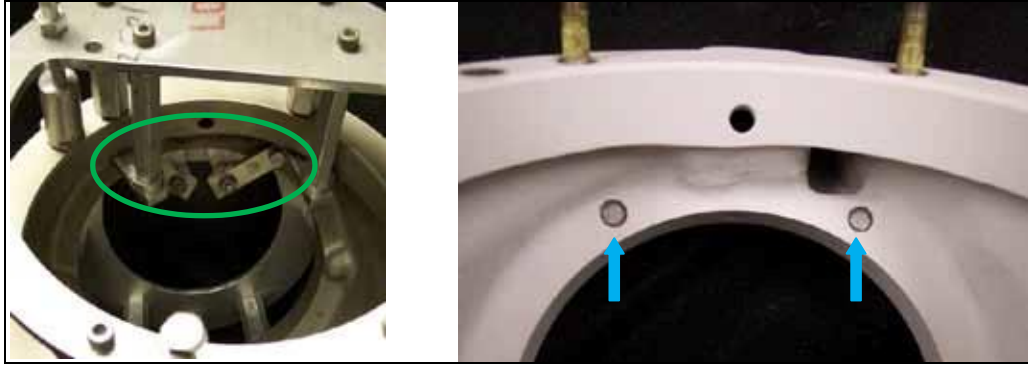
Figure 21. Masking for stud bottoms on H-60 components. Left: masking for stud bottoms using linkage to bridge. Right: close-up of stud bottoms after Tagnite (no damage).

- The UV maskant held up well, but to get the best results, the UV maskant must completely cover the buttons or stud bottoms along with some overlap (1/32 to 1/16 in) onto the magnesium portion of the casting.
- The shoulder on the mounting pad bushing cover could force the O-ring below the lip of the bushing, which would cause a gap between the O-ring and the cover. This movement would result in Tagnite electrolyte reaching the surface of the bushing and oxidizing the surface. We must exercise care when installing the cover to avoid pushing the front part of O-ring out of position.

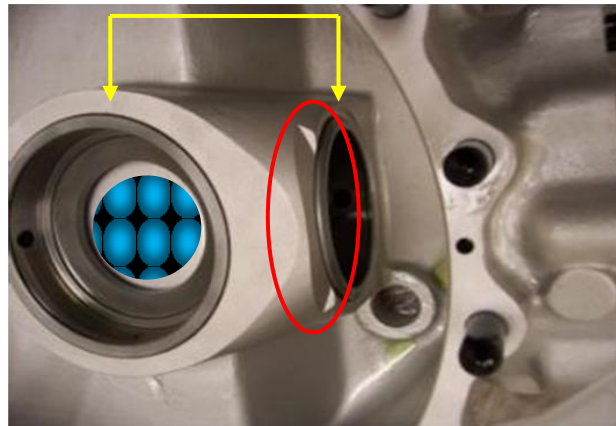
The primary masking challenge on the tail rotor gearbox housing was the masking of the two steel liners inside the housing. The difficulties with these liners were as follows:

1. There was solid magnesium underneath the liners, which eliminates the use of top and bottom covers (figure 34, blue shading).
2. One of the liners had a notch in the magnesium around the perimeter of the steel liner (figure 34, red oval).
3. The steel liners are mounted at a 90° angle to each other (figure 34, yellow).

Figure 34. Tail rotor gearbox housing steel liners.

The masking approach shown in figure 35 used to protect these steel liners was to manufacture aluminum covers and place them over the top of the liners. The covers would be held in place by attaching an aluminum bridge to the threaded stud covers for the studs on the machine faces, then use long aluminum studs anchored in the bridge to hold and seal the aluminum cover into place over the steel liners.

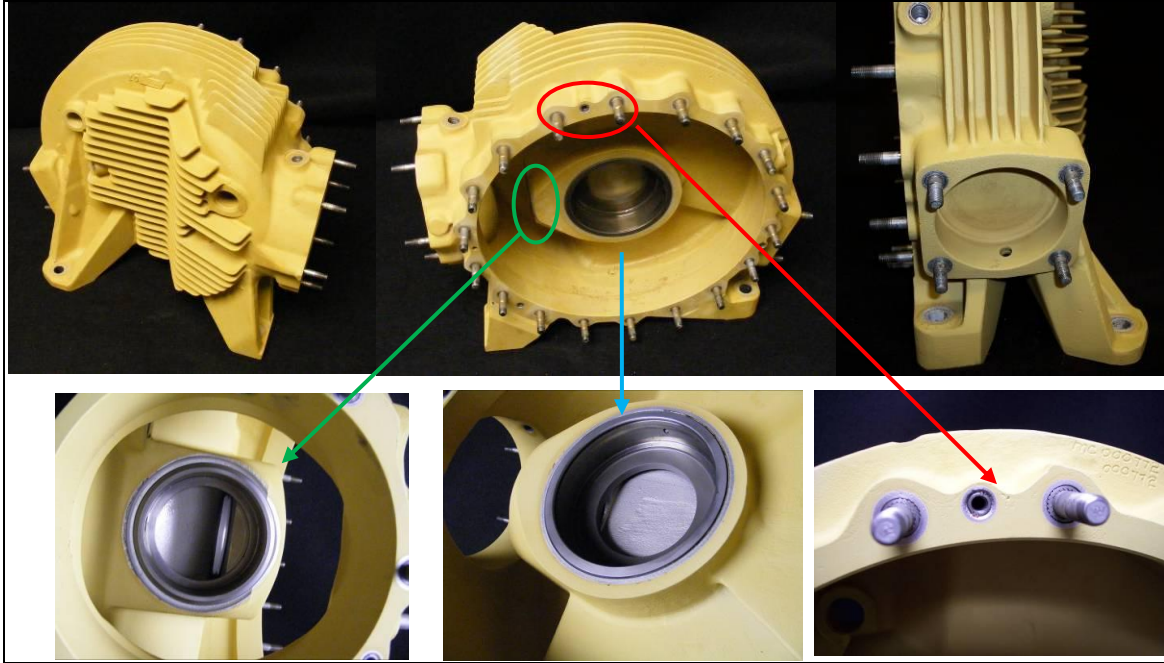
The masked H-64 tail rotor gearbox housings were run through the Immersion Tagnite bath using the same conditions that a new tail rotor gearbox housing without any mixed metal would be processed in the TAG production line. After the immersion Tagnite process, the masking was removed and the parts were inspected. Multiple trials were done using the masking protocol, and there was never a single instance of damage to any mixed metal inserts on this part. Pictures of tail rotor gearbox housings after Tagnite are shown in figure 36.\*

Figure 36. H-64 tail rotor gearbox housing after Tagnite 8500.

After Immersion Tagnite and inspection of the mixed metal inserts, the bare areas around the mixed metals were touched up using low-voltage Brush Tagnite (figure 37).

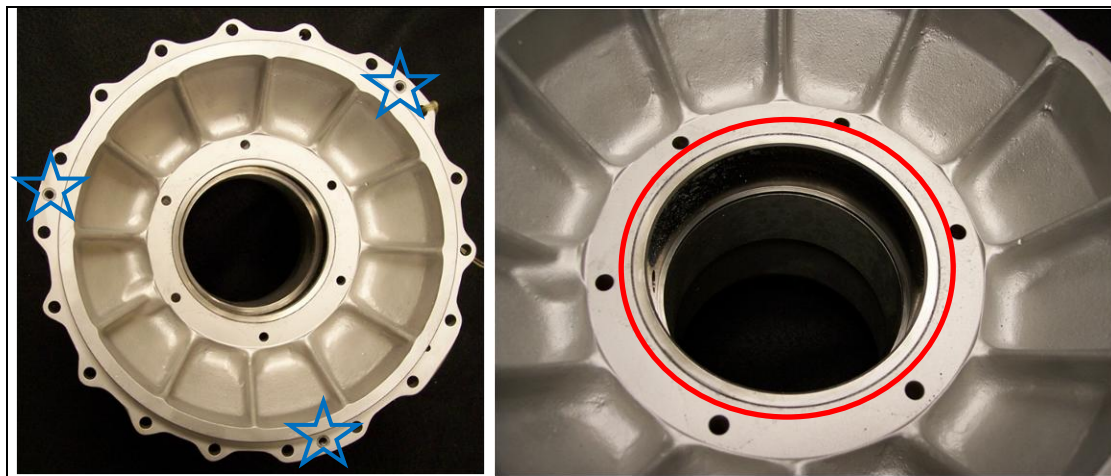
Figure 39. H-64 tail rotor cover contains three helicoil inserts (blue) and one pressed-in bearing liner (red).

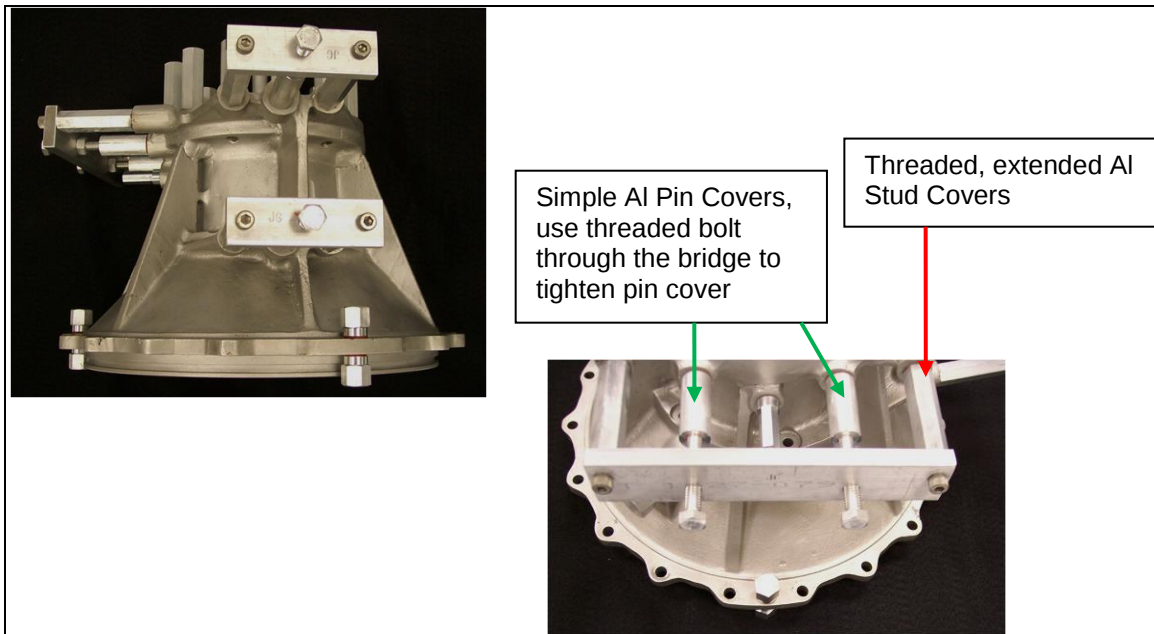
Figure 40. Two types of aluminum bridge designs used to cover alignment pins on H-64 tail rotor cover.

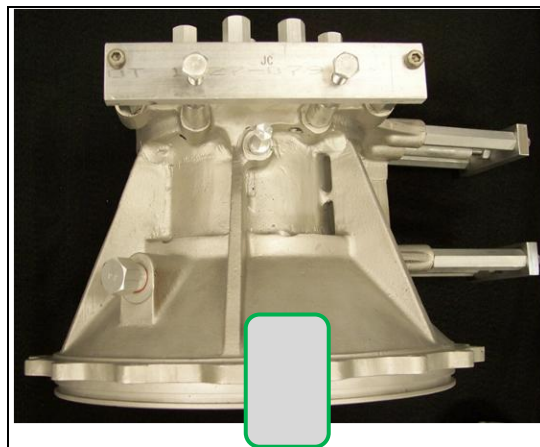
Figure 41. Examples of aluminum insert and helicoil covers.

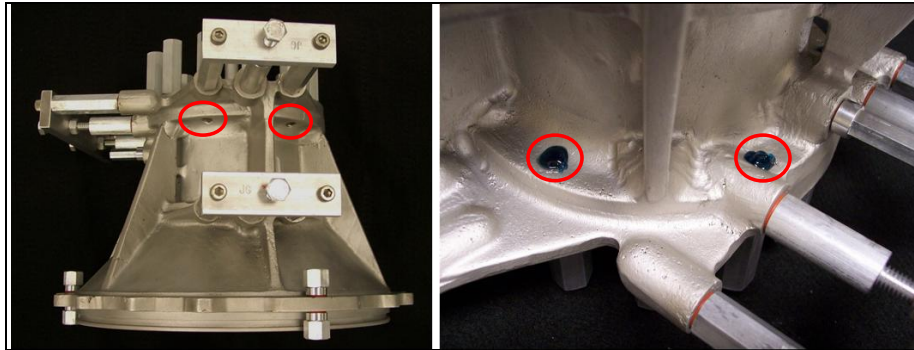
There were studs on the small-diameter opening of the housing that went all the way through flange and broke out of the bottom of the flange, exposing the bottom of the studs (figure 42). The irregular surface in this area eliminated the use of aluminum covers and instead was masked off using the Dymax UV curable maskant applied using a syringe and medium-gauge needle.

Figure 42. Left: location of stud bottoms that are exposed on bottom of the flange.  
Right: stud bottoms after filling with Dymax UV maskant.

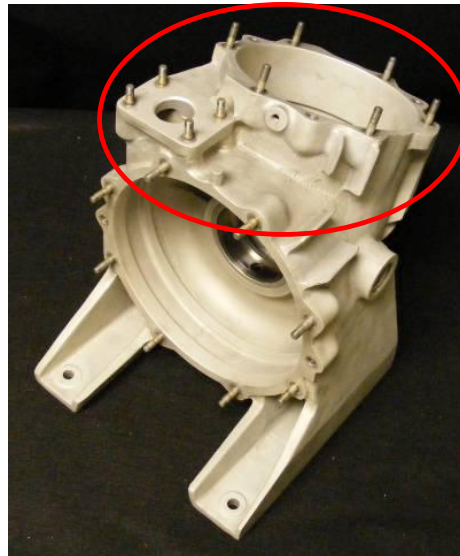
Figure 46. H-64 intermediate gearbox – top of housing contains 10 studs, 3 helicoil inserts, and steel liner in housing body.

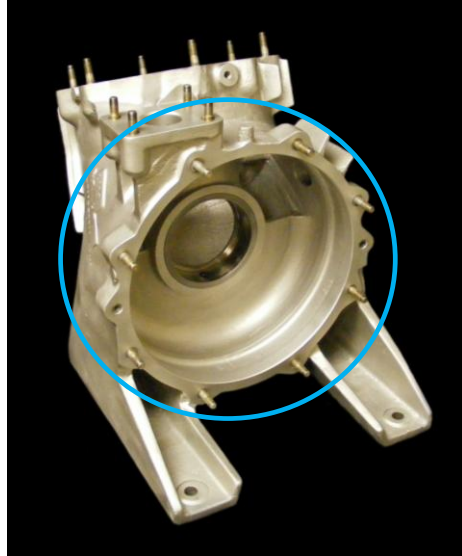
Figure 47. H-64 intermediate gearbox – front of housing contains 8 studs, 3 helicoil inserts, and steel liner in housing body.

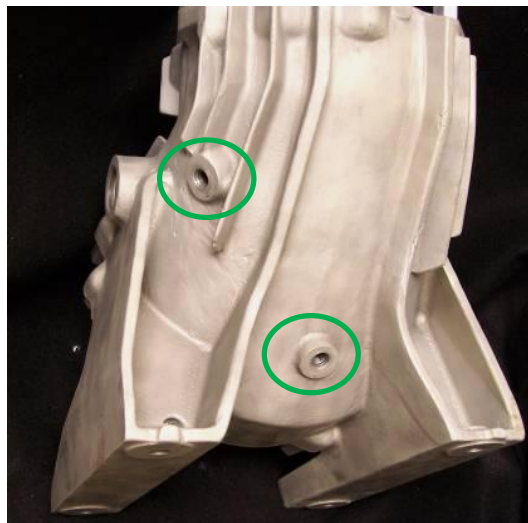
Figure 48. Location of two inserts on backside of H-64 intermediate gearbox.

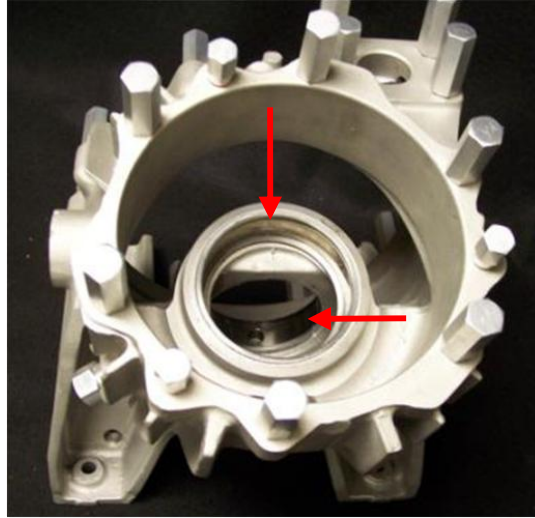
Figure 49. Location of two steel liners in the interior of H-64 intermediate gearbox looking from the top.

The primary challenge on this component was the two steel liners seen in figures 49 and 50, which are in the interior of the component. Additional challenges with these liners are as follows:

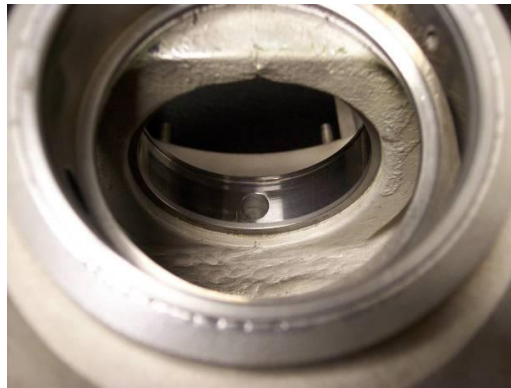
Figure 50. Close up view of two steel liners looking from the top. Steel liners are mounted at a 90° angle.

- The top steel liner rests on a three-quarters moon-shaped hole in the casting (figure 50). The ledge underneath the top liner makes it difficult to seal the bottom portion of this liner.

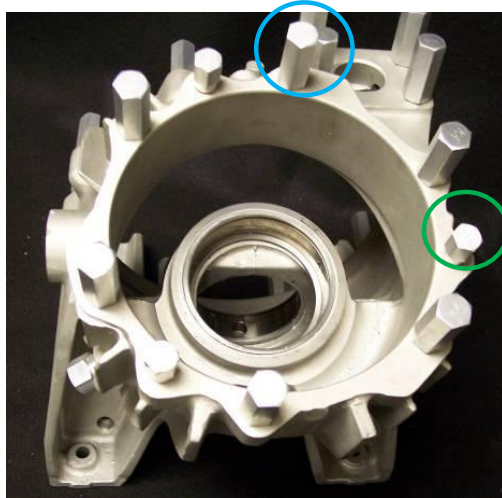
Figure 51. Threaded aluminum stud covers (blue) and helicoil covers (green) installed on the H-64 intermediate gearbox.

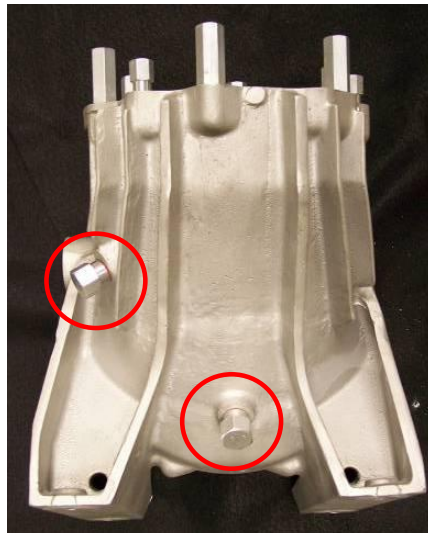
Figure 52. Threaded aluminum insert covers installed on the H-64 intermediate gearbox.

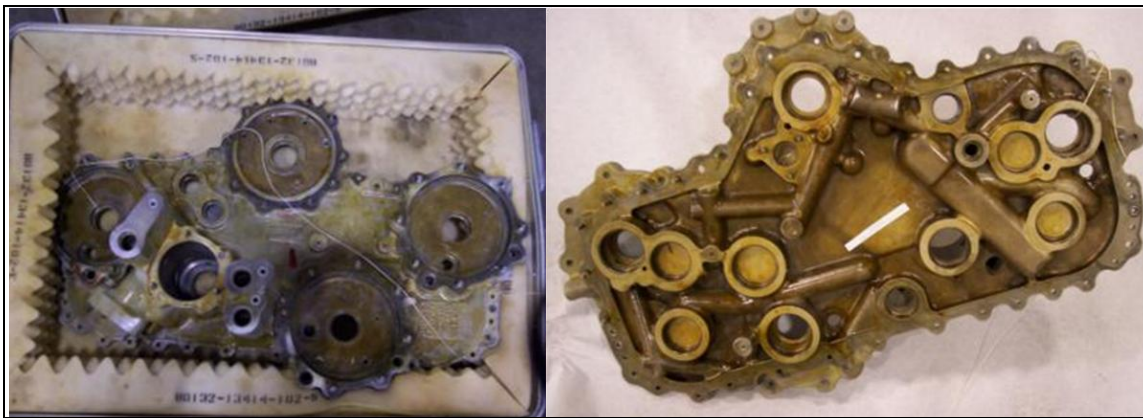
Figure 58. As-received pictures of two H-47 accessory covers from CCAD/SAFR.

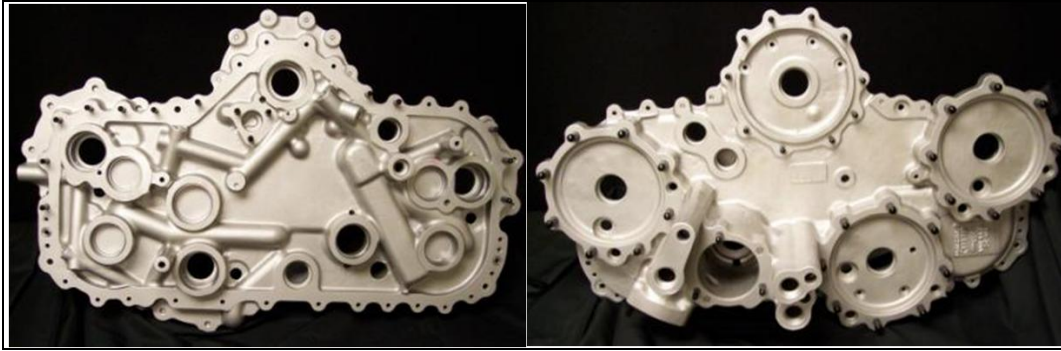
Figure 59. H-47 accessory cover after media blast cleaning.

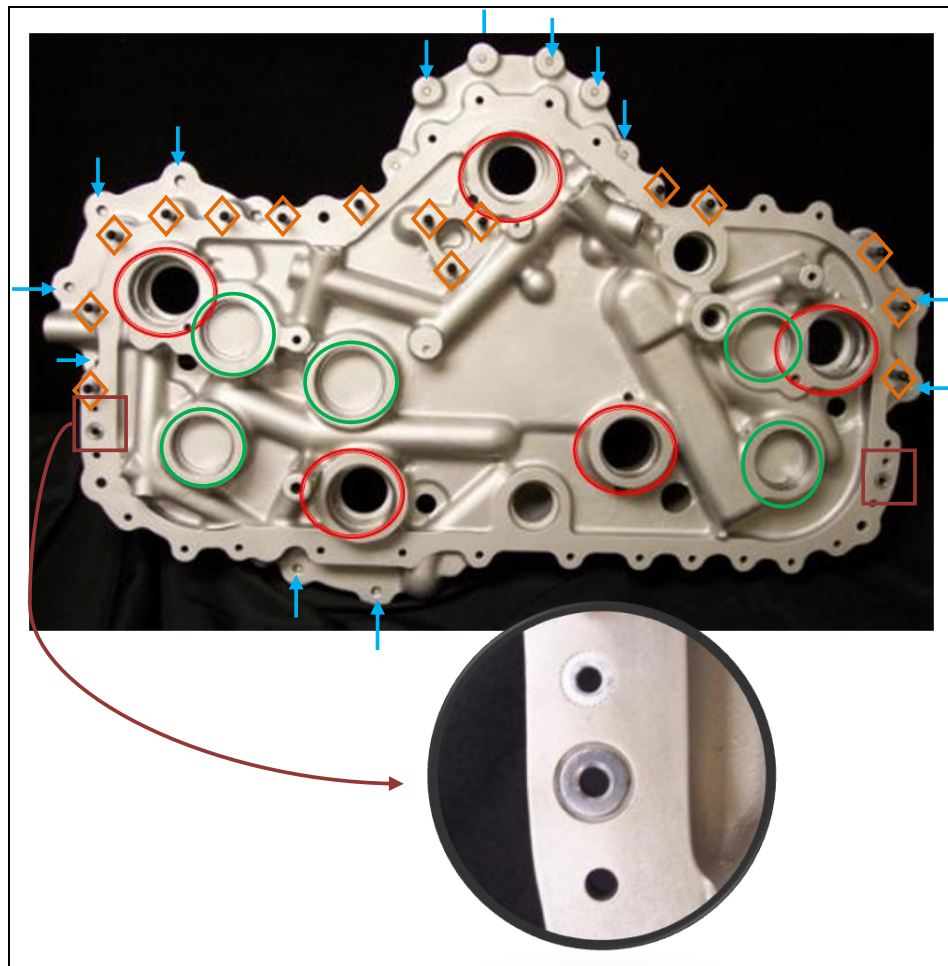
Figure 60. H-47 accessory cover – bottom contains 15 threaded studs, 5 bearing races with through holes, 5 bearing races (enclosed), 13 stud bottoms for UV maskant, and 4 inserts.

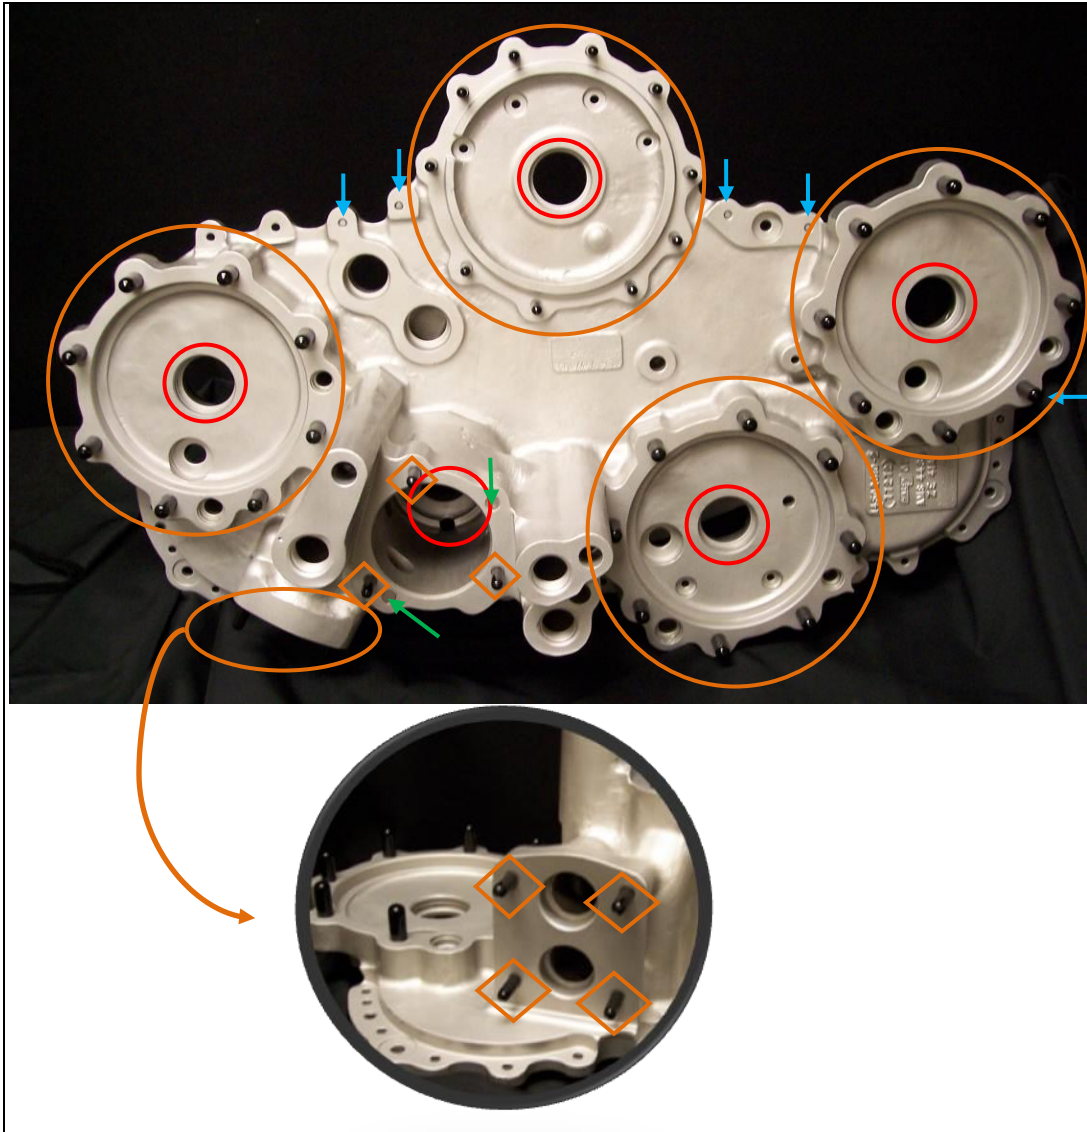
Figure 61. H-47 accessory cover – top contains 41 threaded studs, 5 bearing races with through holes, 2 inserts, and 5 stud bottoms for UV maskant.

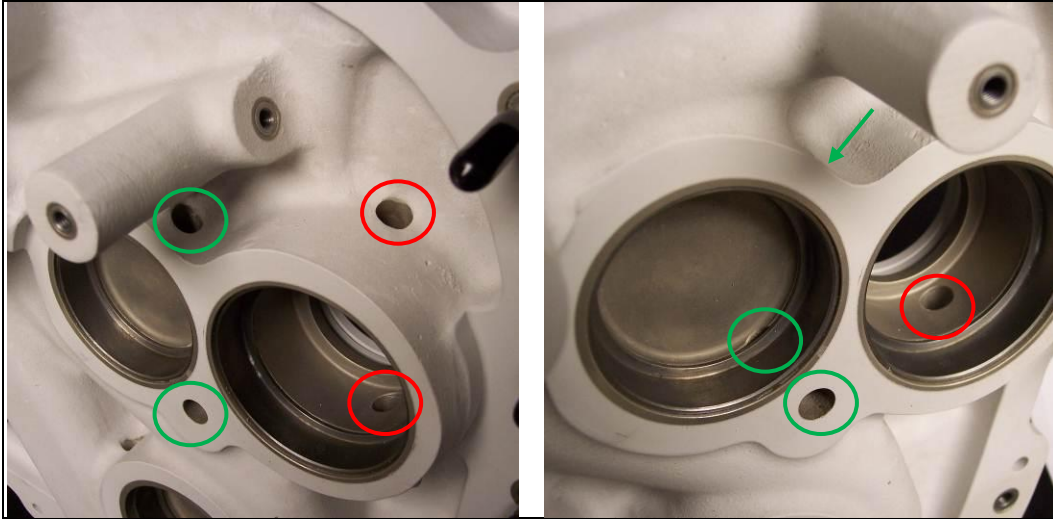
The steel bearing races on the accessory cover are more complicated than the liners on the H-60 and H-64 platforms. Each bearing race has oil drainage holes in the steel or right underneath the steel. There are also two drain holes out of each bearing race that leads to the outside of the housing. Examples of these drain holes are shown in figure 62. These drain holes must all be plugged to prevent Tagnite electrolyte from making contact with the steel races.

Figure 62. Drainage holes for bearing races on H-47 accessory cover. Drainage holes for recessed bearing races (left) and drainage holes for bearing races with through passageways (right).

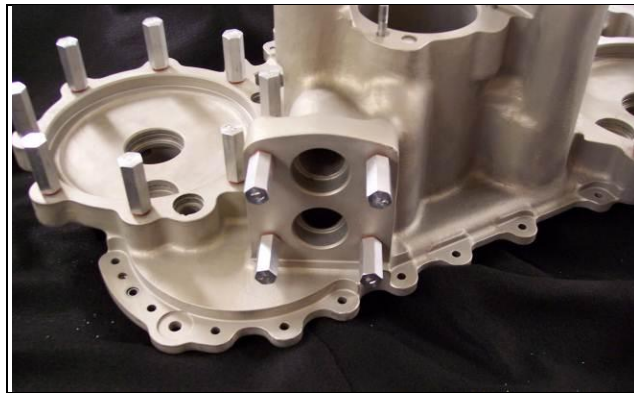
Figure 63. Typical masking on threaded studs.

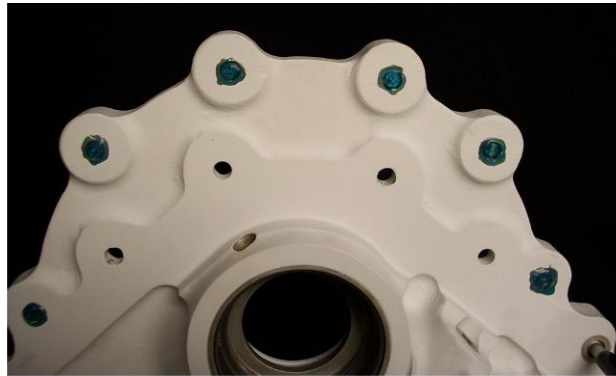
The outside drainage holes were plugged using silicon plugs that were cut down to size and the exposed stud bottoms were masked off using the UV curable maskant (figure 64).

Figure 64. Example of UV curable maskant on stud bottoms of H-47 accessory cover.

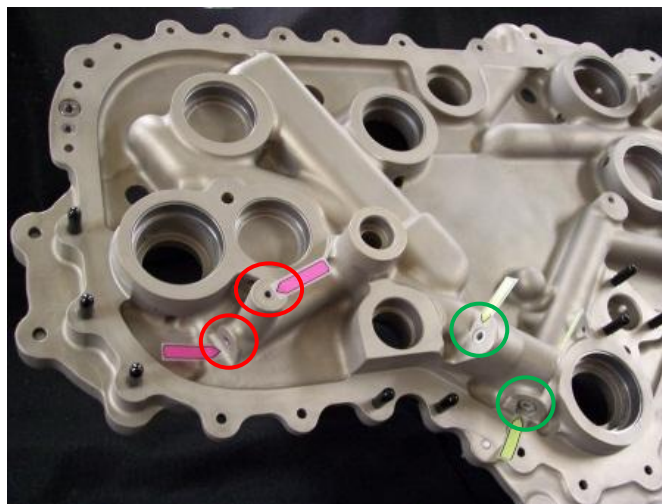
Figure 69. Additional inserts on bottom of second H-47 accessory cover (view 3): nonmagnetic (green) and magnetic (red).

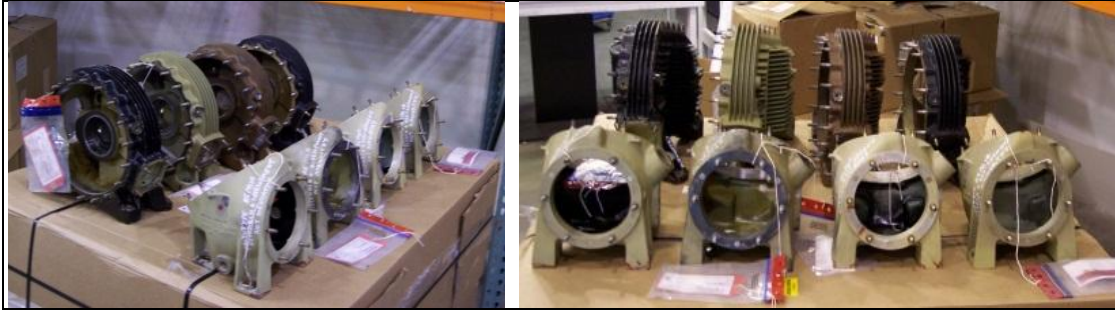
Figure 74. H-60 center housings and H-64 tail rotor gearbox housings for IBIF demonstration (as-received condition).

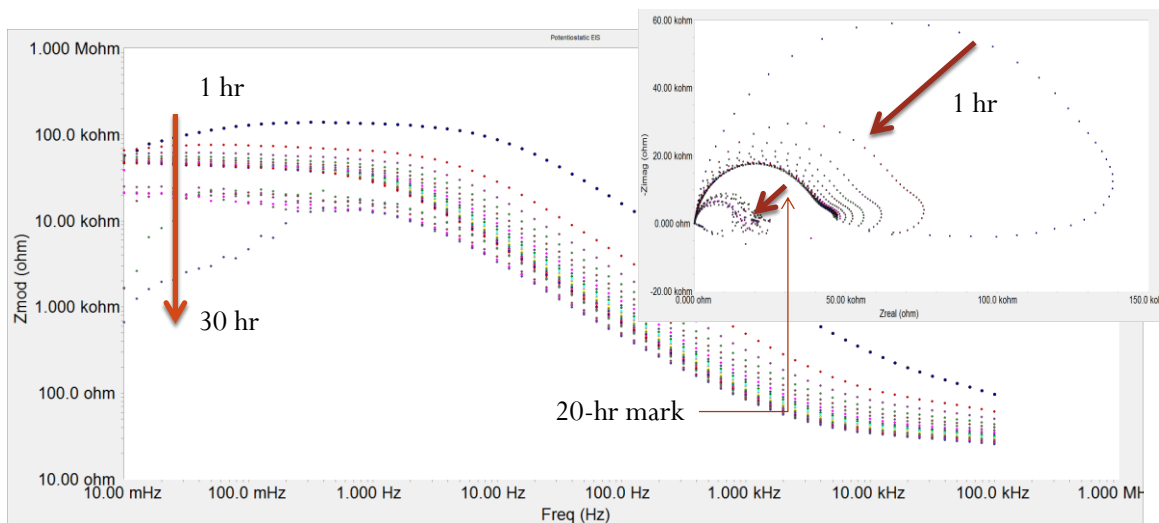
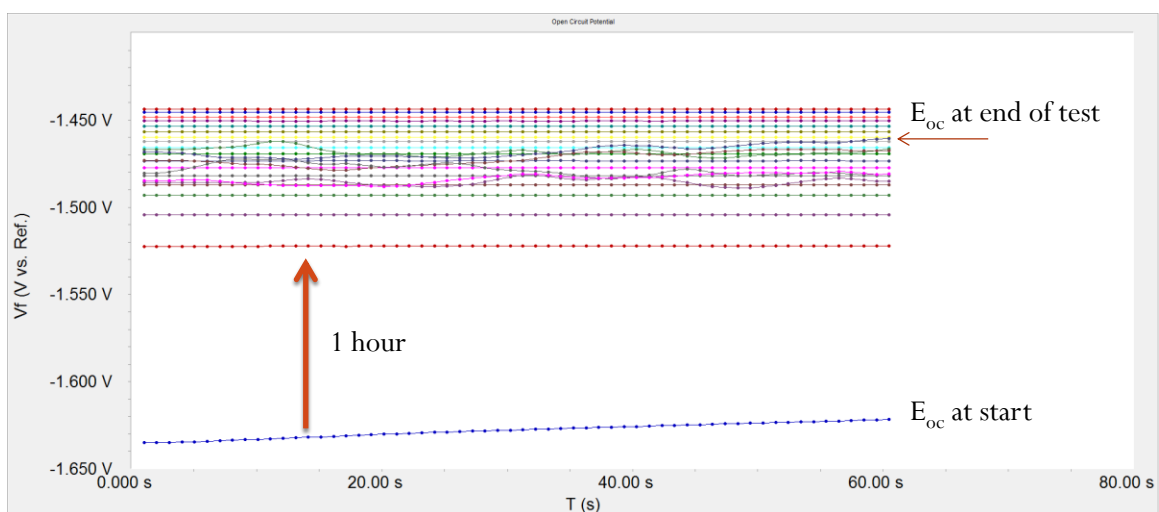
Figures 5 and 6 show the EIS spectra and open circuit potential (OCP) records for the HAE primer on Mg alloy ZE41. Initially, the coating has a low-frequency  $|Z|$  on the order of a few hundred kilo-Ohm, which is typical for primers. However, the coating deteriorates quickly during the first EIS run upon immersion in 1% NaCl. The OCP of -1.65V (vs. SCE) suggests the metal undergoes corrosion at the very start of the experiment, that is, after 20 minutes of soaking in electrolyte, the primer does not prevent the electrolyte from contacting the metal.

One hour into immersion, the OCP moves in the positive direction due to the formation of corrosion products. The EIS spectra show the gradual decrease of the low-frequency modulus, as simultaneously with the formation of corrosion products, the area affected by corrosion increases due to further degradation of the coating. Eventually, the entire coating layer is removed, and only corrosion products remain on the surface. At the 20-hr mark, the corrosion seems to accelerate again, which is indicative of further removal of corrosion products and exposing a new area for further contact with electrolyte. At the 20-hr mark, the trend for OCP going more positive changes direction, and the OCP values begin to trend more negative, back to the OCP values of the bare metal. This is due to more metal being exposed at prolonged exposure.

Figure 5. EIS for ZE41 with HAE: Bode (main) and Nyquist (inset) diagrams.

Figure 6. EIS for ZE41 with HAE: Open circuit potential (vs. SCE).

At the end of EIS tests, once the corrosion products were washed from the surface, there were several areas of exposed metal clearly visible for both HAE and DOW17 primers, indicating complete degradation and removal of the primers during constant immersion in 1% NaCl.

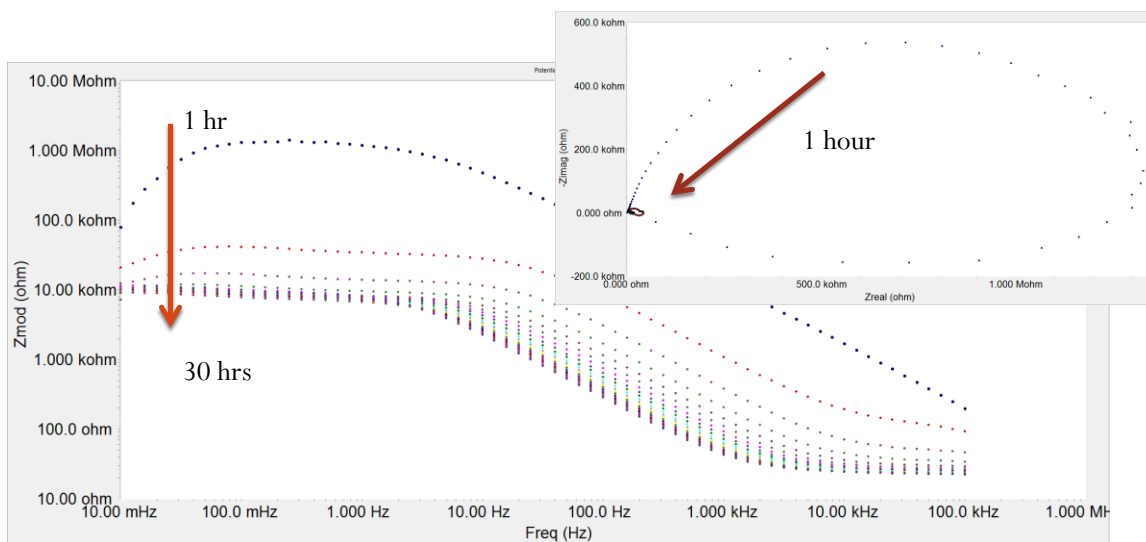
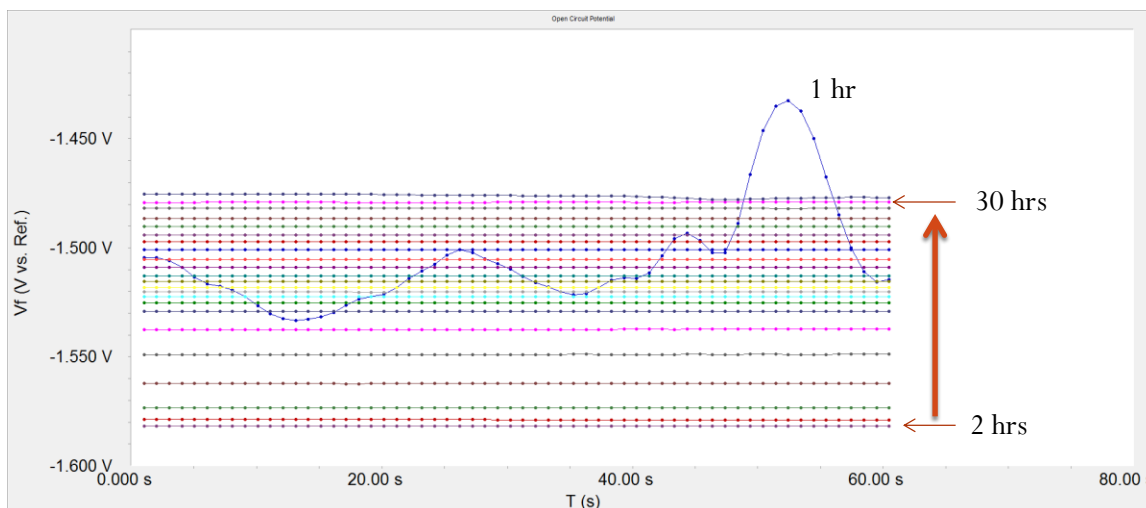
Figures 7 and 8 show the EIS spectra and open circuit potential (OCP) records for the DOW17 primer on Mg alloy ZE41. DOW17 behaves similarly to HAE in that it, too, provides poor barrier protection from corrosion. However, it appears the DOW17 coating presents more of a protection layer than the HAE, judging by the OCP values, albeit not significantly.

The OCP reaches the value for bare Mg at the beginning of the 2<sup>nd</sup> EIS test (vs. 1<sup>st</sup> for HAE), after which it climbs positively for the duration of the experiment. It can be concluded from the EIS spectra that corrosion products gradually form on the surface, and by 30 hours of exposure in 1% NaCl, the film is still being broken down and corrosion products still form on the surface and occupy most of the area. There is no OCP trend reversal back to bare metal, and EIS spectra do not change their shape at the end of the test, unlike HAE (Figure 5), where at the end of the last two EIS runs, the modulus dips down to 1 k $\Omega$ -cm<sup>2</sup>, indicating further exposure of Mg alloy underneath corrosion products upon their removal from the surface.

Figure 7. EIS for ZE41 with DOW17: Bode (main) and Nyquist (inset) diagrams.

Figure 8. EIS for ZE41 with DOW17: Open circuit potential (vs. SCE).

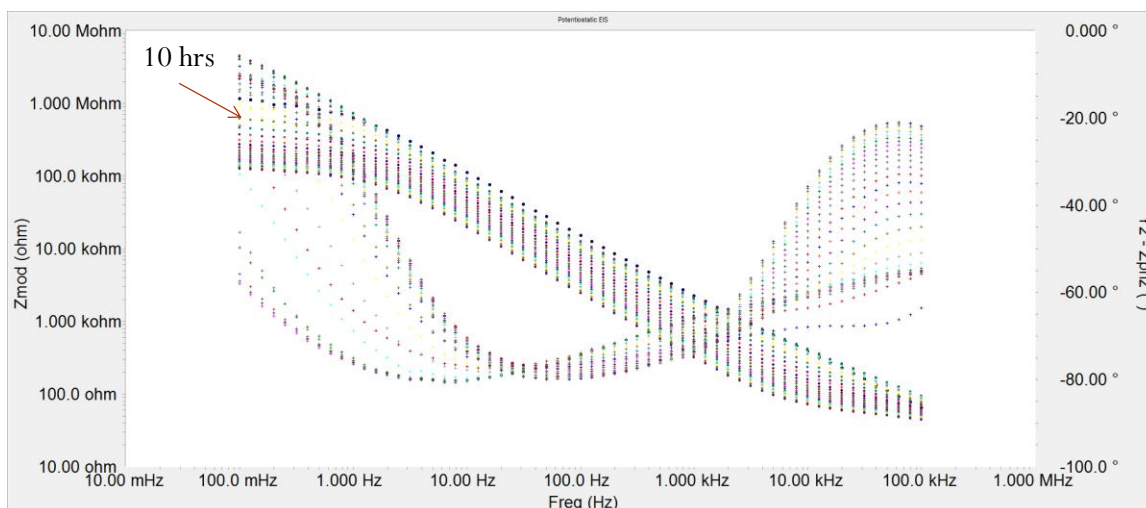
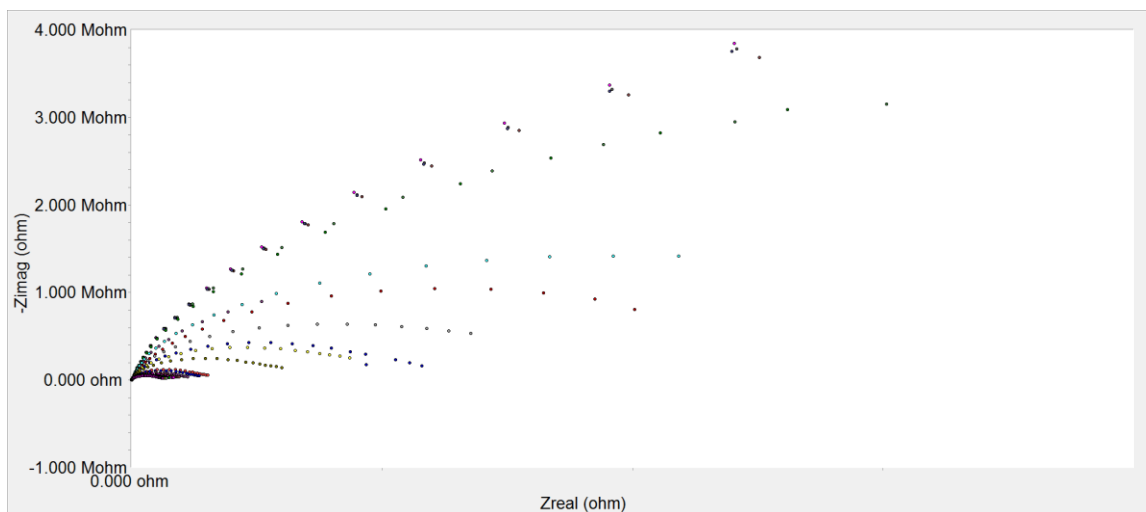
For the non-topcoated TAG8200, the low-frequency impedance modulus,  $|Z_{lf}|$ , indicative of the overall barrier properties of a coating system, decreased with time, as seen in Figure 9. The decrease was not gradual; in fact,  $|Z_{lf}|$  increased initially, albeit slightly. Figure 10 shows the Nyquist diagram for TAG8200 – an alternative representation of EIS data in a complex impedance domain.

Figure 9. EIS for ZE41 with TAG8200 (Bode plot,  $|Z|$  and Phase angle vs. log frequency).

Figure 10. EIS for ZE41 with TAG8200 (Nyquist plot,  $-Z_{Imag}$  vs.  $Z_{Real}$ ).

The Nyquist plots suggest that the initial increase of  $|Z_{lf}|$  is mainly brought about through the increase of the imaginary (capacitive) component of impedance modulus. Over the first 3-4 hours, the real (resistive) component increased from  $\sim 1$  to  $2.5 \text{ M}\Omega\text{-cm}^2$ , whereas the imaginary component jumped from  $\sim 0.1$  to almost  $4 \text{ M}\Omega\text{-cm}^2$ . The imaginary component is associated with the coating's capacitance. The increase in capacitance in this case is brought about by the water ingress into the film. As the electrolyte reaches the surface, corrosion products account for the

After 10 hrs in 1% NaCl, the value for  $|Z_{lf}|$  decreased to the  $10^6 \Omega\text{-cm}^2$  threshold, below which a coating is considered “poor” in terms of corrosion protection. However, the  $10^6 \Omega\text{-cm}^2$  value applies to full coating systems. Therefore, if a topcoat is to be applied over the TAG8200, then the values below  $10^6$  are still meaningful for the purpose of ranking of various surface modification techniques.

At the end of the EIS test, once the corrosion products were removed from the surface, no areas of exposed metal were observed for TAG8200.

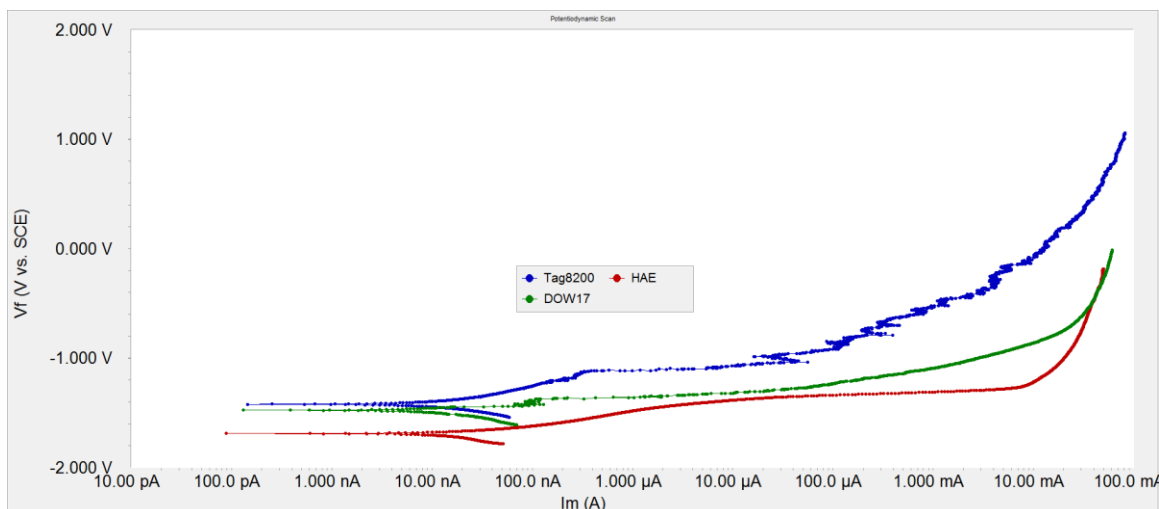
Figure 12 depicts potentiodynamic (PDS) curves for all three types of surface modifications, namely TAG8200 (blue), DOW17 (green), and HAE (red). The DOW17 records a higher corrosion potential than HAE, which is consistent with the OCP values from EIS results. Higher OCP value is indicative of a somewhat higher initial protection afforded by this coating (relative to HAE). The small shoulder in the PDS records of DOW17 at 100 nA corresponds to a potential range of 70 mV. This is the area of passivation brought about by the brief formation and dissolution of corrosion products on the surface of the film. However, this passivation is very insignificant and should in no way be viewed as the evidence that DOW17 is the optimal coating for corrosion protection of Mg alloys. Both HAE and DOW17, as deposited, fail to protect Mg alloy from corrosion even in the presence of a mild electrolyte, such as 1% NaCl. Higher OCP for DOW17, -1.5 V vs. -1.7V for HAE, and the presence of passivation classifies DOW17 as providing marginally better protection for ZE41. However, the high corrosion current, on the order of microamps, makes both HAE and DOW17 poor choices for protection of Mg alloys.

For the TAG8200 sample, the corrosion potential is recorded at -1.42 V (vs. SCE), which is 260 mV above that for DOW17. Additionally, TAG8200 has a higher breakdown/pitting potential than the DOW17. The higher this potential, the more electrochemical stress can the film withstand. At -1.11 V (vs. SCE),  $E_{pit}$  for TAG8200 is 310 mV above its corrosion potential ( $E_{corr} = -1.42$  V) and, thus, indicates a more protective system than HAE or DOW17.

Figure 12. PDS for ZE41 with TAG8200, DOW17, and HAE.

In addition to the presence of a well-defined pitting potential,  $E_{pit}$ , TAG8200 records a smaller corrosion current on the order of tens of nanoamps, which is several orders of magnitude lower than that for HAE and DOW17. A significantly lower corrosion current of TAG8200 makes it a better candidate for corrosion protection of Mg alloys.

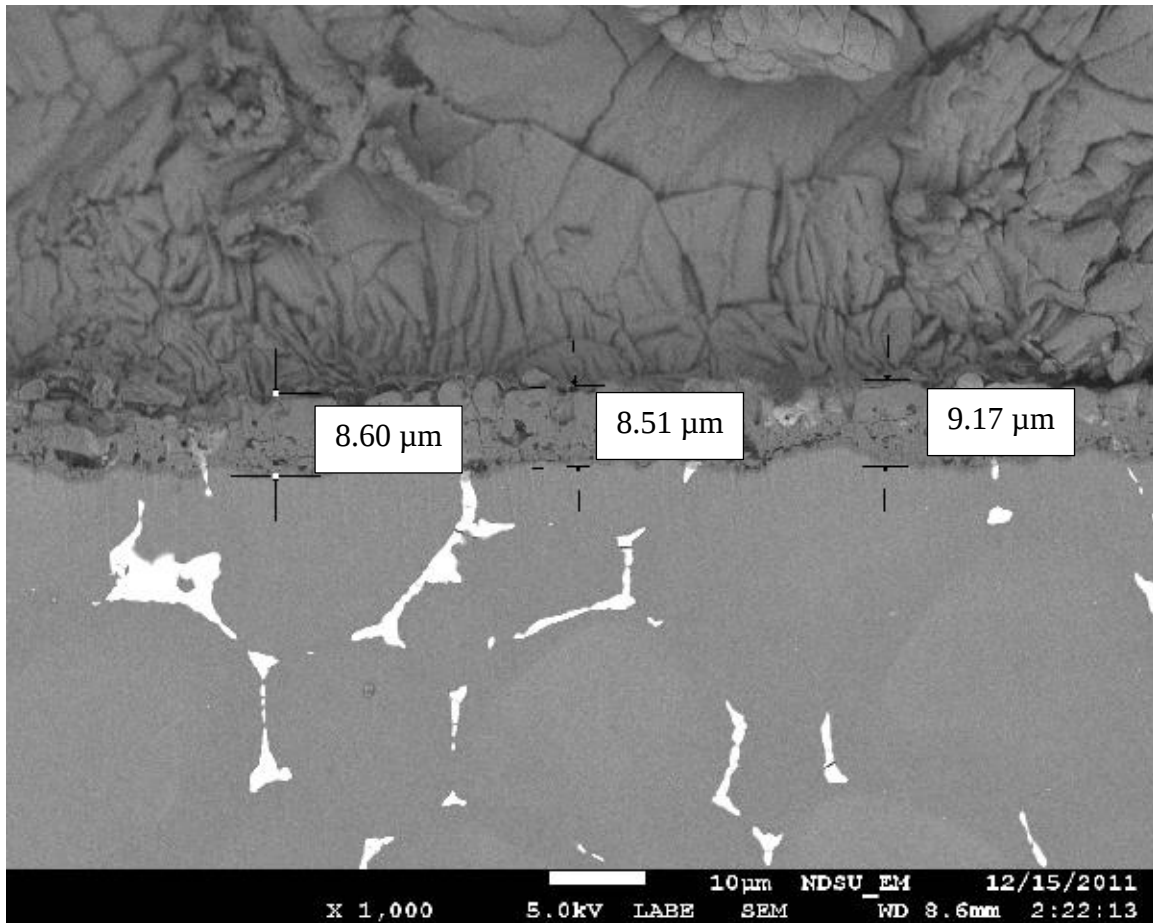
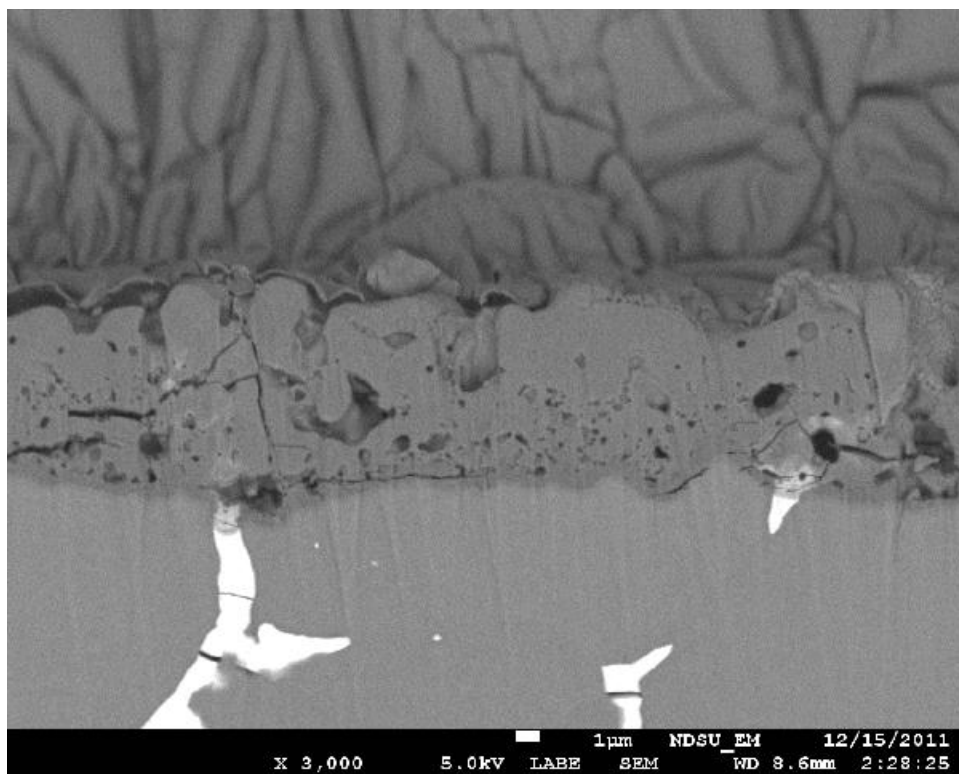
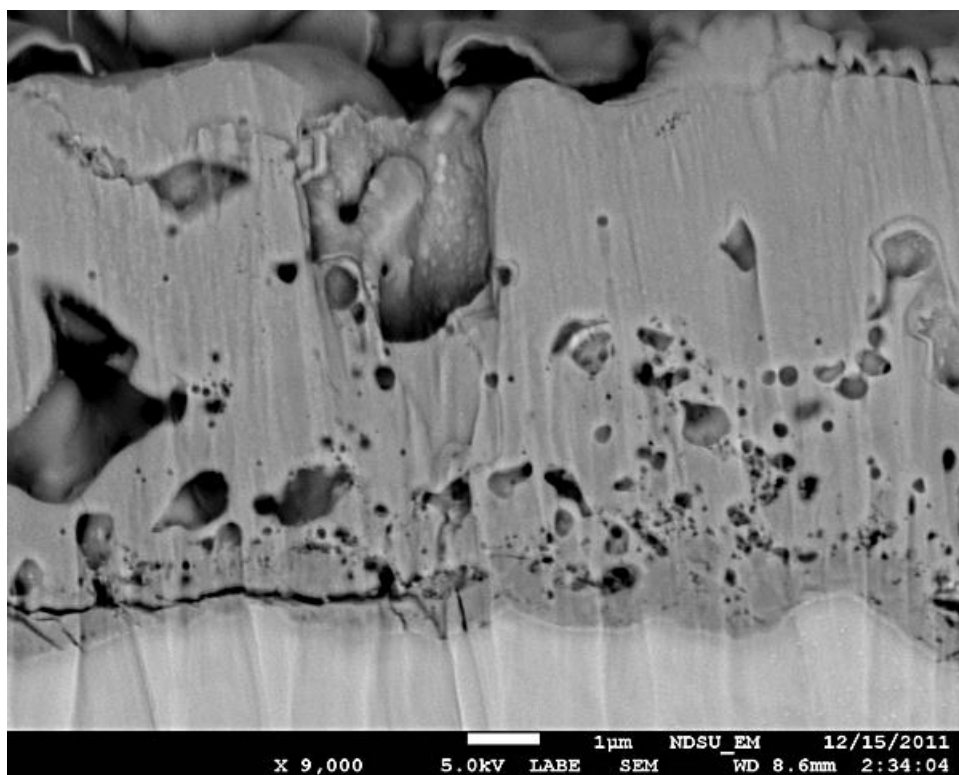
Figures 13-15 show backscatter SEM micrographs at various magnification levels. The film thickness estimates from Figure 13 range between 8.5 – 9.2  $\mu\text{m}$ . A backscatter detector registers stronger signals from heavier atom that scatter more radiation, resulting in brighter areas. Therefore, the white areas in Figures 13 and 14 are not voids, but rather heavier element present in the alloy. According to the EDS analysis, the white areas, identified as Area 5 in Figure 26, represent zinc. Tables 8 and 9 show weight % and atomic % of the EDS areas. Area 5 has the highest concentration of zinc.

Upon closer examination of the TAG8200 film (Figures 14 and 15), two layers of variable lightness can be observed. The thickness of the bottom, darker layer is on the order of 1/10 of the thickness of the upper, lighter layer; and the bottom layer appears to be more porous than the top layer.

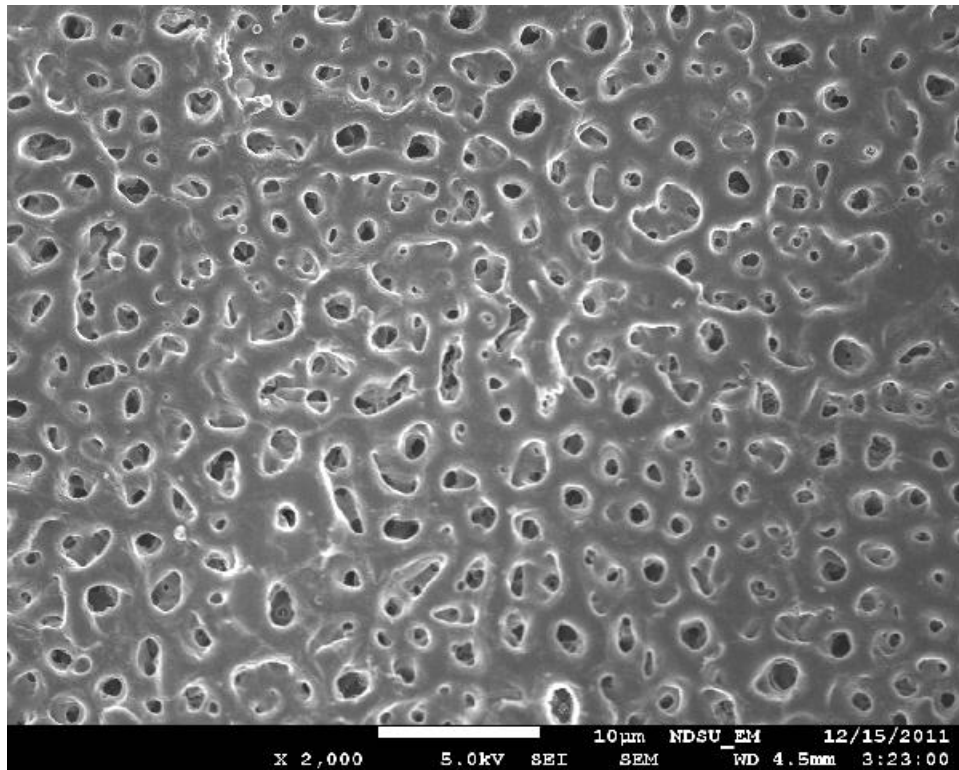
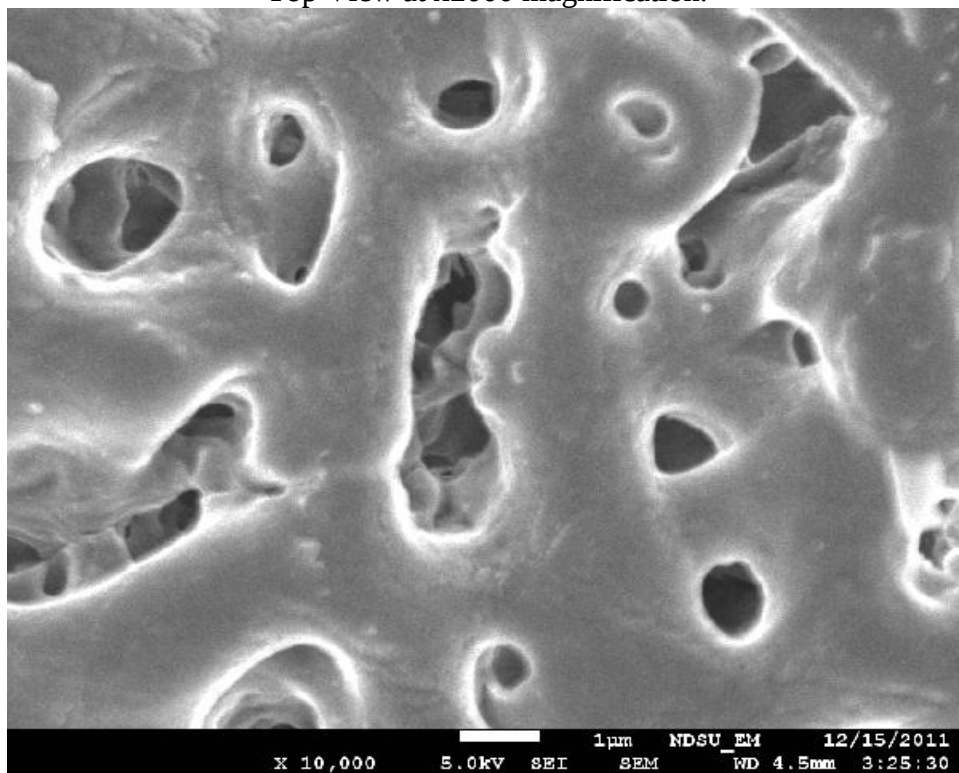
Figure 23. SEM of TAG8200 on ZE41, secondary electron emission.  
Top View at x2000 magnification.

Figure 24. SEM of TAG8200 on ZE41, secondary electron emission.  
Top View at x10,000 magnification.

It can be concluded from the SEI micrographs that the TAG8200 film is very uniform in nature. There is some cratering on the surface, most likely do to gas escaping the surface during deposition. Figures 23 and 24 allow visual estimation of the size of the craters, which range between submicron to 0.5  $\mu\text{m}$  for round shapes, and between 3-4  $\mu\text{m}$  for irregular-shaped pores at their longest dimension.

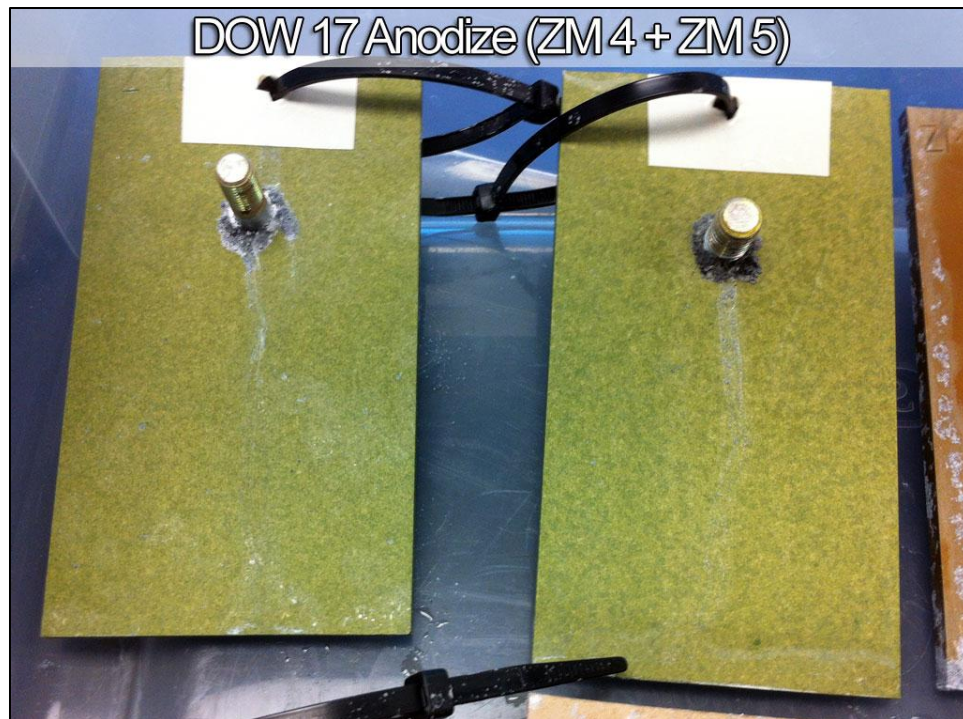
Figure 32. DOW17 Anodize panels after 16 hrs of B117 test.
