**Innovative Masking of Ferrous Inserts in Magnesium  
Aerospace Components Prior to Tagnite Anodization  
(v.1, Unlimited Release)**

**ARL-CR-716**

**July 2013**

**Technology Applications Group, Inc.  
810 S. 48th St.  
Grand Forks, ND 58201**

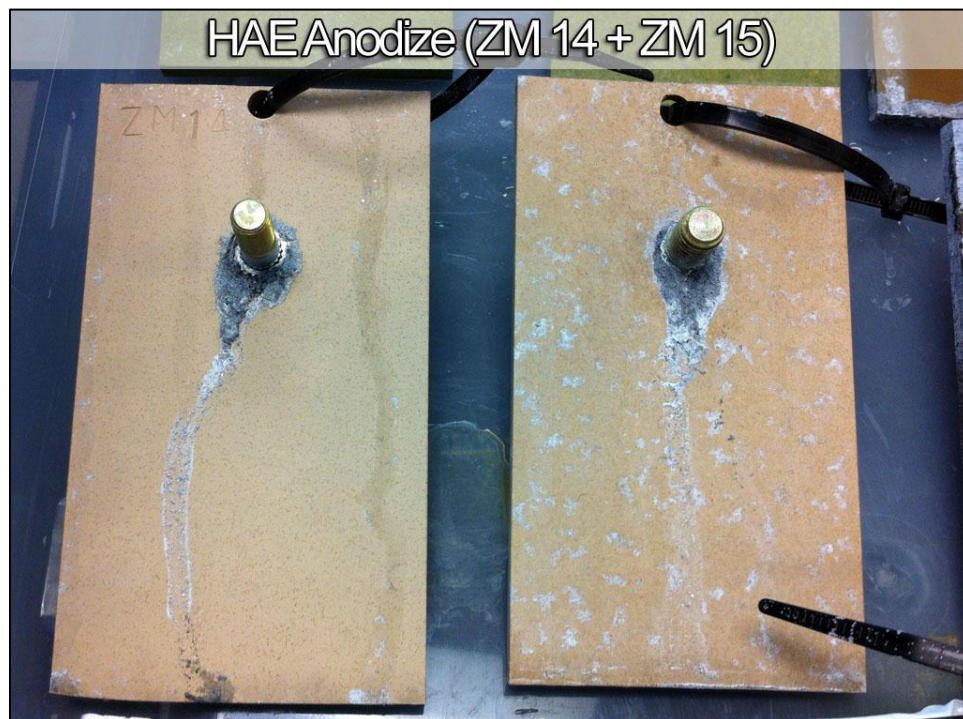
Figure 33. HAE Anodize panels after 16 hrs of B117 test.

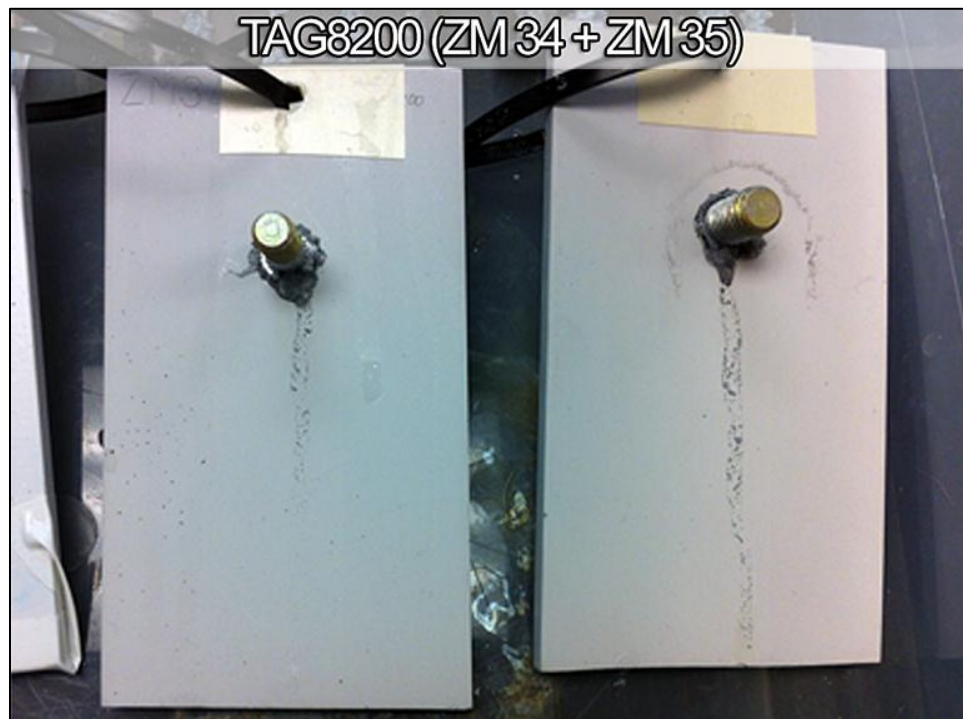
Figure 34. TAG8200 panels after 16 hrs of B117 test.

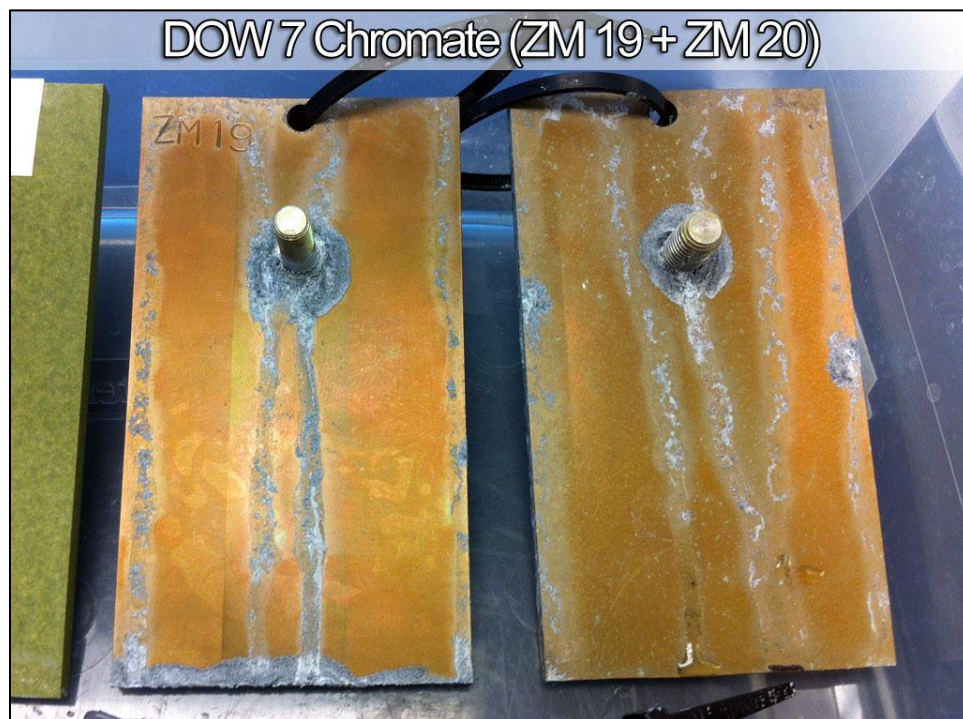
Figure 35. DOW7 Chromate panels after 16 hrs of B117 test.

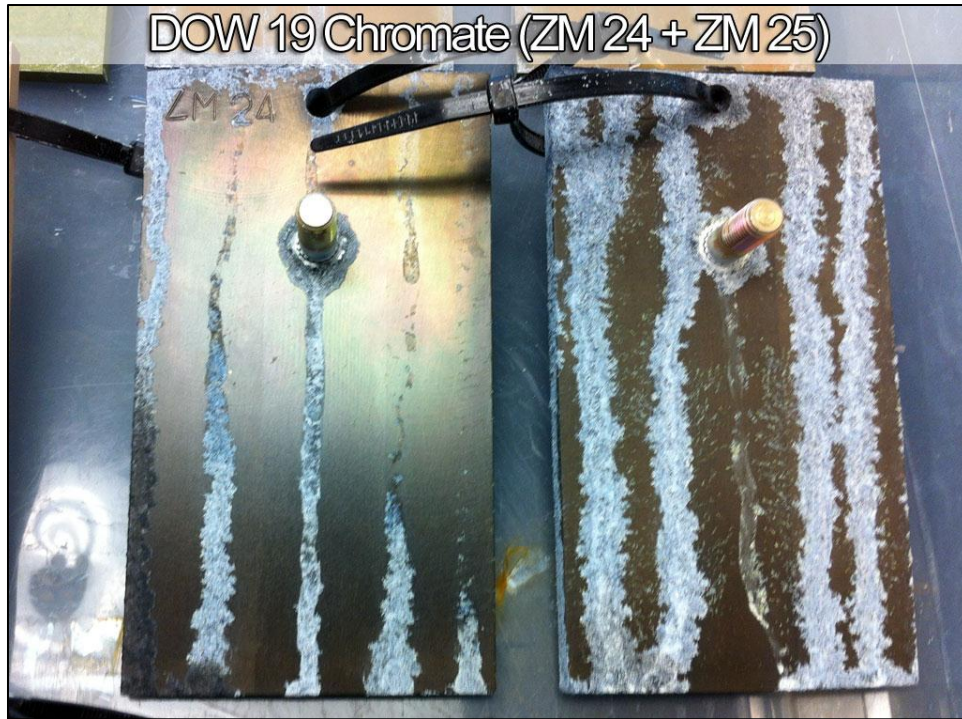
Figure 36. DOW19 Chromate panels after 16 hrs of B117 test.

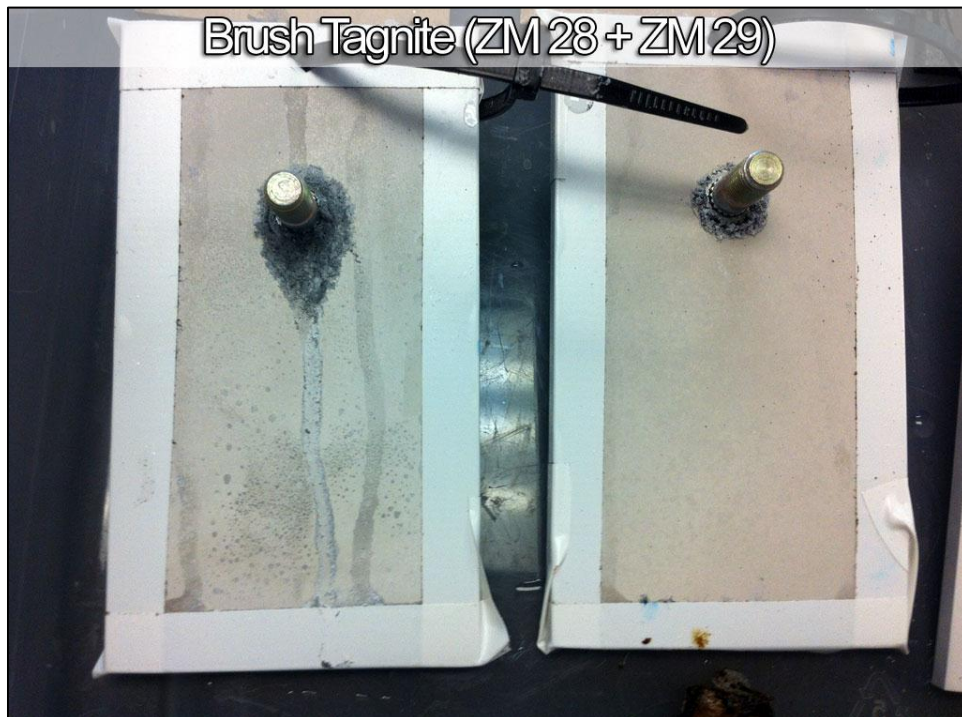
Figure 37. Brush Tagnite panels after 16 hrs of B117 test.

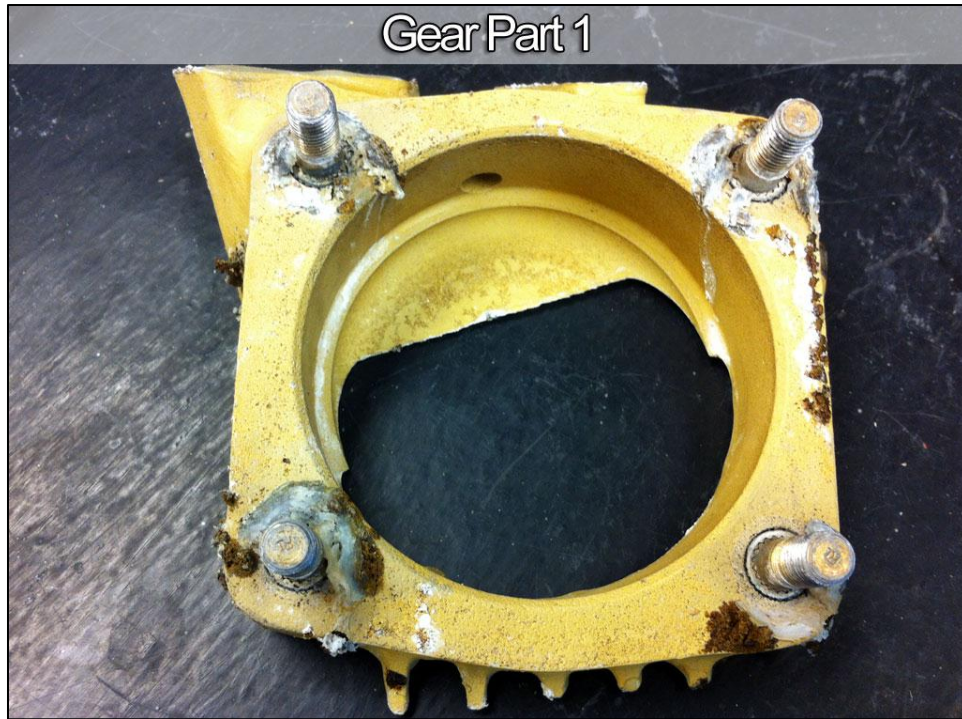
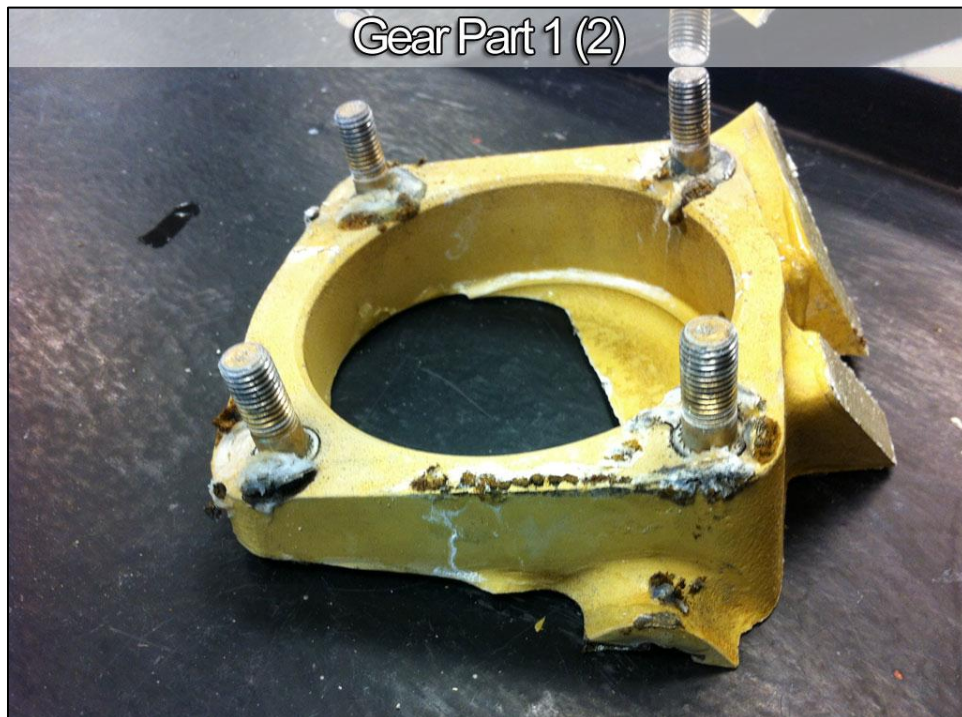
Figure 38. Helicopter gear Part 1 after 16 hrs of B117 test.

Figure 39. Helicopter gear Part 1 after 16 hrs of B117 test, alternate view.

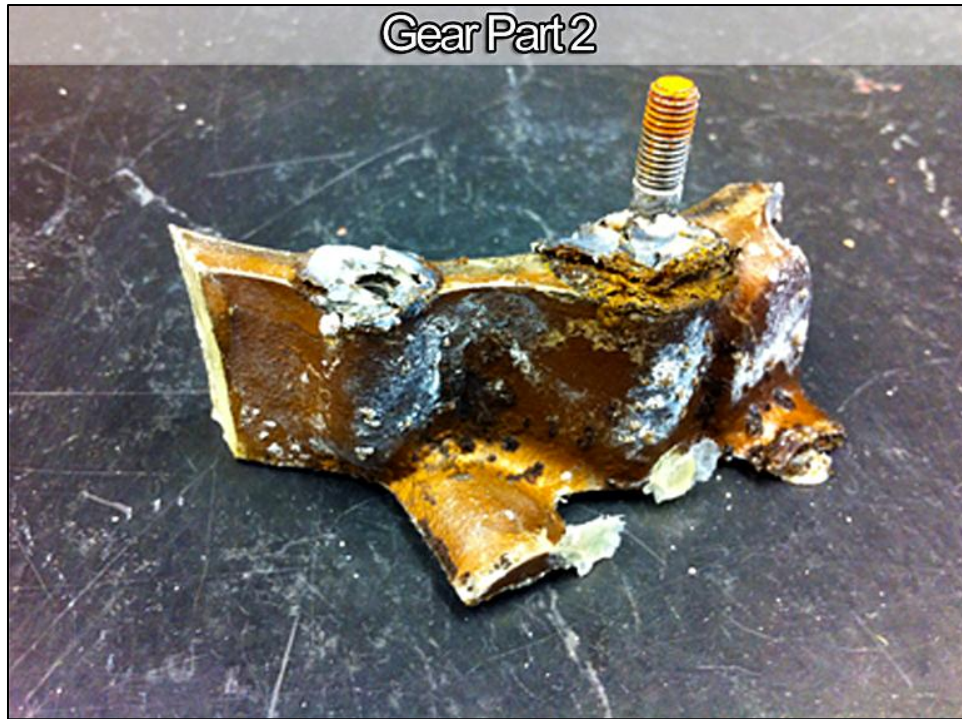
Figure 40. Helicopter gear Part 2 after 16 hrs of B117 test.

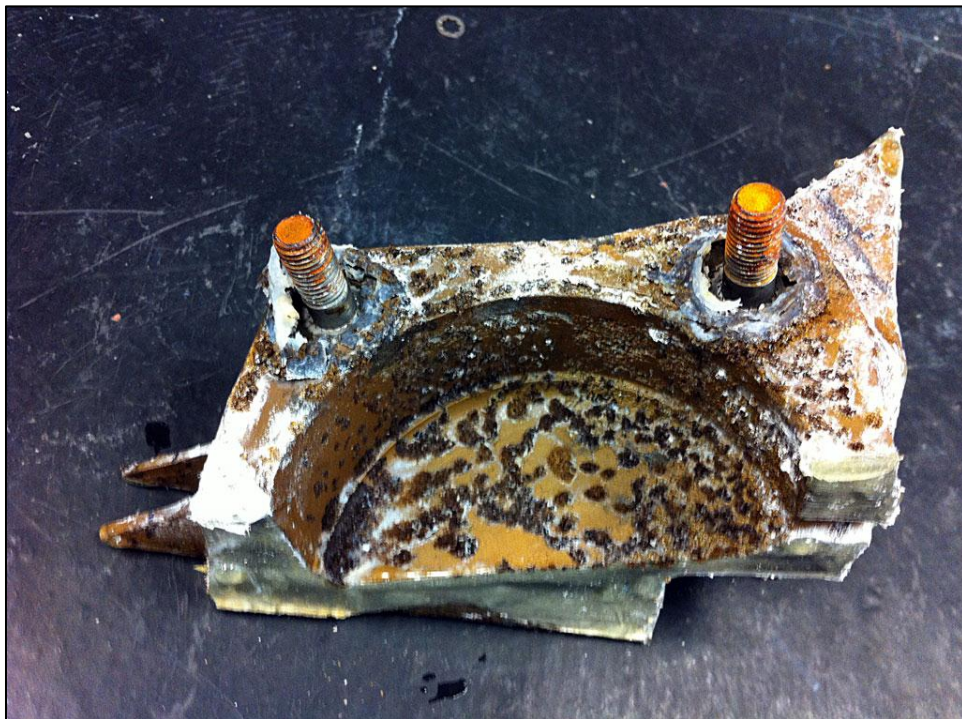
Figure 41. Helicopter gear Part 3 after 16 hrs of B117 test.

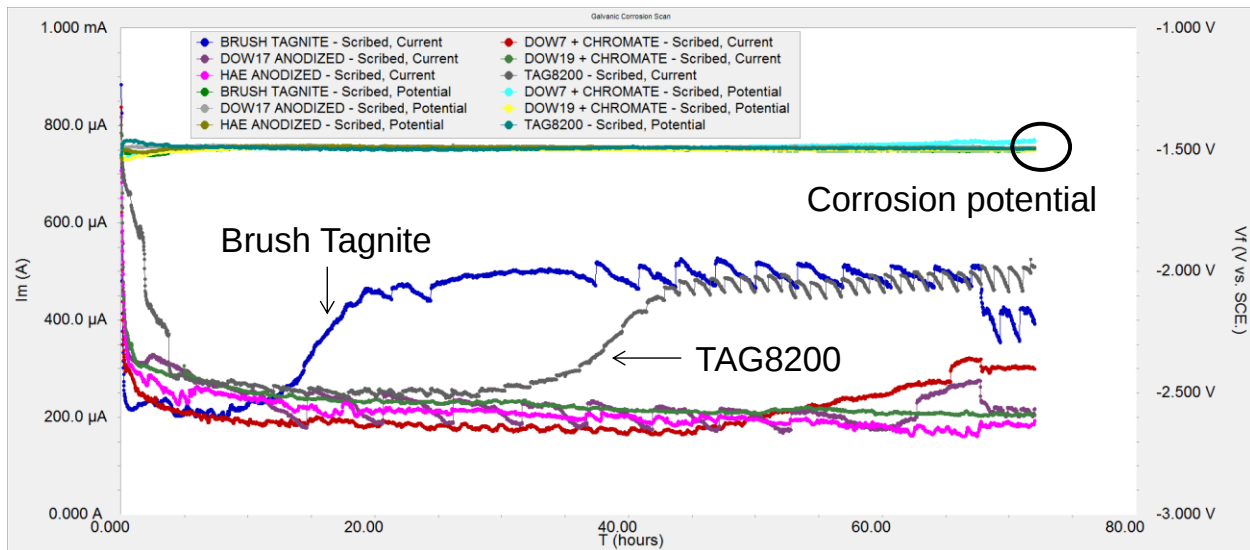
Figure 42. Galvanic corrosion for six types of surface treatments for Mg alloy ZE41.

The corrosion potential records (labeled Vf) in Figure 42 overlap due to fact that the value of  $E_{\text{corr}}$  is dependent on the underlying corrosion reaction of the metal or metals. During the first 30 mins to an hour, it is possible to differentiate the six surface treatments based on their  $E_{\text{corr}}$  values, as the presence of the coating, albeit very thin, would alter the corrosion potential. However, as soon as the electrolyte reaches the metal,  $E_{\text{corr}}$  is dictated by the electrochemical potential of the metal and is independent of the coating deposited on the substrate. Variations in

Galvanic current,  $I_{\text{corr}}$  (labeled  $I_m$  in Figure 42) stabilizes after several hours for all types of coatings. The decrease of the corrosion current is due to the formation of corrosion products in the scribe that impede the flow of charge in the cell. After 12 hrs, the corrosion current for Brush Tagnite increases, indicating that further corrosion of metal is taking place. Similarly, corrosion current for TAG8200 increases after 36 hours, and for DOW7 Chromate and DOW17 Anodize, the  $I_{\text{corr}}$  increase takes place at the 50-hr mark. While it appears that HAE Anodize and DOW19 Chromate have the lowest corrosion current at the end of the 72-hr GC experiment and thus could be considered best performers in a typical galvanic corrosion experiment, due to the highly reactive nature of Mg alloys, visual observation of the surfaces performed after the test provide additional information about the corrosion protection properties of the surface treatments.
