## F-111 Adhesive Bonded Repairs Assessment Program - Progress Report 1: Analysis of FM300 Repairs

*Eudora S. Y. Yeo and Andrew N. Rider*

DSTO-TR-2849

# F-111 Adhesive Bonded Repairs Assessment Program - Progress Report 1: Analysis of FM300 Repairs

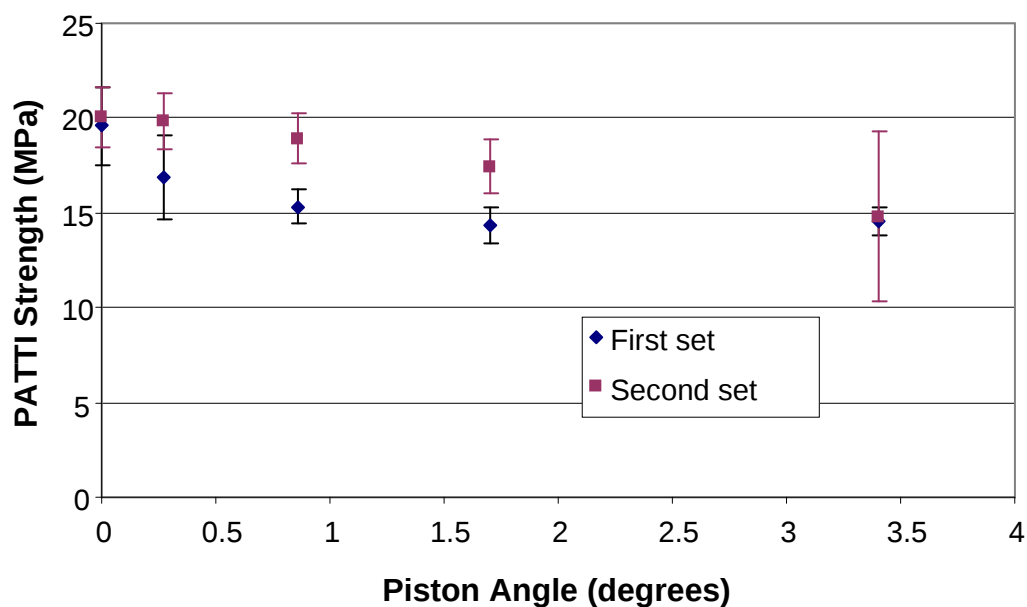
Figure 4 shows the relationship between PATTI strength and the angle of piston to the test surface. Stubs in the first set used staged adhesive. At a 5.1° piston angle, the gasket popped out of the piston before sufficient pressurisation was reached to achieve stub failure. It is unlikely that field experiments would have been able to undertake any tests with a piston angle much greater than 3.4°. If 3.4° is taken as the maximum practical angle that the piston could have achieved, then it appears that when the substrate thickness is 3.2 mm, a pristine stub could fail at loads as low as 15 MPa due to potential off-angle loading effects of the piston. It is also noteworthy that as the piston misalignment increases, the degree of variation in the measured PATTI strength increases significantly. If this variation is considered, then values approaching 10 MPa are possible in the worst case for a repair which had not experienced any significant strength degradation.

Figure 4 Relationship between PATTI strength and the angle of piston to the test surface. Stubs in the first set used staged adhesive.

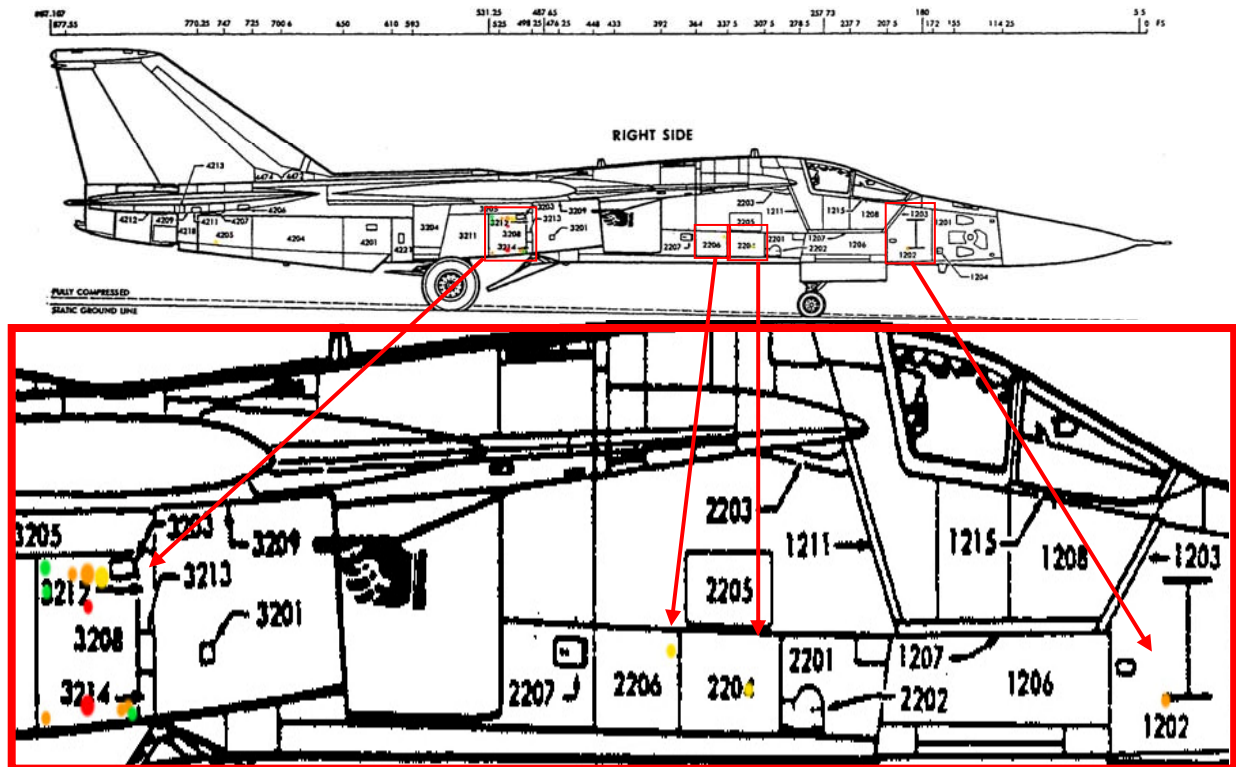
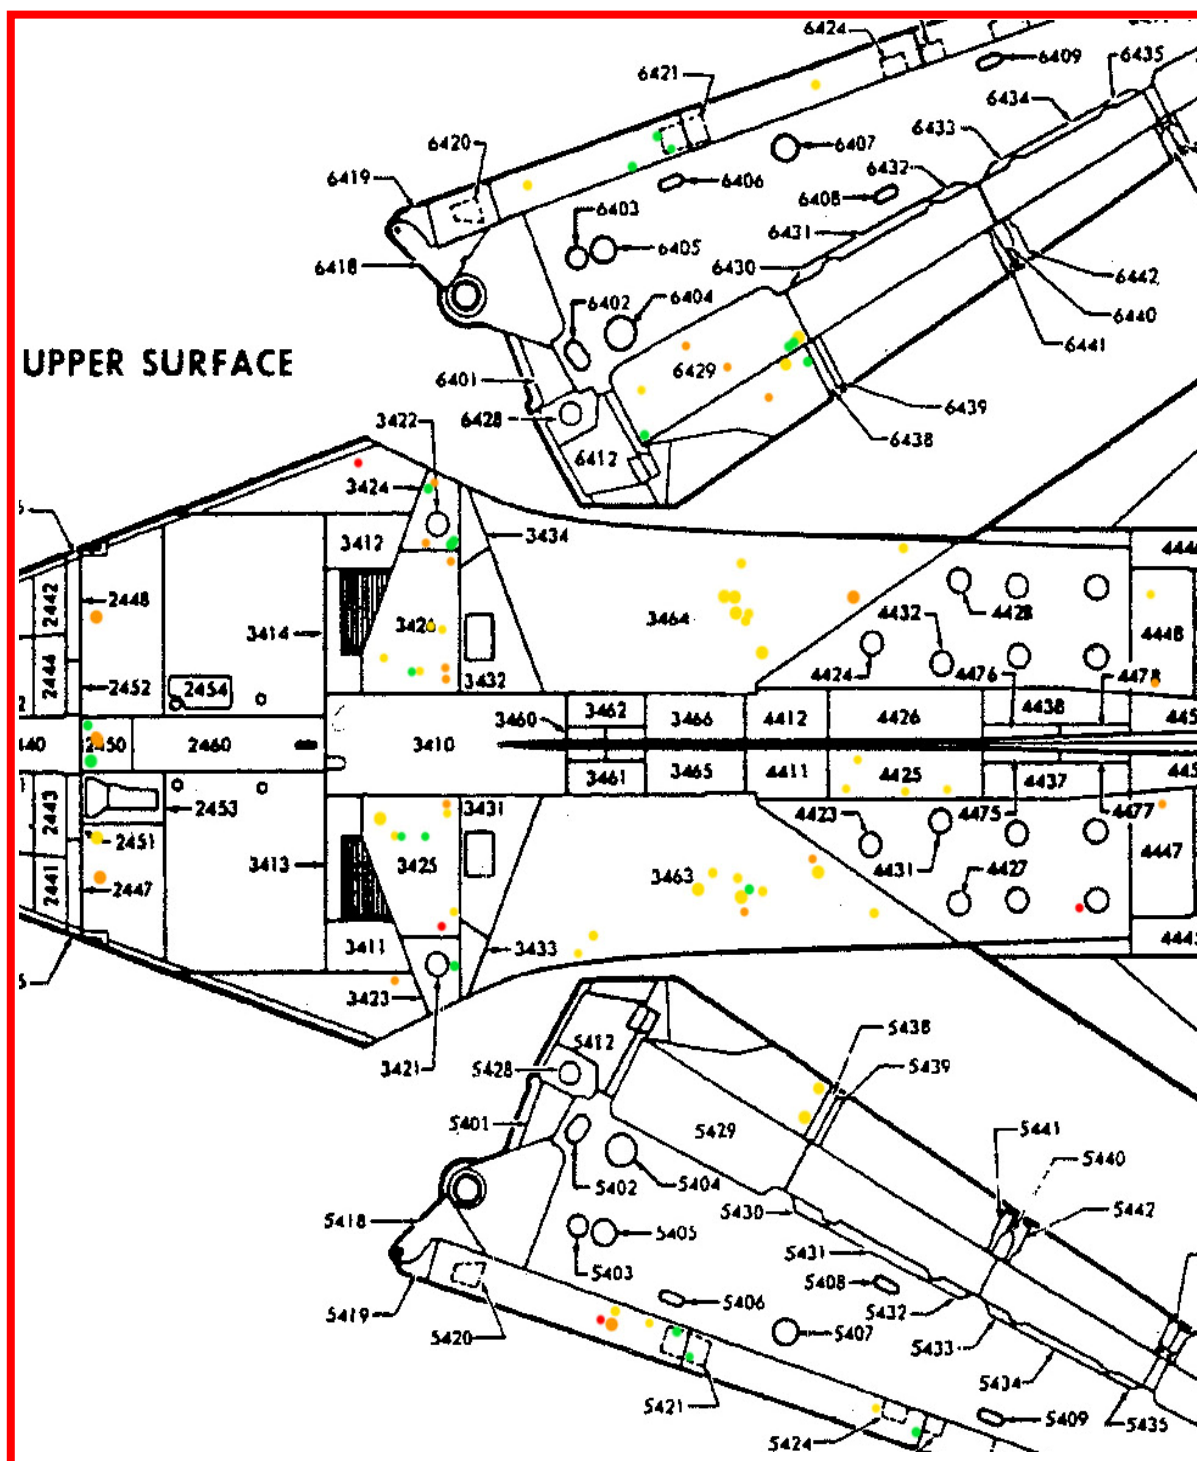
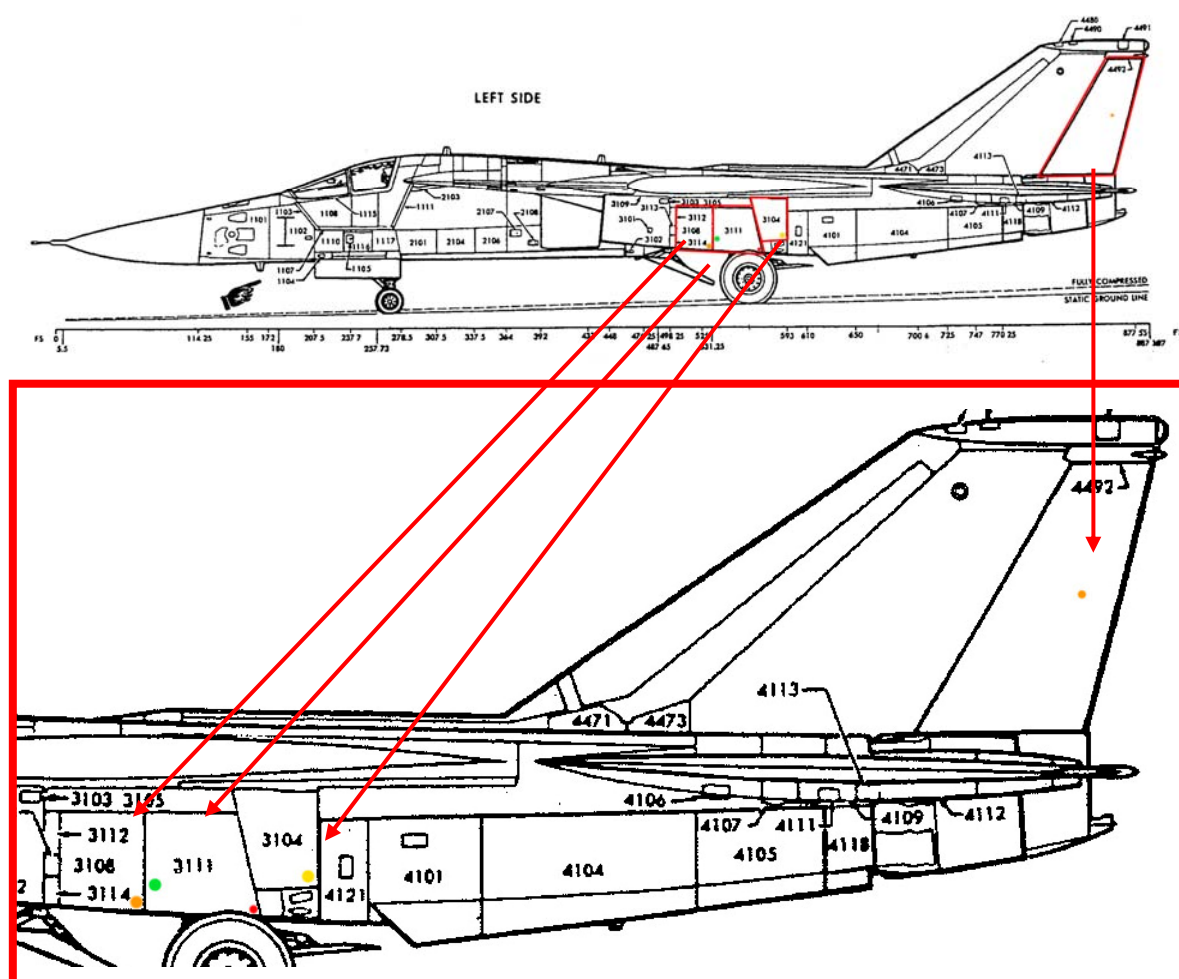
Close inspection of the location of the seven low strength (red) repairs suggests that most were located on components which had a higher degree of surface curvature. The low strength repairs were on panel 3208 (RHS) (two repairs), the rotating glove panel (panel 3424 upper surface), panel 3425 (upper surface), panel 3111, the inboard leading edge flap (upper surface), and the saddle tank. As most of the repairs analysed existed on the upper surface of the aircraft, it is not possible to determine a correlation between repair location and strength. However, the HSTABs had a considerable number of repairs on upper and lower surfaces near leading and trailing edges and did not exhibit any trend in repair strength with location. The surfaces with higher degrees of curvature may have some sensitivity to measured strength due to misalignment of the piston head being more likely, as indicated in Figure 2. However, the repairs on similar components in close proximity to the low strength repairs exhibited acceptable strength, which would suggest that component geometry was not a major factor influencing the measured repair strength. Further analysis of these low strength repairs will be provided in following sections.

Figure 9 Location of inspected FM300 repairs on the aircraft. Red markings denote repairs with a low strength (less than 10 MPa), orange and yellow markings represent medium strength repairs, and green markings represent high strength repairs (greater than 20 MPa).

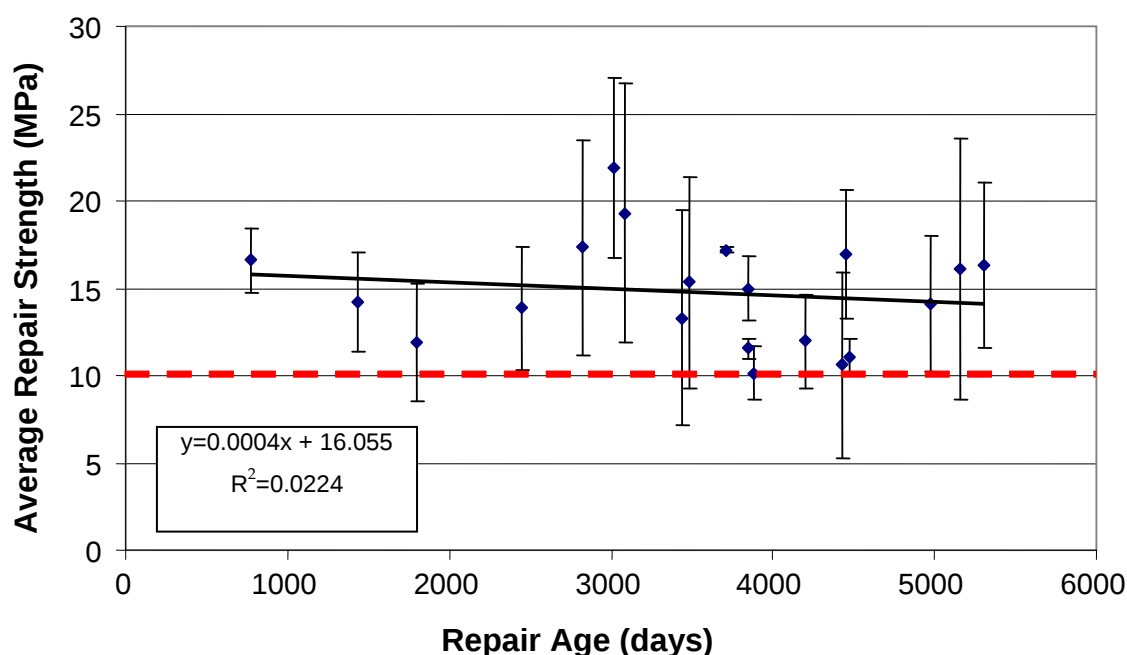
The initial analysis of the bonded repairs examined if a correlation existed with the average repair strength and the repair age (Figure 10). The repair age represents the total accumulated time since the repair was applied to the time the repair was tested. There is no correlation in strength with repair age as indicated by the wide distributions of strength that exist for the repairs ranging between 500 and 6000 days or around 1.5 to 16 years. The extent of variation for discrete repair ages is greater than the difference in the average value for nearly all the data.

Figure 10 The average repair strength measured as a function of total age of the repair where the error bars represent the 95% confidence interval for all repairs measured with the same lifetime. The broken red line represents the lower limit expected for undegraded bonds accounting for possible geometrical variations in loading.

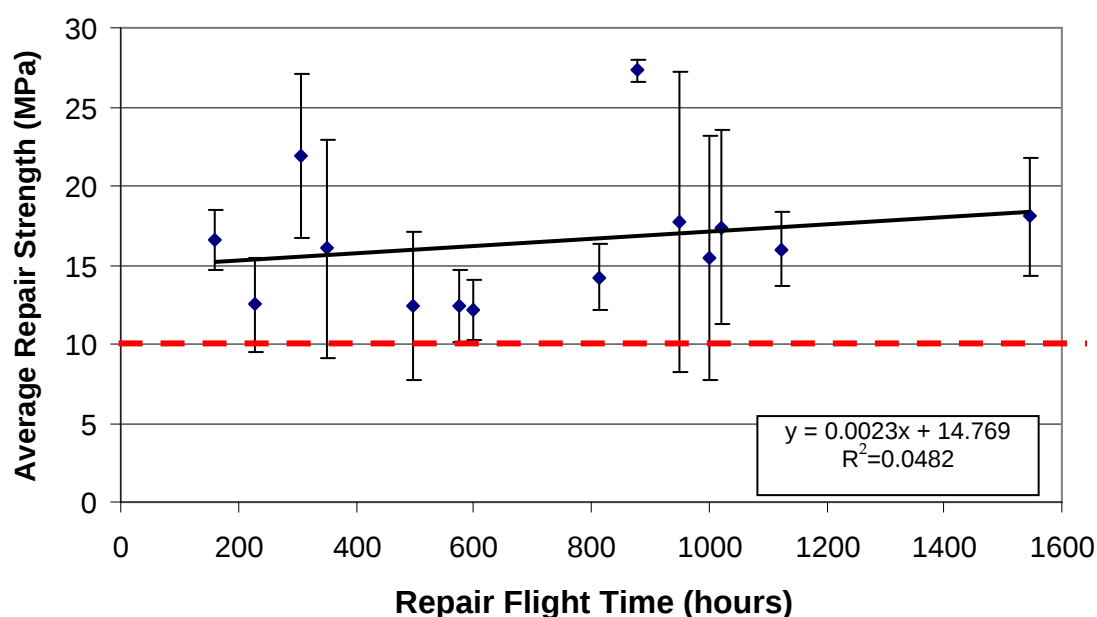
Figure 11 indicates the average repair strength as a function of accumulated flight hours. The data is similar to Figure 10 and shows that the strength does not depend on the accumulated flight hours, with the variation of repair strength at discrete times being typically greater than the average strength over period between 100 and 1600 hours.

Figure 11 Correlation between flight hours experienced by each repair and average repair strength, where the error bars represent the 95% confidence interval for all repairs measured with the same accumulated flight hours. The broken red line represents the lower limit expected for undegraded bonds accounting for possible geometrical variations in loading.

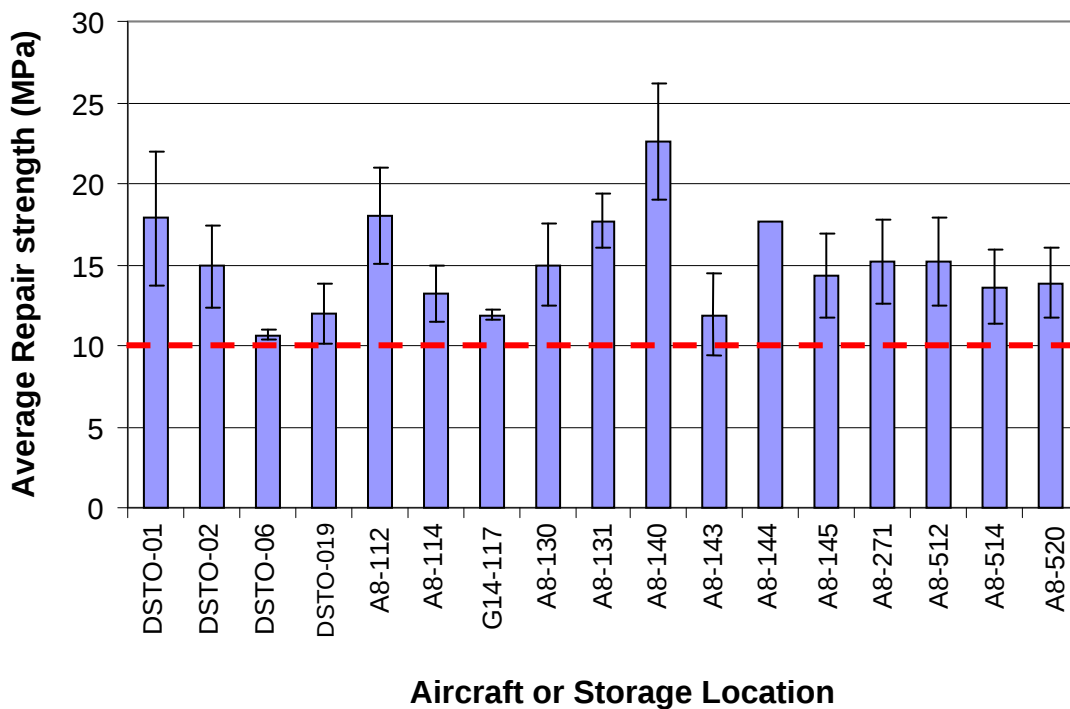
Figure 13 Average repair strength for each aircraft examined or for components recovered from storage locations. The dataset has stub results reported in Table 2 and repairs with only single measurements removed. The broken red line represents the lower limit expected for undegraded bonds accounting for possible geometrical variations in loading.

Specifically, repair number five from A8-143 had 10 pull stub tests carried out and 9 of the 10 tests from this repair had strengths below 10 MPa. The low strength repair location on panel 3208 was identified in Figure 9. Table 3 shows a detailed analysis of each of the pull-stub tests from repair 5 on A8-143. It was noted that most stubs exhibited higher levels of voiding than were previously observed on average strength stubs and that some evidence of adhesion failure was noted, shown in Figure 14. The strength below 10 MPa is believed to represent a reduction in strength from the typically applied repair, with high voiding levels suggesting deficiency in the application process, whereby either high humidity

levels may have existed during application or inadequate drying procedures were employed. It is believed that the adhesion failure observed is a direct result of the high voiding levels. As only the stubs were available for detailed examination, it is difficult to tell whether moisture induced degradation was also present.

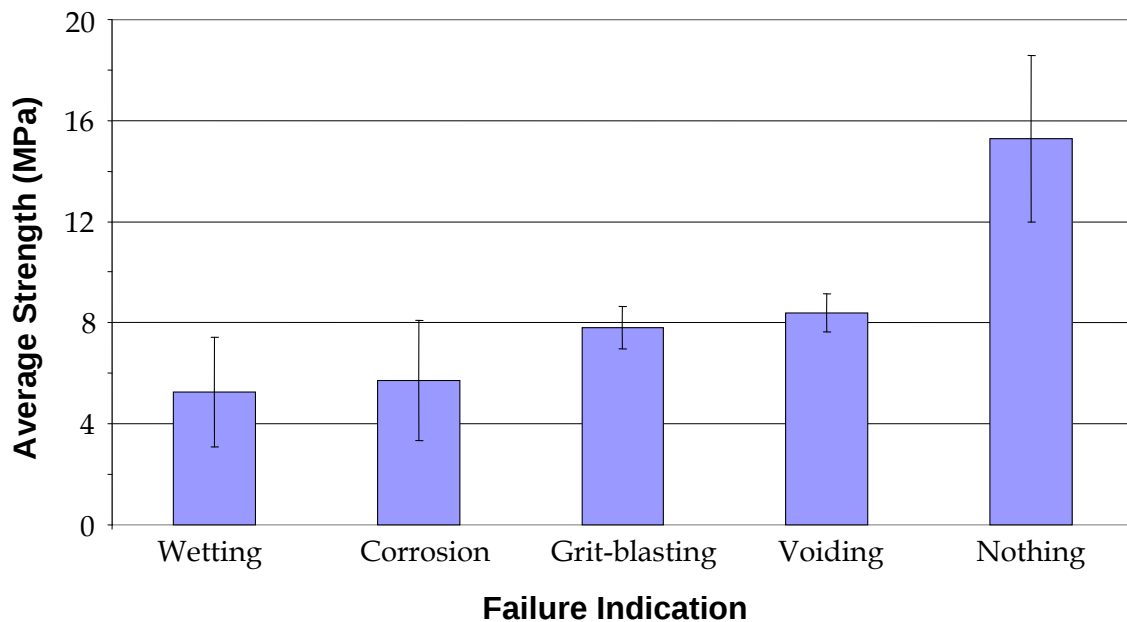
A summary of the failure indications and the average strength associated with each type is provided in Figure 21. The results indicate the average strength for each indication type, with the spread in data shown by error bars, which represent the 95% confidence limits. The plot provides a useful measure of the relative severity of each type of failure with respect to the reduction in the overall stub strength in the locally affected areas. Both corrosion damage and poor adhesive wetting of the aluminium surfaces leads to significant decreases in strength, indicating identification of these defects would have the highest priority in repair inspection and maintenance. The poor grit-blasting also causes reduction in strength, but together with high voiding does not appear to lead to as significant reductions as corrosion and wetting, but would be important to identify in any post repair inspections. Interestingly, the areas of the repair without any indications provided average strengths and deviations that are very similar to the average values determined in Figure 15 and Figure 16. This suggests that average repair strengths for the filtered data represent the significant majority of the total repair areas examined, with degradation in strength being confined to relatively localised regions. Generally, this would imply that no single repair had significant levels of strength reduction associated with long term environmental or service exposure.

Figure 21 Average strength for individual pull-stubs with failure indications categorised according to problems with adhesive wetting (wetting), localised corrosion (corrosion), inadequate grit-blasting (grit-blasting) and high levels of voiding (voiding). The strengths are compared to stubs measured on the same repairs without any indications (nothing).
