**REHABILITATION OF THE SUROOR  
ELEMENTARY SCHOOL  
UNDER THE ECONOMIC SUPPORT FUND  
HUSSEINIYA, IRAQ**

**SUSTAINMENT ASSESSMENT**

**SIGIR PA-08-135  
APRIL 7, 2009**

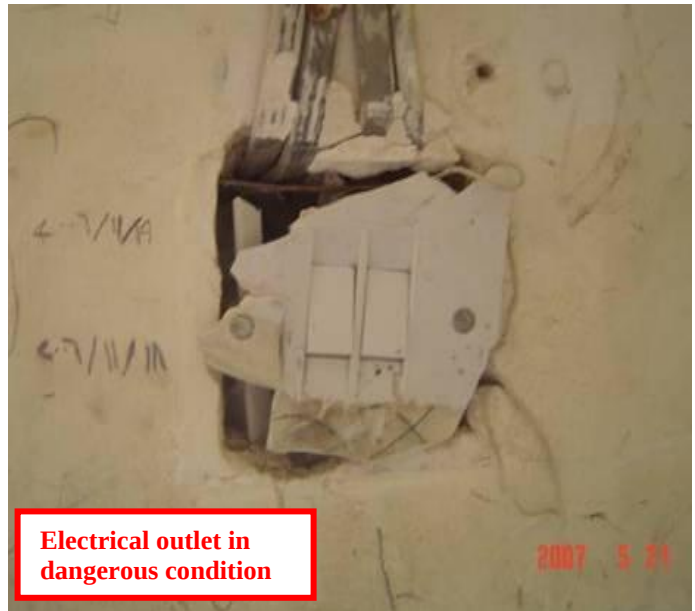
The school is located in the Husseinia village near Baghdad, Iraq. The school was in a state of major disrepair from years of neglect and failure to maintain adequate upkeep. Site Photos 1 and 2 document the poor condition of the school prior to renovation. The school's electrical system was unsafe, the plumbing system unusable, the restrooms unsanitary, and overall the school was unsafe.

Site Photos 1 and 2. Suroor Elementary School prior to renovation (Courtesy of GRC)

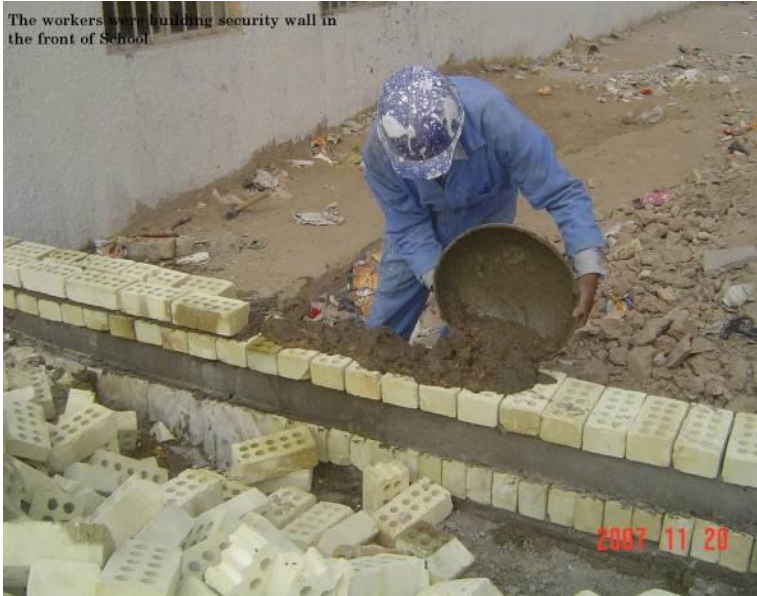
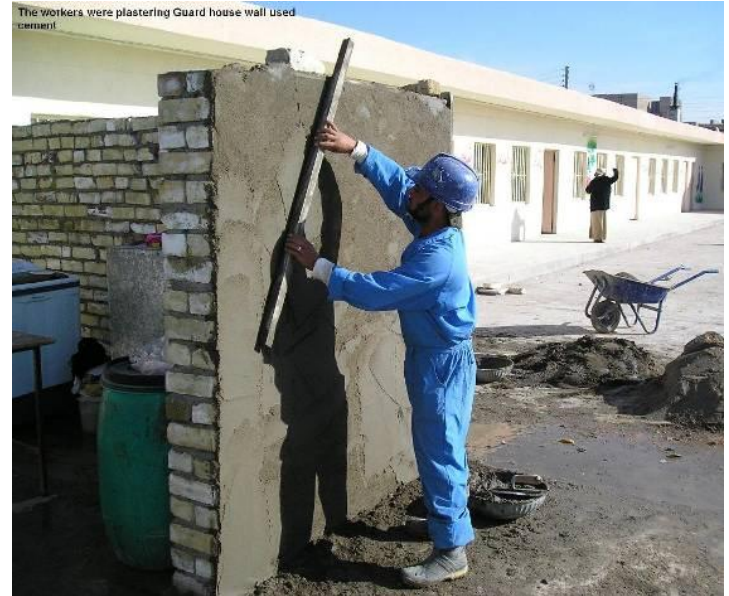
Site Photos 3 and 4 document the construction of the security wall and guard house wall, respectively.

**Site Photos 3 and 4. Construction of the security wall and guard house wall (Courtesy of GRC)**
