**NSWCCD-65-TR-2005/04** March 2005

## **Preliminary Report on the SIDER Testing of Large-Scale Sandwich Panels**

1. Reference (a) requested the Naval Surface Warfare Center, Carderock Division (NSWCCD) to investigate the use of broadband vibration data to determine the integrity of composite structures. Enclosure (1) presents the results of Structural Integrity and Damage Evaluation Routine (SIDER) inspection demonstrations of two large-scale balsa core panels.

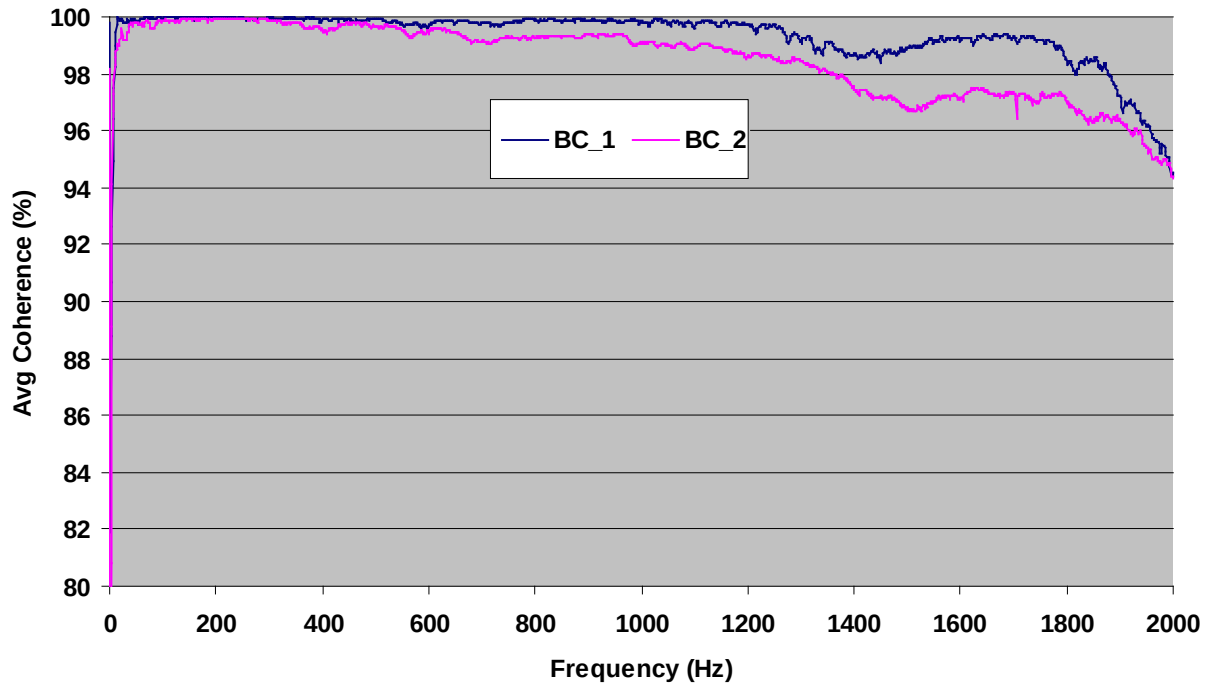
**Figure 2. Average Coherence Comparison between Test Parts**

Note that the coherence axis for each graph is expanded, and only shows the range 80%-100%. We would normally consider a high quality data set to have an average coherence in excess of 95%, and preferably more than 95%.

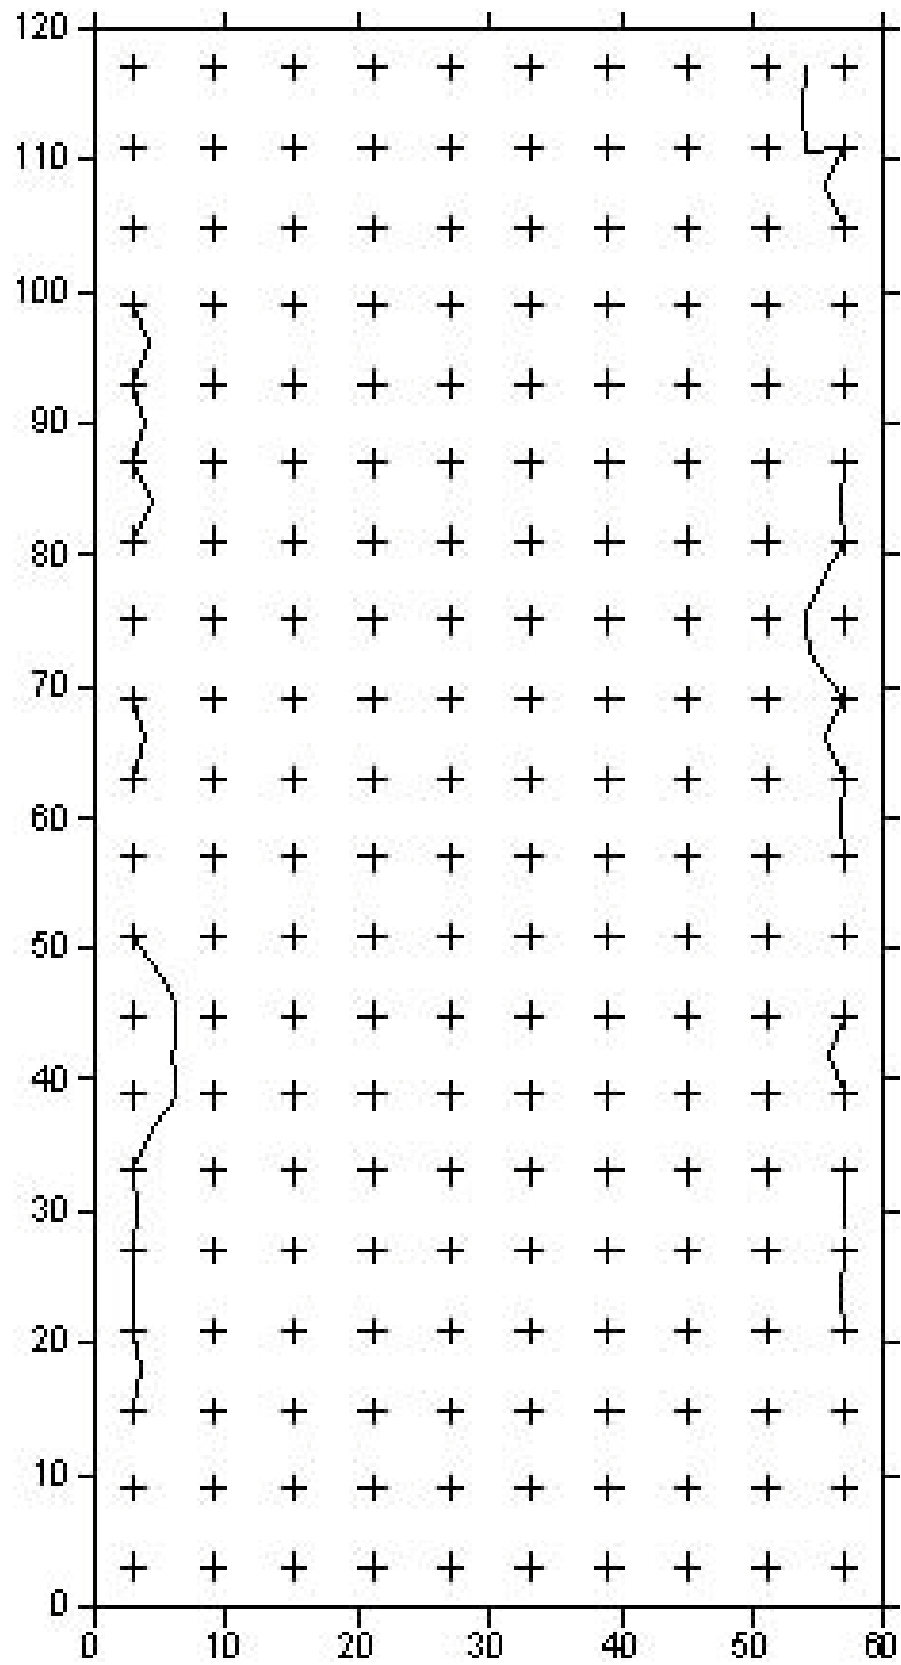
Figure 5 through Figure 8 show the SIDER contour plots for each of the parts. The axes numbering is the distance in inches from the global origin. The crosses identify the test mesh. The SIDER is a directional test. Thus, there are two figures for each tested part, one for the analysis in the x-direction and one for the analysis in the y-direction. All graphs have the same scaling, such that the same contour color identifies similar SIDER values. White indicates little or no irregularity in structural stiffness, and red indicates a higher level of irregularity.

Figure 5. Part #1, Y-Direction Analysis

Figure 6. Part #1, X-Direction Analysis

In this case, there are two small areas on panel 1 which show a difference from the rest of the panel. These areas are located near grid points 76 and 86, and grid points 192 and 193. For panel 2, there are many additional areas of concern which are too numerous to mention specifically here. It should be noted that with additional SIDER testing of more components, a baseline SIDER value could be established whereby only indications above this value are considered significant and indicative of manufacturing problems or damage.

Panel #1 showed minimal damage in two distinct areas of the panel. The rest of the panel appears damage free.

*The recommendation is to interrogate those locations only with an alternative technique such as ultrasonics. With additional alternate testing, it may be possible to identify the specific cause of the SIDER features, and whether they are of structural significance.*

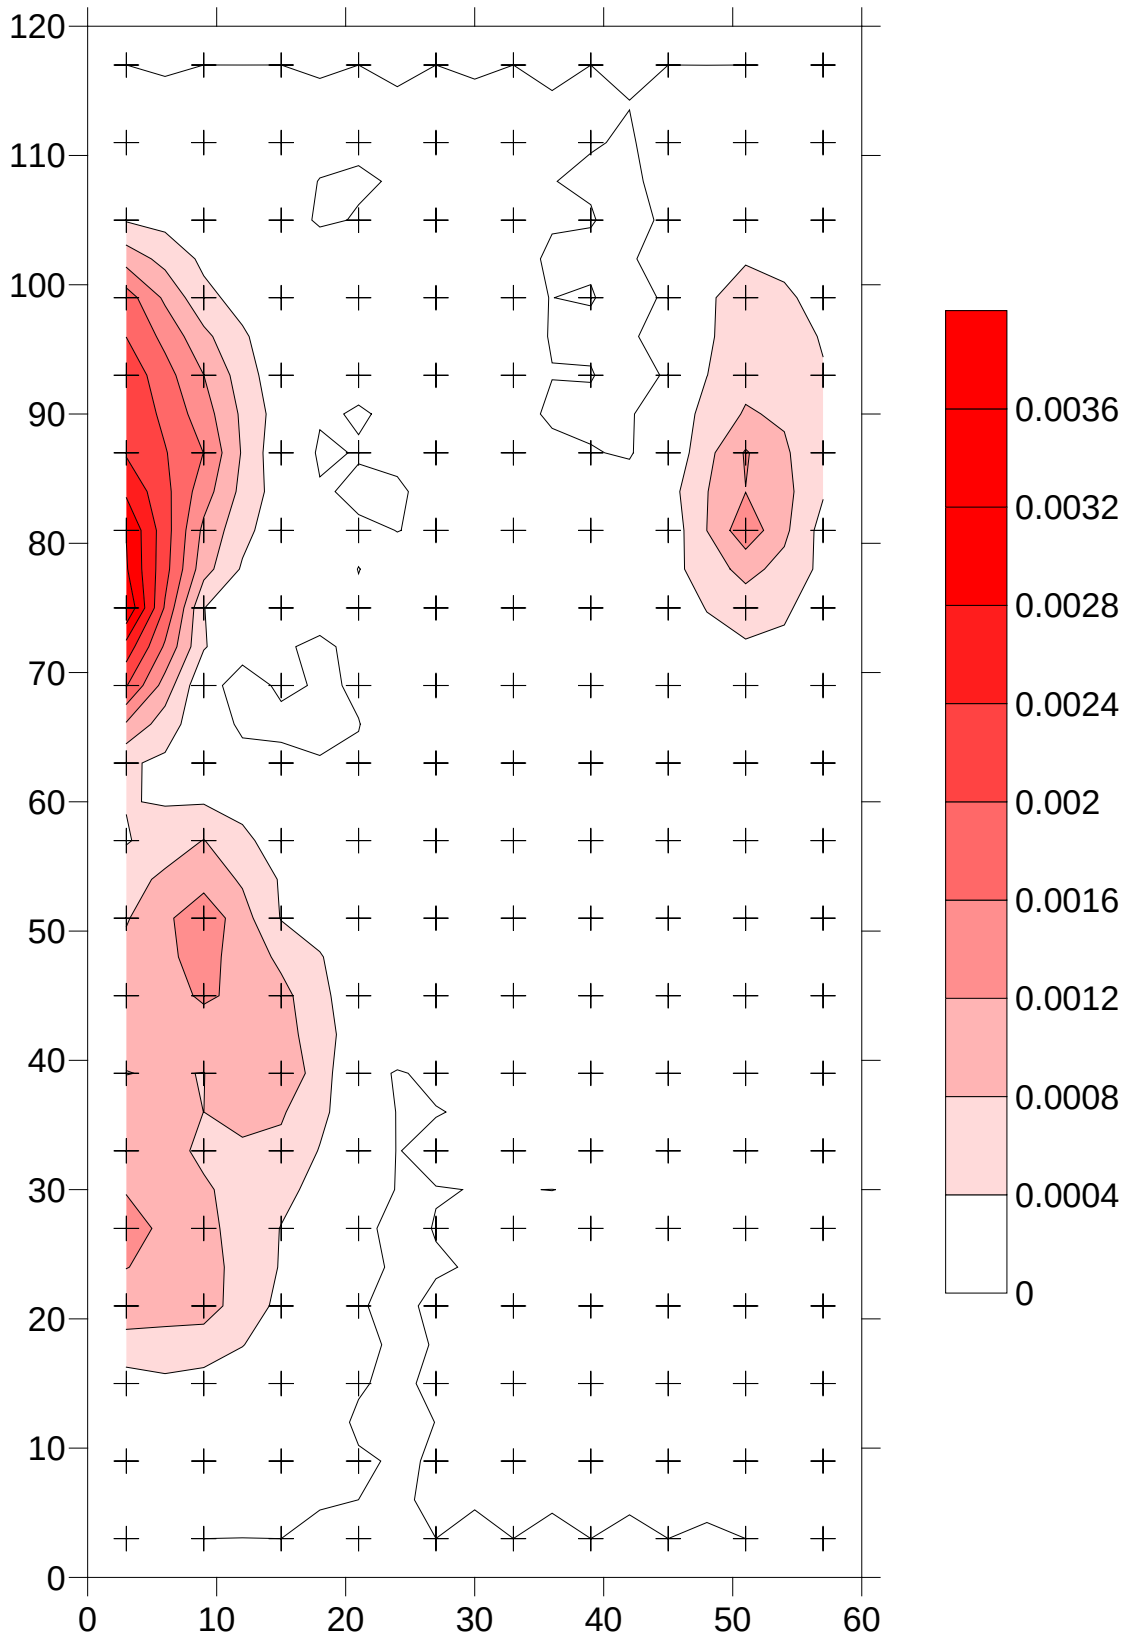
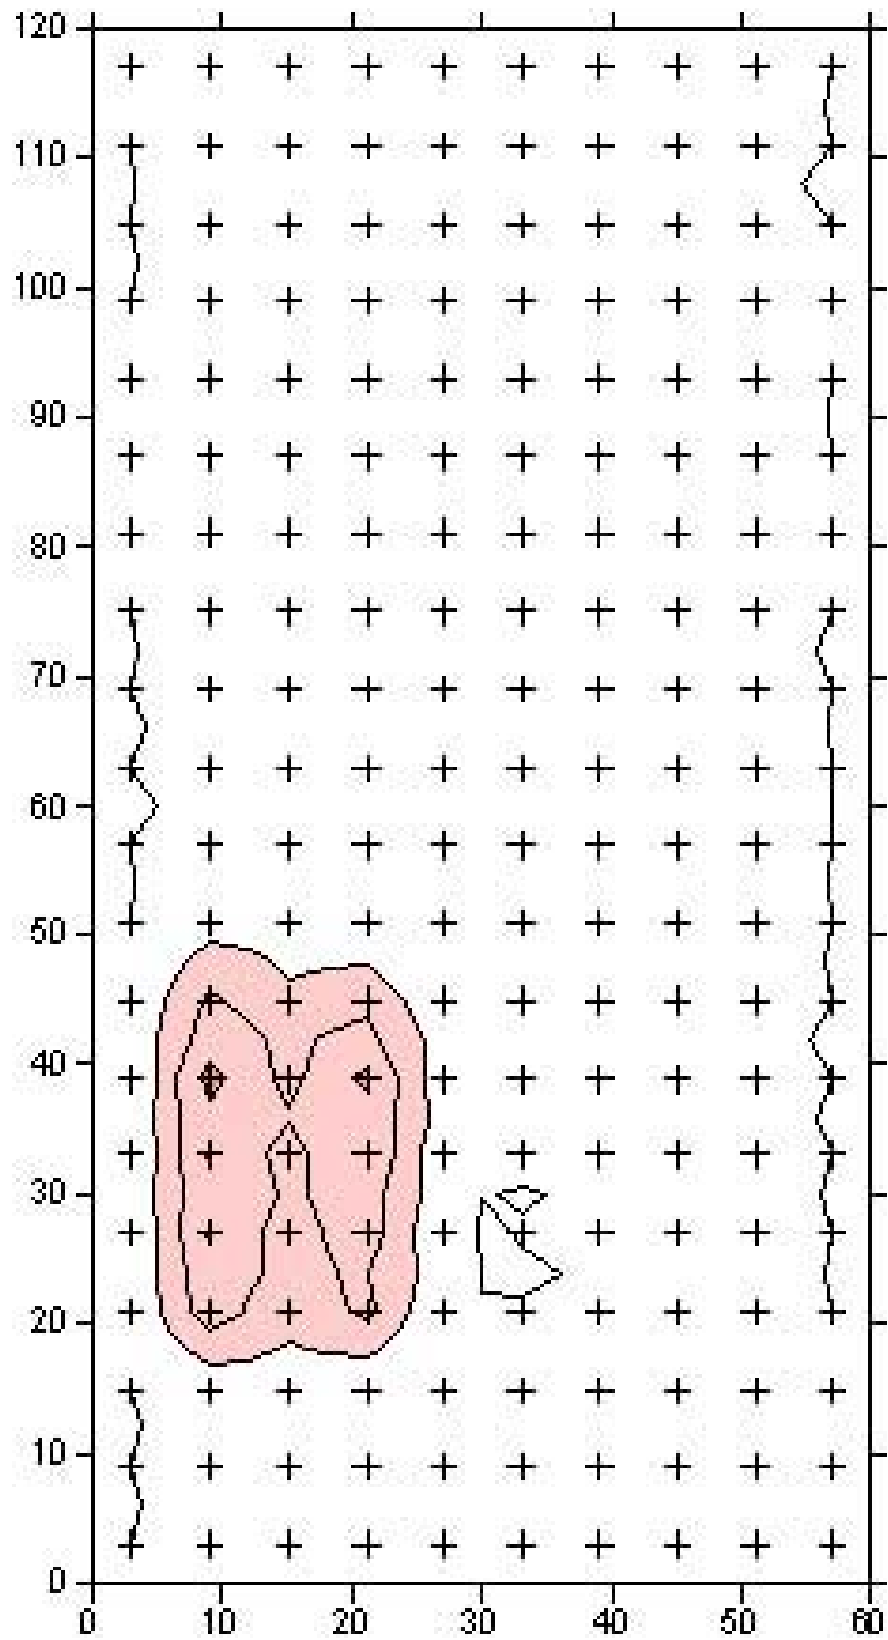
Figure 7. Part #2, Y-Direction Analysis

Figure 8. Part #2, X-Direction Analysis

Due to the severe nature of the damage identified in Part #2, it was decided to replot the SIDER results using a different scale. In a single SIDER inspection, when a component demonstrates a feature which significantly dominates the plots, the original auto-scale plots can hide other less severe features that may still be of interest. Rescaling will often enable these less severe features to be identified. If multiple parts were to be inspected, a scaling could be established which would automatically indicate regions above the component norm. Figure 11 through Figure 14 repeat Figure 5 through Figure 8, but with a tenfold magnification. On these plots anything over an original value of 10% is set to a uniform maximum value.

Panel #2 had several large areas of significant damage. These areas cover virtually the entire plate.

*The main recommendation is to use ultrasonics to map out the boundaries of the major delaminations/debonds in order that they can be compared with the SIDER results. Additionally, if time permits, it may be appropriate to test the "SIDER-good" areas to ensure that they are, indeed, damage free.*

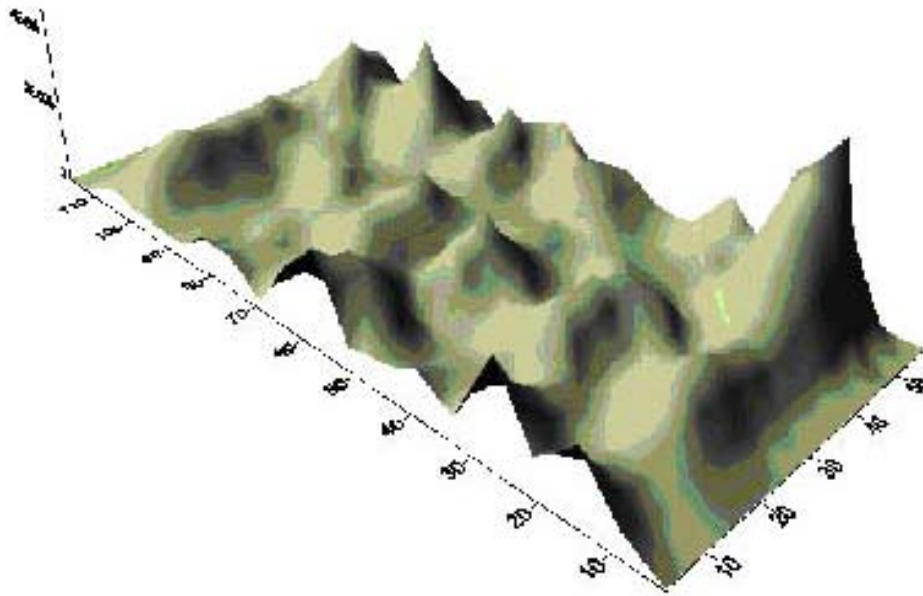
**Figure 9. Part #1, Y-Direction Analysis**

Figure 9 and Figure 10 show the y-axis analyses only using a surface plot. The plots are auto-scaled, so that the coloring cannot quickly be converted to SIDER values. However, these figures can sometimes help visualize locations where there is structural irregularity.
