**Technical Report 1628**  
September 1993

# **Dynamic and Static Exposure Tests and Evaluations of Alternative Copper-Based Antifoulant Coatings**

**NAVAL COMMAND, CONTROL AND  
OCEAN SURVEILLANCE CENTER  
RDT&E DIVISION  
San Diego, California 92152-5001**

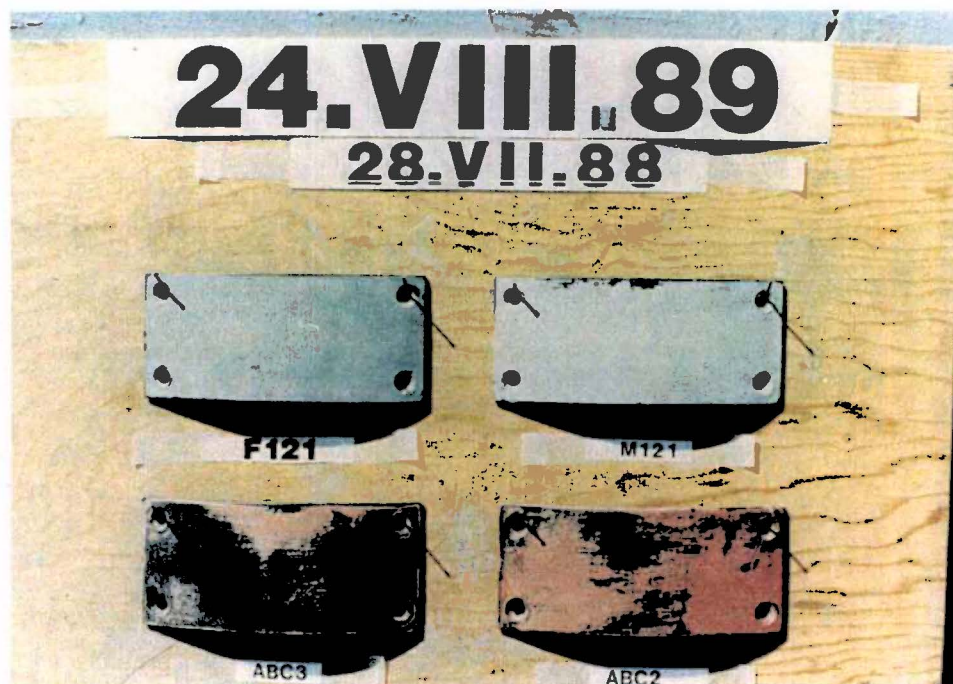
Figure 7. After 1 year of dynamic/static exposure, ABC3 completely lost one layer (red) of AF coating. ABC2 shows similar erosion. Loss of green AF coating appeared on the middle of the edge of M121.

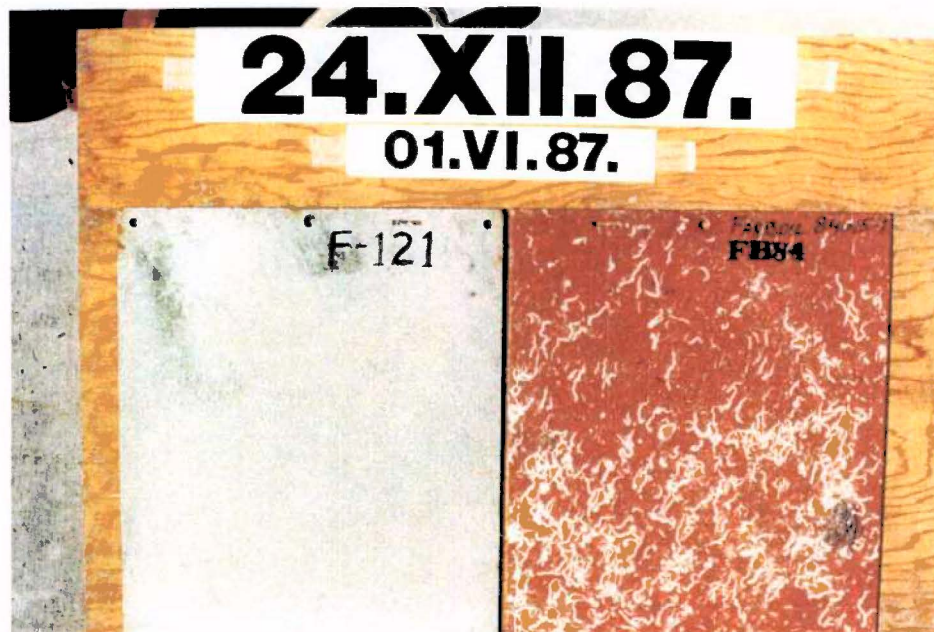
The FB84 retained its paint integrity better than any other paint system in this series. It also remained bright red during the entire test. The leaching rate, however, plunged below the critical  $10 \mu\text{g-Cu}/\text{cm}^2/\text{day}$  level within 30 days, and the paint accumulated heavy fouling within 2 months (graph B-45 and figure 14).

Figure 14. Farboil 844015-1 remained red, but accumulated heavy tubeworm growth within 6 months of static exposure.

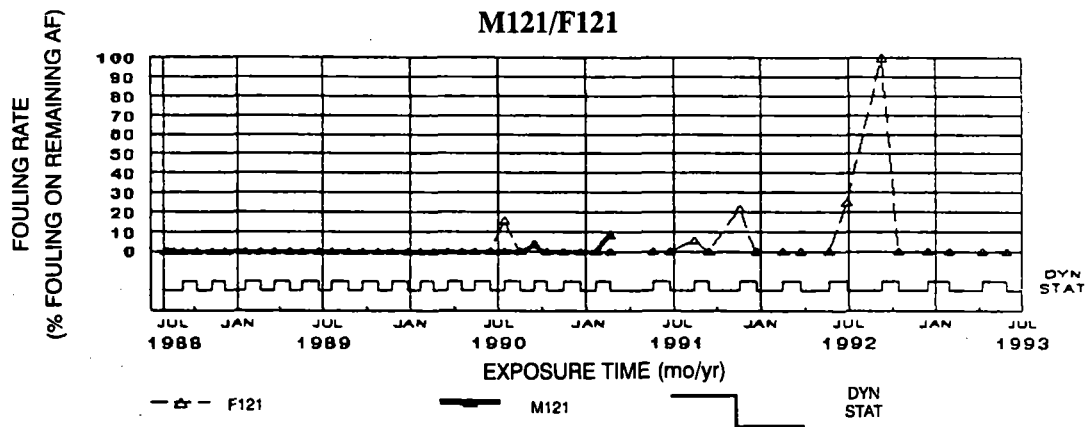
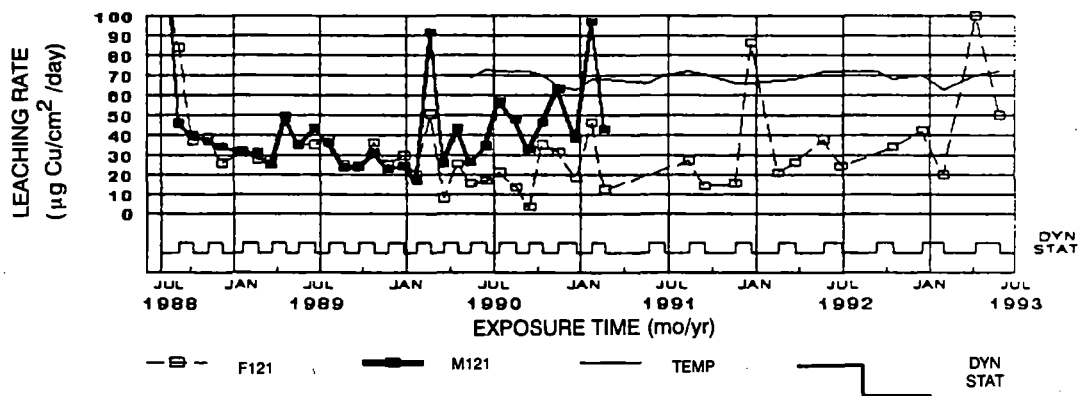
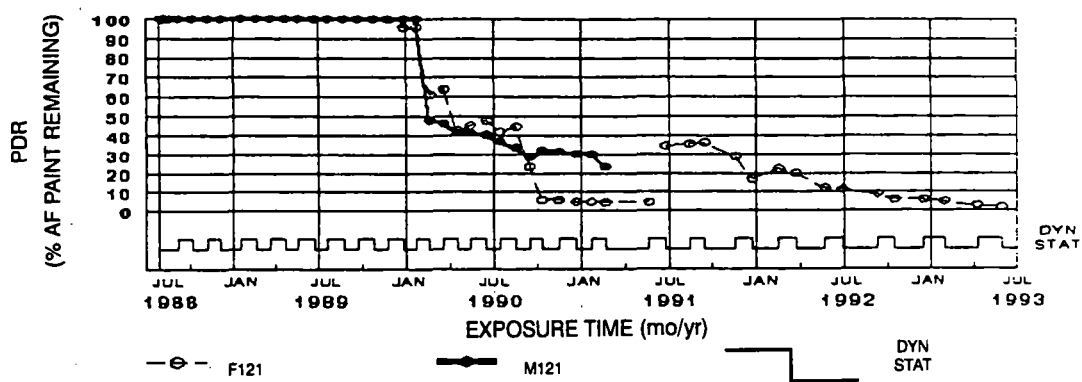
The M121 paint is basically an F121 formula modified by addition of 0.5%  $(\text{NH}_4)_2\text{SO}_4$  to increase the acidity (lower the pH) of the paint matrix and to prevent the formation of the green layer. The AF layer eroded quickly after 18 months dynamic/static exposure (graphs B-12 and B-13 in the appendix). The leaching rates of M121 and F121 were essentially identical. Similarly, the color changes of the original and the modified formula were identical as shown in figures 4 through 6 (and graph B-14 of the appendix). The surface pH of the 0.5%  $(\text{NH}_4)_2\text{SO}_4$  modified formula was somewhat lower than that of the unmodified F121 (graph B-15 in the appendix), but no significant benefit from the 0.5%  $(\text{NH}_4)_2\text{SO}_4$  addition was found. The exposure of the modified formula was discontinued after 32 months.

**Graph B-12. Dynamic/static exposure tests for M121 from July 1988 to July 1993.**

Graph B-13. Comparison of M121 and F121 fouling rate, Cu leaching rate, AF paint deterioration rate (PDR) in dynamic/static tests from July 1988 to July 1993.

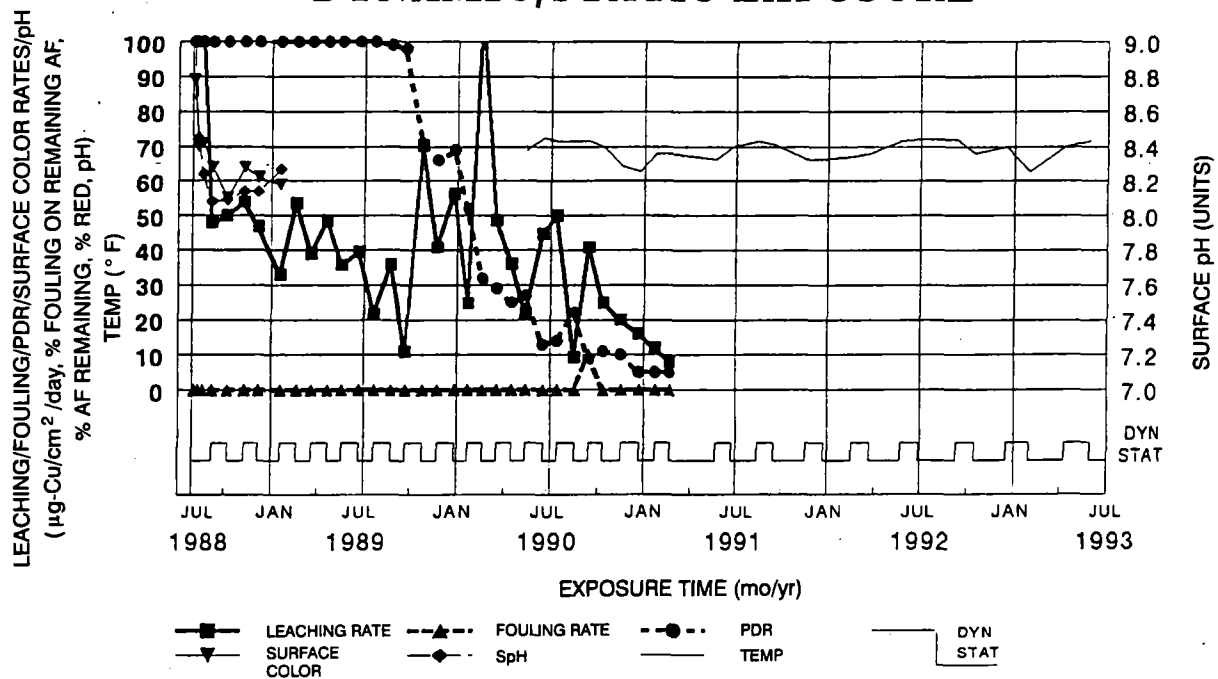
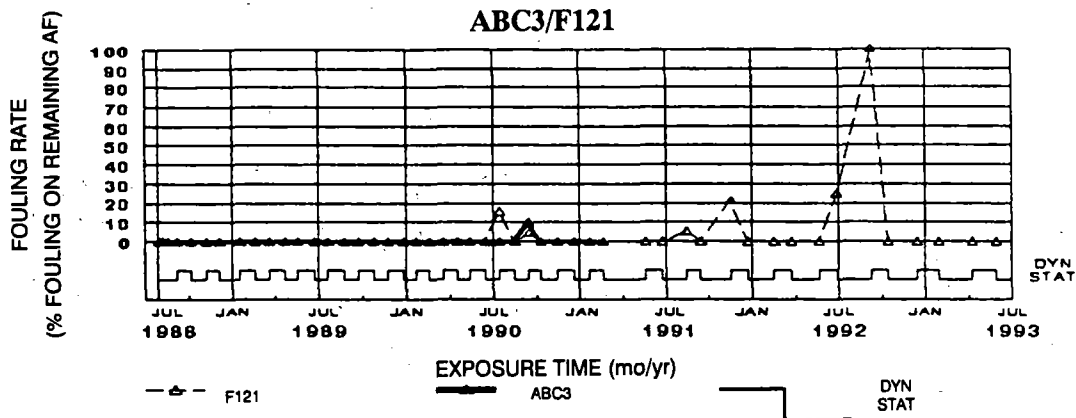
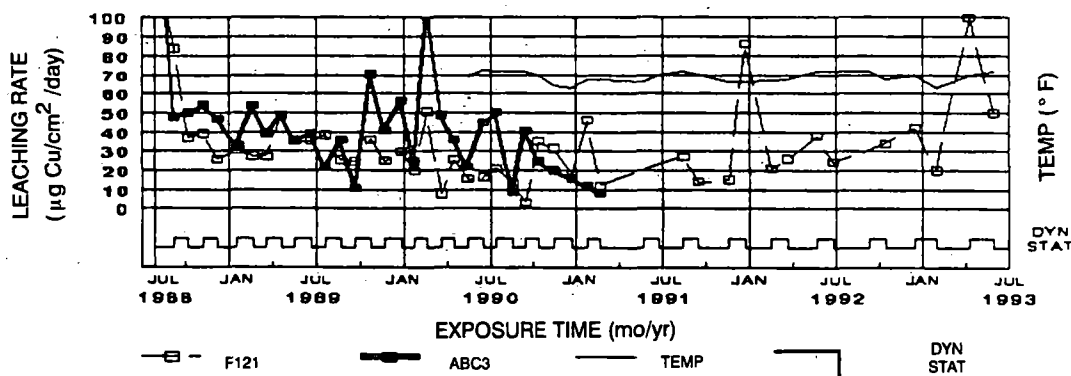
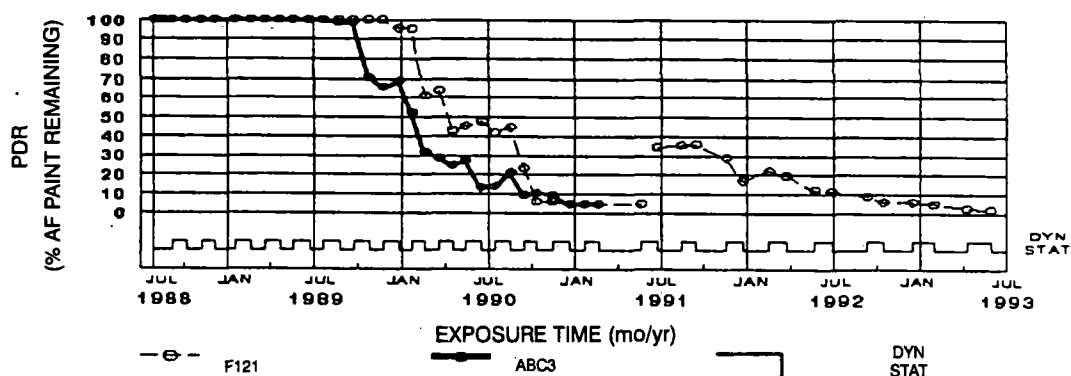
The ABC3 is essentially the ABC2 organotin/ $\text{Cu}_2\text{O}$ -based ablative coating formula without the organotin component. ABC3 showed the fastest erosion among the tested paint systems in the dynamic/static exposure (graphs B-16 and B-17 in the appendix). Erosion could already be detected after only 6 months (figures 4 through 9) and complete loss of the AF layer appeared after only 15 months of exposure. Most of the AF was lost by the end of the second year (figures 8 and 9). The remaining AF paint showed reasonable protection against fouling. The leaching rate was strongly affected by the dynamic/static cycles, and it remained relatively high (avg  $30 \mu\text{g-Cu}/\text{cm}^2/\text{day}$ ). Apparently, ABC3 (and ABC2) are relatively soft formulations that cannot withstand high currents. Because of paint deterioration, the dynamic/static exposure of ABC3 was discontinued after 32 months.

**Graph B-16. Dynamic/static exposure tests for ABC3 from July 1988 to July 1993.**

Graph B-17. Comparison of ABC3 and F121 fouling rate, Cu leaching rate, and AF paint deterioration rate (PDR) in dynamic/static tests from July 1988 to July 1993.

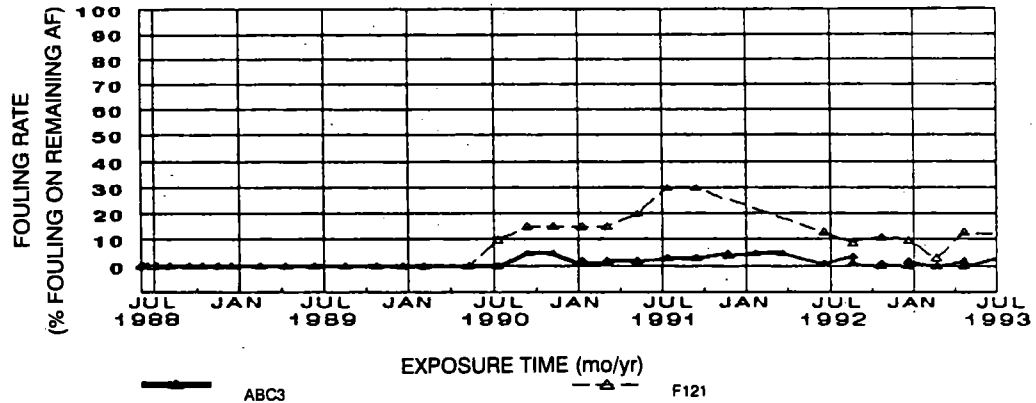
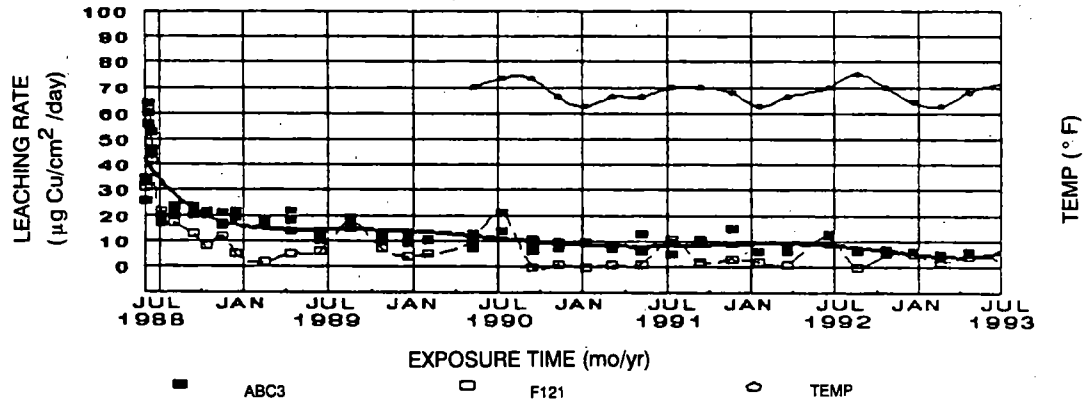
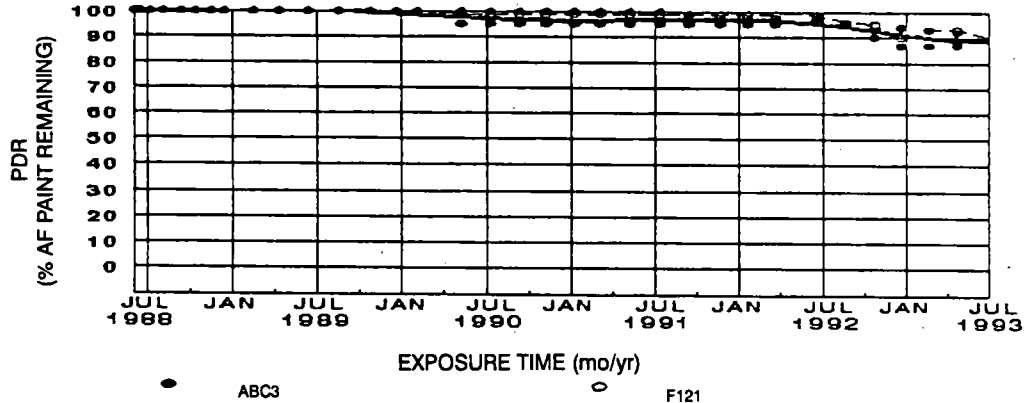
Some deterioration of ABC3 was observed during static exposure, as well (graphs B-18 through B-19 in the appendix). In an earlier experiment, ABC3 started peeling off after only 6 months static exposure (graphs B-20 and B-21 in the appendix). The leaching rate of ABC3 in the static exposure was equivalent, or somewhat higher than that of F121. Also, it had slightly better AF efficiency than F121. The color of ABC3 varied throughout the 5-year exposure. By the end of the 6-month monitoring period, it had turned green (graph B-22 in the appendix). Later, it recovered its red and showed several cycles between red and green during the 5-year exposure. There was no significant difference between ABC3 and F121 in surface pH.

Graph B-18. Static exposure tests for ABC3 from July 1988 to July 1993.

Graph B-19. Comparison of ABC3 and F121 fouling rate, leaching rate, and AF paint deterioration rate (PDR) in static exposure tests from July 1988 to July 1993.
