# ESD Repair of Army Main Battle Tank Components

January 26, 2006

# Repair of M1 Sun Gear Shaft

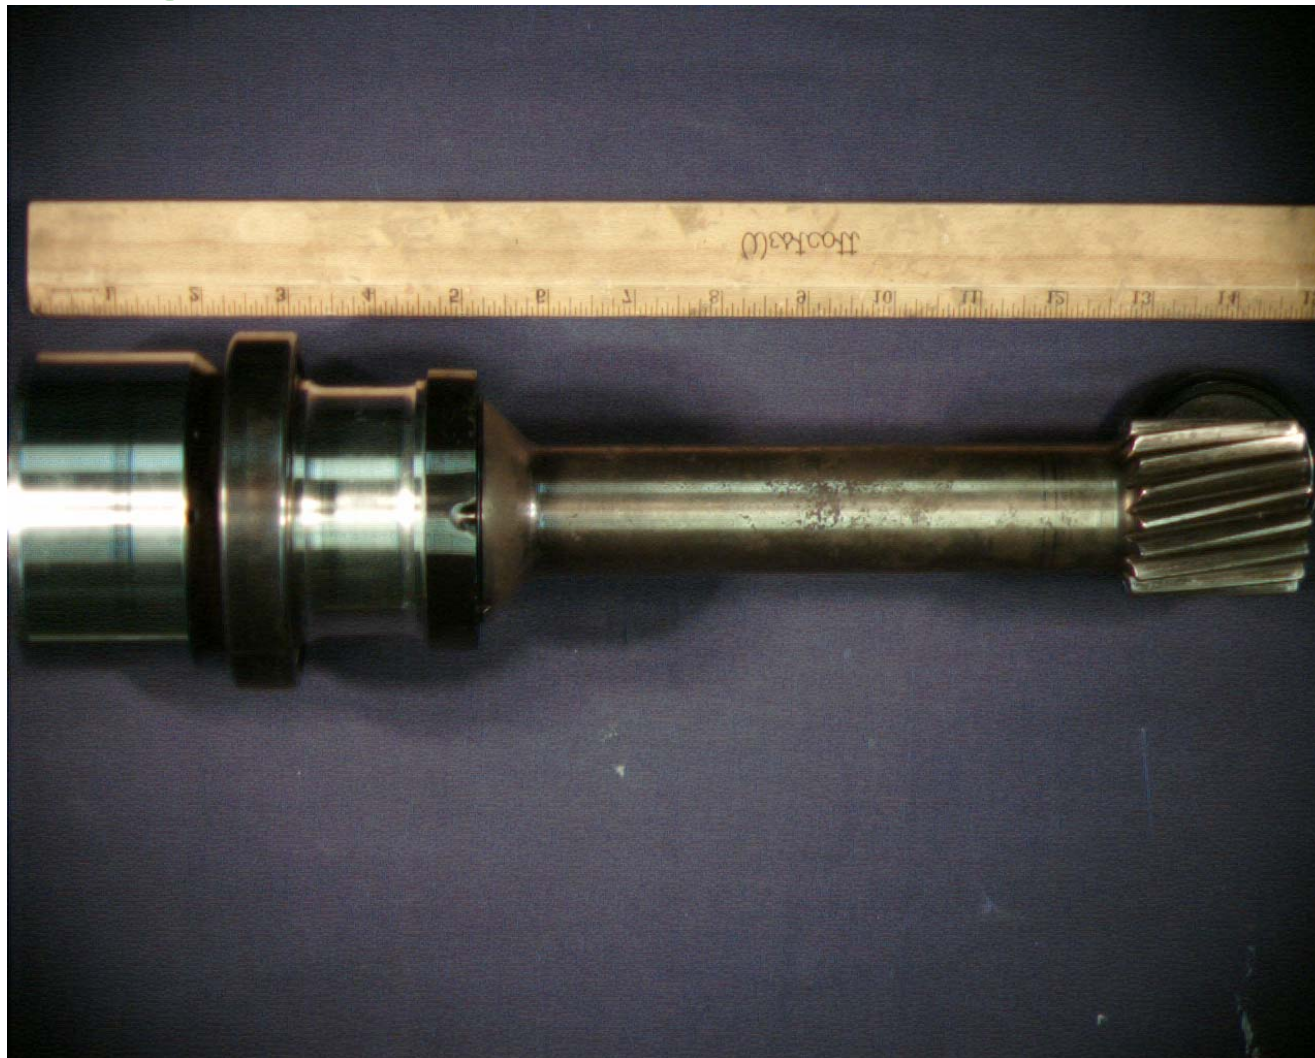
# Photograph of M1 Sun Gear Shaft

- Small corrosion pits and wear marks noted on chrome plated surfaces on the exterior and interior of the Sun Gear Shaft. Some damage extends into base metal
- Shaft is AISI 9310 steel with chrome plating in some regions.
- Shaft is part of the RGB (Reduction Gear Box), which transmits power from the M1's turbine engine to the transmission.
- The Sun Gear Shaft has an input RPM of 32,000, and drives a planetary gear with an output of 3,000 RPM.
- The seals which ride on the chrome plated surfaces are carbon based spring loaded seals, providing very low levels of wear to this part.

- Remove Chrome Plating via grinding.
- Using a hand held grinding tool with mild abrasive bit, grind away any corrosion product until clean metal surfaces are present.
- Clean the surface to be repaired with a solvent such as ethyl alcohol and dry.
- Apply a 35 CFH flow of argon gas over the area to be repaired.
- Install a clean Inconel 718 electrode in the rotating torch.
- Perform ESD process to fill the corrosion pit to a level above the surface of the part.
- Using a hand held grinding tool and a polishing bit, polish away excess ESD material until the surface being repaired is flat and flush with the rest of the part.
- Finish polishing the surface of the part using an ultra-fine grit silicon carbide paper (>1200 grit).
- Plate with Chrome to thickness of 0.002-0.005."

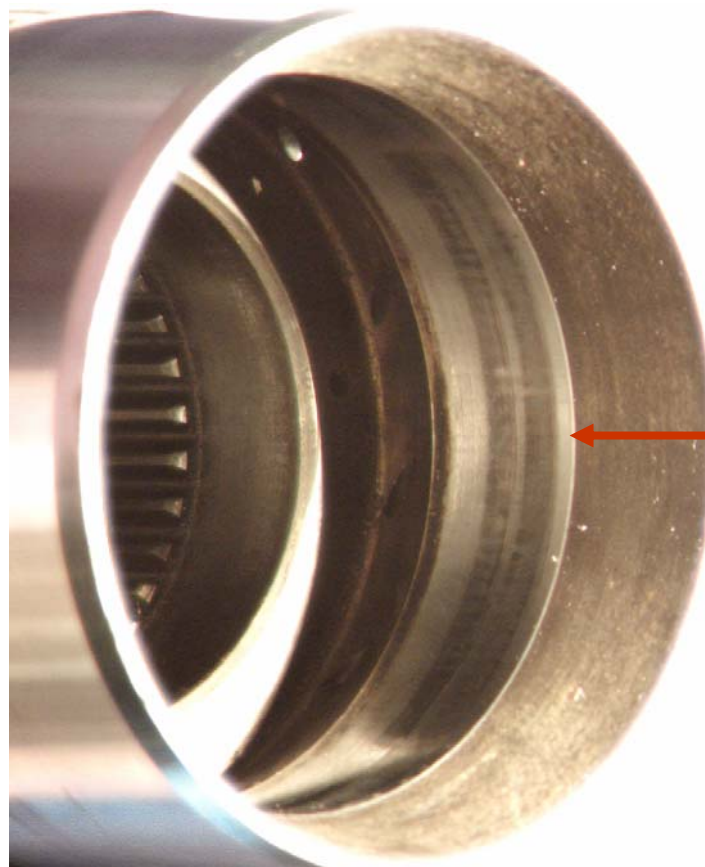
# Interior Chrome Plating on M1 Sun Gear Shaft

← **Chrome  
Plating**

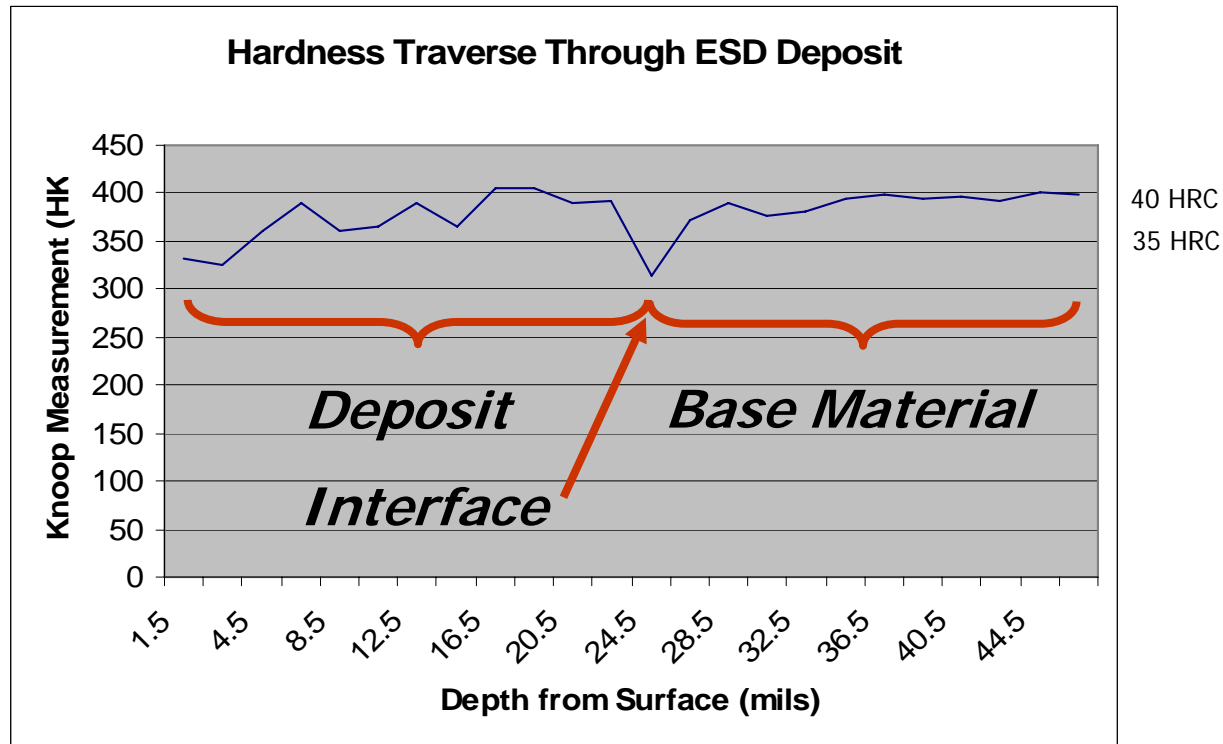
# Microhardness Through an ESD Deposit

- Knoop microhardness measurements (500gmf load, 50x objective) were taken through ESD deposits into base material (AISI 9310). Typical hardness results are as shown:

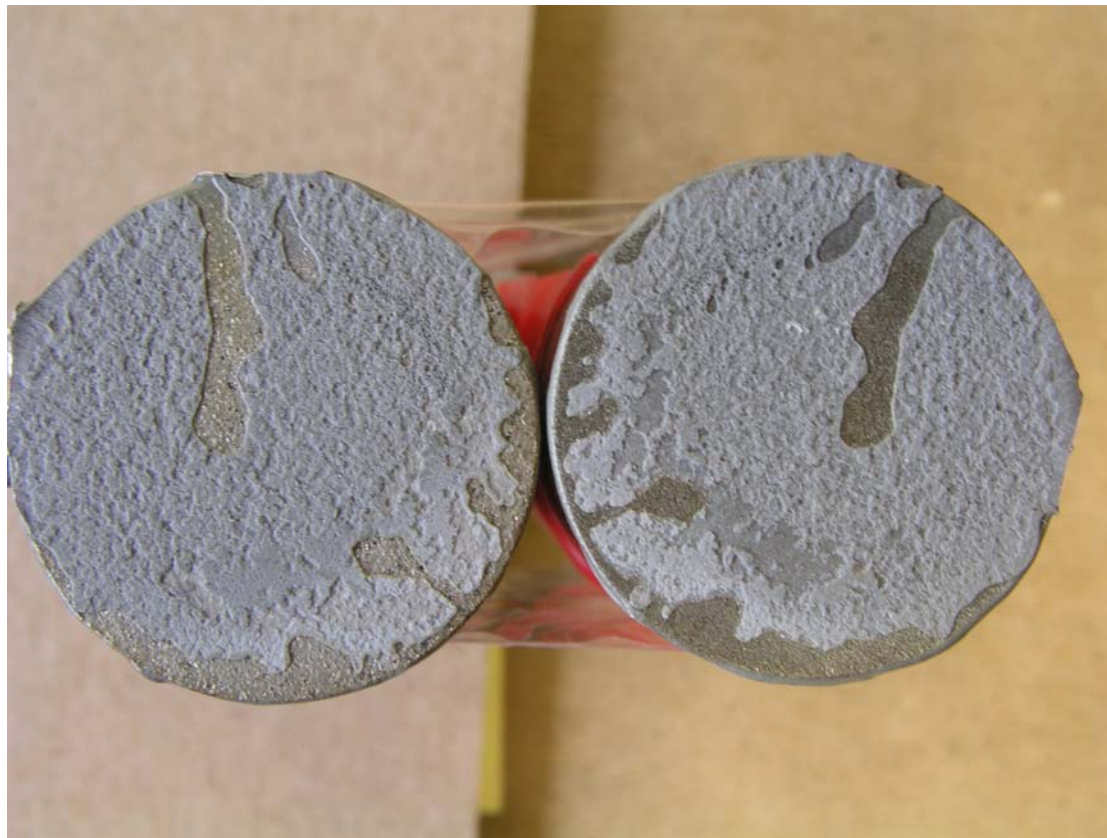
# Tensile Test Bond Bars

(ESD on 9310 Steel)

Note: All were adhesive bond failures

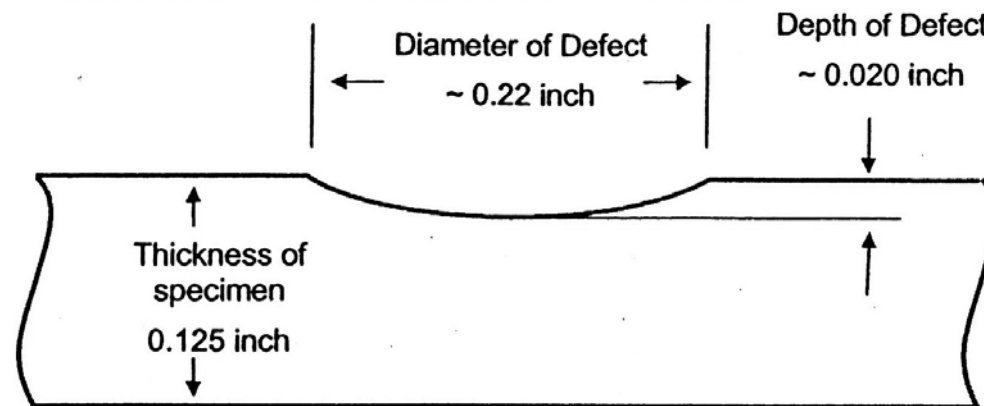
# Fatigue Specimen Defect

Type 1 Defect to be machined into center of gage section of fatigue specimens and ESD filled.

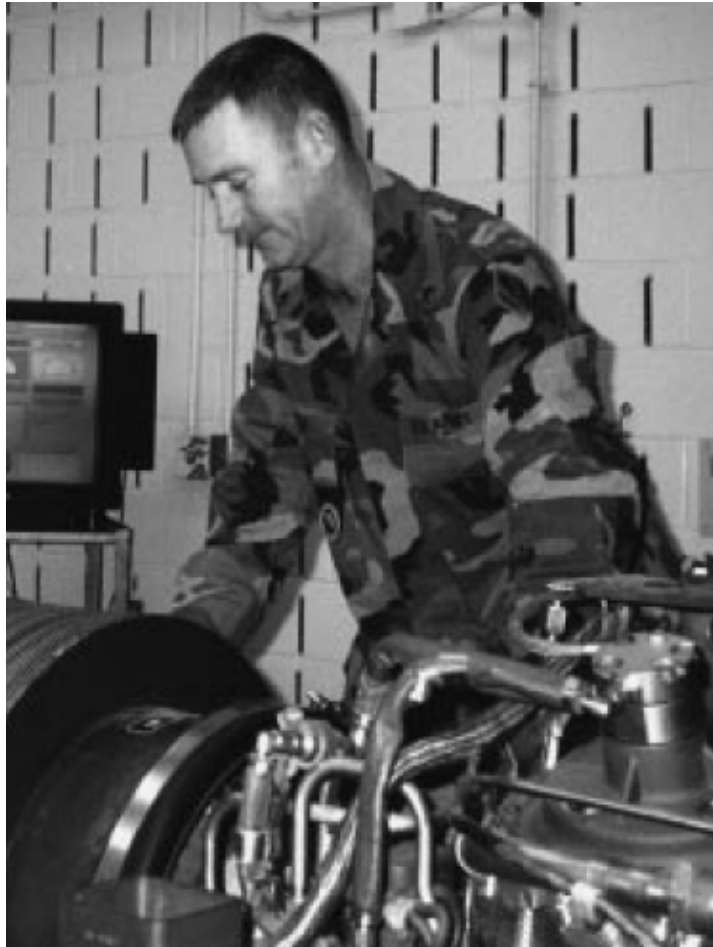
# AGT Testing

Mechanic operating an AGT-1500 Engine Test Stand. A similar test stand will be used for future testing of sun gears with ESD deposits.
