**TECHNICAL REPORT**  
**TR-NAVFAC-EXWC-PW-1303**  
**SEPTEMBER 2013**

**BUILDING INTEGRATED PHOTOVOLTAIC (PV)  
ROOFS FOR SUSTAINABILITY AND ENERGY  
EFFICIENCY**

**ESTCP Number: EW-200813**

**September 2013**

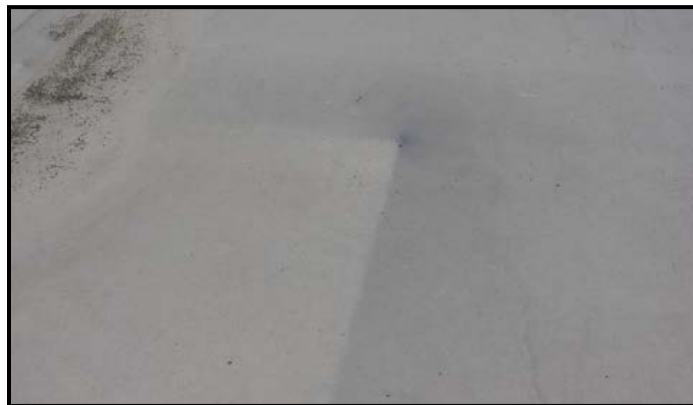
ROOFER EMS survey records for Site II (NAS Patuxent River) are shown Appendix H and the resulting condition indices are shown Table-5. The condition indices were significantly impacted by mold growth on the PVC and a warping dens-deck shown in Figure-28 and water ponding shown in Figure-29. Since mold growth was not present at either Site I (Luke AFB) or Site III (MCAS Yuma), it was once again determined to be worthwhile for the ROOFER survey team to measure the roof reflectance while they were on site (Table-6; Appendix I). Due to a lack of clear skies, a condition necessary for proper roof albedo measurement, only one measurement was acquired for Site II (NAS Patuxent River). In addition, it was impossible to properly measure the albedo of the PV modules due to water ponding. Water ponds also reduce the amount of sunlight the PV modules receive, thus, reduces the PV energy output.

**Figure-28: Mold growth (upper left corner) and warping dens-deck (center) at Site II (NAS Patuxent River).**

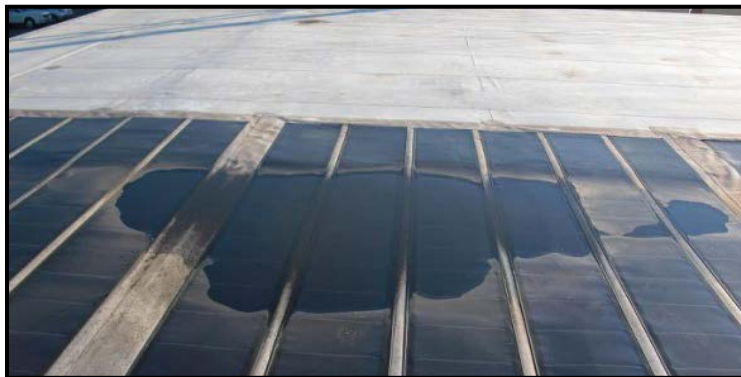
**Figure-29: Significant ponding at Site II (NAS Patuxent River).**

water and the pool of water that is shown in Figure-29. There was a lack of snow events, so snow impacts could not be quantitatively determined, but it is expected that snow retention on the roof will significantly reduce the PV power output more than the water retention.

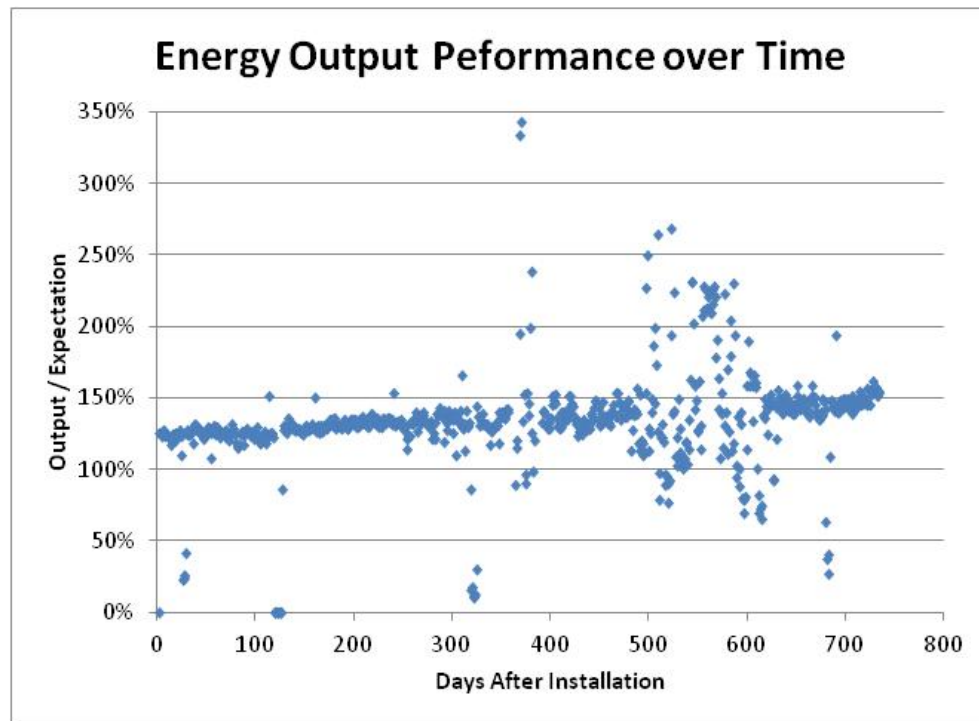
system performed above expectations, thus, meeting the performance objective (Figure-49). This can be accredited to the fact that thin film PV material tends to perform relatively well in diffuse sunlight when compared to crystalline PV material and this data provides evidence that the characteristic should be considered when developing future PV systems in similar climates. Note that at times when the performance appeared exceptionally high, such as over 150% of the expectation, this often occurred when the solar insolation was very low, such as early or late in the day or during heavy rainfall, so it does not have a major impact on the overall energy production.

**Figure-49: Site II (NAS Patuxent River) performance compared to estimates based on available solar resource.**

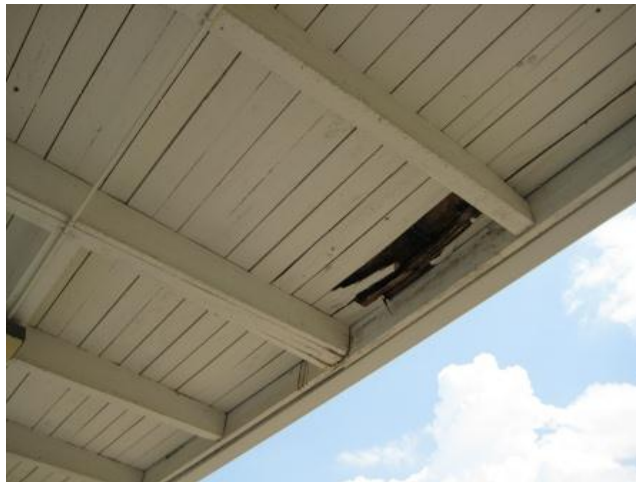
**Figure 3 Building 515 Rotten Section**
