**TEARDOWN AND INSPECTION OF THE CUMMINS  
VTA-903 - EVALUATED USING THE SINGLE COMMON  
POWERTRAIN LUBRICANT (SCPL)**

**INTERIM REPORT  
TFLRF No. 450**

**Contract No. W56HZV-09-C-0100 (WD21 – Task 2.6)**

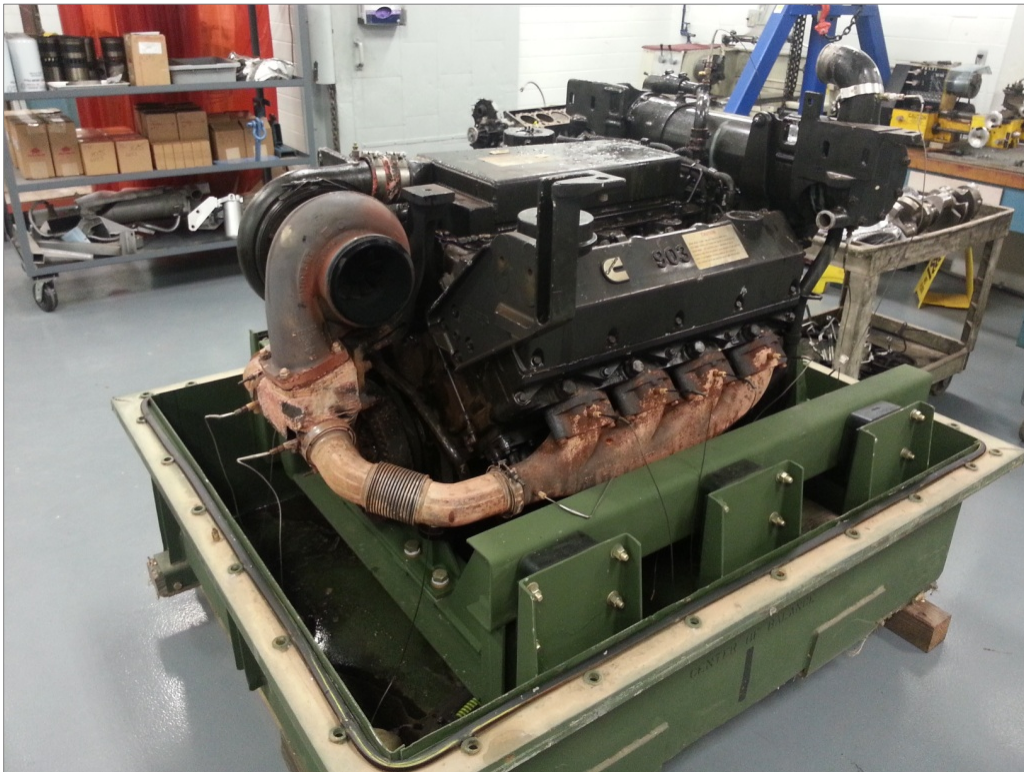
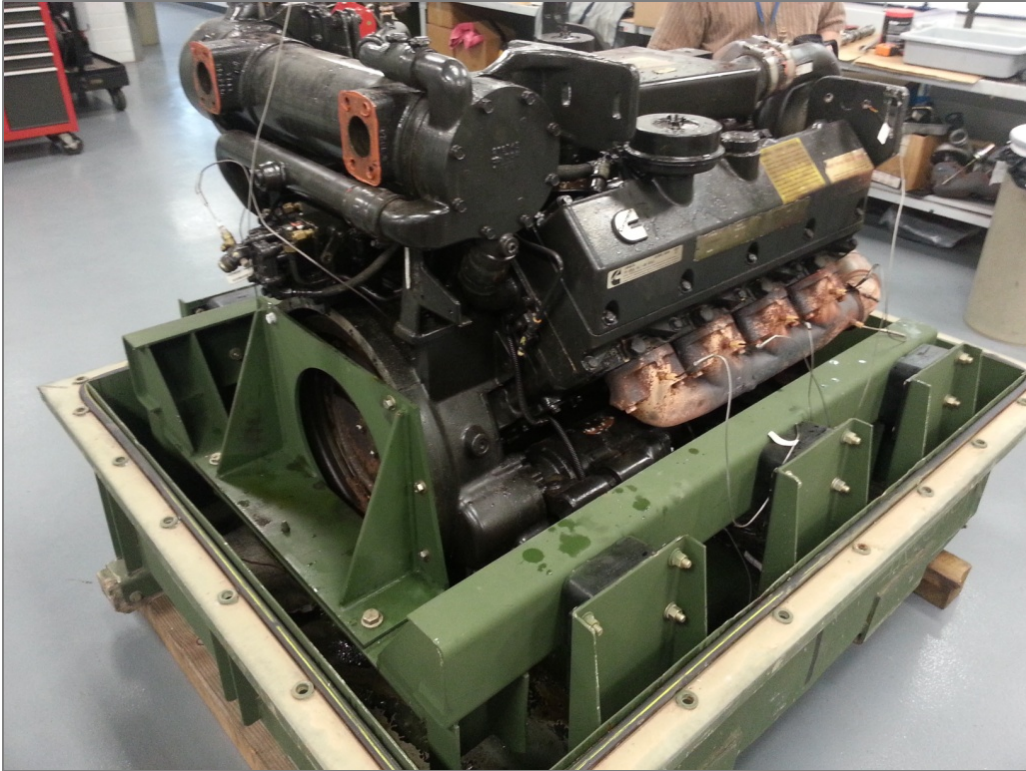
The SCPL evaluated engine was received by TFLRF in a standard government issue engine shipping container specific to the Cummins 903 engine family. It was received at the TFLRF in the 1<sup>st</sup> QTR FY13, and remained in storage as received until late April 2013 when the funding for this effort was received and the inspection process was initiated. During this approximate 6 month storage time, the engine container was stored in a partially enclosed (3 sided) storage building. The shipping crate was not exposed to direct weather during this time. Upon opening at the start of inspection, a significant amount of moisture was noted within the container. In

addition, excess used oil had accumulated in the bottom of the container which required cleaning prior to removal. The moisture present within the container was unexpected, and may have contributed to, or become apparent in some results reported within this report. Specific notations will be made in each suspected area. Figure 1 and Figure 2 show generic shots of the engine as received and uncrated at TFLRF. Figure 3 and Figure 4 show the moisture and oil present within the container upon opening.

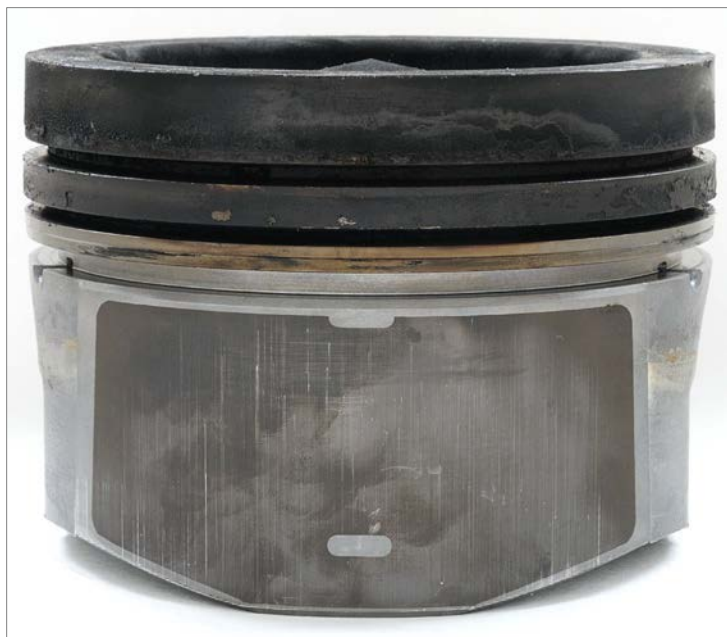
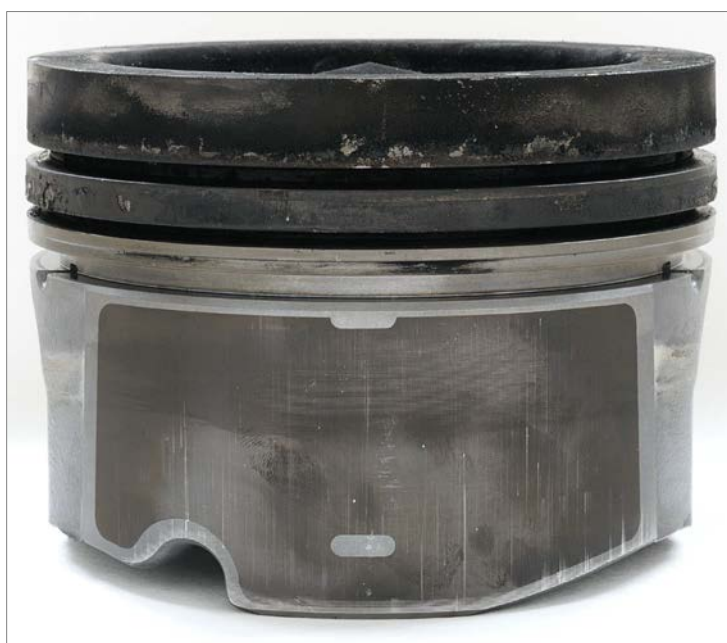
**Figure 22. Piston Skirt, Cylinder #1, Thrust**

PISTON CONDITION: Thrust &amp; Ant. Thrust Skirt have light vertical line scratches.

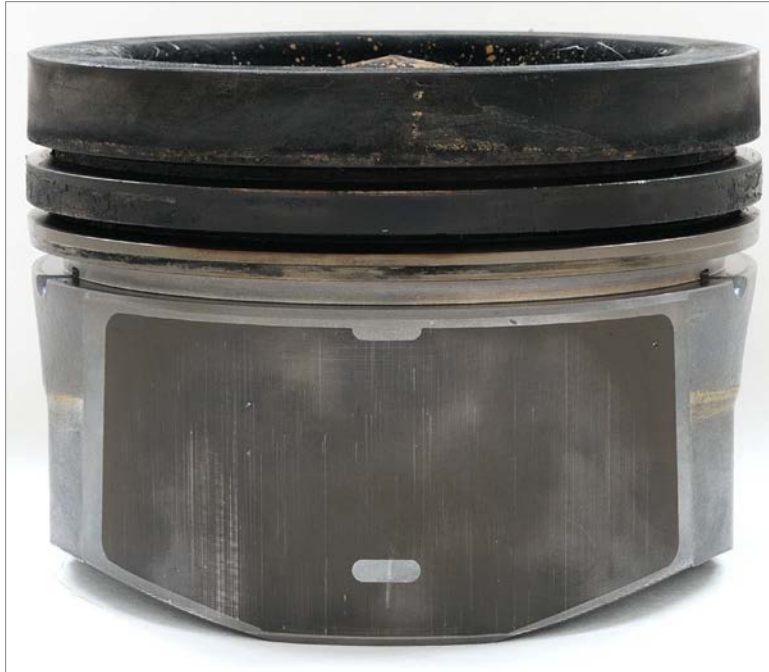
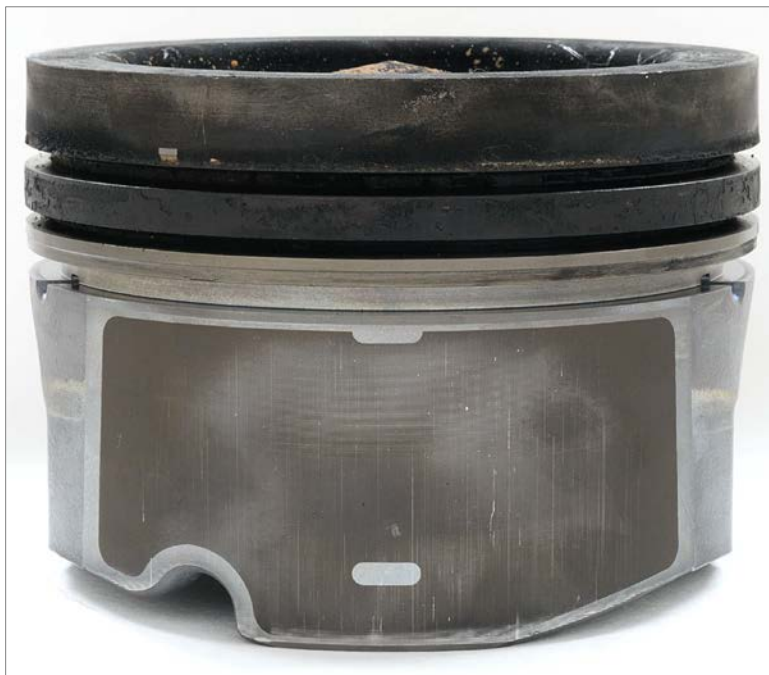
**Figure 26. Piston Skirt, Cylinder #2, Thrust**

PISTON CONDITION: Thrust &amp; Ant. Thrust Skirt have light vertical line scratches.

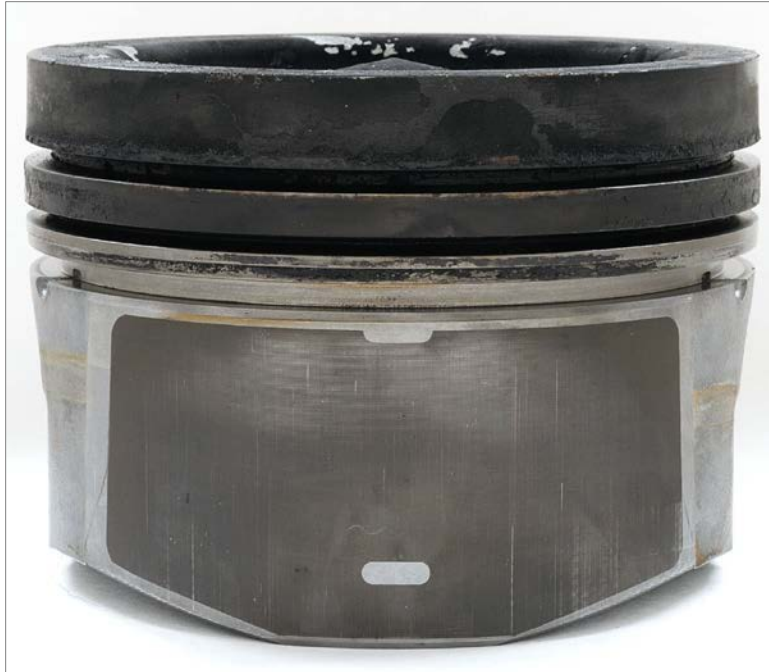
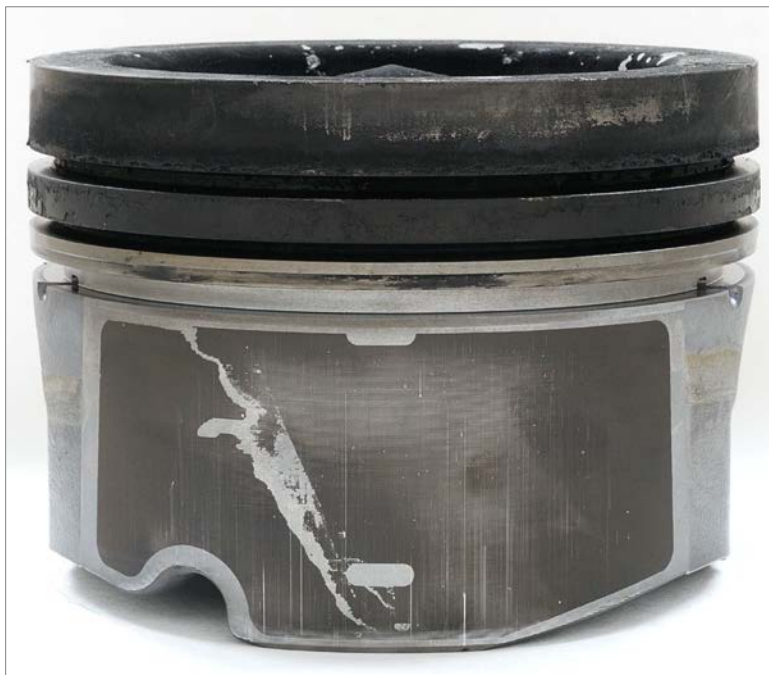
**Figure 30. Piston Skirt, Cylinder #3, Thrust**

PISTON CONDITION: Thrust &amp; Ant. Thrust Skirt have light vertical line scratches.

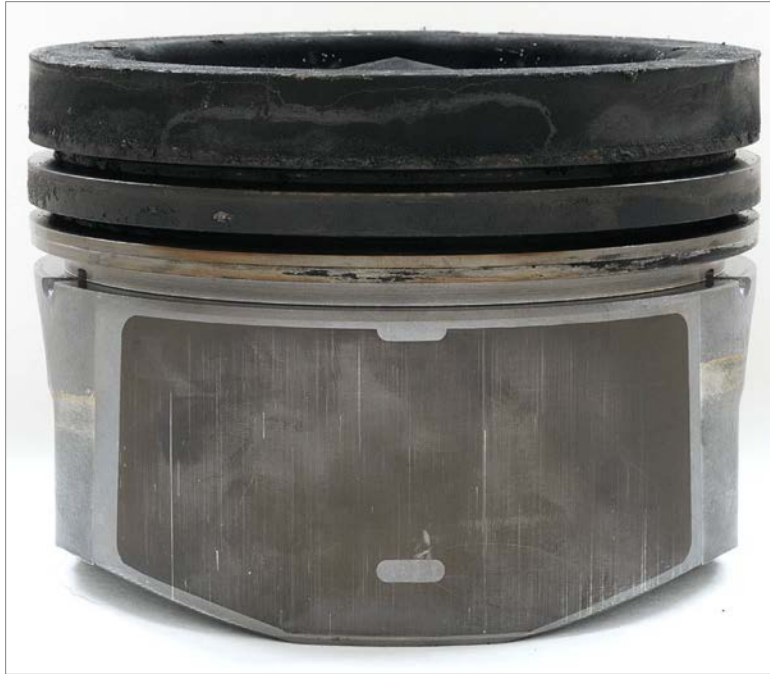
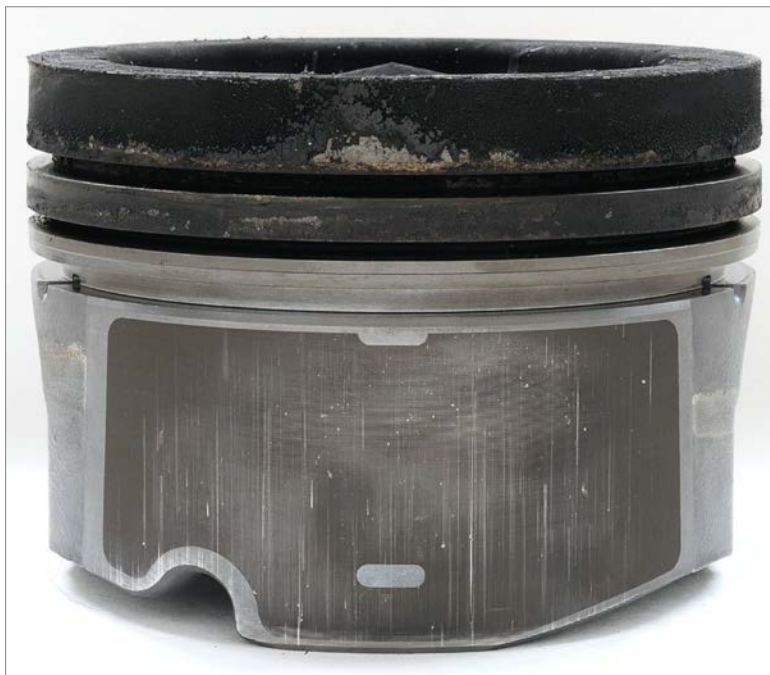
**Figure 34. Piston Skirt, Cylinder #4, Thrust**

PISTON CONDITION: Thrust &amp; Ant. Thrust Skirt have light vertical line scratches.

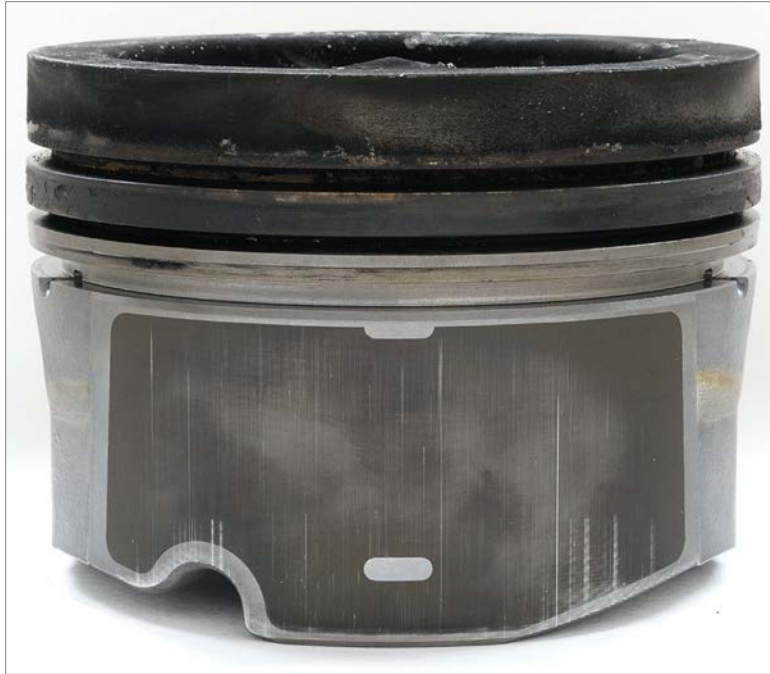
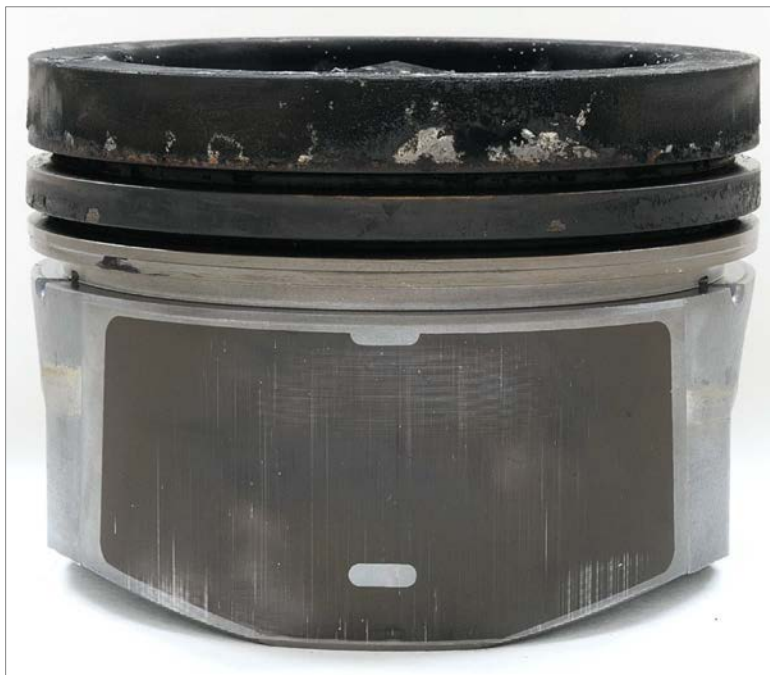
**Figure 38. Piston Skirt, Cylinder #5, Thrust**

PISTON CONDITION: Thrust &amp; Ant. Thrust Skirt have light vertical line scratches.

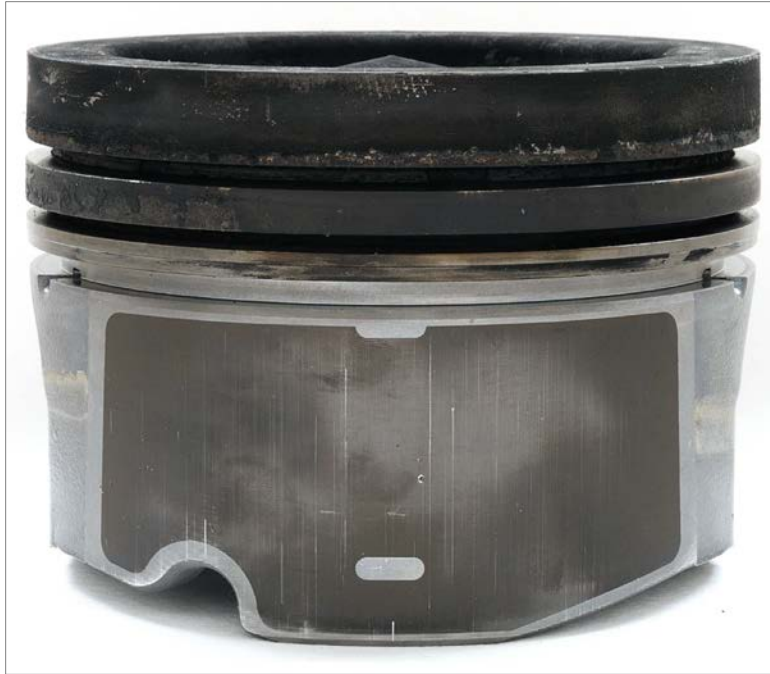
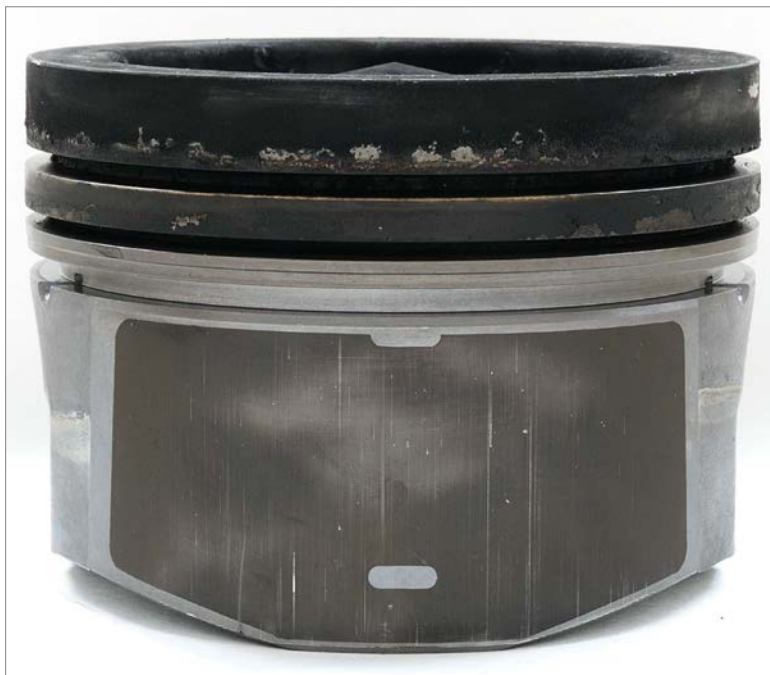
**Figure 42. Piston Skirt, Cylinder #6, Thrust**

PISTON CONDITION: Thrust &amp; Ant. Thrust Skirt have light vertical line scratches.

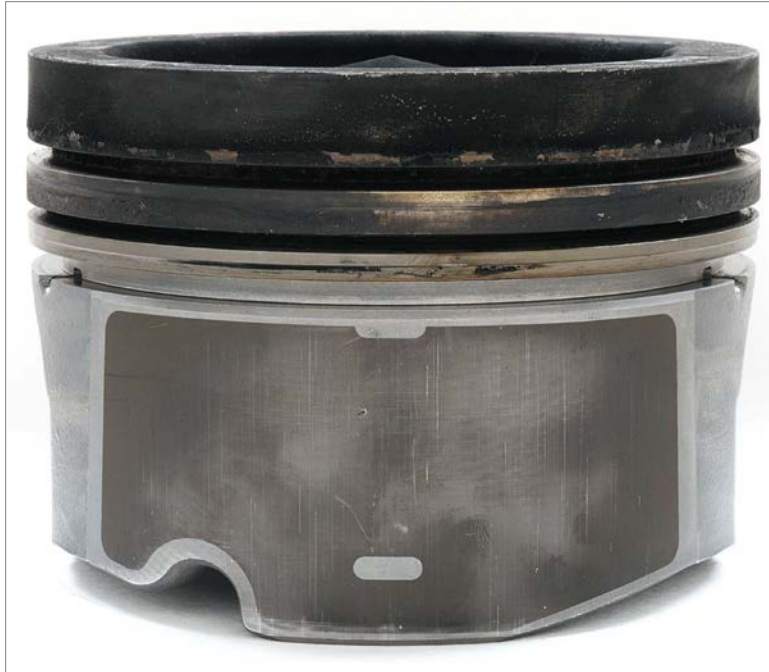
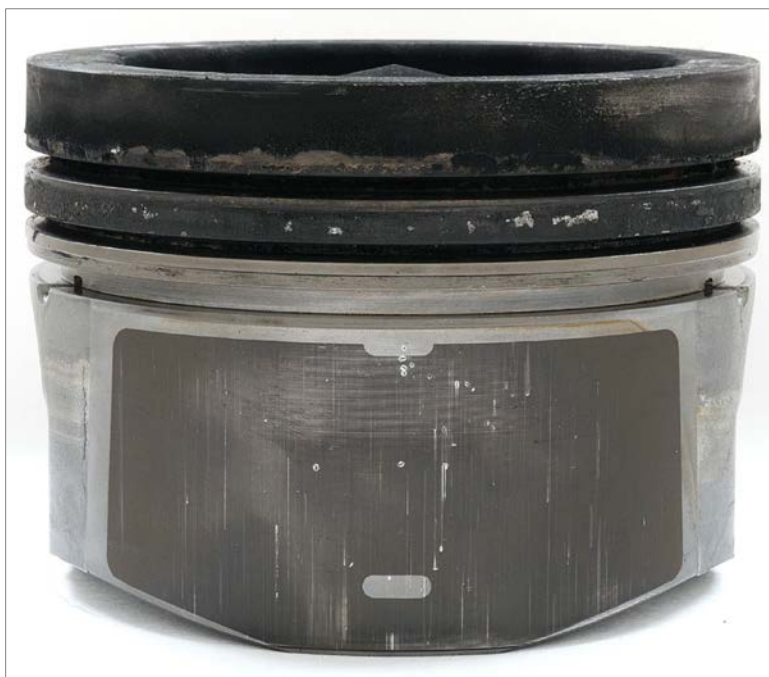
**Figure 46. Piston Skirt, Cylinder #7, Thrust**

PISTON CONDITION: Thrust &amp; Ant. Thrust Skirt have light vertical line scratches.

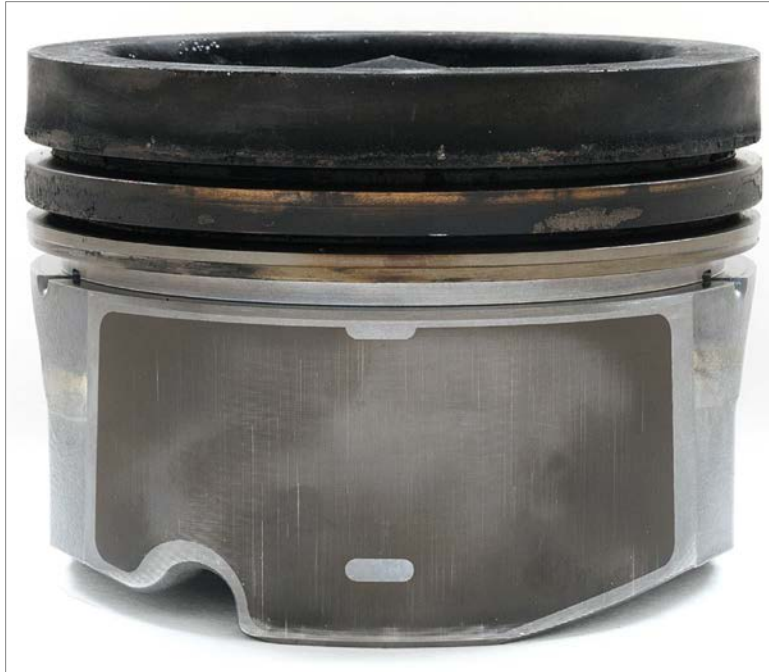
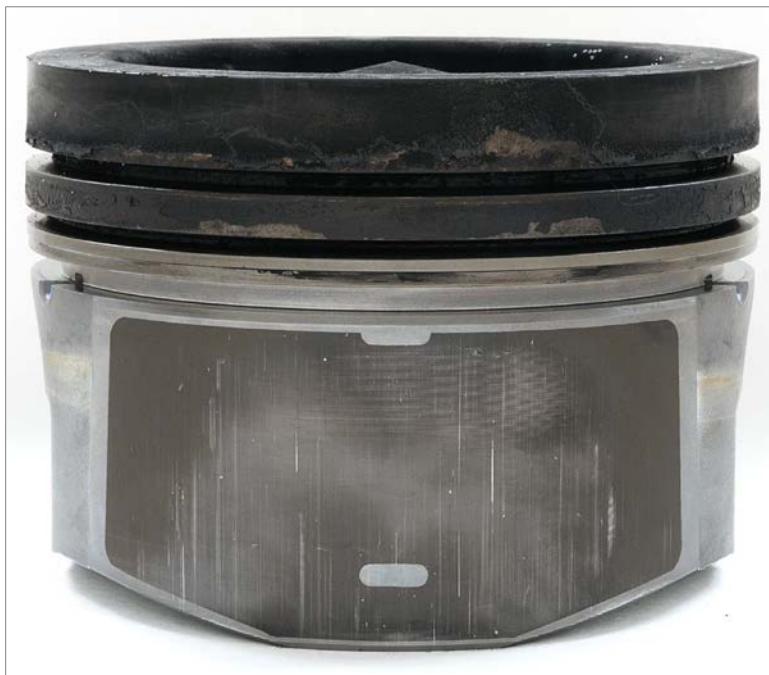
**Figure 50. Piston Skirt, Cylinder #8, Thrust**

PISTON CONDITION: Thrust &amp; Ant. Thrust Skirt have light vertical line scratches.

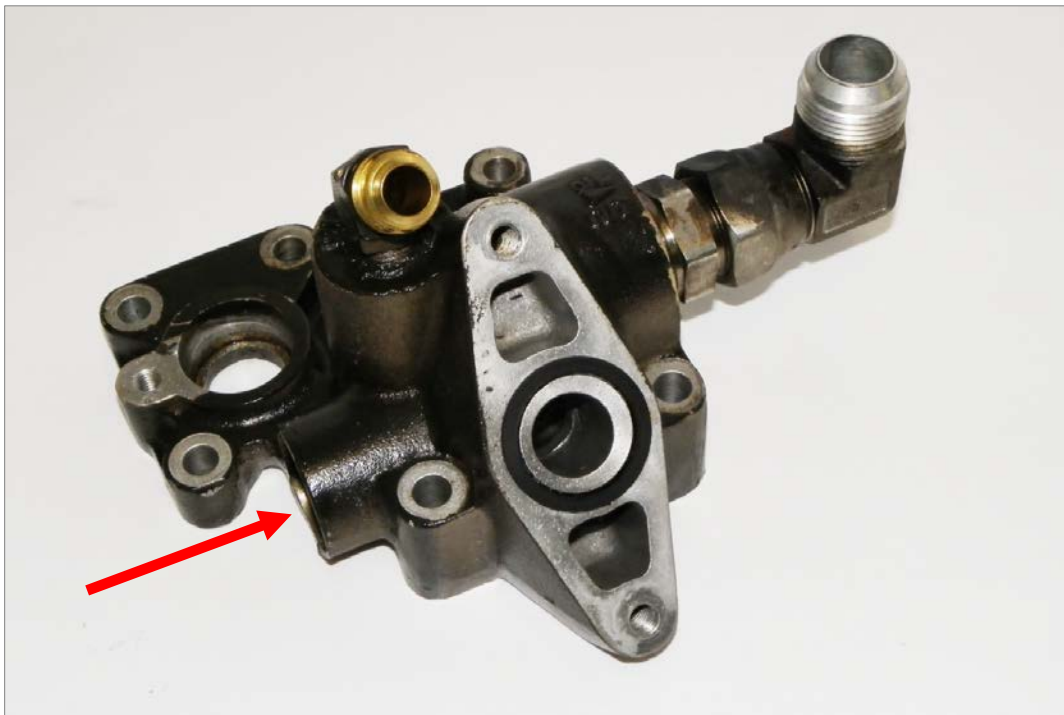
**Figure 81. Oil Cooler Mounting Assembly/Secondary Relief/Bypass Valve Location**

For reference, Figure 81 below shows the oil cooler mounting assembly where the secondary relief piston/bypass is located. The location of the photo shown in Figure 80 above was taken through the opening shown directly facing in the photo below. The secondary relief piston/bypass valve is inserted through the bore at the bottom of this housing (note: 90° steel AN fitting considered the top of the housing for frame of reference, secondary relief piston bore opening and movement axis denoted by red arrow).
