Infrared Reflectance Imaging for Corrosion Inspection Through Organic Coatings (WP-0407)

13. SUPPLEMENTARY NOTES ASETSDDefense 2009: Sustainable Surface Engineering for Aerospace and Defense Workshop, August 31 - September 3, 2009, Westminster, CO. Sponsored by SERDP/ESTCP.

TECHNICAL CONCEPT

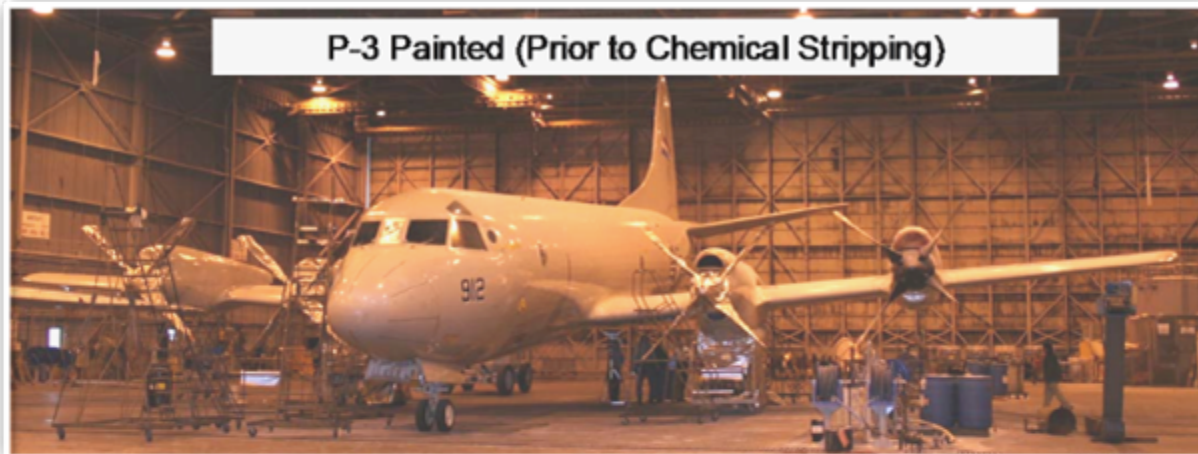
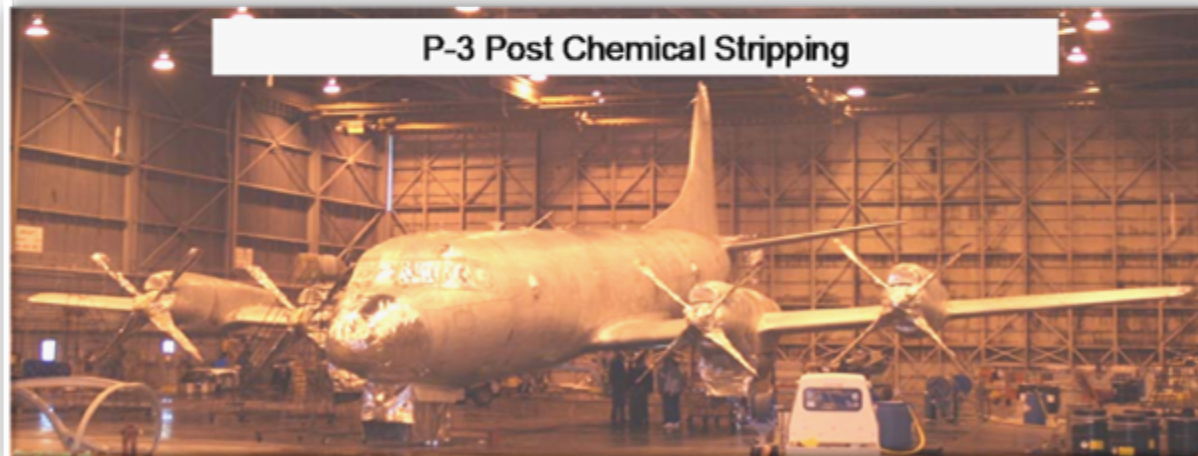
IRRIT Results (Painted) vs. Visible Results (Stripped)

Comparing the IRRIT results of the painted aircraft versus the visible results of the chemically stripped aircraft will demonstrate and validate that the IRRIT is a viable inspection method to reduce pollution products.

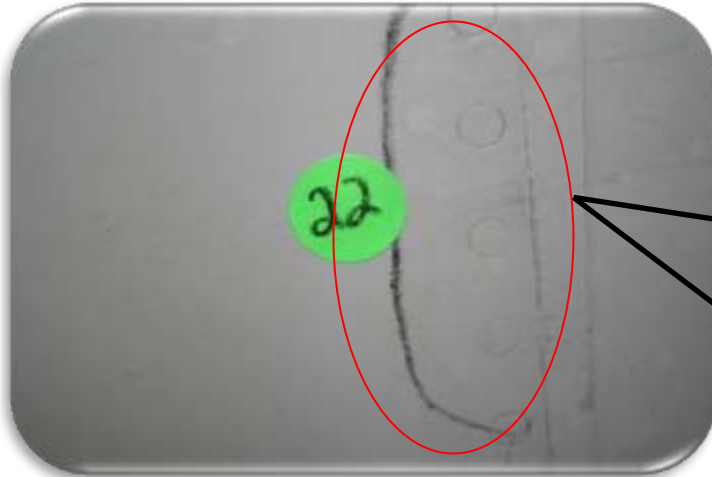
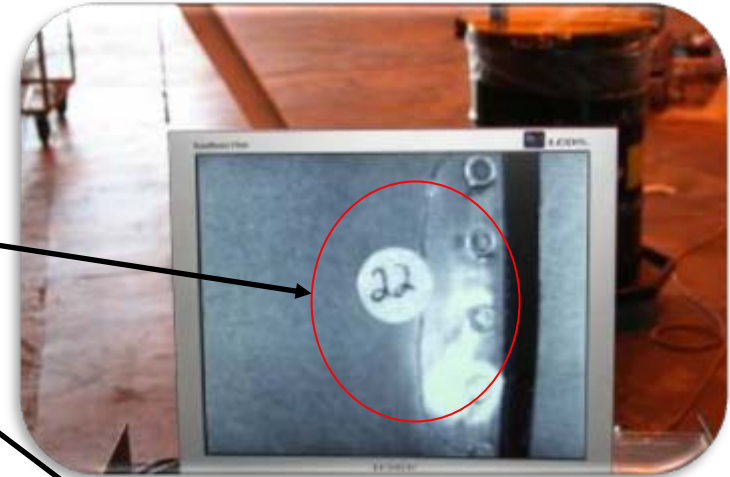
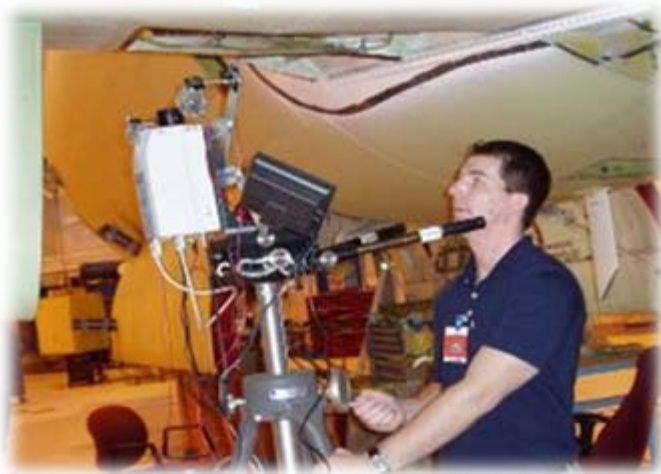
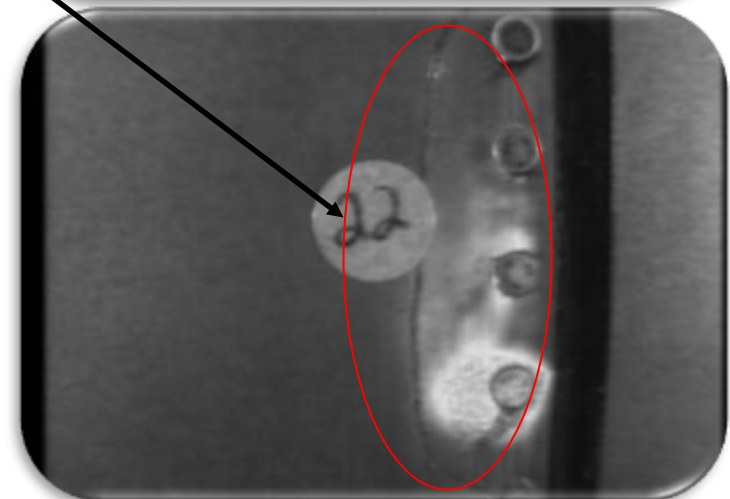
Started Official Dem/Val (2of 3) – P-3 BU# 162772, SEQ 311

Note: Several corroded areas were found while checking the scan rate on this region, all corroded areas found via the IRRIT were confirmed by chemically stripping.

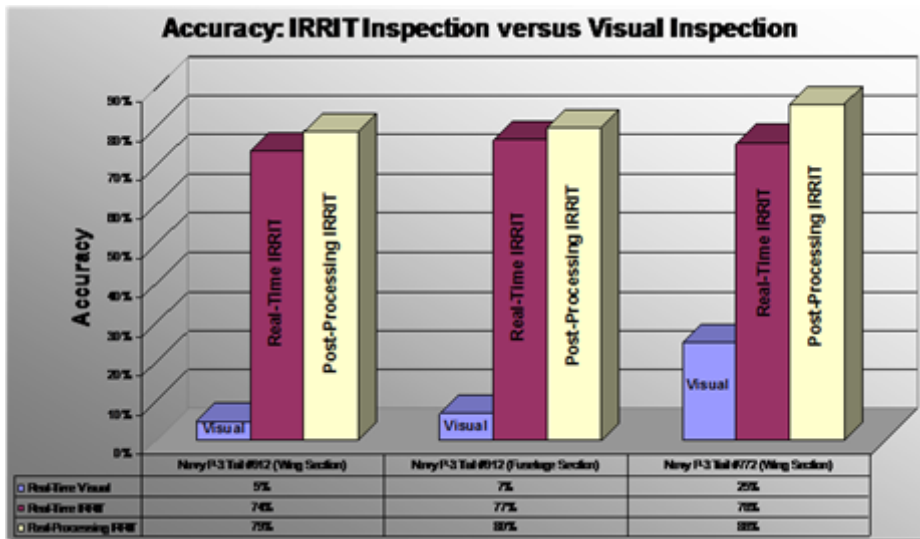
Results

1. The IR method directly images corrosion by-product through the paint system due to reflectance contrast differences of the substrate.
2. The visual method relies upon the identification of paint surface irregularities/blistering (i.e., paint degradation) as a result of substrate volume changes associated with corrosion formation.

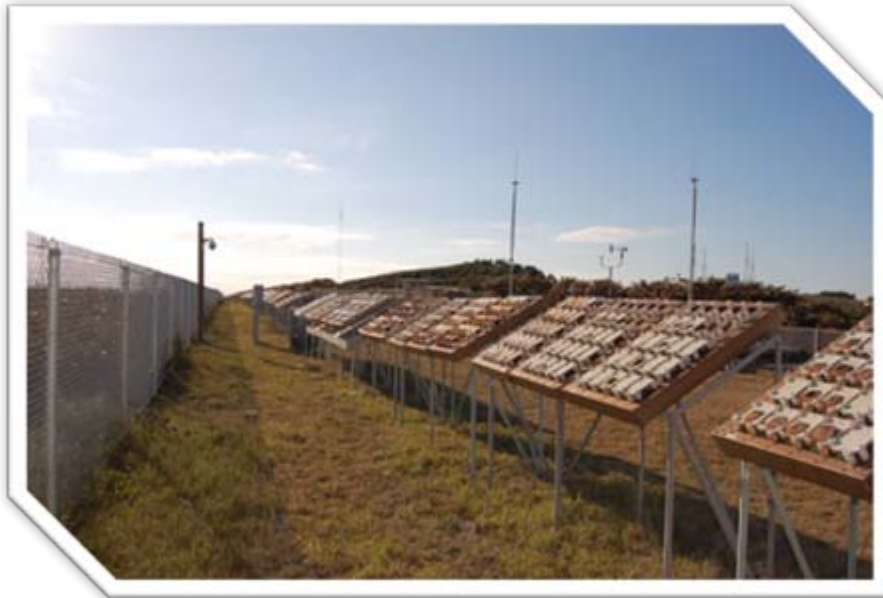
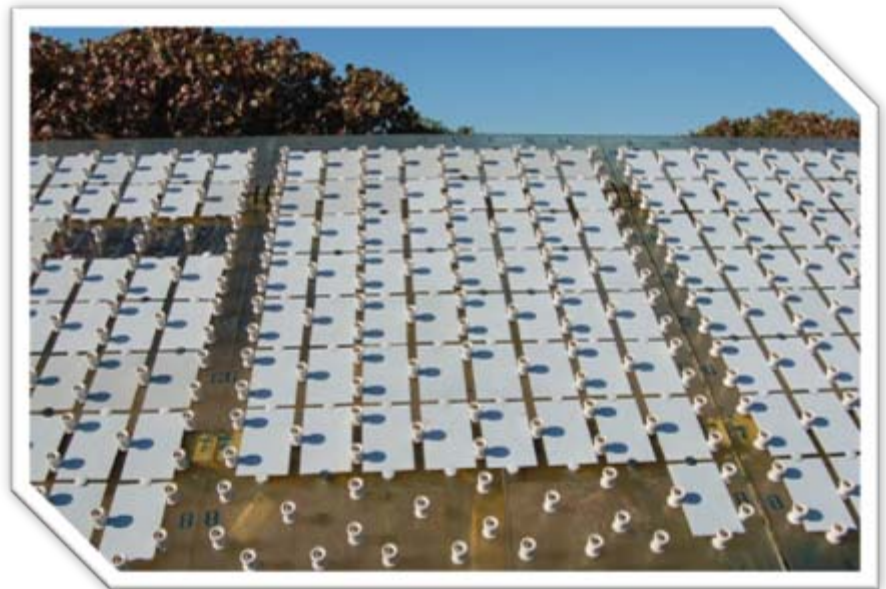
- Outdoor Exposure Testing – Evaluation of NAVAIR exposure coupons located at Cape Canaveral, FL

Exposure Test Facility

Exposure Coupons

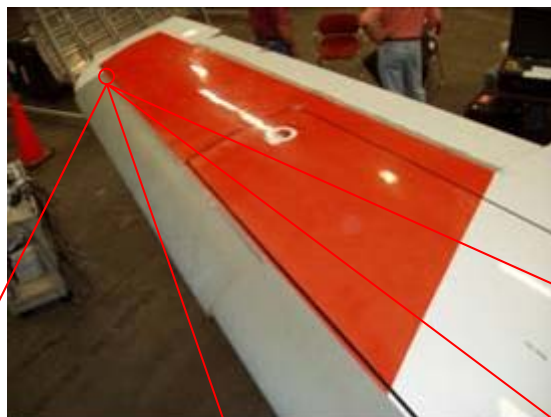
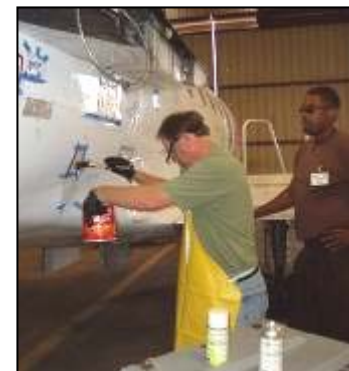
USCG HU-25 INSPECTION

Paint Thickness in this Zone = ~6.5 mils
