Geophysical Surveys for Detecting Anomalous Conditions, Algiers Canal Levees, New Orleans, Louisiana

José L. Llopis and Joseph B. Dunbar

August 2014

Final report

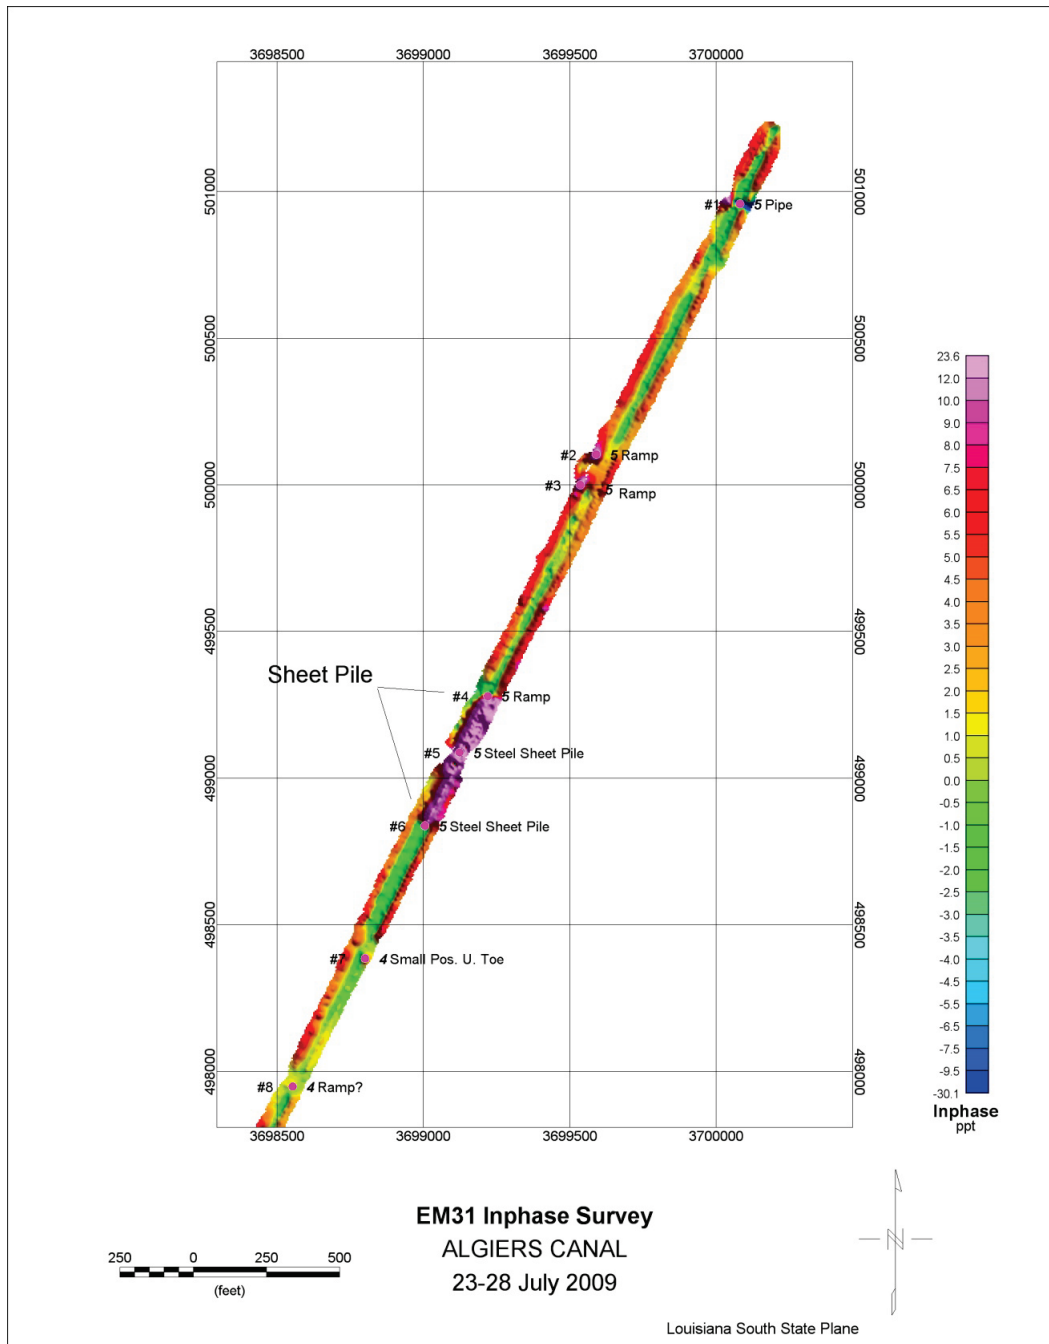
Figure A1. EM31 in-phase survey results, Section 1.

Section 1 extends from the Highway 23 tunnel (station 980+00) southwesterly to approximate station 1018+21. The survey results for Section 1 are presented in Figure 5. No priority 1 or 2 anomalies were interpreted for this

section. The highest priority given to an anomaly in this section was a priority of 4. A steel sheet pile, located between approximate stations 1001+81 and 1006+78, is clearly evident (hot pink area). With the exception of the area in the vicinity of the steel sheet pile, the values along the center line of the levee are fairly consistent indicating very little or no metallic debris within the levee. However, the values along the toes of the levee have considerable variability. This variability is mainly caused by the effects of nearby metallic objects (e.g., cranes, metal buildings, pipes, reinforced concrete slabs). The anomalies along the toes are not considered to be a threat to the integrity of the levee and thus are not noted.

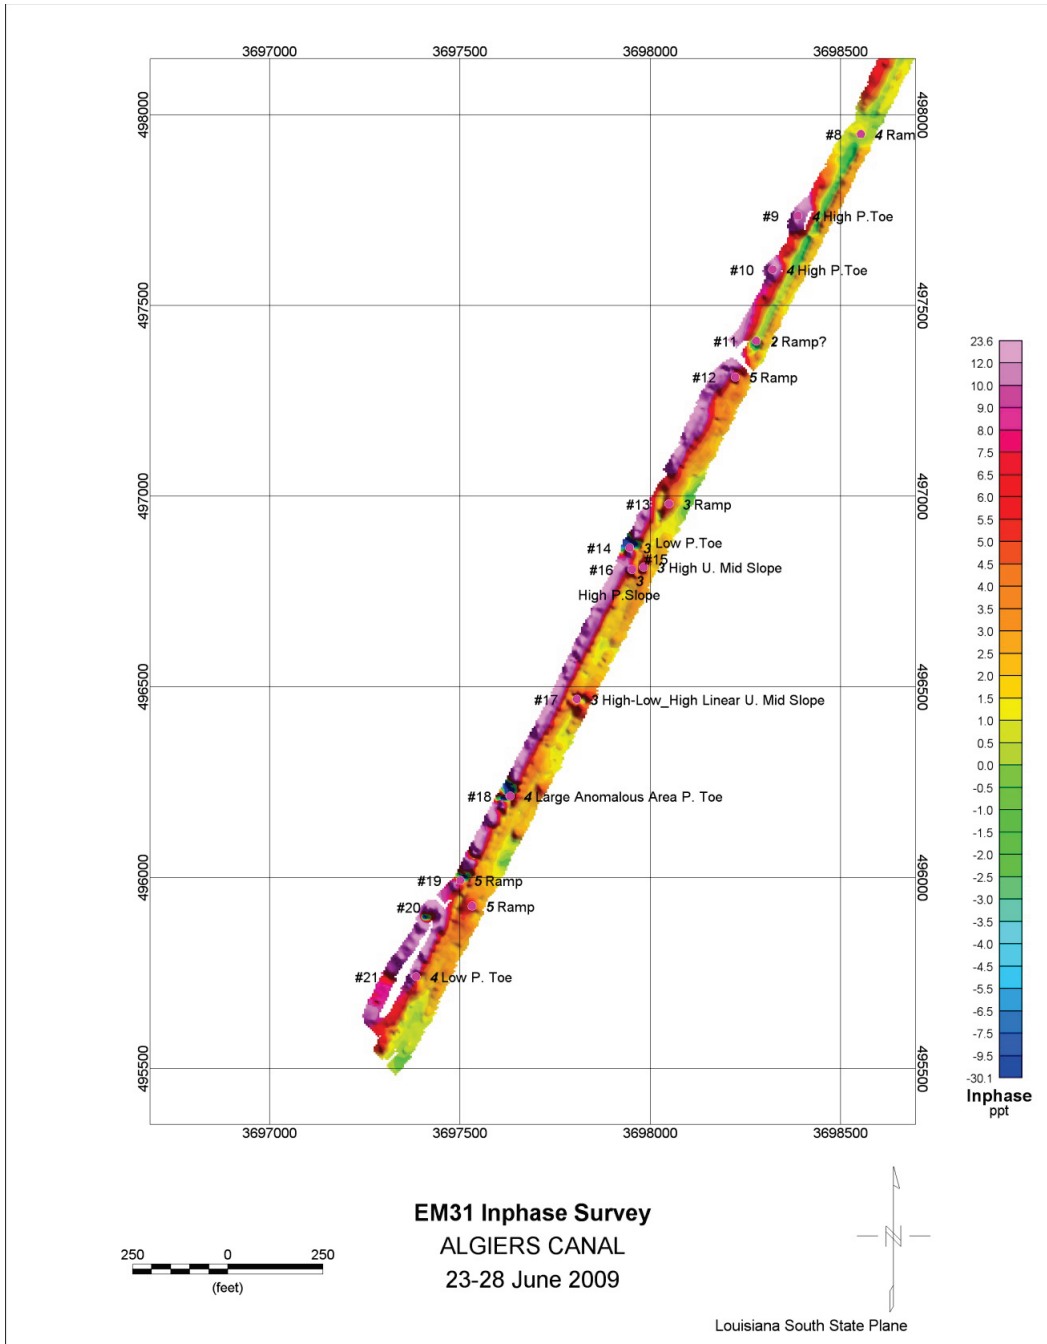
Figure A2. EM31 in-phase survey results, Section 2.

Section 2 continues in a southeasterly direction between approximate stations 1018+21 and 1044+18. The results are shown in Figure 6. A priority 2 anomaly is indicated for anomaly #11 at approximate station 1022+90 and may be caused by a small buried metallic object. A cluster of priority 3 anomalies (anomalies #14, #15, and #16) are shown near station 1029+48.

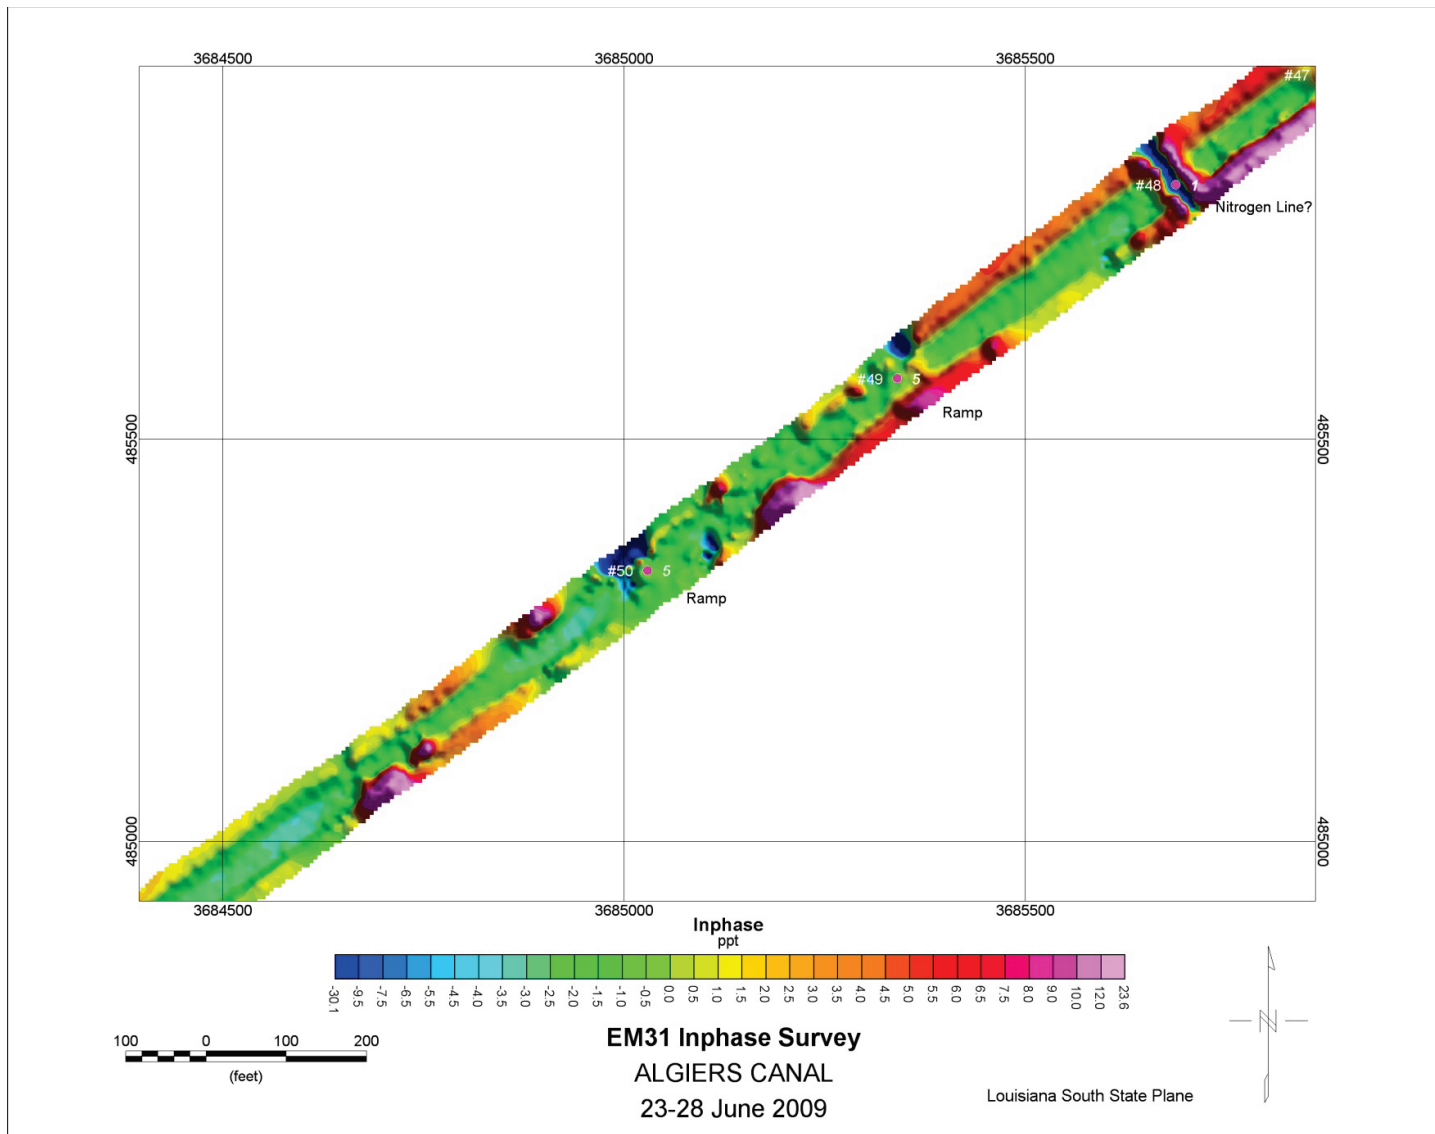
Figure A7. EM31 in-phase survey results, Section 7.

Section 7 is located between approximate stations 1194+31 and 1211+26. Three anomalies were interpreted for this section as shown in Figure 11. Anomaly 48, located at station 1196+64, is a strong linear-shaped anomaly that crosses the levee. A hump crosses the levee center line directly over the location of the anomaly. It is presumed that this anomaly is caused by a buried nitrogen line indicated in the construction drawings.

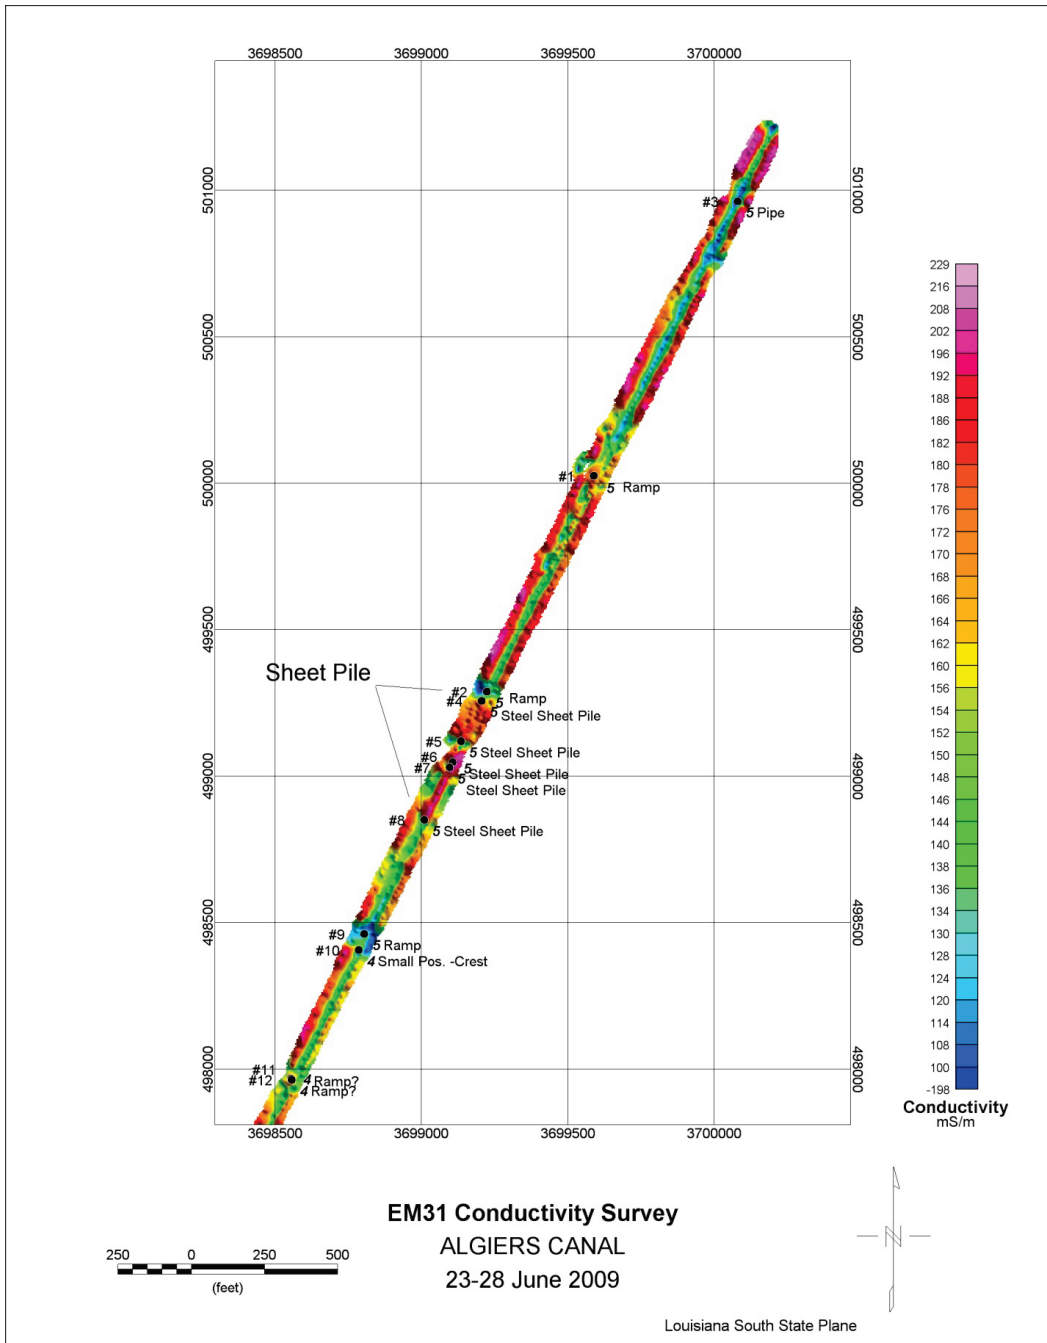
Figure B1. EM31 conductivity survey results, Section 1.

Section 1 extends from the Highway 23 tunnel (station 980+00) southwesterly to approximate station 1018+21. The survey results for Section 1 are presented in Figure 13. No priority 1 or 2 anomalies were interpreted for this section. The highest priority given to an anomaly in this section was a priority of 4. As was the case for the in-phase survey, a steel sheet pile, located between approximate stations 1001+81 and 1006+78, is clearly evident. It is again noted, with the exception of the area in the vicinity of the steel sheet pile, that the values along the center line of the levee are fairly consistent indicating little or no metallic debris within the levee.

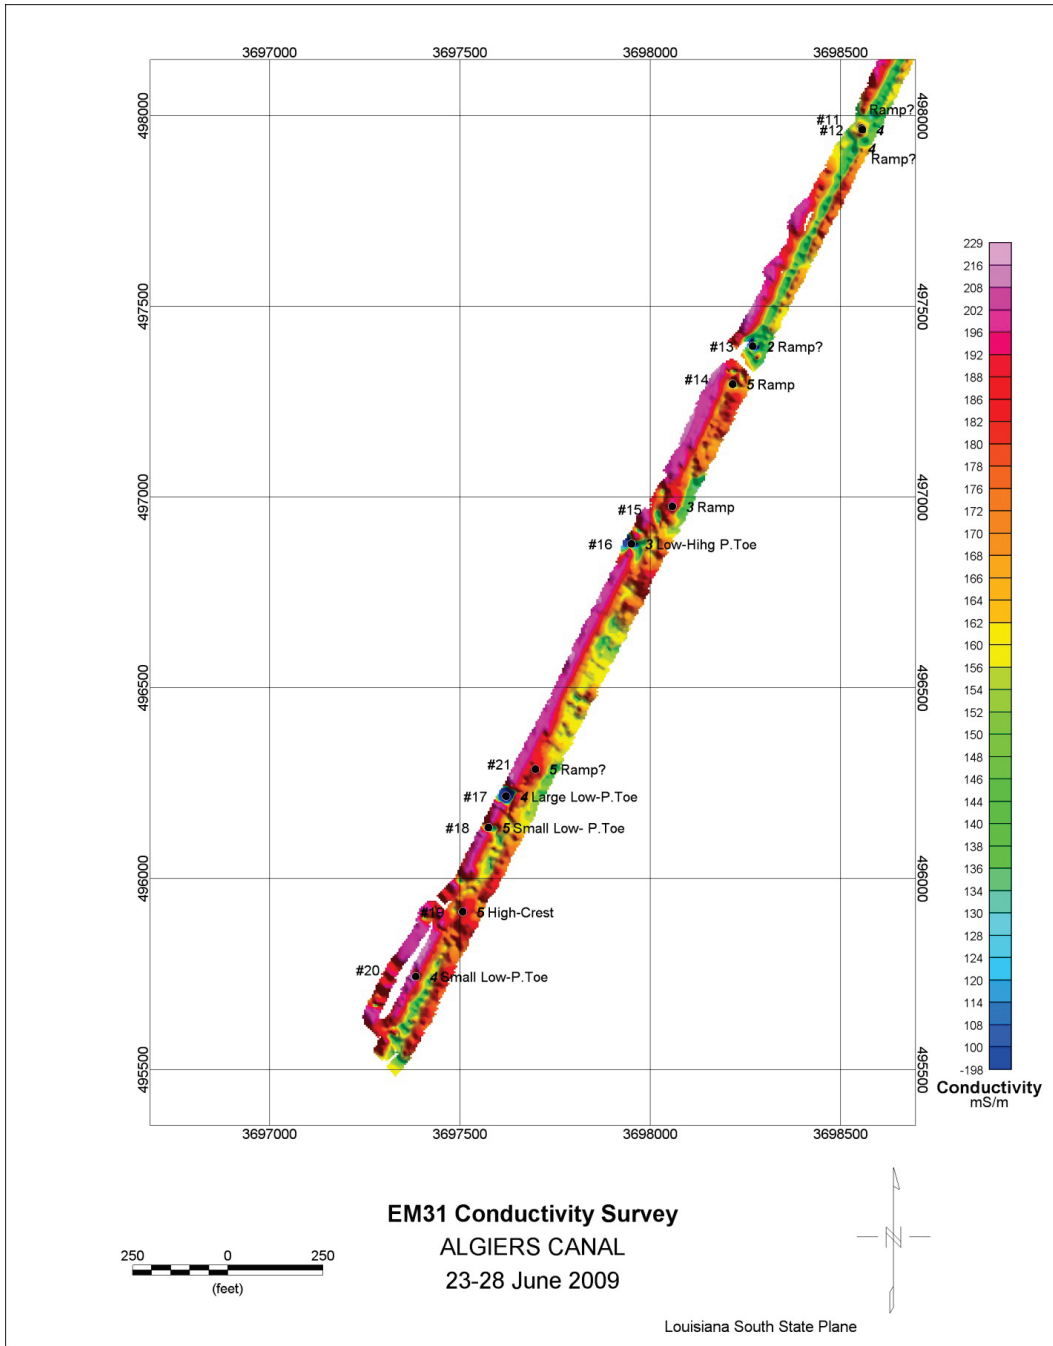
Figure B2. EM31 conductivity survey results, Section 2.

Section 2 continues in a southeasterly direction between approximate stations 1018+21 and 1044+18. The results are shown in Figure 14. A priority 2 anomaly is indicated for anomaly 13 at approximate station 1023+02 and may be caused by a small buried metallic object.

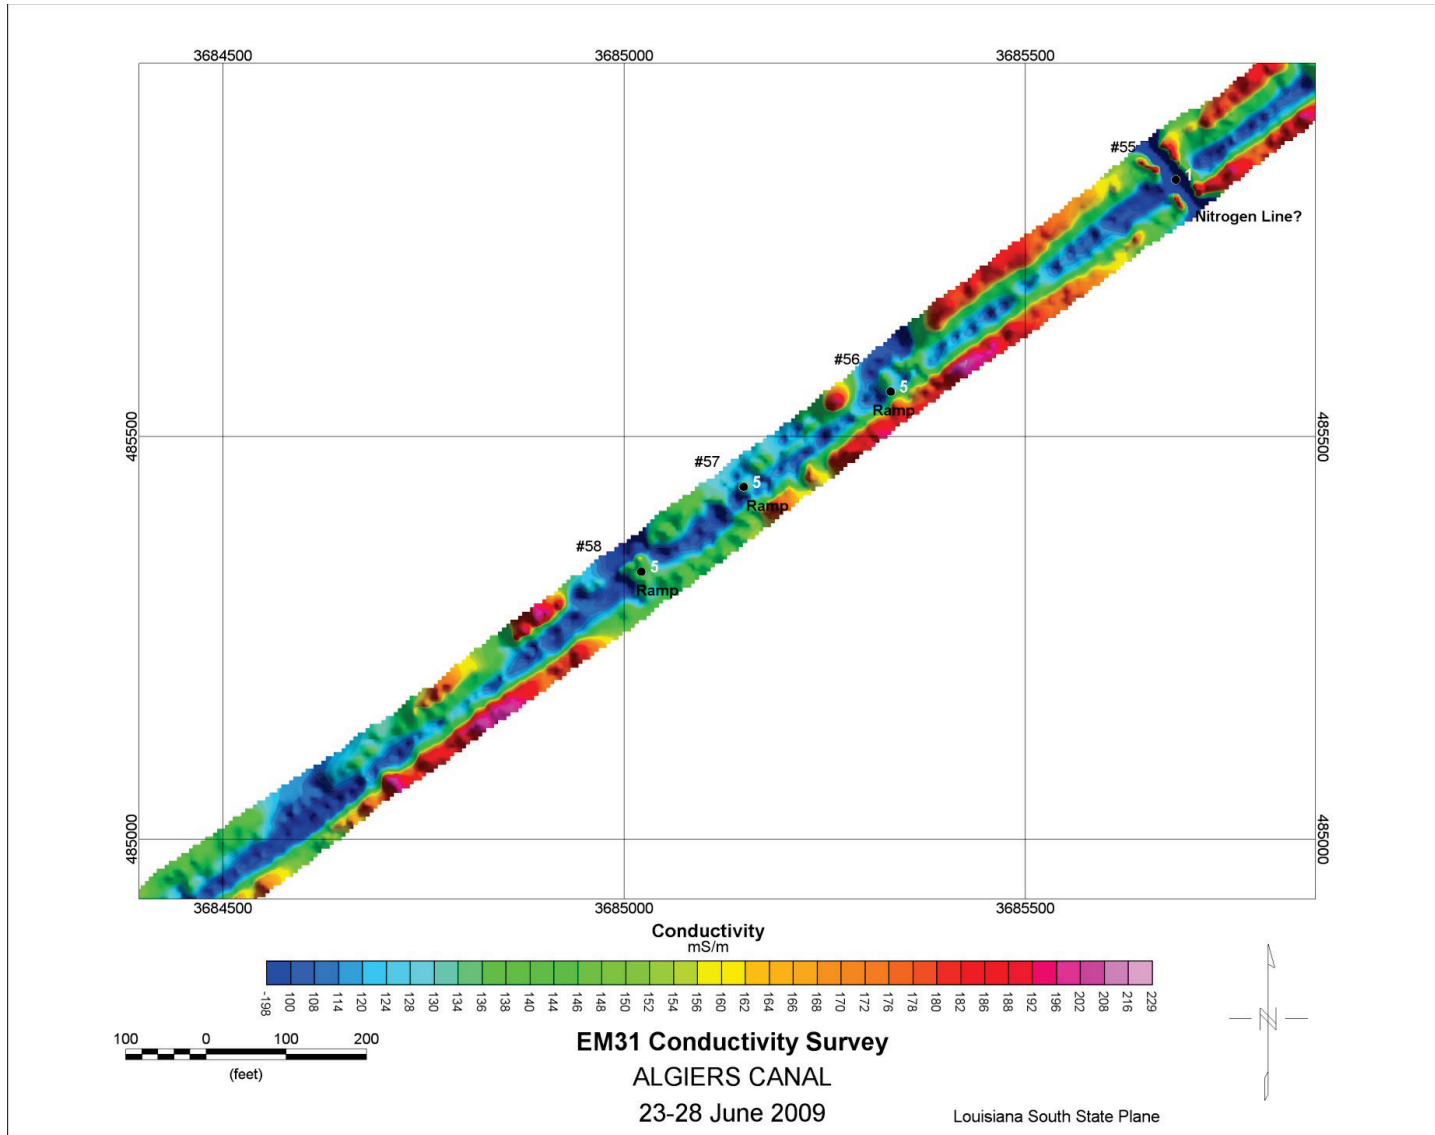
Figure B7. EM31 conductivity survey results, Section 7.

Section 7 extends between approximate stations 1194+31 and 1211+26 (Figure 19). Four anomalies, one a priority 1 and the remaining three priority 5 anomalies, were interpreted for this section. Anomaly 55, a priority 1 anomaly, is located at station 1196+63, and is a strong linear-shaped anomaly that crosses the levee. There is a hump in the levee center line directly over the location of the anomaly. It is presumed that this anomaly is caused by a buried nitrogen line indicated in the construction drawings. The remaining anomalies coincide with the locations of ramps.
