# INSPECTOR GENERAL

OCTOBER 28, 2014

## Military Housing Inspections – Republic of Korea

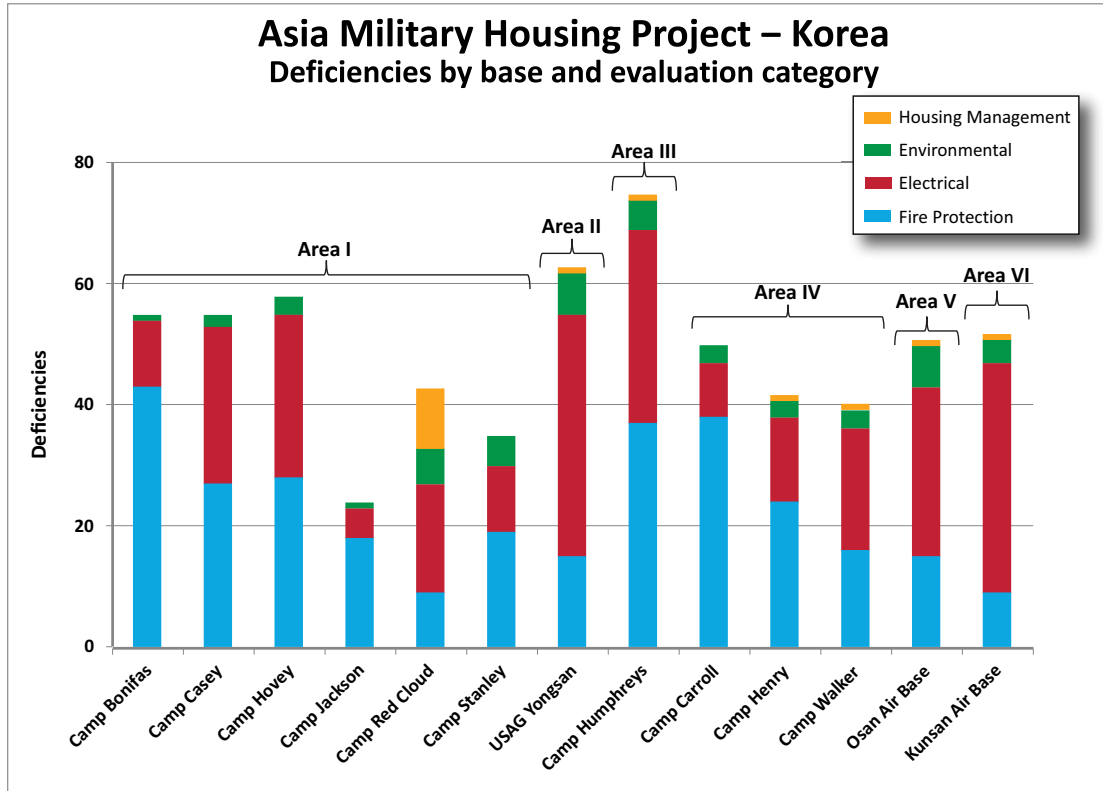
Figure 2. Number Of Deficiencies By Base Installation And Evaluation Category

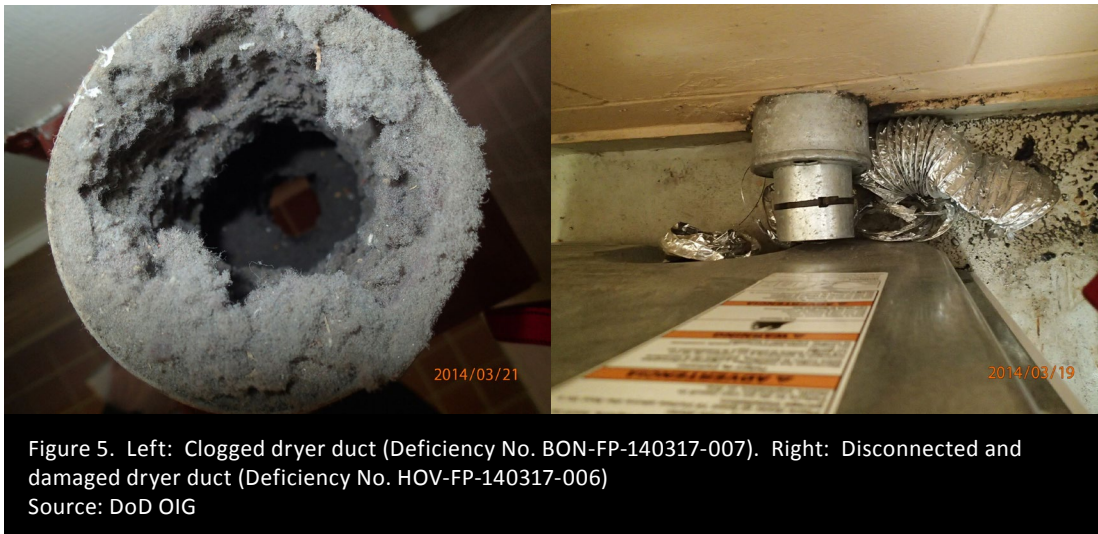
Figure 4. Ineffective use of fire doors allows fire to draft through the entire building. Left: Fire rated doors often propped open (Deficiency No. CAS-FP-140317-024) Right: Broken automatic closing mechanisms (Deficiency No. CRC-FP-140324-013) Source: DoD OIG

Fire protection deficiencies included fire doors that were propped open, did not automatically and fully close, and were not fire rated (see Figure 4). We found dryer vents that were disconnected, pinched or shredded, and constructed of improper material (see Figure 5). Also, we found multiple sprinkler systems that were out of service and without temporary life safety measures.

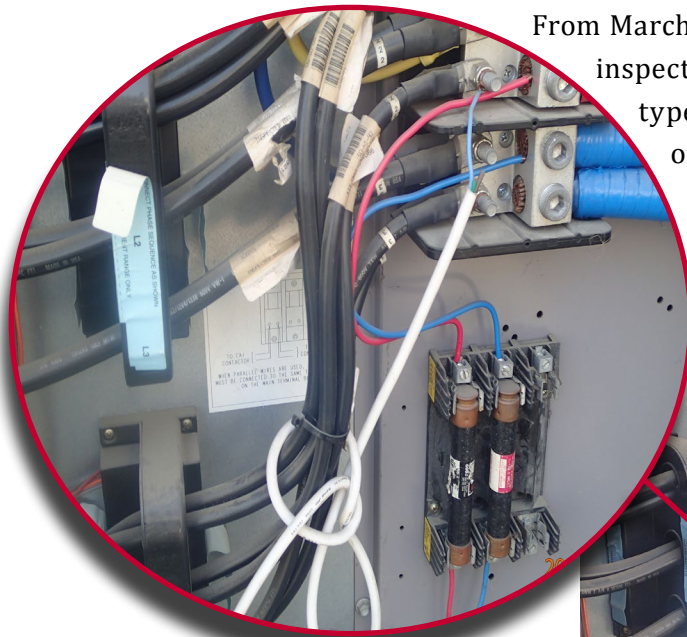
action (out of the 75 deficiencies identified at Camp Humphreys). These deficiencies included an entire building not grounded, an exposed energized wire inside an elevator motor, and an extension cord incorrectly hard-wired to a high-powered electrical panel (see Figure 7). We also found that the drinking water supply had not been tested monthly for coliform bacteria since July 2013 as required by the USFK EGS.

Figure 7: A drop cord hard-wired directly to conductors fused at 400 Amps inside the chiller electrical power panel (Deficiency No. HUM-EL-140331-021A)  
Source: DoD OIG

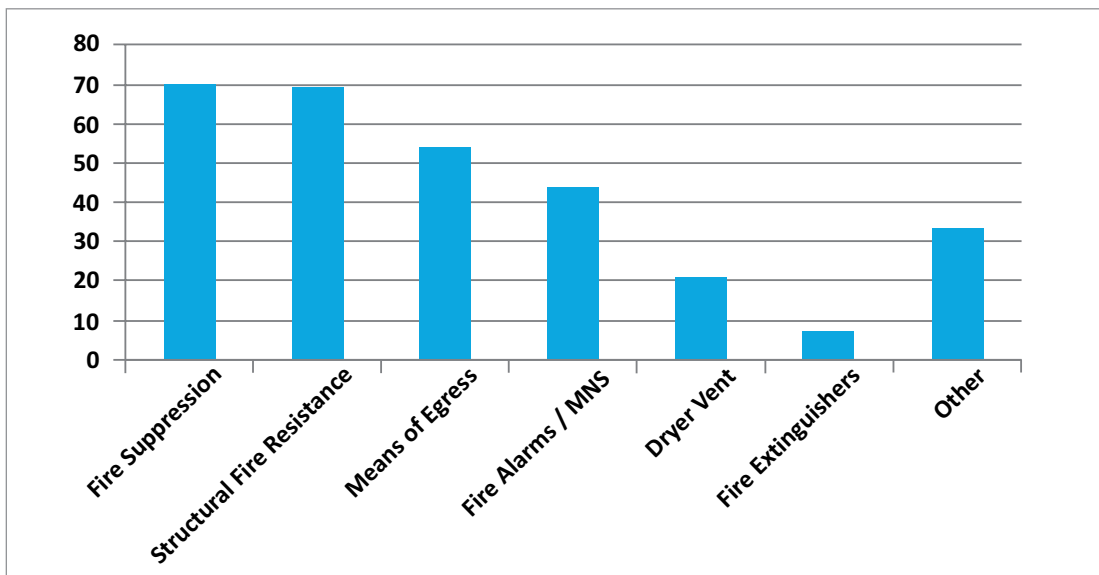
Figure 12. Fire Protection Deficiencies

We found deficiencies in the fire suppression systems throughout installations in Korea. For example, many buildings had sprinkler systems that were broken, not maintained, improperly installed, or missing altogether. In the area of structural fire resistance, we found fire doors that were propped open, damaged, not rated, or were missing closers. We also found deficiencies in the means of egress. For example, many buildings did not have adequate emergency lighting in the fire escape stairways and hallways. Fire alarm deficiencies included missing carbon monoxide detectors and missing or broken fire alarms. Dryer vent transition ducts were bent, crushed, disconnected, pinched, or clogged and were not constructed

of fire rated material. We found a lack of periodic inspection of fire extinguishers, many with low levels of extinguishing agent. Other deficiencies were items stored in prohibited locations, heating oil leakage in areas where ignition is probable, and excessive lint build-up in laundry rooms. These deficiencies increase the risk of fire, loss of life, and property.

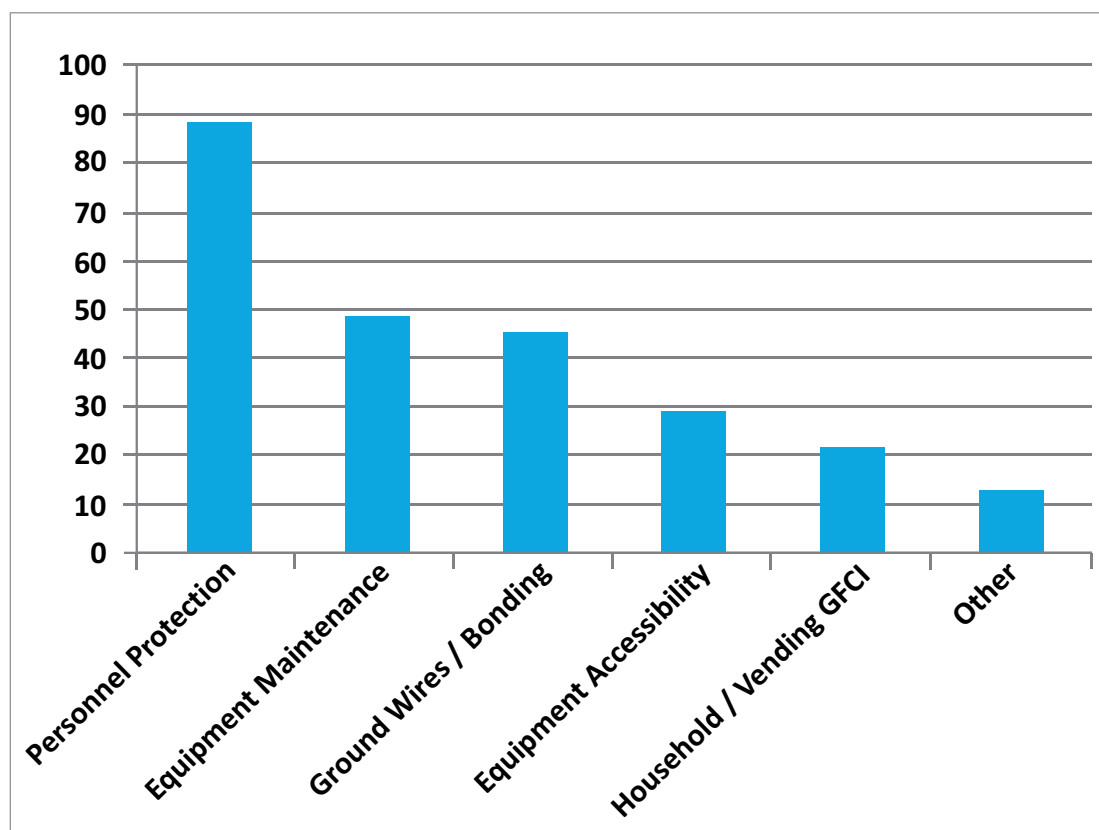
Figure 13. Electrical Deficiencies

Personnel protection deficiencies included exposed wires not contained or protected by junction boxes in mechanical rooms, missing electrical service panel breaker blanks or broken electrical covers, incomplete or broken electrical conduits, missing light fixture covers in damp and wet locations and within reach

of personnel in the shower, and missing knockout seals and covers in a junction box. In the area of equipment maintenance, we found electrical service-drop conductors providing electricity to the main electrical panel of the house that were too low, corrosion on junction boxes, and many buildings being served by multiple service drops. Also, we found inadequate or nonfunctioning climate control for electrical rooms and equipment. Ground wires/bonding issues included unbonded main electrical panels, and water circulating pumps with disconnected ground wires. Equipment accessibility deficiencies included junction boxes and electrical panels that were obstructed and inaccessible. We found lack of GFCI protection in laundry rooms, outside areas, vending machines, and water coolers. Other deficiencies included electrical panels with missing or incorrectly labeled directories, incorrect fittings being used to connect a conduit, and receptacles wired for incorrect voltage. These deficiencies create a risk of fire, electric shock, or electrocution for installation personnel and occupants.

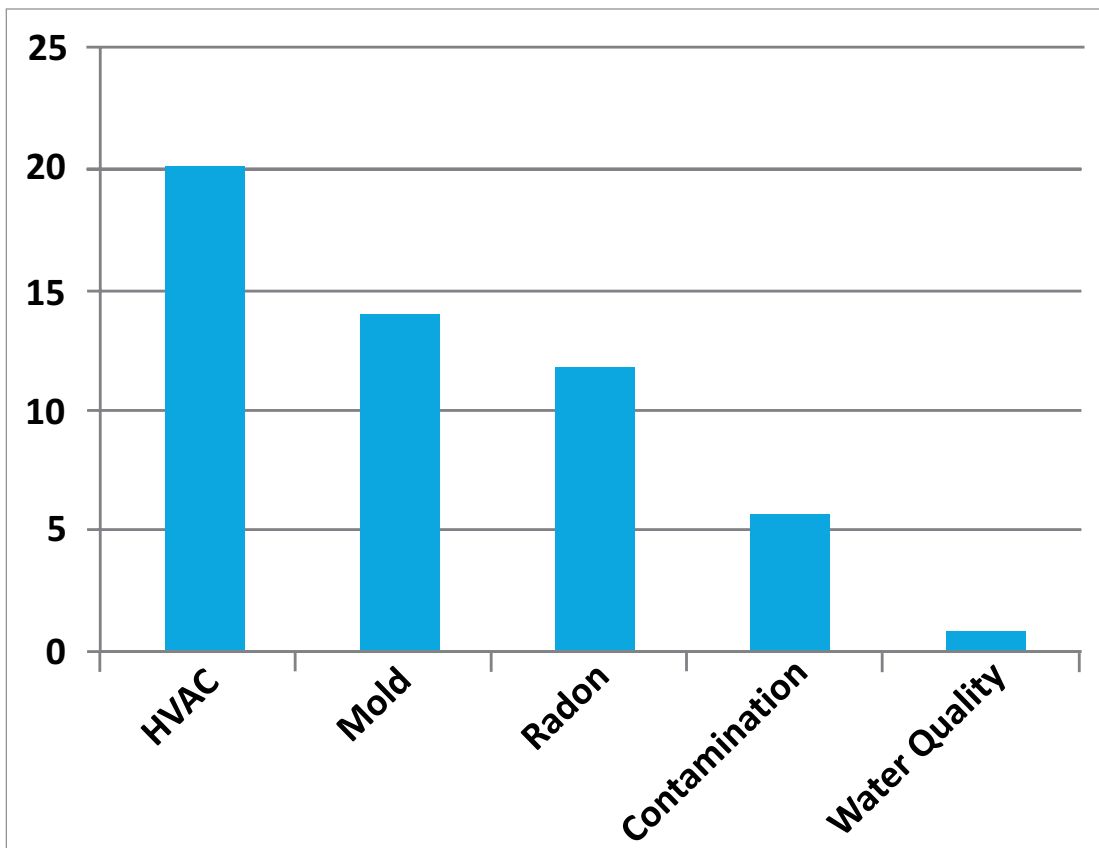
Figure 14. Environmental Health and Safety Deficiencies

We found a lack of properly maintained HVAC units, fan coil units, filters, and plumbing system pipes. Air handling units (AHU) were broken and out of service for extended periods, which could allow moist air to enter the building through negative pressure and cause mold growth. In unaccompanied units, responsibilities were not clearly defined between building occupants and managers for operating and maintaining air handling system components in living quarters or for addressing water leaks and mold problems. In addition, there is no DoD-wide policy or guidelines on mold mitigation and control. Mold may increase the potential for respiratory illness and other mold and indoor air quality-related health issues.

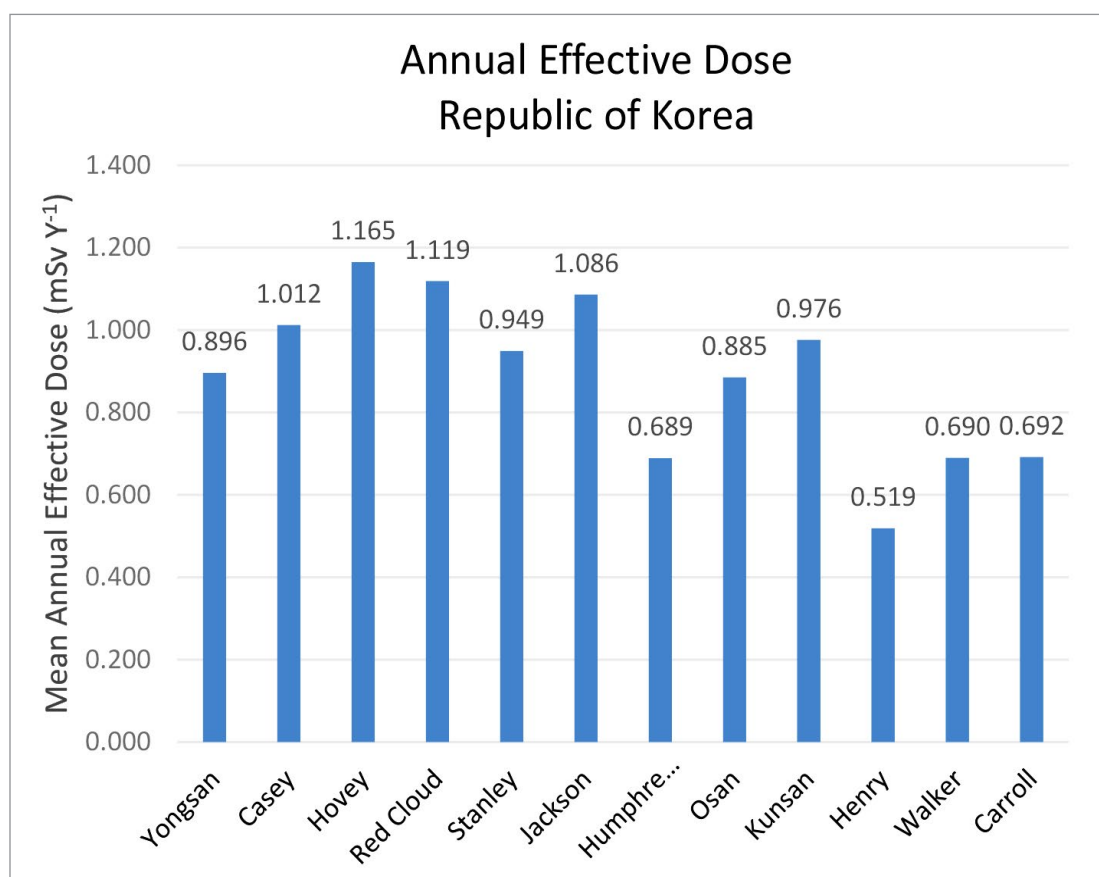
Figure C1. Estimated Mean Individual Effective Dose, Military Housing Facilities ROK
