## **Demonstration and Validation of a High-Performance Floor-Sealant System to Reduce Concrete Degradation**

Final Report on Project F10-AR02

Under Project F10-AR02, "Application of an Innovative, High Performance Concrete  
Floor Sealant at Hunter Army Airfield, Georgia"

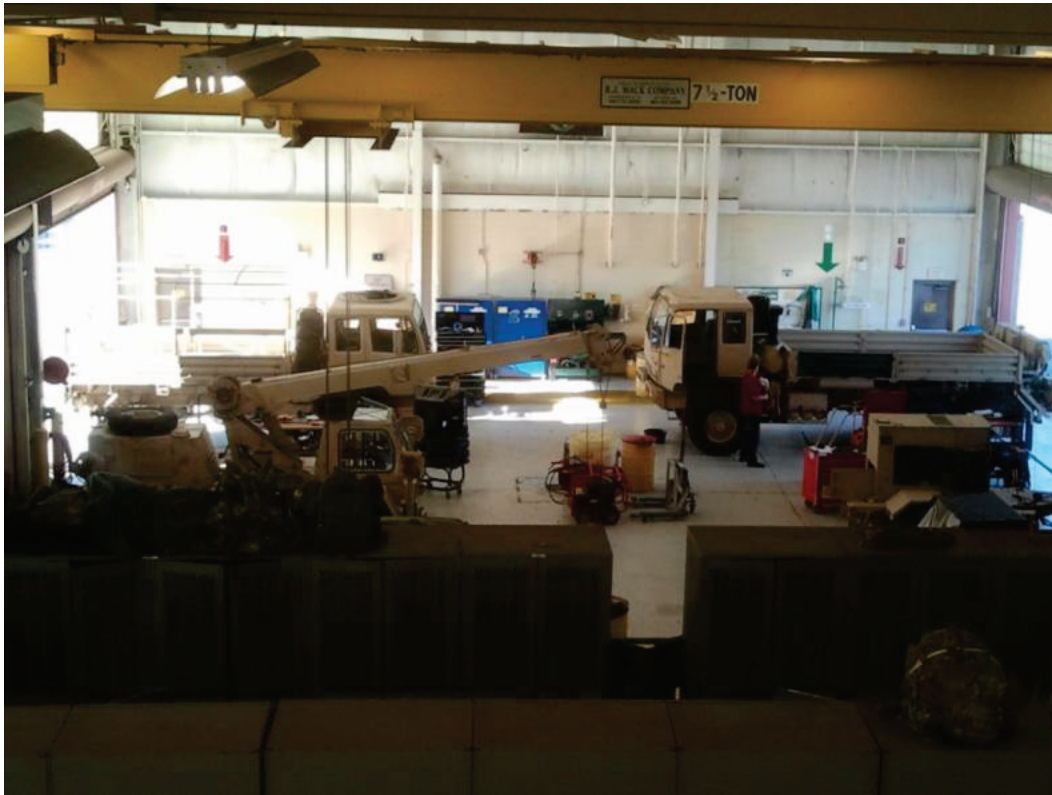
Figure 1. Maintenance bays in Building 8005.

The previous paint on the maintenance bay floors was an epoxy-based coating that was deteriorating. The appearance of the floor was poor due to peeling, chipping, and staining. Because of the light color of the floor, frequent cleaning was necessary. In addition to the maintenance bays (Figure 1 and Figure 2), a tool room (Figure 3), office (Figure 4), training room (Figure 5), and hallways (Figure 6) were also included in this demonstration. The training room and hallways were covered with two layers of vinyl tile that had to be removed.

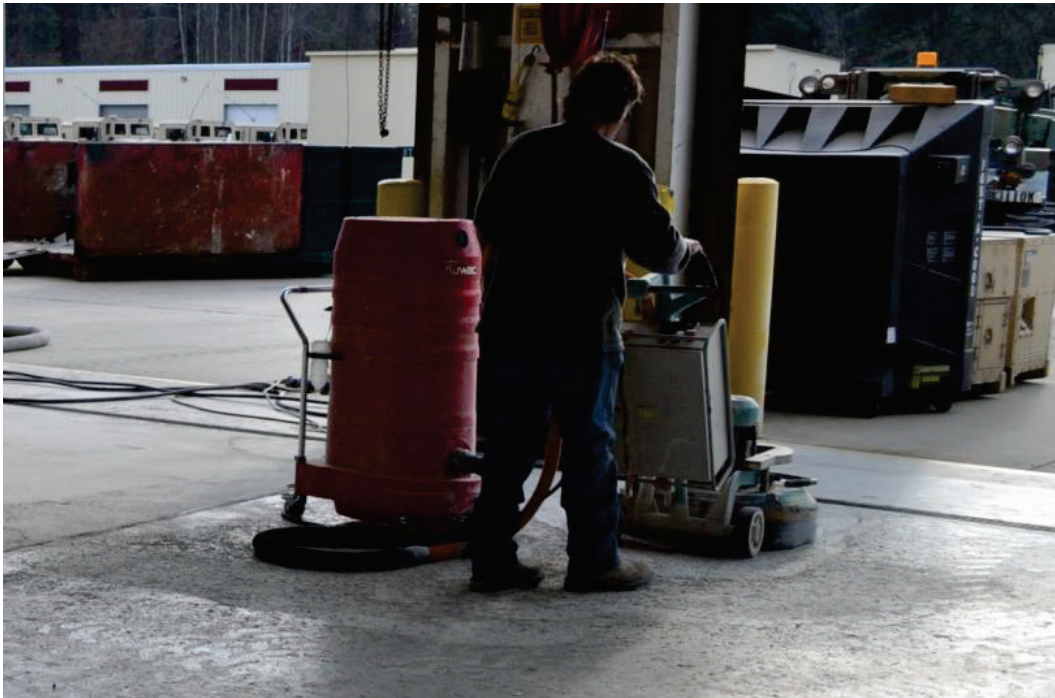
Figure 7. Planetary grinder removing paint.

The vehicle maintenance bays and two support offices had floors coated with an epoxy paint system. The paint first had to be removed mechanically using a planetary grinder with 30 grit abrasives. Figure 7 and Figure 8 show the paint removal equipment being used in the vehicle maintenance bays. The asphalt tile in the hallways and office spaces was removed with a reciprocating chisel and scraper (Figure 9).

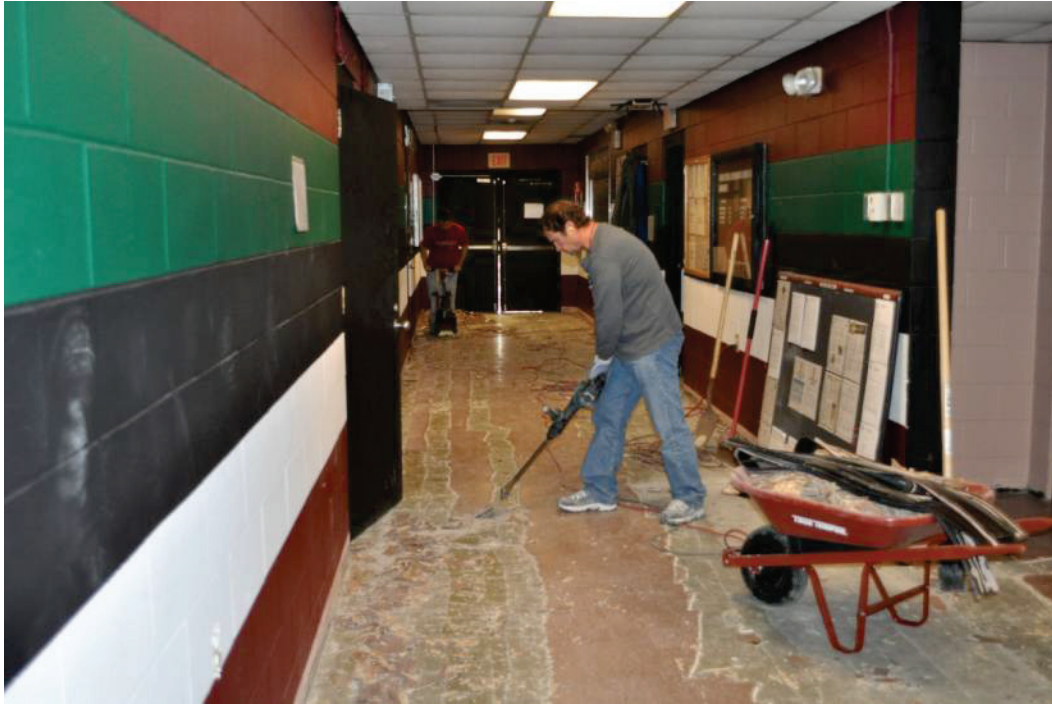
Figure 9. Chisel removal of floor tile

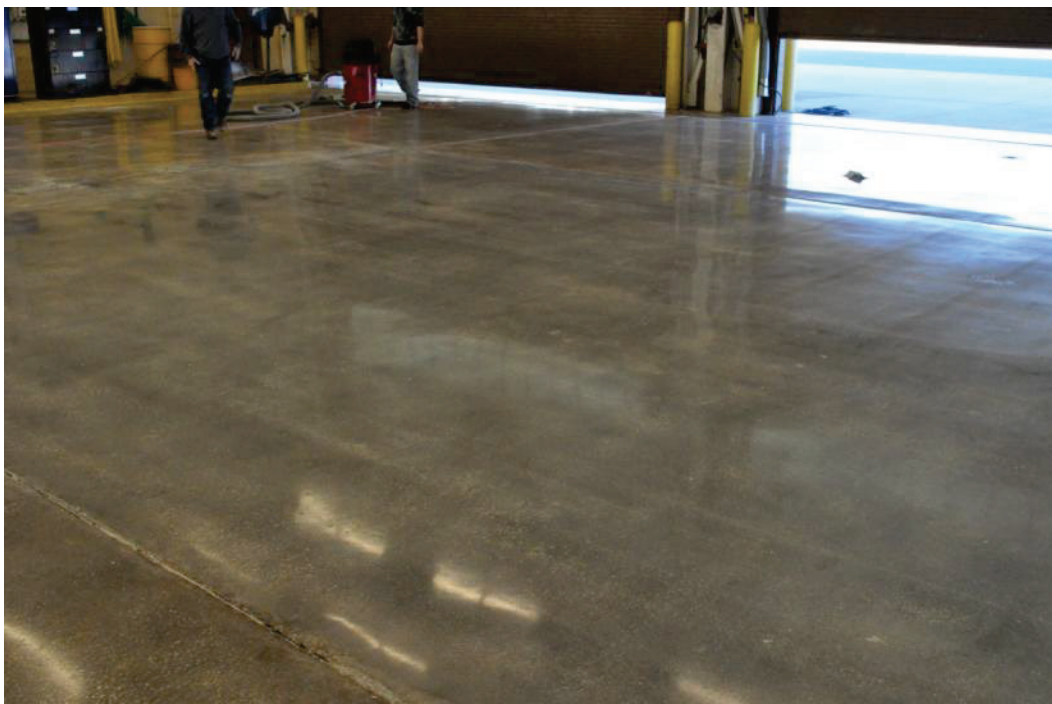
The completed floors had an appearance and quality that facility personnel judged to be attractive (Figure 18–Figure 20).

Figure 18. Far-end completed vehicle maintenance bay.

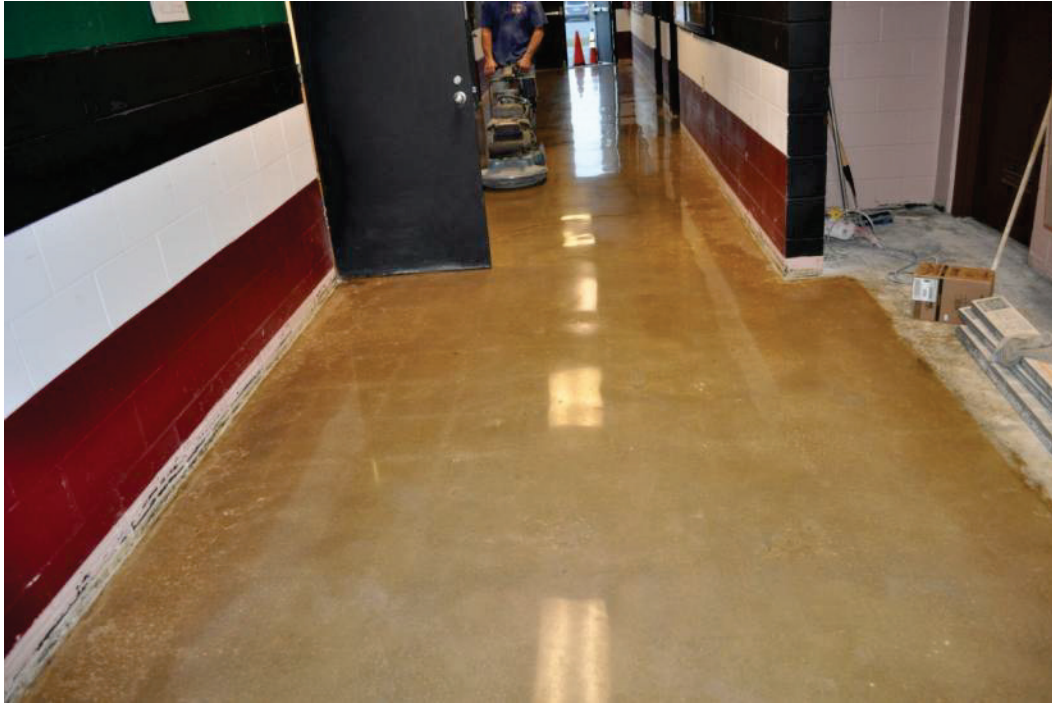
Figure 19. Completed hallway showing concrete with applied stain.

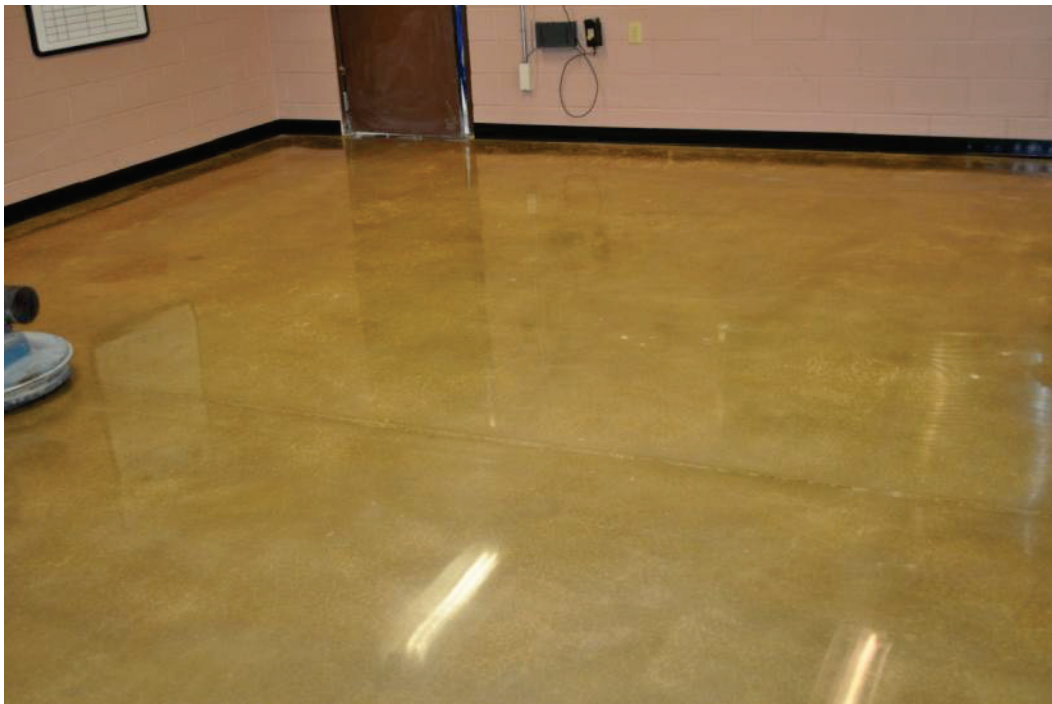
Figure 20. Completed training room showing concrete with applied stain.
