U.S. Air Force Airfield Damage Repair (ADR) Modernization Program

Large Crater Repair at Silver Flag Exercise Site, Tyndall Air Force Base, Florida

August 2015

Final report

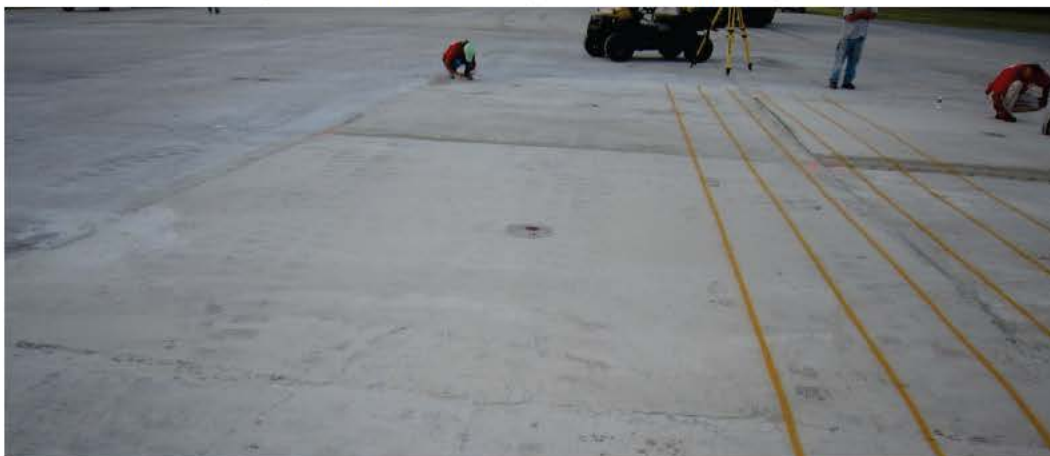
Figure 54. Crater 1, west quadrants, finished repair.

Each crater was photographed before trafficking began to document any cracking or other distress to the concrete surface. Several defects were noted in Crater 1. Figure 54 shows the two west quadrants of the finished crater repair. A slightly rough surface in some locations and some shrinkage cracks were noted in these quadrants. Figure 55 displays the two east quadrants of the finished crater repair. The surface of the southeast quadrant was quite rough. The rough surface was caused by the concrete mix being placed too dry, reducing its workability. Also, one track of the CTL loader from the

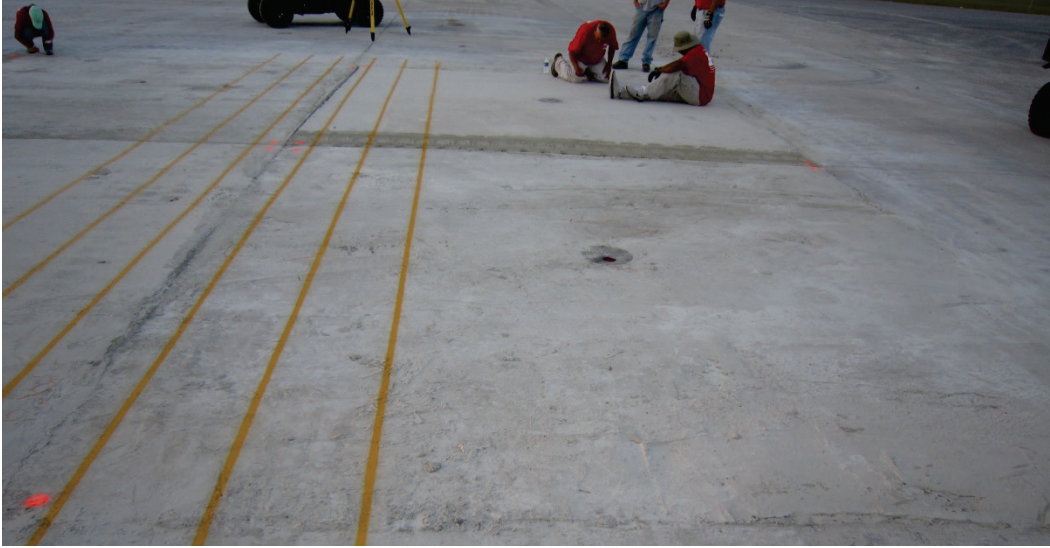
Figure 55. Crater 1, east quadrants, finished repair.

FOD debris removal team entered the northeast quadrant before final set was obtained, resulting in the row of track imprints, shown as the horizontal dark area in Figure 55. The plastic joint board cap on one of the quadrants was removed before final set, resulting in a small spall that ran the length of the west edge of the northeast quadrant. The small shrinkage cracks were caused by a concrete mix that contained excess water. Even a small amount of water will typically migrate to the top of the concrete cap during placement and can lead to shrinkage cracking. The variability in the concrete mix was caused by the diesel engine of the simplified volumetric mixer suddenly shutting down in several instances, to the point where a second simplified volumetric mixer was employed.
