*Airfield Damage Repair Modernization Program*

## **AM2 Mat End Connector Modeling and Performance Validation**

August 2015

Final report

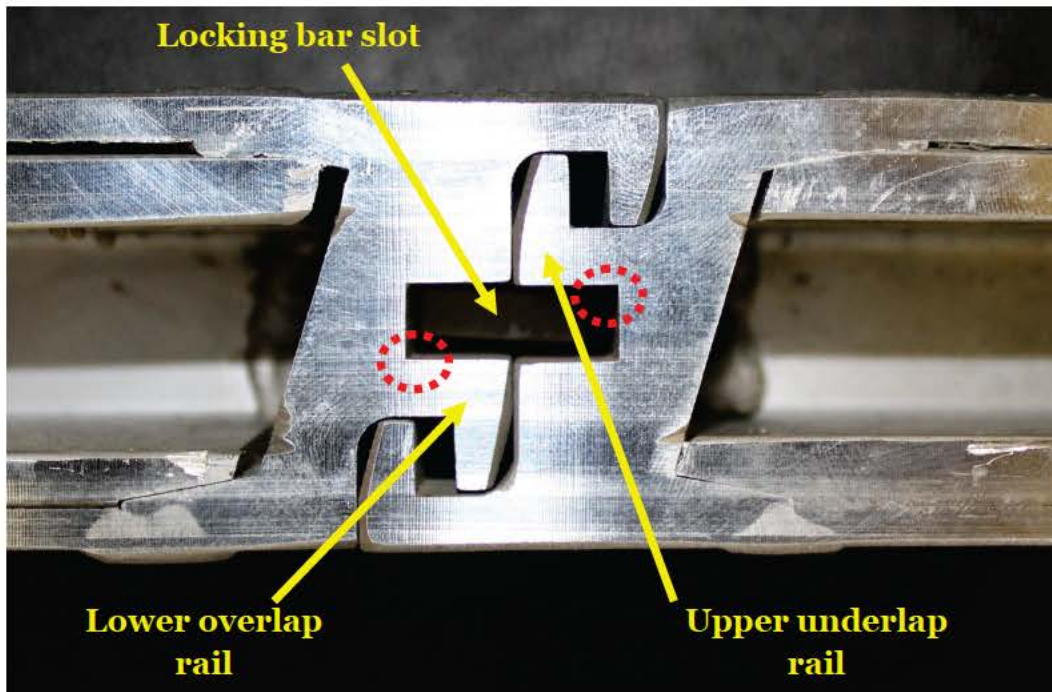
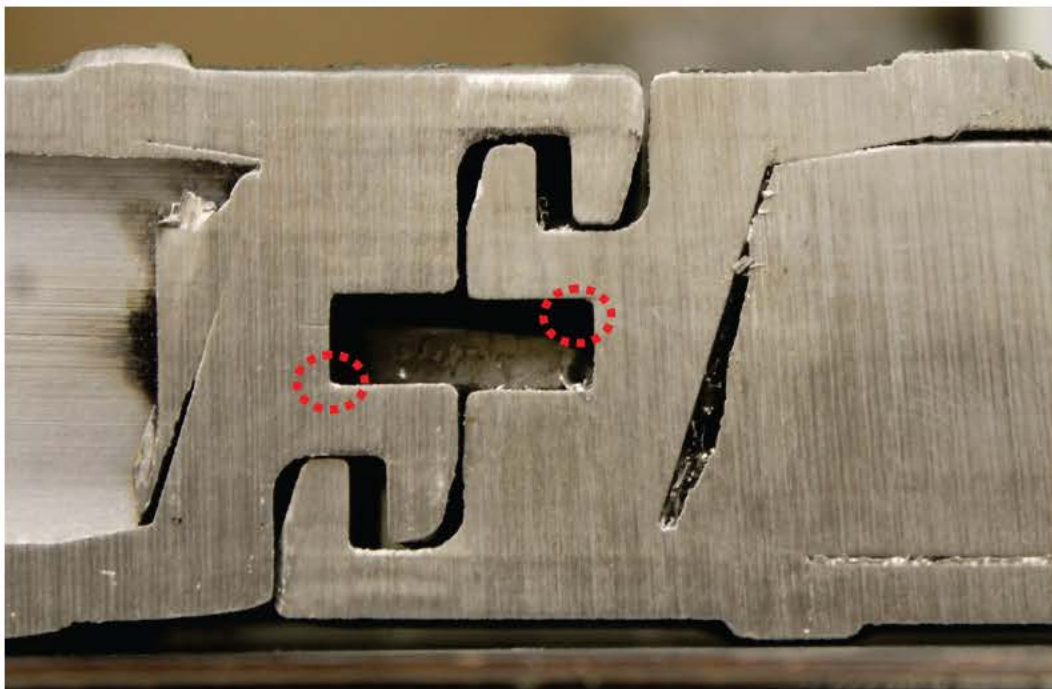
Several modeling efforts showed that these corners were areas of high stress concentration, shown in Figure 2. In Figure 2a, the load (i.e., F-15E tire load) is applied on the right side of the joint. In this case, the load is transferred to the lower overlap rail through the locking bar, and a high tensile stress is shown at the corner adjacent to each rail. In Figure 2b, the load is applied on the left side of the joint. In this case, the loading results in a compressive stress at the internal rail radii at the locking bar corners. In both cases, critical stresses developed at the locations shown in Figure 1, which is consistent with rail breakage commonly reported by Rushing and Tingle (2007), Rushing and Torres (2007), Rushing et al. (2008), Rushing and Mason (2008), and Garcia and Rushing (2013). An example of crack initiation at one of the corners is shown in Figure 3.

Figure 2. AM2 joint modeling analysis: (a) load on right side; (b) load on left side.

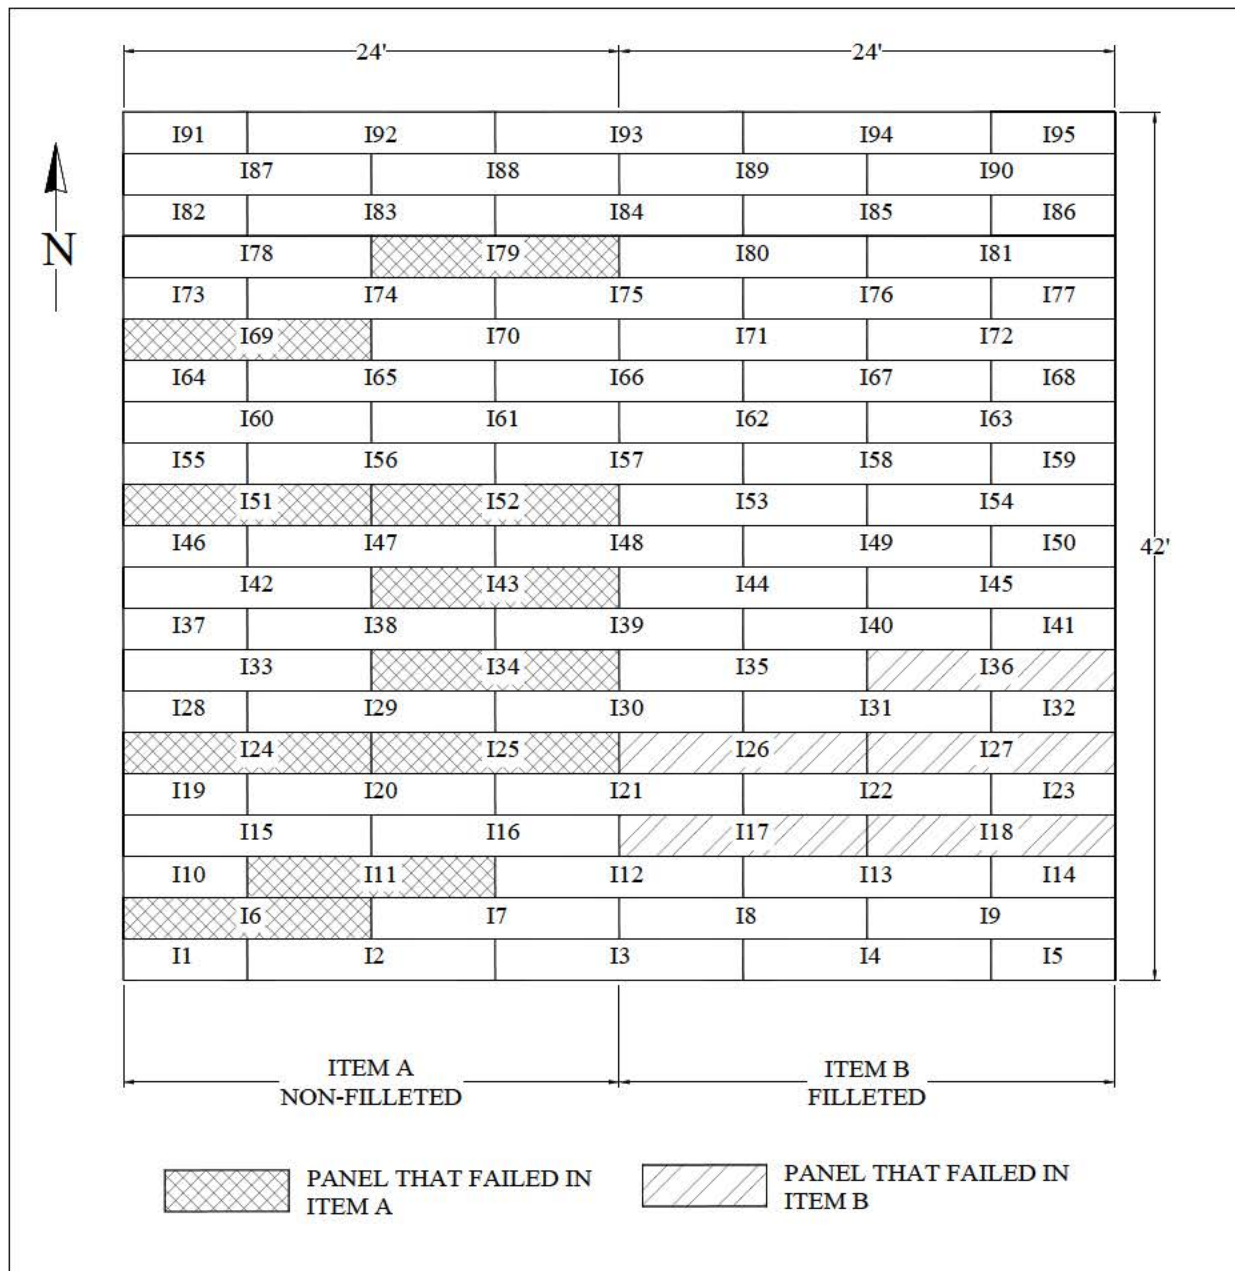
The following sections describe all mat breakage and the behavior of the AM2 airfield mat. Figure 26 shows the layout of failed panels in each test item.

Figure 26. Layout of failed panels.

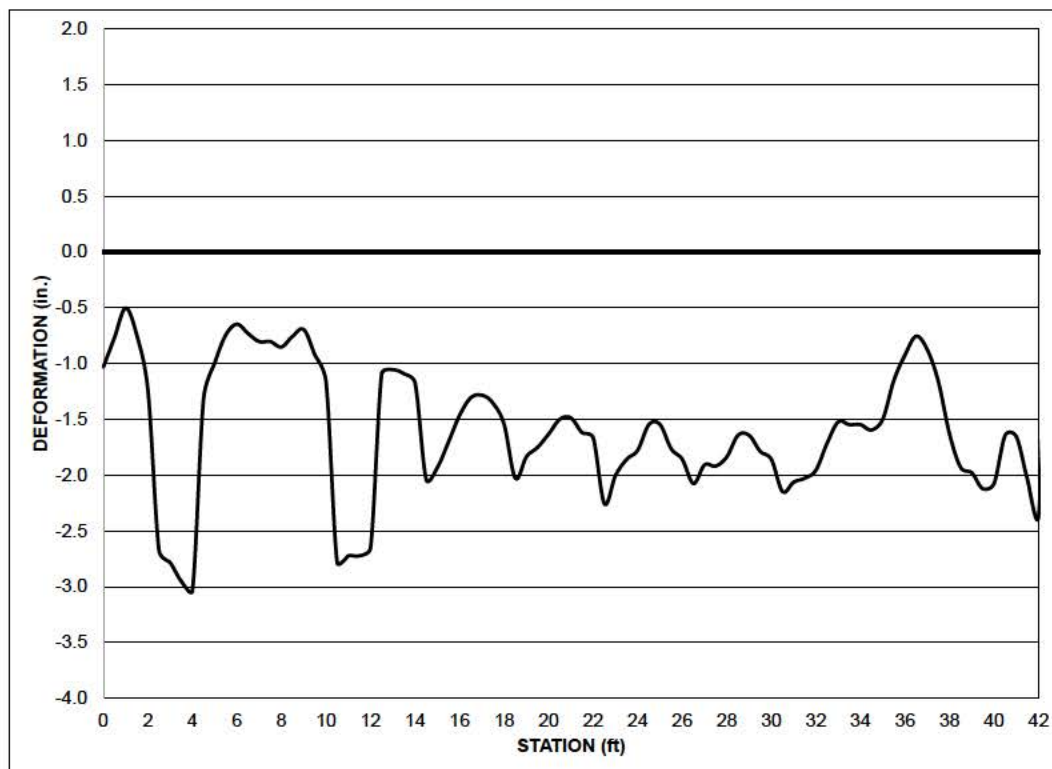
In Item A, stations 2 to 4 and stations 10 to 12 were areas of panel end connector rail failure and are represented as deep depressions in the subgrade (Figures 38). These were disregarded when analyzing the profile since they were associated with mat breakage and not necessarily with the system's ability (or inability) to prevent excessive roughness. As shown in Figures 39 and 41, the same is true for stations 14 to 16 in Item B. Buildup of material also occurred beneath the plate placed above panels I-17 and I-18 (about stations 6 to 8); therefore, the change in elevation from stations 8 to 10 in Figure 39 would appear to be the maximum roughness value. This was also disregarded when analyzing the subgrade profile, since it was associated with the metal plate placed above the mat surface and not with the performance of the system itself.

Figure 38. Subgrade centerline profile of Item A after 1,008 passes.

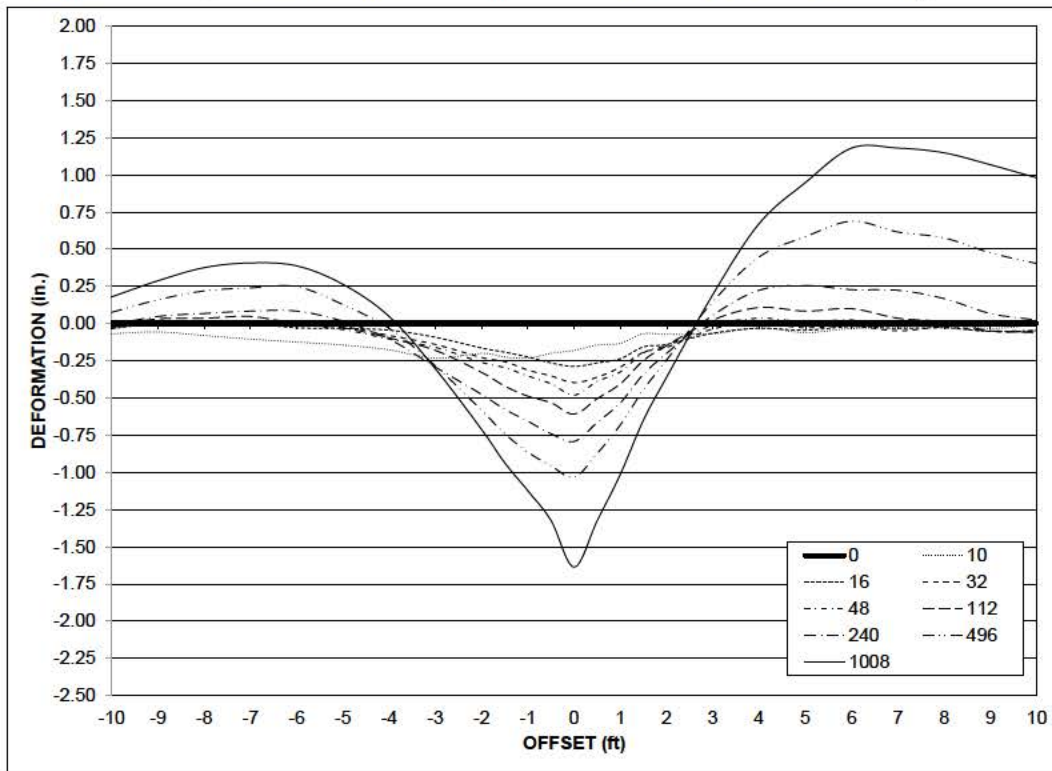
Figure 46. Average deformation on the loaded mat surface of Item A at different pass levels.

Test Item	Item A		Item B		
	496	1,008	496	1,008	2,060
Subgrade Profile Max Abrupt Change in Elevation (in.)	-	0.84	-	-	0.60
Mat Surface Profile Max Abrupt Change in Elevation (in.)	0.32	0.29		0.08	0.12
Subgrade Permanent Deformation (in.)	-	2.97	-	-	2.98
Loaded Deformation on Mat Surface (in.)	1.51*	2.45	1.06	1.81*	3.38
Unloaded Deformation on Mat Surface (in.)	0.56	1.05	0.36	0.72	1.34

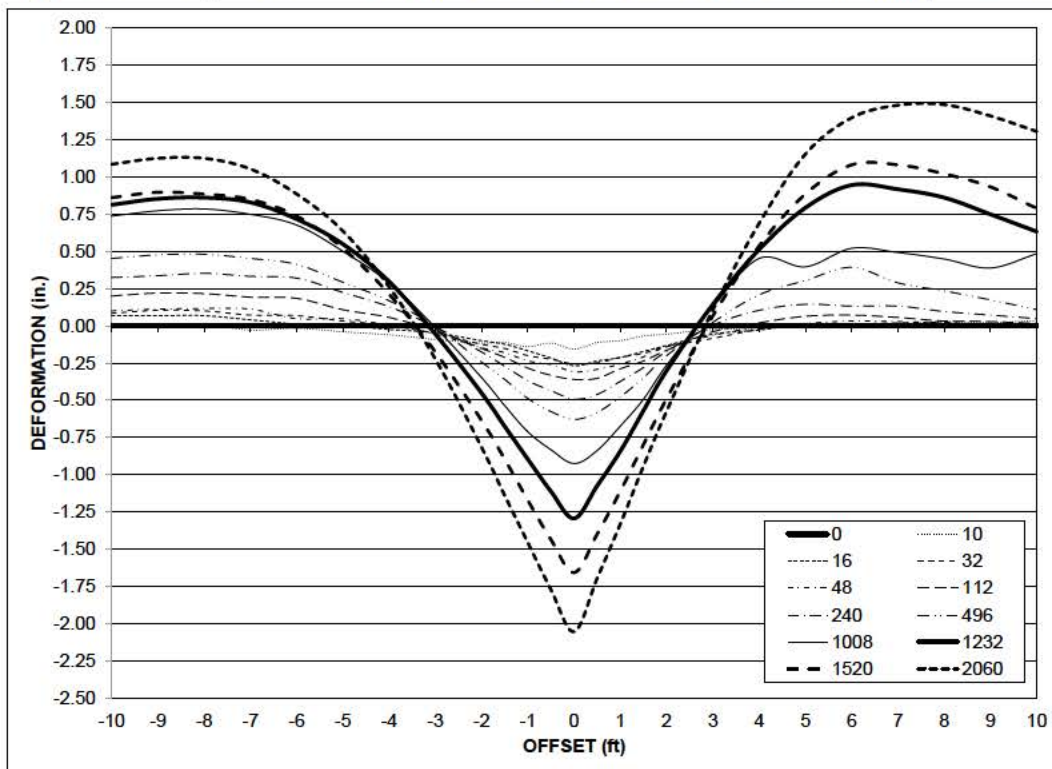
Figure 47. Average deformation on the loaded mat surface of Item B at different pass levels.

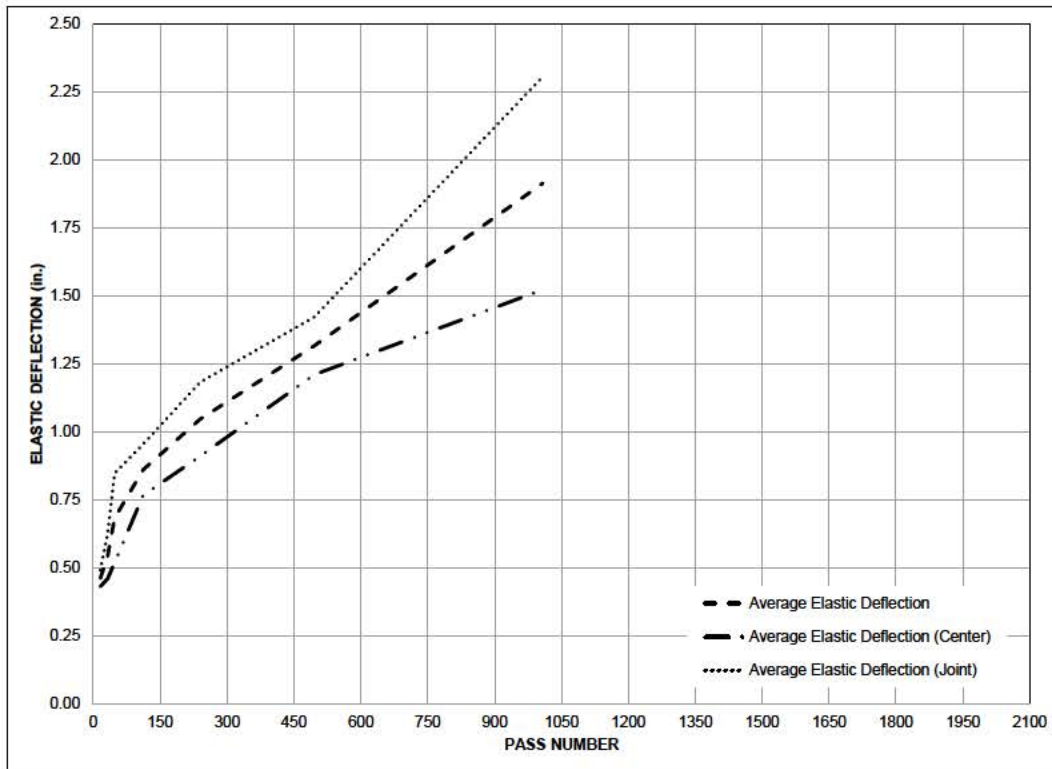
Figure 48. Elastic deflection in Item A.

The difference between the loaded (immediately adjacent to the tire of the load cart) and the unloaded elevation at the locations shown in Figure 22 represents the elastic deflection, or rebound, of the mat and the subgrade at each location. The measurements determined from readings taken at the center of three panels were averaged to give a final elastic deflection value. The same was done for measurements determined from readings taken at three joints. The average of these two values was also calculated. One number was reported for each condition at each pass level in Table 6. The results are shown in Figures 48 and 49 for Item A and Item B, respectively.

Historically, elastic deflection measurements were used to monitor performance of mat systems, but were not used for mat system fatigue failure criteria. Average elastic deflection of the mat and subgrade increased throughout testing for both test items. The rate of increase was higher in Item A than in Item B. The elastic deflection reached approximately 2.25 in. for both test items, but this value was reached in Item A at half the number of passes that were sustained by Item B before reaching the same value. Assuming that the elastic deflection of the subgrade remained nearly constant throughout trafficking, the increase in the total elastic deflection of the mat and subgrade indicates that the air gap beneath the mat increased as deformation occurred in the subgrade surface. Since permanent deformation of the loaded mat surface in Item A occurred at a faster rate than in Item B, the elastic deflection then also increased at a higher rate. As expected, the average elastic deflection at the joints was higher throughout testing than at the center of panels, but the curves remained approximately parallel. Therefore, the rate of increase in elastic deflection was about the same at both locations, but the actual measured deflection was obviously higher at the joints.

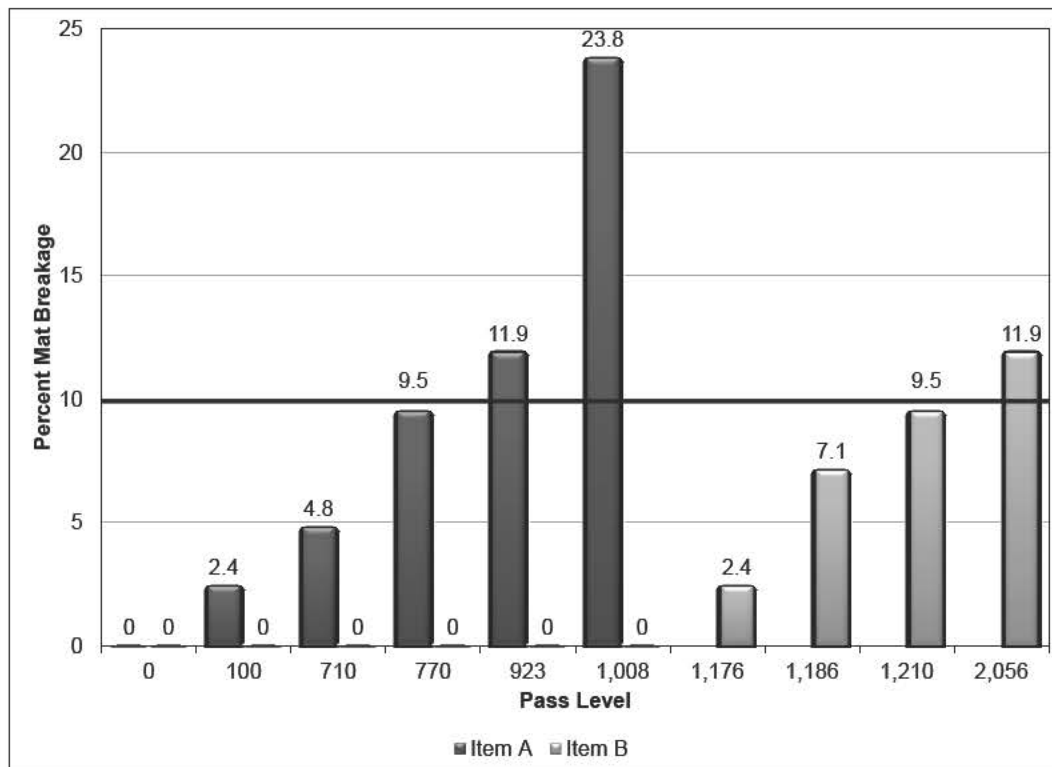
Figure 50. Comparison of percent mat breakage.

A summary of the progression of mat breakage for each test item is shown in Figure 50 for comparative purposes. Item A and Item B were able to sustain 923 passes and 2,056 passes, respectively, before failure by mat breakage. Two important things to note from Figure 50 are (1) panel failures in Item B started to occur about 250 passes after Item A was rated as failed and (2) at the end of each test, percent mat breakage in Item A was twice the amount noted in Item B. A comparison of the number of occurrences of the different failure mechanisms in each test item is provided in Table 10. Mat breakage in both test items was typical and similar to that reported by Rushing and Tingle (2007), Rushing and Torres (2007), Rushing et al. (2008), Rushing and Mason (2008), and Garcia and Rushing (2013) in AM2 when trafficked over weak subgrade conditions. End connector rail failures were the most common mechanism of mat breakage reported by these authors.

It is obvious from the level of mat breakage and the number of occurrences of rail failures in Item A that the lack of filleted corners in the locking bar channel greatly decreases the performance life of AM2. The inclusion of the fillet was able to decrease stress concentrations in those areas, thus improving the fatigue life by inhibiting crack incubation from occurring at low cycles. With the filleted design, the critical damage location after a larger number of cycles began to shift from the upper underlap/lower overlap rails to the upper overlap rail, above the interface with the upper underlap rail of a connecting panel (Figure 35). This has not been documented for AM2 tests on soft soils. Most panels with end connectors along the traffic lane were noted to have developed cracking at this location and at the end connector weld. Although these did not increase in length to render a panel failed, it seems that after a larger number of load cycles, high stress concentrations developed at the upper overlap rail. This is consistent with the stress conditions shown in Figure 2b. Since improvement was noted with the filleted design in terms of rail breakage, changes could be made to the upper overlap rail to further increase fatigue life of the joint.

- Damage in the filleted end connector design was noted to shift from the critical stress location to the upper overlap rail. Joint optimization analyses should be conducted to improve this area of the end connector and further increase the fatigue life of the joint.
