Airfield Damage Repair Modernization Program

AM2 Brickwork Pattern Evaluation with Refurbished Matting

Lyan Garcia, Timothy W. Rushing, and Jeb S. Tingle

August 2015

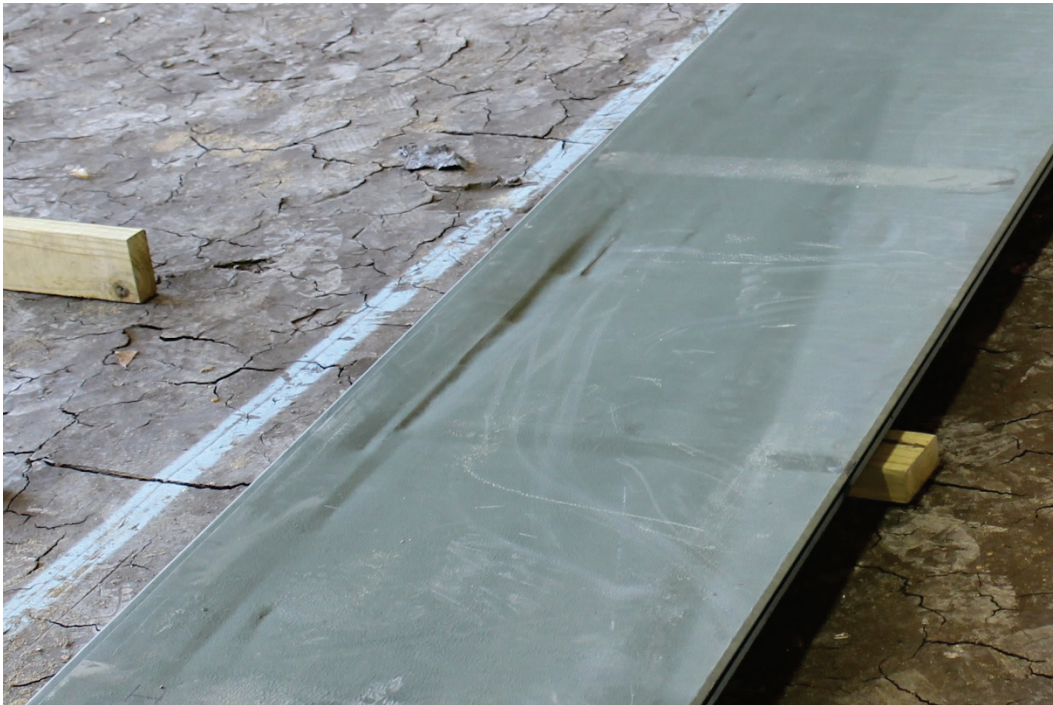
All AM2 mat used for testing, including new Mod 5 and refurbished matting, was obtained from NAVAIR. The AM2 panels were delivered in F71 and F72 packages. Photos of the AM2 F71 and F72 packages similar to those used in this test are shown in Figure 1. Minor damage, such as that shown in Figure 2, was noted on some of the refurbished panel designs received. A few panels were noted to be two-piece AM2 and other versions prior to Mod 5.

Figure 2. Damage noted on refurbished AM2 panel before applying traffic.

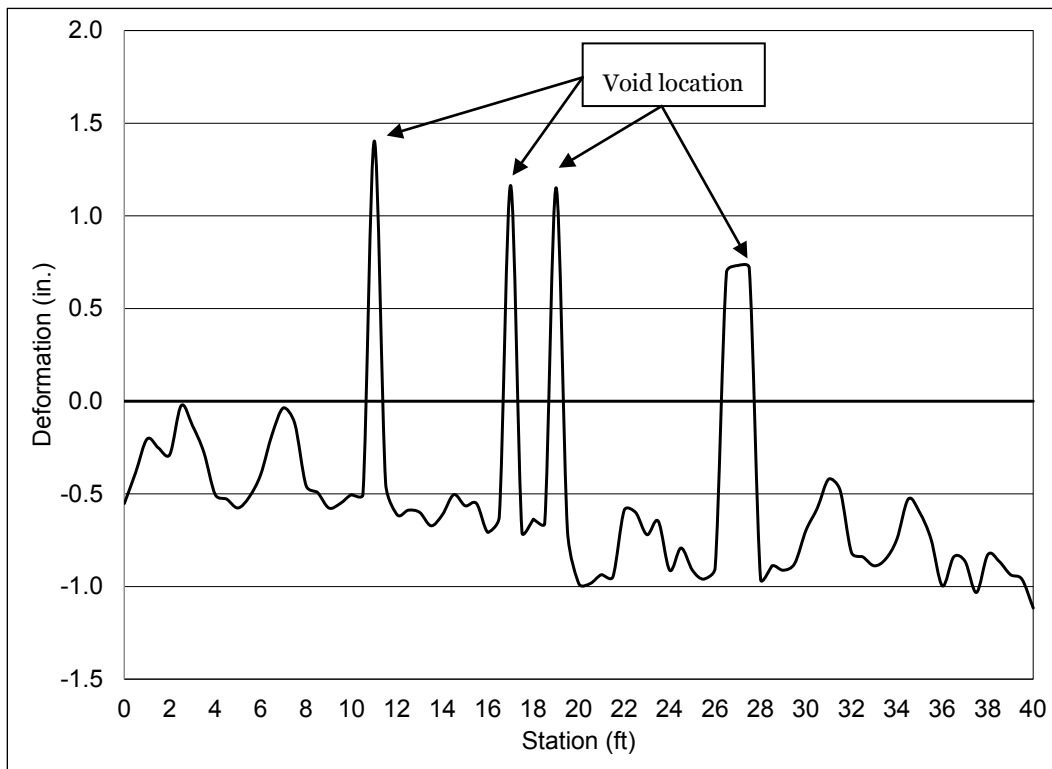
Figure 45. Subgrade centerline profile of the F-15E-V item after 322 passes.

Plots of the centerline profile data on the subgrade and mat surface, as determined from robotic total station recordings, are shown in Figures 45 and 46, respectively. In Figure 45, peaks observed at stations 11, 17, 19, and 27 were the locations of voids V1-A, V-F, V1-B, and V1-C, respectively, along the centerline. The positive values are a result of rearrangement of material into the excavated void area during traffic. The initial depth of the voids was 2 in., but the depth decreased throughout traffic with the rearrangement of particles. These were ignored when determining the maximum roughness value. Plots of the average cross-section elevation data, collected along lines A1, A2, and A3, are shown in Figures 47 through 49.

Pass Number	322
Subgrade Profile Max Abrupt Change in Elevation, (in.)	0.54
Mat Surface Profile Max Abrupt Change in Elevation, (in.)	0.16
Subgrade Permanent Deformation, (in.)	0.64
Loaded Deformation on Mat Surface, (in.)	0.50
Unloaded Deformation on Mat Surface, (in.)	0.31

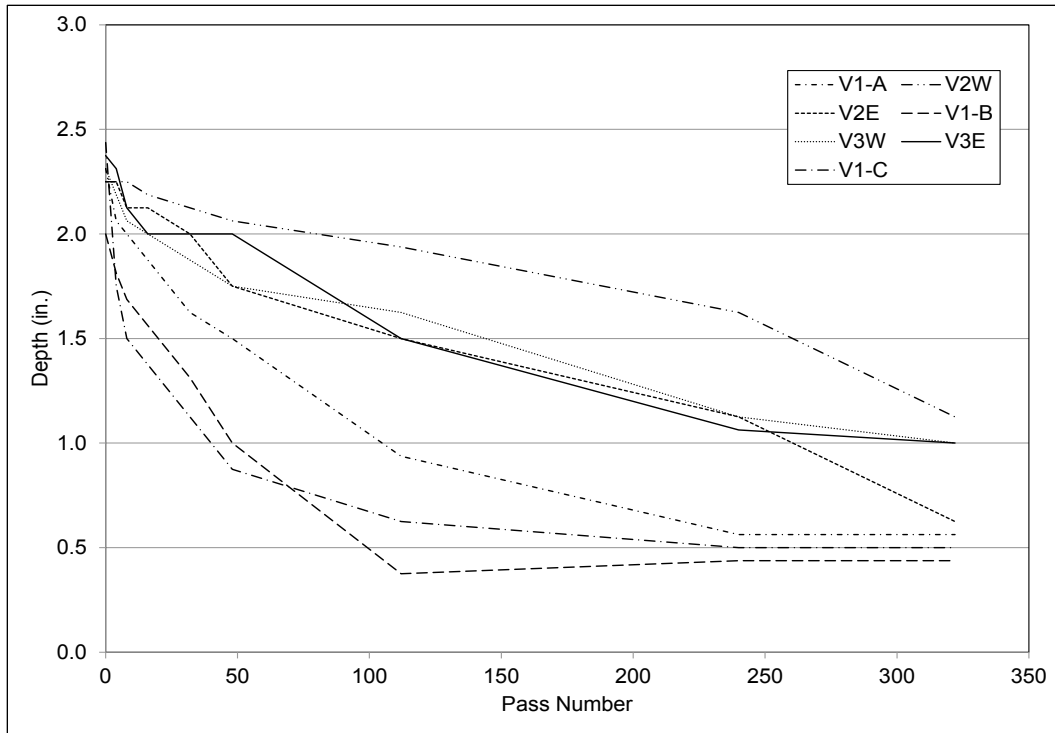
Figure 50. Void depth beneath the mat throughout traffic in the F-15E-V item.

In an attempt to monitor the progression of deformation where voids were excavated, observation holes were drilled in several panels at the positions where voids were located (with the exception of void V-F). Void V-F was excavated to determine the effect on the performance and strain measurements at an F-joint. Figure 50 shows the variation of the depth of the voids underneath the mat during traffic. After removing the mats, the voids were visually inspected to determine the extent of movement of material in those specific areas. It was observed that the diameter of the voids reduced and that material filled in the excavated areas, making the center of the voids nearly level and uniform with the subgrade surface. Figure 51 shows pretest and posttest photos of voids V2W, V2E and V1-C.

The elevation measurements of the data collected along the two tracks 4.5 in. from the centerline were used for the analysis. Calculations determined the average elevation of points within ± 3 in. of each centerline profile elevation location in terms of northing. The calculated average elevation corresponding to each station was then subtracted from measurements taken on the unloaded mat surface at the same location. For example, the average of dynamic deflections at each station for Passes 32 through 48 was subtracted from the unloaded centerline profile recordings at each station collected at pass 32. The difference in the loaded and unloaded measurements is the elastic deflection, or rebound, of the mat and subgrade as the test wheel moved over the surface. An example of the raw data as collected is shown in Figures 52. The average elastic deflection at each station for each data collection interval is shown in Figure 53. For the F-15E-V item, the elastic deflection remained at approximately 1.0 in. throughout testing. Elastic deflection was not measured at the end of the test (322 passes) to prevent damage to the F-15E tire by tire hazards present in the traffic lane.

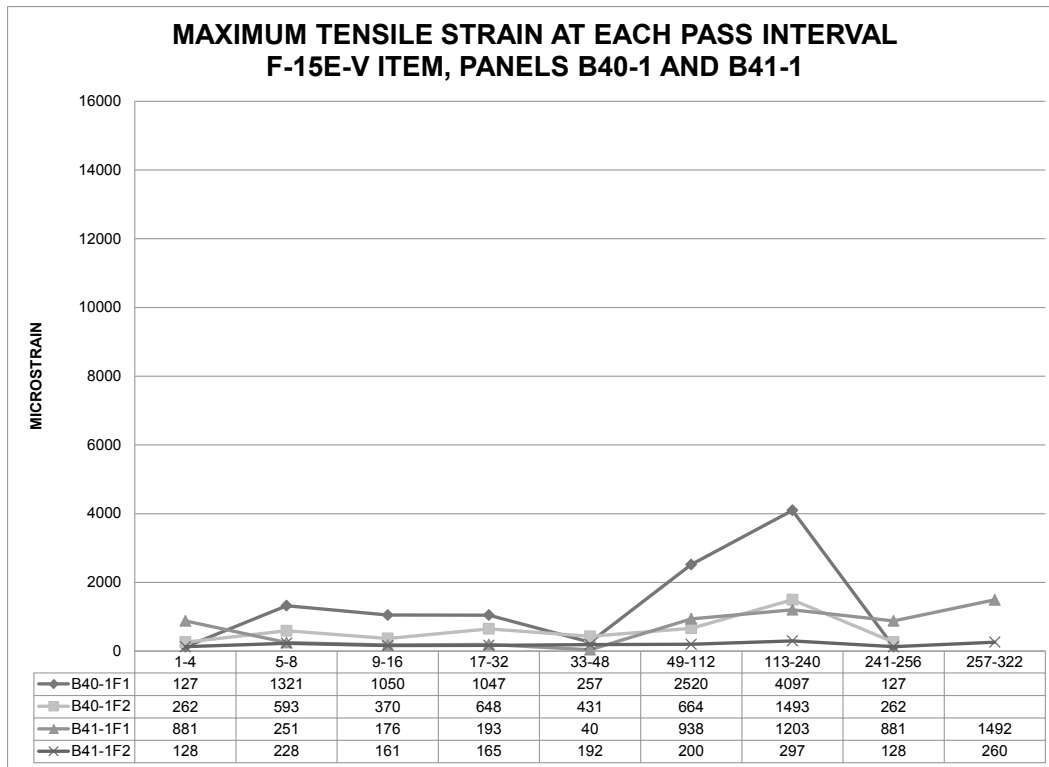
Figure 60. Max tensile strain at F-15E-V item panels B40-1 and B41-1.

Failure of the upper underlap rail of panel B40-1 at 322 passes is apparent from the disappearance of data in Figures 60 and 61 during pass interval 257-322. Gauges B40-1F1 and B40-1F2 both malfunctioned and recorded unusable data after the rail broke. Gauge B37-2F2 was damaged during mat installation; therefore, any data recorded by this gauge was disregarded and not reported. High compressive strains were recorded throughout at the test at B37-2F1, which was located above void V-F. Tensile and compressive strains at refurbished Panel B41-2 (located between the largest voids) on average appeared to be higher than at other locations. Its connecting panel (B40-2), which was new, recorded relatively high tensile strains, but very low compressive strains (on average) at the lower overlap rail. The remaining data show that a clear trend is not observed that links void size the panel strain measurements.

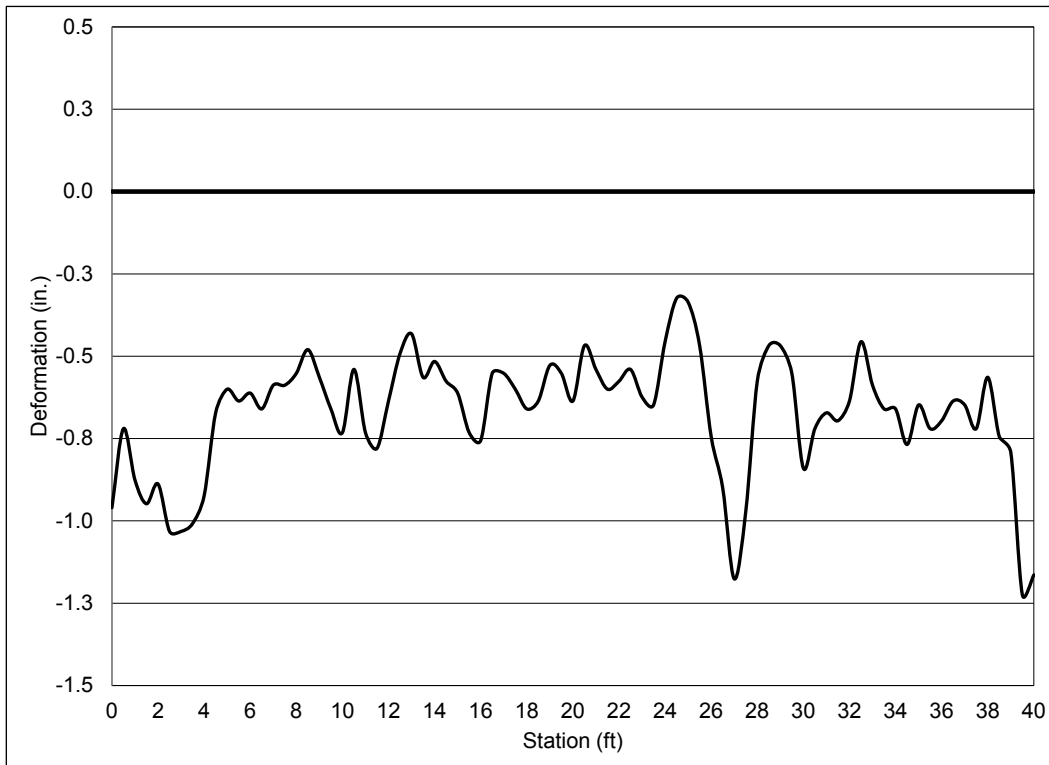
Figure 72. Subgrade centerline profile of the F-15E item after 430 passes.

boundary conditions were ignored (i.e., first eight and last six stations along the centerline in Figure 73). This was done because of the different properties at the interface of the test section subgrade and the surrounding material (the latter being much stronger). In Figure 74, a peak shown at station 26 was a result of material buildup where Panels 101 and 89 failed. This was ignored when analyzing the profile for roughness values. Plots of the average cross-section elevation data, collected along lines A1, A2, and A3 from Figure 36 for each test item, are shown in Figures 76 through 81.

Test Item	F-15E	C-17
Pass Number	430	1,308
Subgrade Profile Max Abrupt Change in Elevation (in.)	0.84	0.90
Mat Surface Profile Max Abrupt Change in Elevation (in.)	0.17	0.52
Subgrade Permanent Deformation (in.)	0.75	3.06
Loaded Deformation on Mat Surface (in.)	0.65	2.72
Unloaded Deformation on Mat Surface (in.)	0.44	1.67

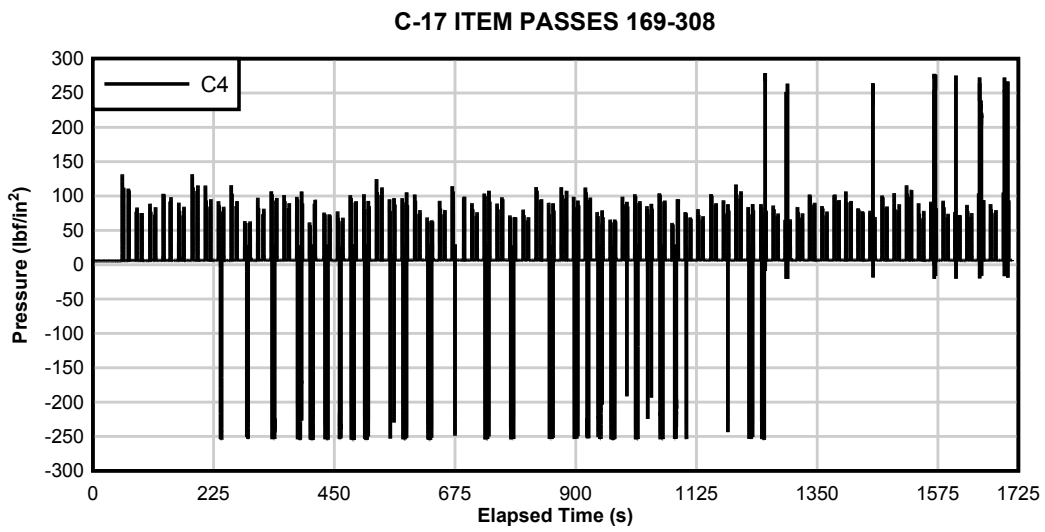
Note: C3 malfunctioned. Did not report usable data after pass 168.

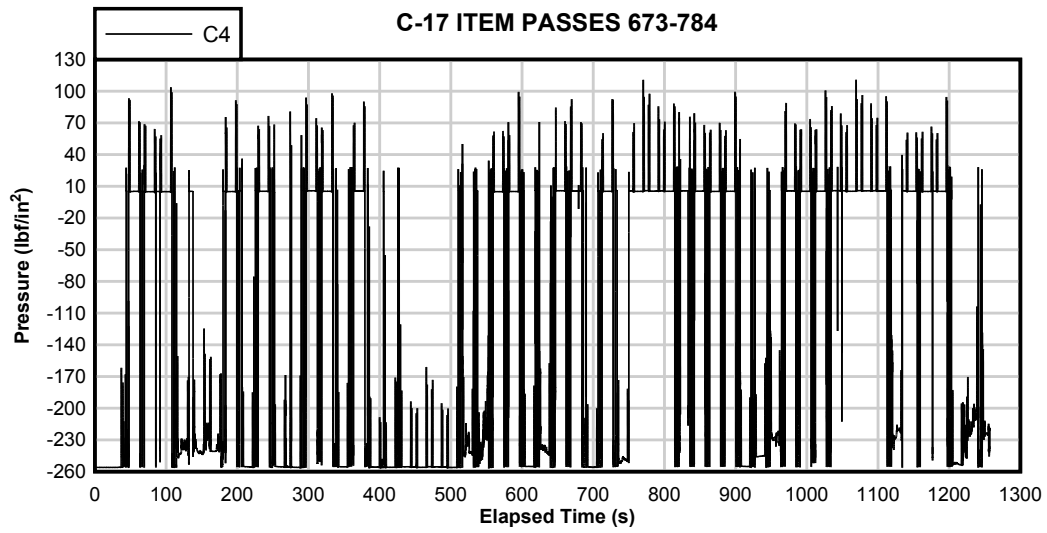
Note: Complete malfunction of C4 after pass 672.

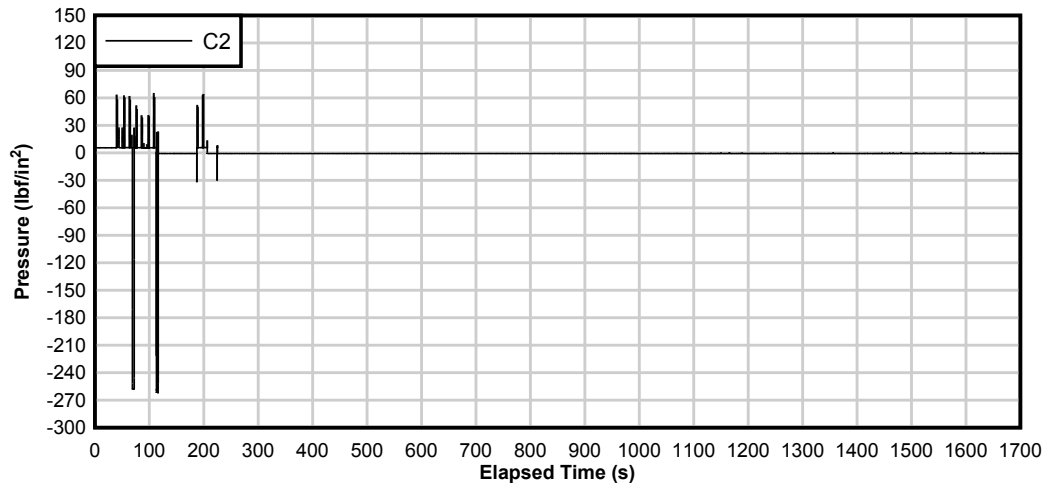
Note: Complete malfunction of C2 after pass 784

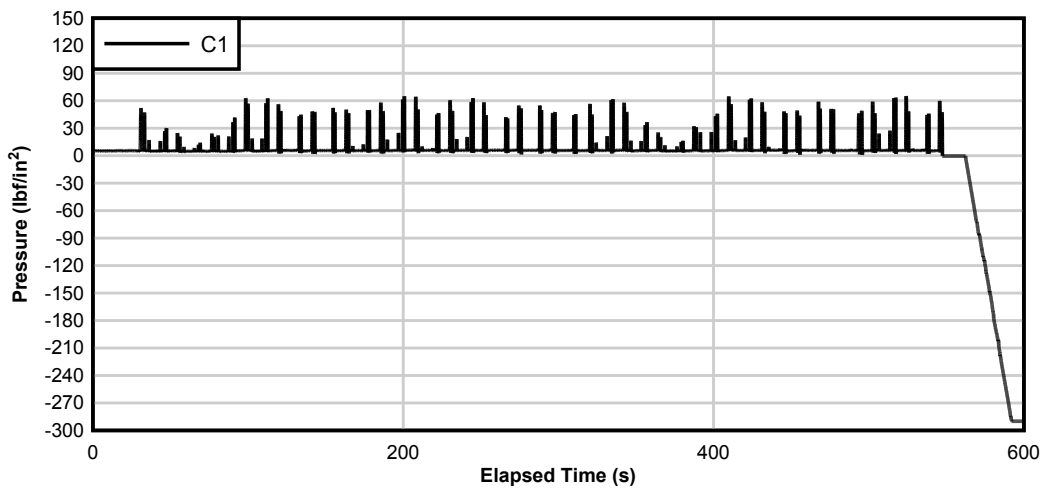
C-17 ITEM PASSES 1169-1215

Note: Complete malfunction of C1 after pass 1,215.
