Airfield Damage Repair Modernization Program

AM2 Modified 2-1 Lay Pattern Evaluation under F-15E Traffic

Final report

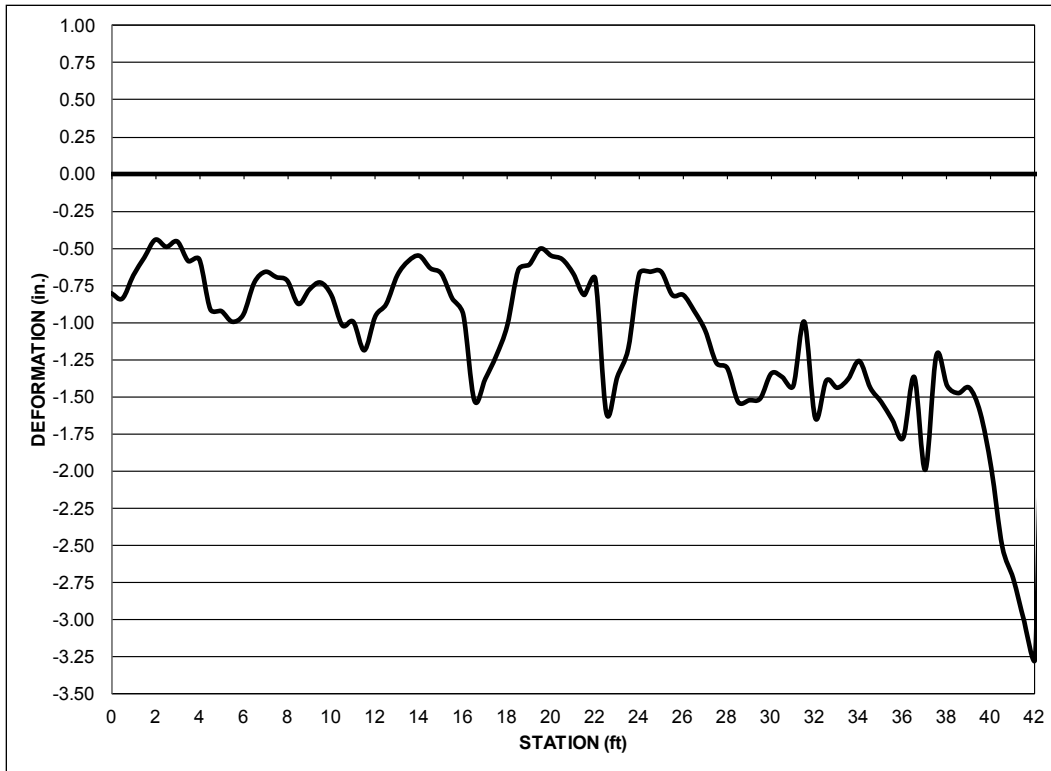
Figure 32. Subgrade centerline profile after 2,850 passes.

The pre-traffic data were subtracted from all subsequent data collected after trafficking began to normalize the data and show only the changes caused by trafficking. Plots of the centerline profile data, as determined from robotic total station recordings, are shown in Figures 32 and 33. When determining the maximum roughness value in each item, boundary conditions were ignored (i.e., first and last two stations along the centerline in Figures 32 and 33). This was done because of the different properties at the interface of the test section subgrade and the stronger surrounding material. Stations 16, 22, and 31 to 38 were areas of panel end connector rail failure, severe skin tears, or core crushing, and are represented as deep depressions in the subgrade and the mat surface. These were disregarded when analyzing the profile, since they were associated with mat breakage and not necessarily with the system's ability (or inability) to prevent excessive roughness.

Pass number	1,008	2,032	2,850
Subgrade profile max abrupt change in elevation (in.)	-	-	0.46
Mat surface profile max abrupt change in elevation (in.)	0.17	0.19	0.13
Subgrade permanent deformation (in.)	-	-	1.74*
Loaded deformation on mat surface (in.)	0.74	1.01*	1.34*
Unloaded deformation on mat surface (in.)	0.20	0.32*	0.66*

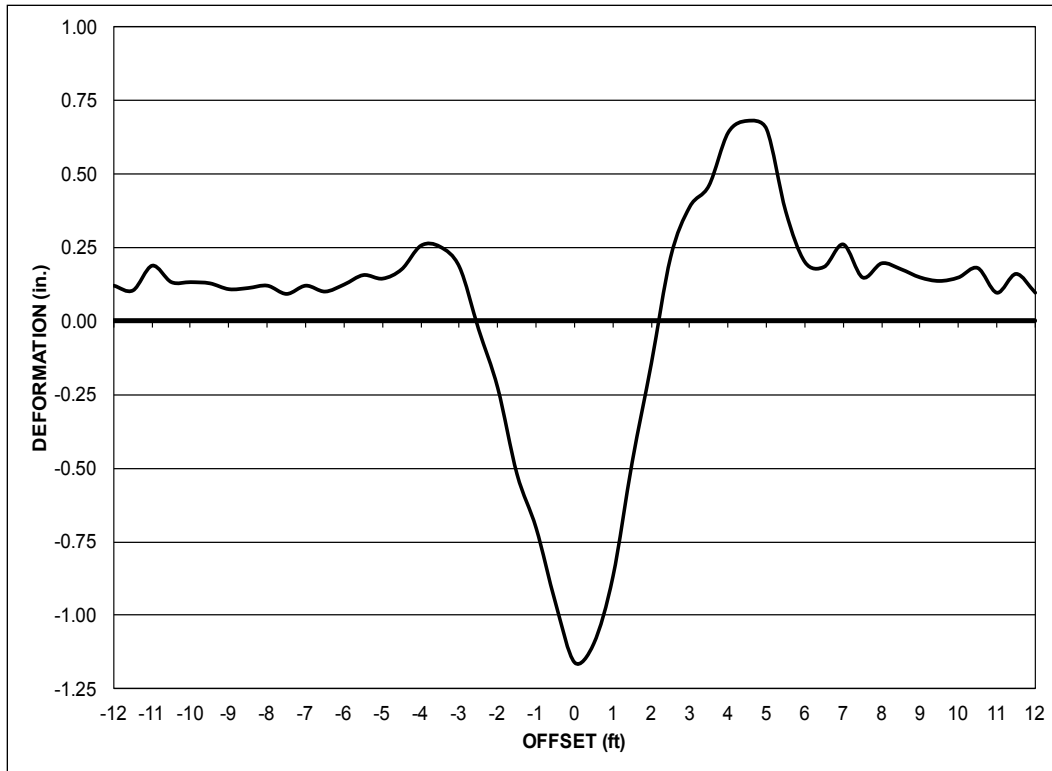
Figure 34. Average deformation on the subgrade after 2,850 passes.

Plots of the average cross-section elevation data, collected along lines A1, A2, and A3, are shown in Figures 34-36. Table 9 summarizes important deformation values determined from all the plots for comparison to the failure criterion. Note that after failure of panel J46, which was located at cross section A2, material rearrangement and buildup occurred beneath and around line A2. This affected any data collected along line A2 for the remainder of the test, giving an unrealistic measure of the deformation on the mat surface and the subgrade. Therefore, measurements shown in Figures 34-36 after pass 1,644 were the average of data collected along lines A1 and A3.

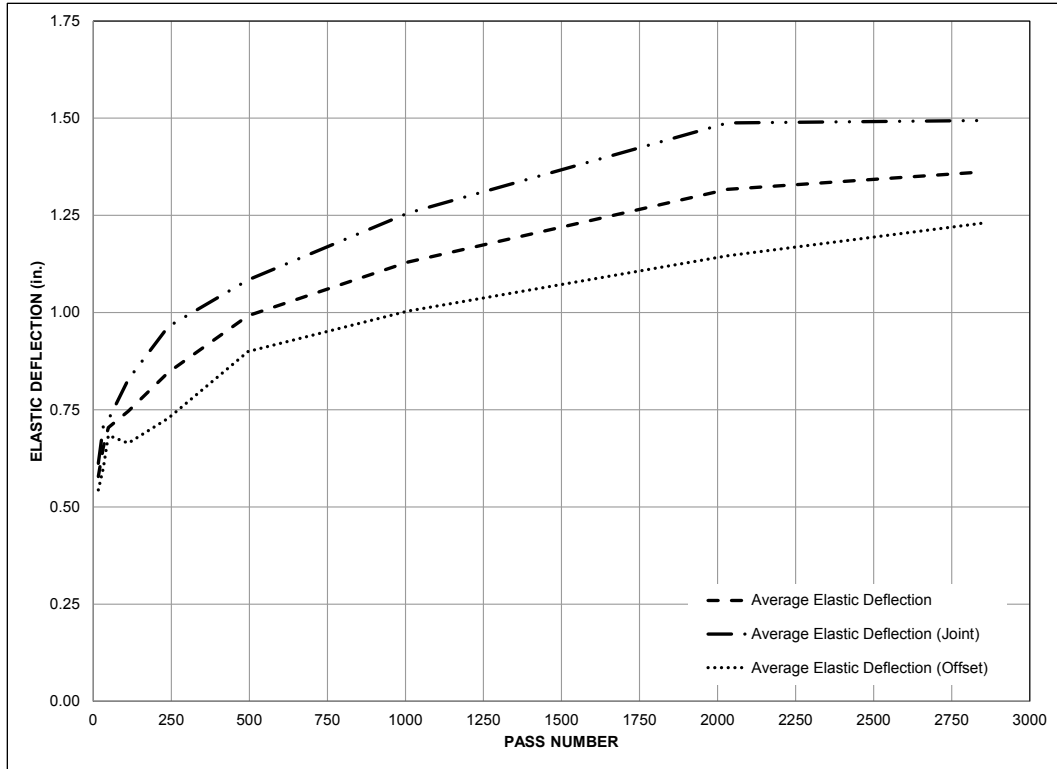
Figure 37. Elastic deflection.

The difference between the loaded (immediately adjacent to the tire of the load cart) and the unloaded elevations at the locations shown in Figure 21 represents the elastic deflection, or rebound, of the mat and the subgrade at each location. The measurements determined from readings taken at the quarter point (3 ft from end) of the three panels were averaged to give a final elastic deflection value. The same was done for measurements determined from readings taken at three joints. The average of these two values was also calculated. One number was reported for each condition at each pass level in Table 7. The results are shown in Figure 37. Note that measurements after pass 1,644 (failure of J46) represent the average of data collected near stations A1 and A3.
