ESTCP Cost and Performance Report

(WP-200906)

Non-Chromate, ZVOC Coatings for Steel Substrates on Army and Navy Aircraft and Ground Vehicles

December 2014

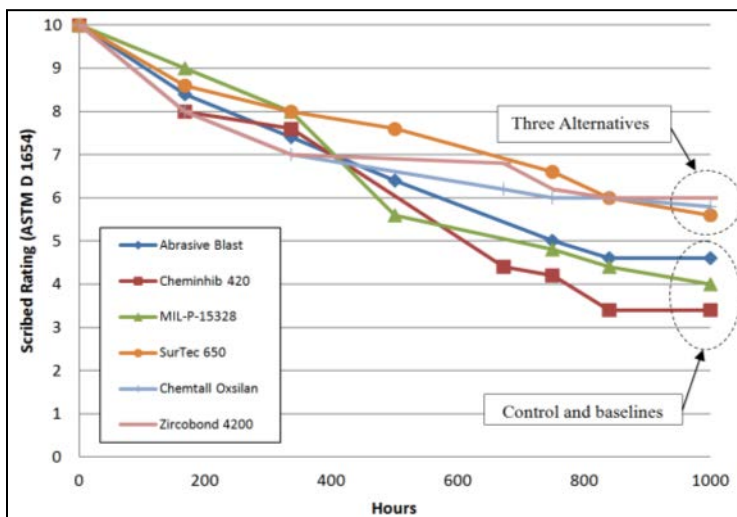
Figure 4. ASTM D 1654 rating for abrasive blasted HHA panels through 1000 hours of ASTM B117 salt fog exposure.

Only test panels coated with CARC system (MIL-DTL-53022/MIL-DTL-53039) were tested in ASTM B117. The primary mode of failure measured was creepage from the scribe. The ratings of five replicates of each pretreatment were averaged and presented in Figure 4. Beyond 500 hours of exposure, the alternatives displayed less creepage from the scribe than the baseline and control, and meeting the success criteria of a ≥ 6 scribed. After all samples had completed 1000 hours, they were scraped before the final measurements were made. All three of the alternatives were markedly better than the control, baseline Cheminhib 420, and chromate wash primer DoD-P-15328. In fact, all were very close to meeting the 6.0 rating even after 1000 hours. As previously mentioned, the Cheminhib 420 is the baseline the alternatives are being evaluated against. It proved to be the worst of all the test panels measured in ASTM B117 salt fog.
