TECHNICAL REPORT REMR-CS-6

**IN SITU REPAIR OF DETERIORATED  
CONCRETE IN HYDRAULIC STRUCTURES:  
FEASIBILITY STUDIES**

R. P. Webster, L. E. Kukacka

May 1987  
Final Report

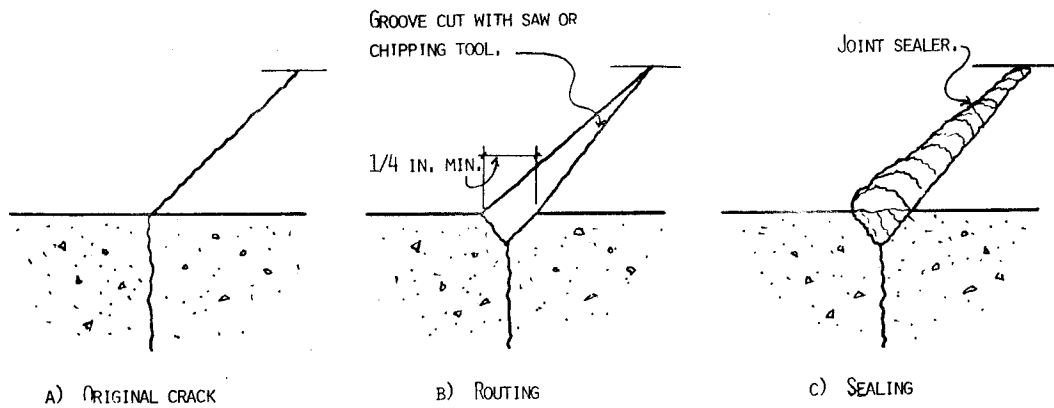
Figure 4. Repair of crack by routing and sealing (ACI Committee 224, 1984).

The technique simply entails enlarging the crack along its exposed face and filling and sealing it with a suitable joint sealant (Figure 4). Choice of the sealant depends on how tight or permanent the seal must be. Epoxy compounds are most commonly used, although hot-poured joint sealants have been used when watertightness is not required and appearance of the repair is unimportant. Urethanes, which remain flexible through large temperature variations, have been used successfully in cracks up to 0.75 in. in width.

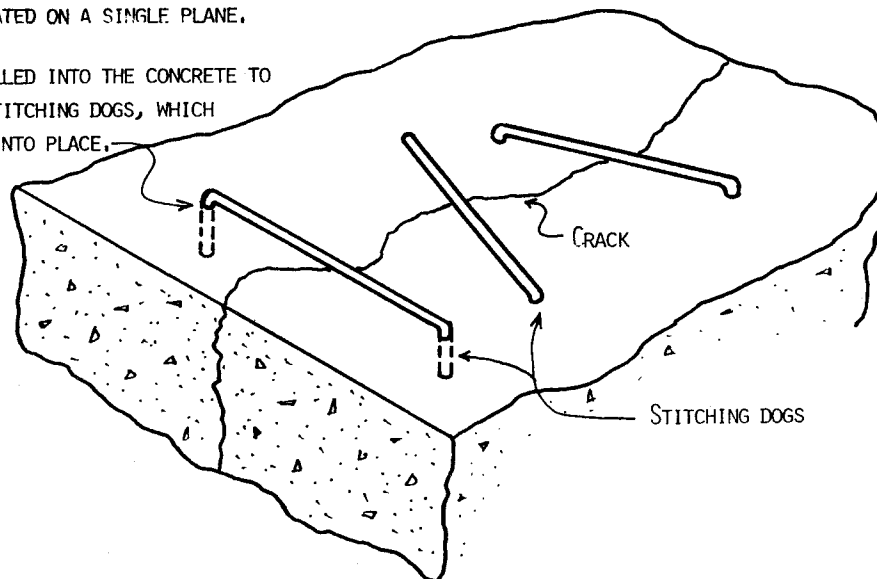
NOTE VARIABLE LENGTH, LOCATION AND ORIENTATION OF DOGS SO THAT TENSION ACROSS CRACK IS DISTRIBUTED IN THE CONCRETE RATHER THAN CONCENTRATED ON A SINGLE PLANE.

HOLES ARE DRILLED INTO THE CONCRETE TO RECEIVE THE STITCHING DOGS, WHICH ARE CEMENTED INTO PLACE.

Figure 5. Repair of crack by stitching (ACI Committee 224, 1984).

3. Stitching. This technique involves drilling holes on both sides of the crack and grouting in U-shaped reinforcing bars (stitching dogs) that span the crack (Figure 5). A non-shrink grout or an epoxy resin is normally used to anchor the legs of the bars. Stitching is generally used when it is necessary to reestablish tensile strength across major cracks. Stitching does tend to stiffen the area being repaired, which may accentuate the overall stiffness of the structure and cause cracks to develop elsewhere. It is, therefore, generally necessary to strengthen the adjacent sections using external reinforcement.

Stitching will not close a crack but can be used to prevent it from propagating further. If water is a problem, the crack should be made water tight before it is stitched to protect the bars from corrosion.

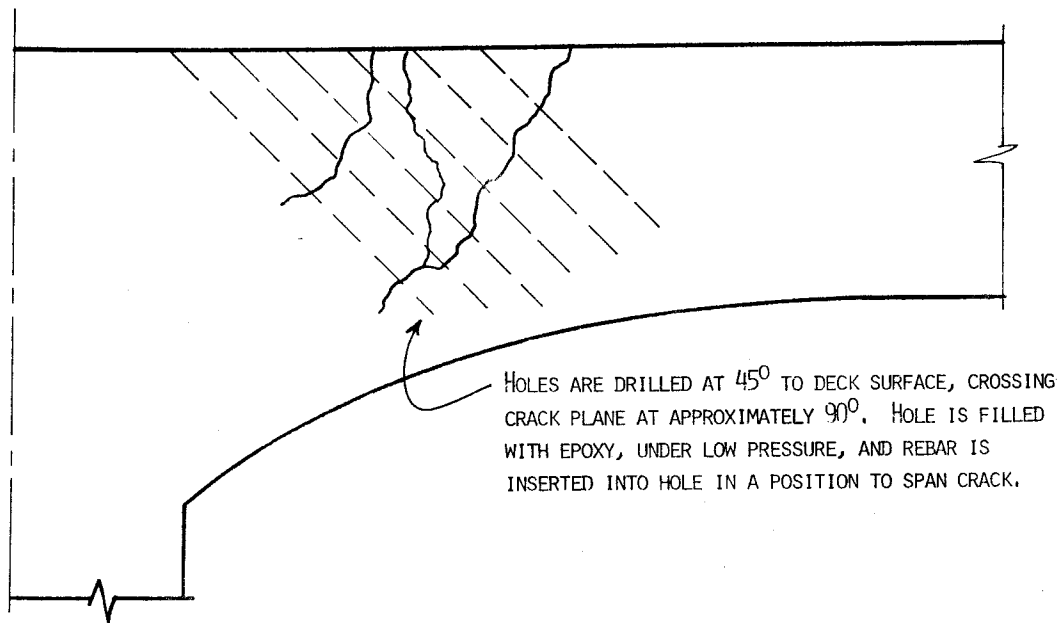
Figure 6. Repair of crack by post reinforcement.

Post-reinforcement is a technique developed by the Kansas Department of Transportation to repair cracked structural bridge concrete. The method consists of sealing the surface of the crack, drilling holes at  $45^\circ$  to the deck surface, and crossing the crack plane at approximately  $90^\circ$ , filling the hole and crack plane with epoxy pumped under low pressure, and placing a reinforcing bar into the drilled hole in a position to span the crack (Figure 6). The epoxy bonds the bar to the walls of the hole; it fills the crack plane, thereby rebonding the cracked concrete surfaces in one monolithic form and reinforcing the section.

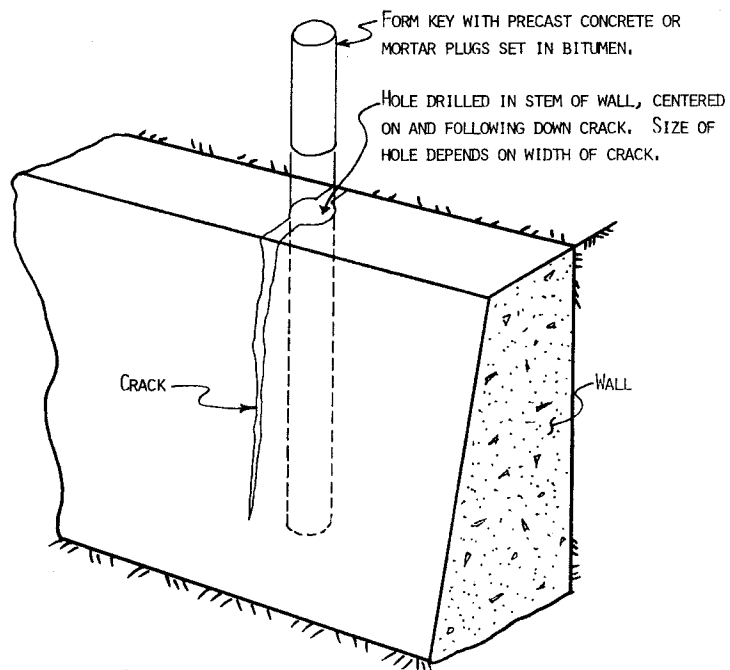
Figure 7. Repair of crack by drilling and plugging (ACI Committee 224, 1984).

5. Drilling and Grouting. This technique is useful for repairing vertical cracks which are reasonably straight and are accessible at one end of the crack such as in retaining walls. It consists of drilling a hole, usually 2 to 3 in. in diameter, down the length of the crack and grouting it in to form a key (Figure 7). The grout key prevents transverse movement of the concrete adjacent to the crack and will also reduce heavy leakage through the crack. If watertightness is essential and structural load transfer is not, the drilled hole is filled with a resilient material in place of the grout.

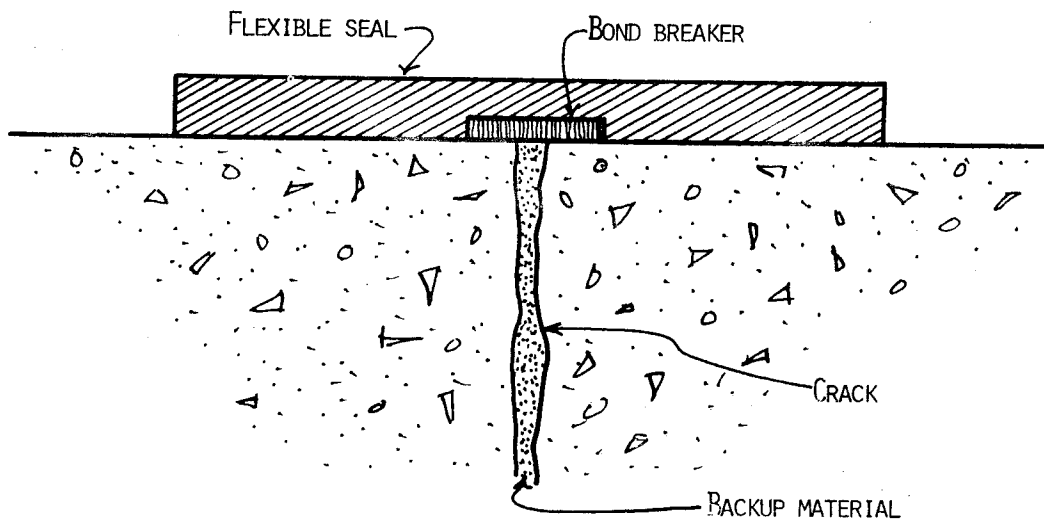
Figure 8. Repair of crack using a flexible seal (ACI Committee 224, 1984).

6. Flexible Sealing. Active cracks can be sealed by routing them out and filling them with a suitable flexible sealant. This technique is applicable where appearance is unimportant and in areas where the cracks are not subject to traffic or mechanical abuse. The repairs are made by routing out a slot or groove along the length of the crack of sufficient width and shape to accommodate the expected movement. The slot is then filled with a backing material, covered with a bond breaker, and finally sealed with the flexible joint sealant (Figure 8).

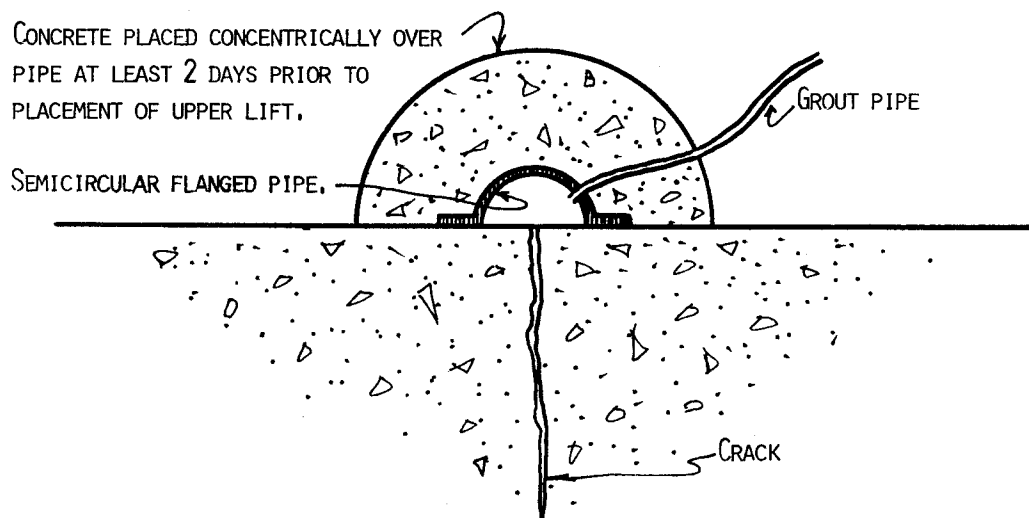
Figure 9. Repair of crack using the crack arrest method (ACI Committee 224, 1984).

9. Crack Arrest. This technique is commonly used to prevent reflective cracking into new concrete which is being placed over existing concrete. The technique, in general, arrests the cracking by blocking it and spreading the tensile stresses causing the cracking over a larger area. One technique consists of placing semicircular sections of steel pipe over the crack and then covering the pipe with concrete to anchor it in place. After this concrete cap has set, the new concrete is placed over the cap. The steel pipe is later filled with grout to complete the structural continuity of the member (Figure 9).

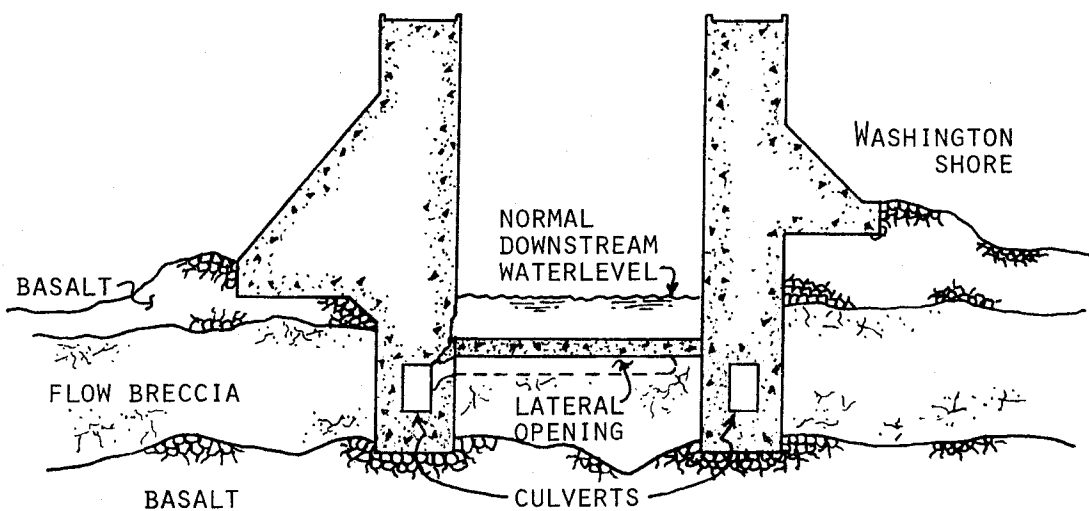
Figure 14. John Day Navigation Lock.

During an inspection in 1975, significant structural cracking and related spalling were discovered in two of the lock monoliths, monoliths 17 and 19. By 1979, cracking and spalling had been detected in four additional monoliths, monoliths 13, 15, 21, and 23. The structural distress in the monoliths consisted of cracks that originated at and propagated from the upper inside corner of the filling and emptying culvert and terminated at the surface of the wall in the lock chamber. Because of the continued progression of the cracking and spalling, a series of remedial repair procedures were devised and implemented to halt and correct the ongoing deterioration (Adhesive Engineering Bulletin, 1981b, Barlow, 1986, and Neuberger, 1982).

The objectives of the selected repair procedures were to restore the existing cracked structure to near its original uncracked condition, to eliminate the cause of the cracking, and to effect the repairs without
