# FLOOD PROOFING TESTS

Tests of Materials and  
Systems for Flood  
Proofing Structures

August 1988

US Army Corps of Engineers

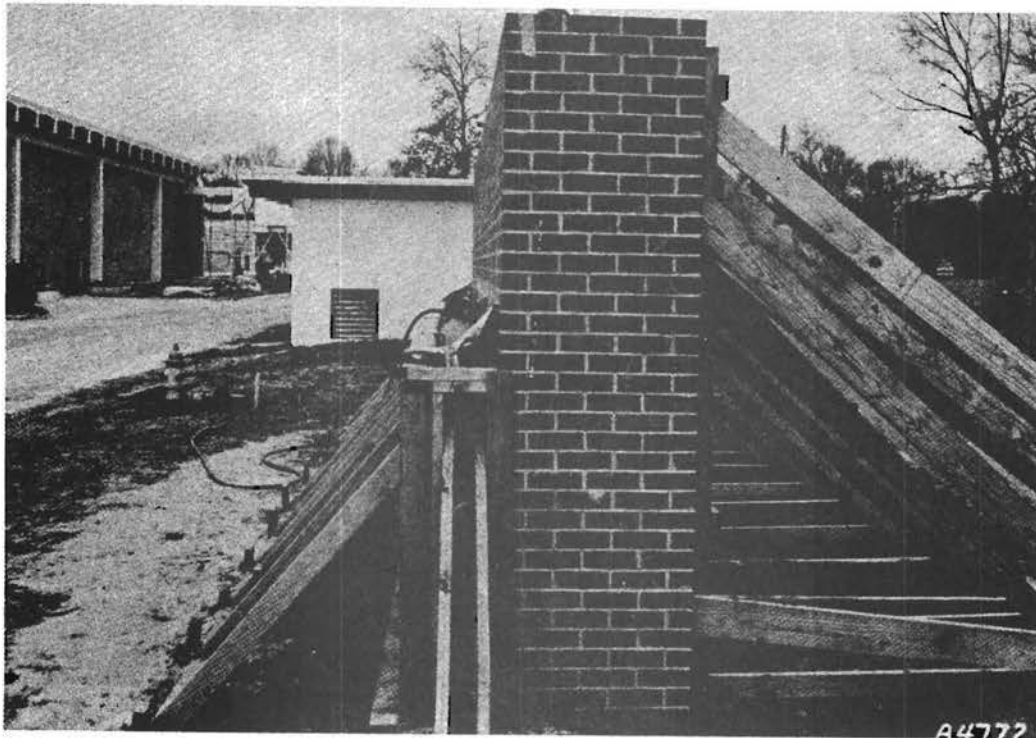
even a slight deflection (Figure 9). This means that the wall itself was seriously damaged at relatively small deflections. To be conservative, the wall deflection should be kept below approximately 0.01 in. in the direction of the water loading. The deflection of the wall is mentioned because it is probably a more reliable guide for general wall configurations than the water depth. For example, the same water depth might produce less deflection or damage on a short wall than on a longer wall. Similar damage would more than likely occur around the same wall deflection than the same water depth. If the wall deflects more than 0.01 in., there is damage and a chance that it will not support service loads or vibrations during normal operation. The deflection criteria will be practicable only after further study and failure charts are developed by computer solutions.

Figure 9. Wall 1. Wall deflection

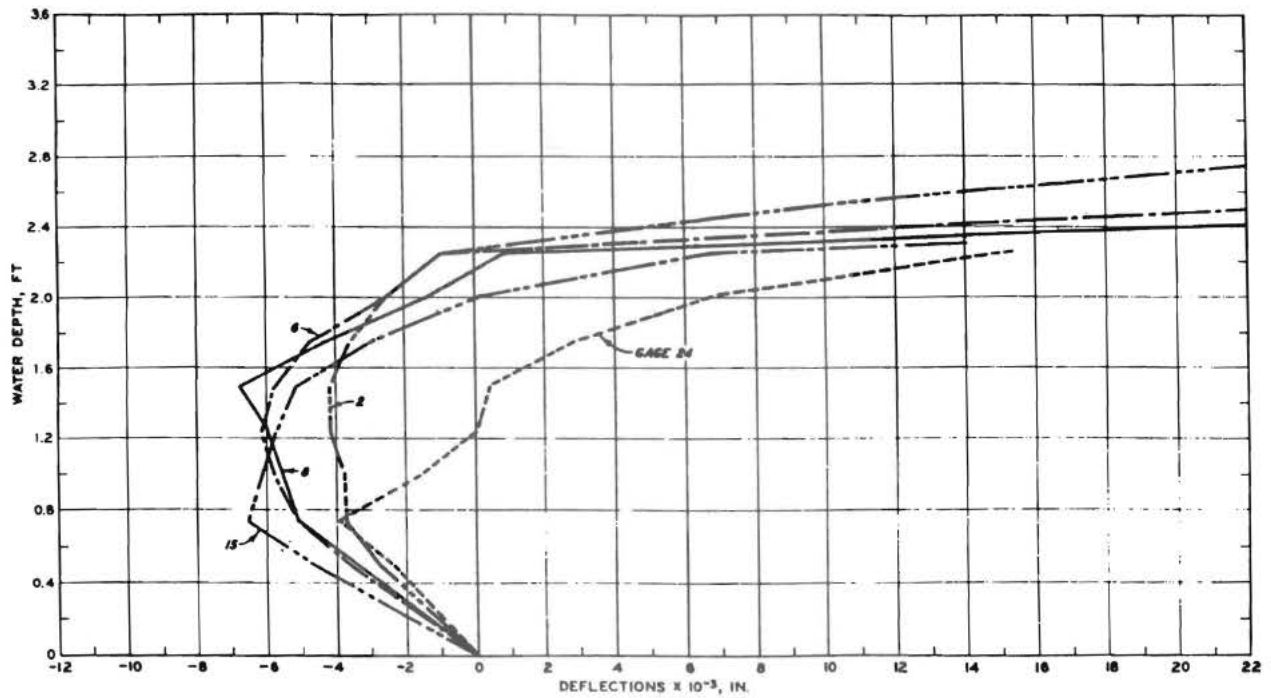
As the water depth increased, the gages were monitored and the deflected shape of the wall was measured. A typical plot of water depth versus wall deflection is shown in Figure 12.

Figure 12. Wall 2. Brick-veneer wall deflections, vertical gage line, initial loading

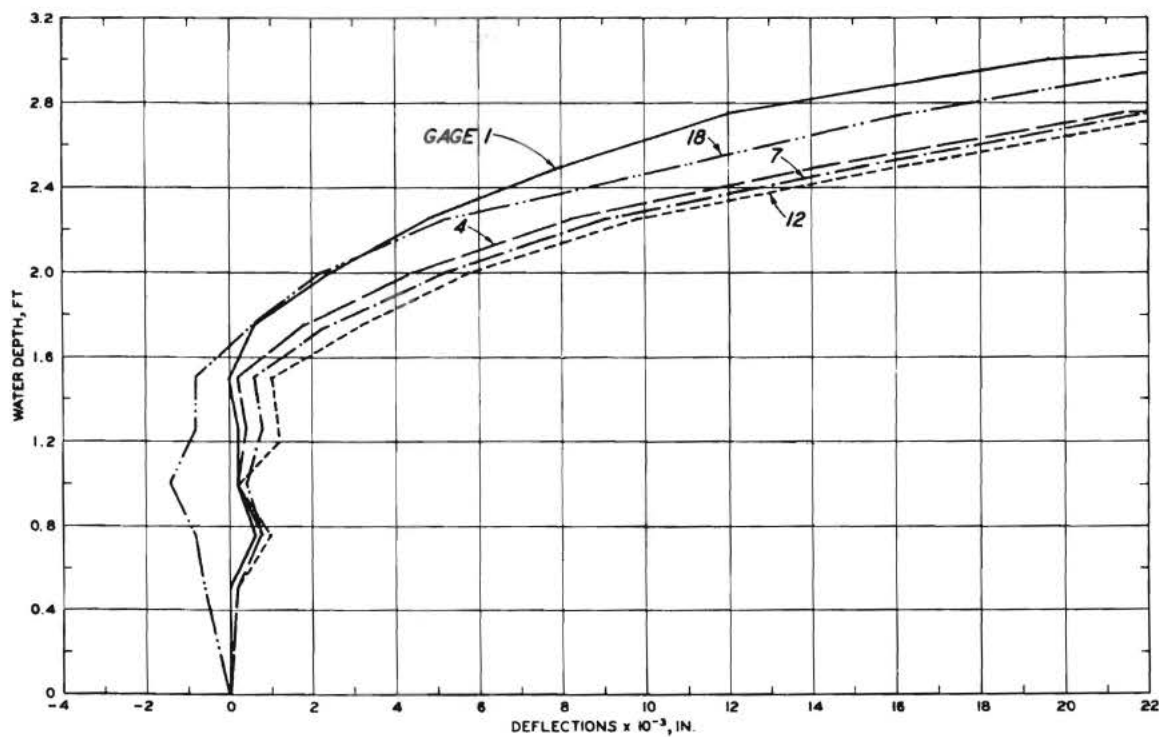
of water depth versus brick wall deflection for Wall 3 are presented in Figure 15. Because of the ceiling joist and roof rafter restraints, the negative movement along the top of the wall was less pronounced than that of Wall 2.

Figure 15. Wall 3. Brick-veneer wall deflection, vertical gage line

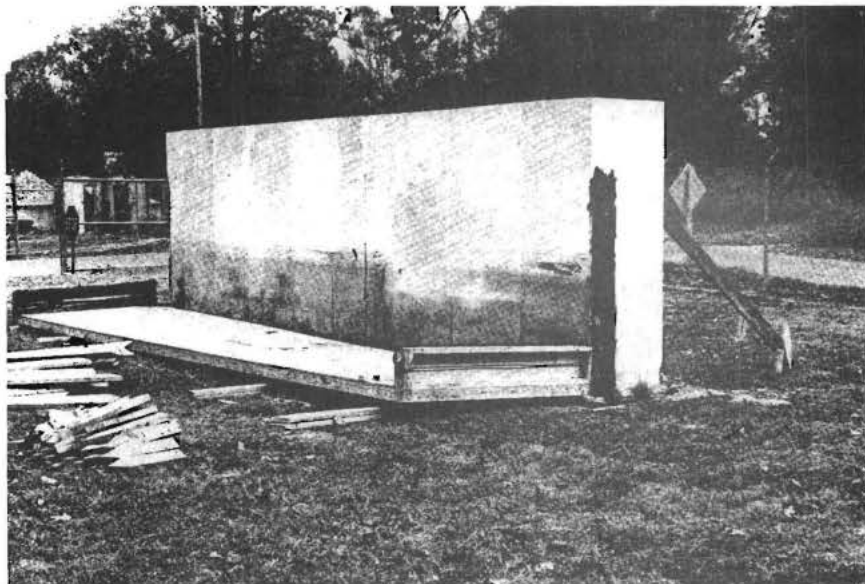
Figure 18. Block Wall 1

Block Wall 1, before and after the testing, is shown in Figure 18. The front of the first wall was plastered, and a bulkhead was constructed in front of it to contain water to be supplied from a fire hydrant. The second block wall is shown in Figure 19. Block Wall 2 was used to test several flood protection systems.

a. Before testing

b. After testing

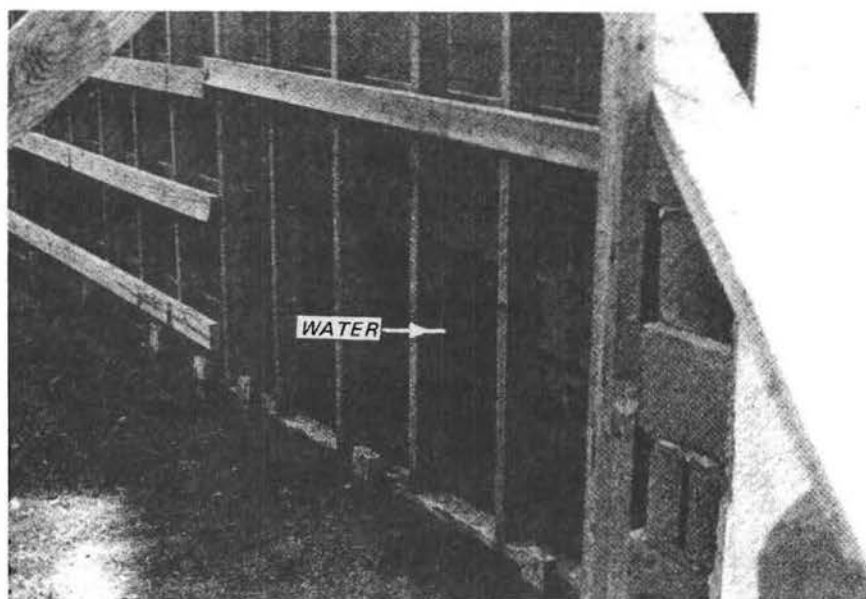
a. Stream of water coming through wall

Figure 21. Leakage through block wall

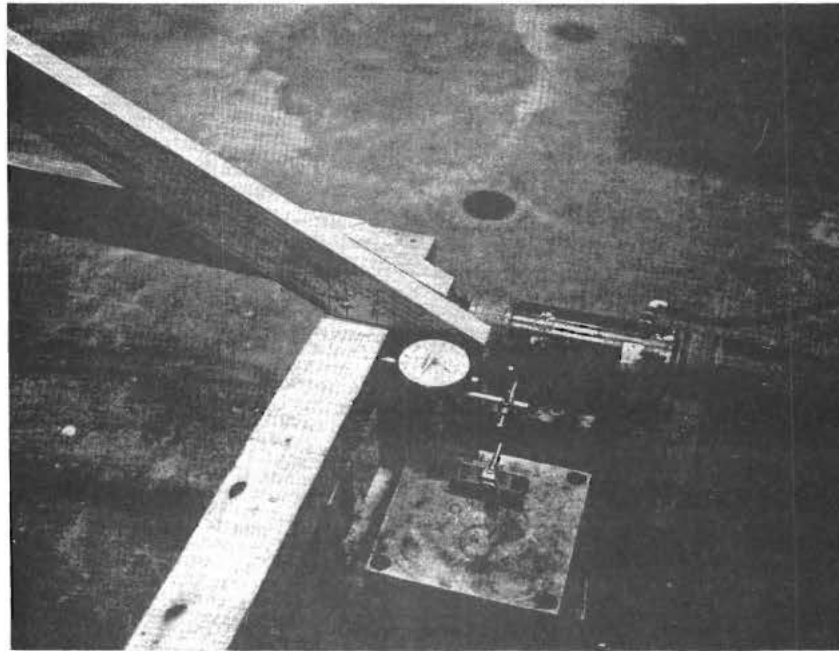
Figure 22. Nailed roof rafter and ceiling joist connection (connection has been failed)

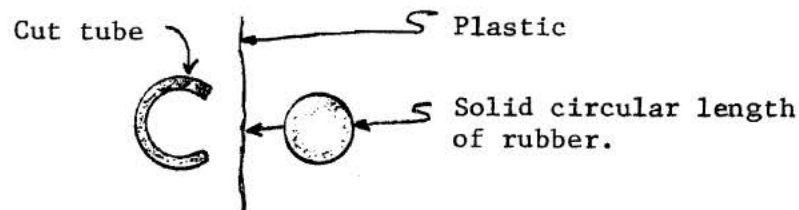
- A solid circular length of rubber was placed against the plastic and snapped into the cut tube (schematically illustrated in the sketch below).

After only one test was performed on this brick-veneer wall, the system performed well. Other tests are necessary to determine the reliability of the system. Difficulties encountered prompted the test to be stopped. Water leakage under the bottom of the beam and base of the wall was to such a degree that further testing was useless. A particular advantage to this system is that seals and gaskets for individual openings in the structure are not necessary.
