CHARACTERIZATION OF HIGH POWER GAS SWITCH FAILURE MECHANISMS

E. E. NOLTING

Naval Surface Weapons Center
White Oak, Silver Spring, Maryland 20910

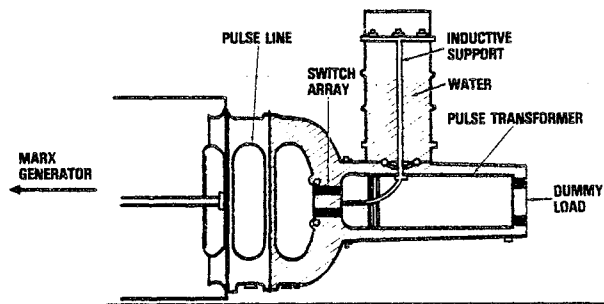
Fig. 2. Experimental arrangement used for testing gas switches on the Casino simulator.

The entire switch column assembly was rigidly connected at the positive (output) end of the switch. At the opposite end, the switch columns were attached to a plate which was electrically connected by several short, braided straps. This cantilevered switch assembly allowed shifting of the pulse line and transformer, when transmission line fluids were transferred, without creating stresses in the switch components. Figure 2 shows location and mounting of the switch assembly.
