HCAT PROGRESS REPORT SEPTEMBER 2002

13. SUPPLEMENTARY NOTES 21st Replacement of Hard Chrome Plating Program Review Meeting, September 25-26, 2002, Toronto, Ontario. Sponsored by SERDP/ESTCP.

TEST 1: MLG FATIGUE TEST

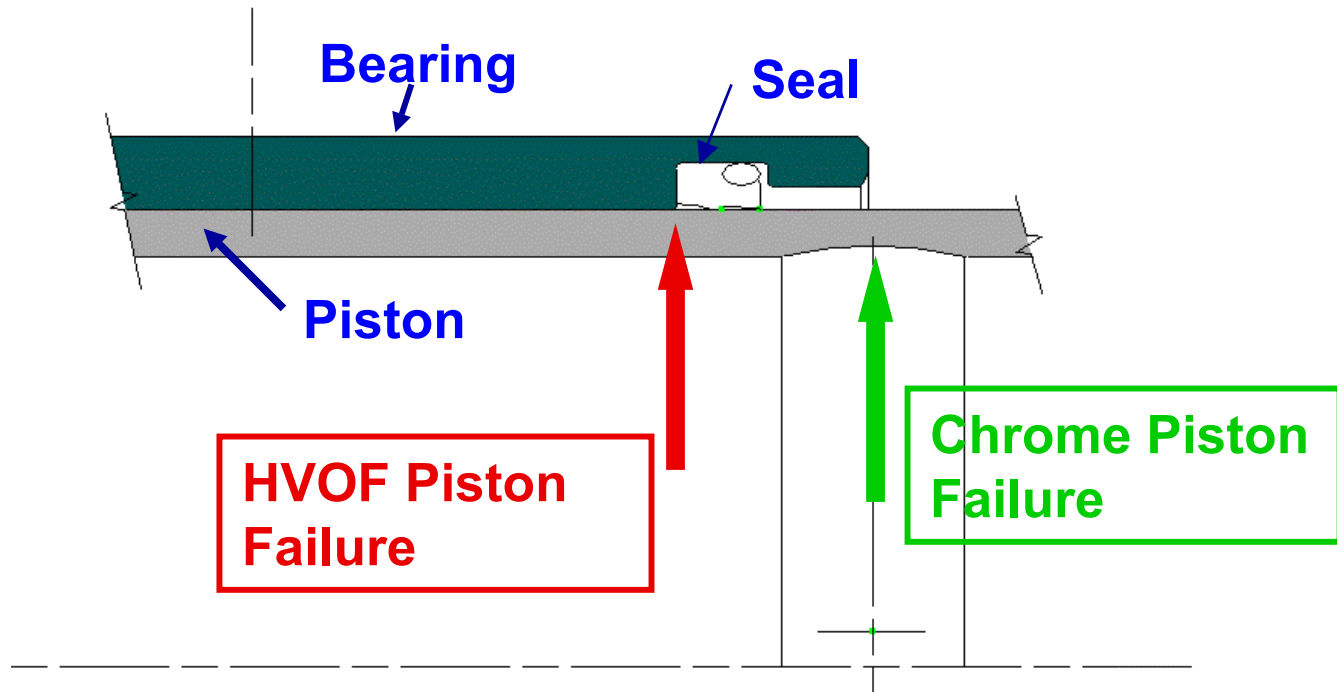
TEST RESULTS

Piston	Stress (bending)	Cycles	Failure Mode
1st Cr	100 ksi	407K	ID, @ notch (inclusion)
2nd Cr	110 ksi	1M	
	135 ksi	20k	ID, @ notch
3rd Cr	125 ksi	62K	ID, @ notch
1st HVOF	100 ksi	570k	coating failed (250K)
	110ksi	185K	OD, @ bearing
2nd HVOF	125 ksi	33K	OD, @ bearing
3rd HVOF	125 ksi	25K	OD, @ bearing

- **HVOF pistons failed at contact point with bearing - Failure originated at OD; Chrome plated pistons failed at notch - Failure originated at ID.**
- **Cracking of coating is circumferential, localized and appears to occur relatively early ~5 K cycles @125ksi**
- **Coating failure is cohesive (substrate still coated).**
- **Coating application and finish - not a factor.**
- **Commercial Landing Gear Stresses are comparable to test - but # of cycles much smaller.**
 - **LG spectrum 125 ksi -- 575 cycles/5 lives (120 one life)**
 - **Test regime 125 ksi -- 5,000 - 7,000 cycles**
- **Test conditions too severe, not representative of LG.**

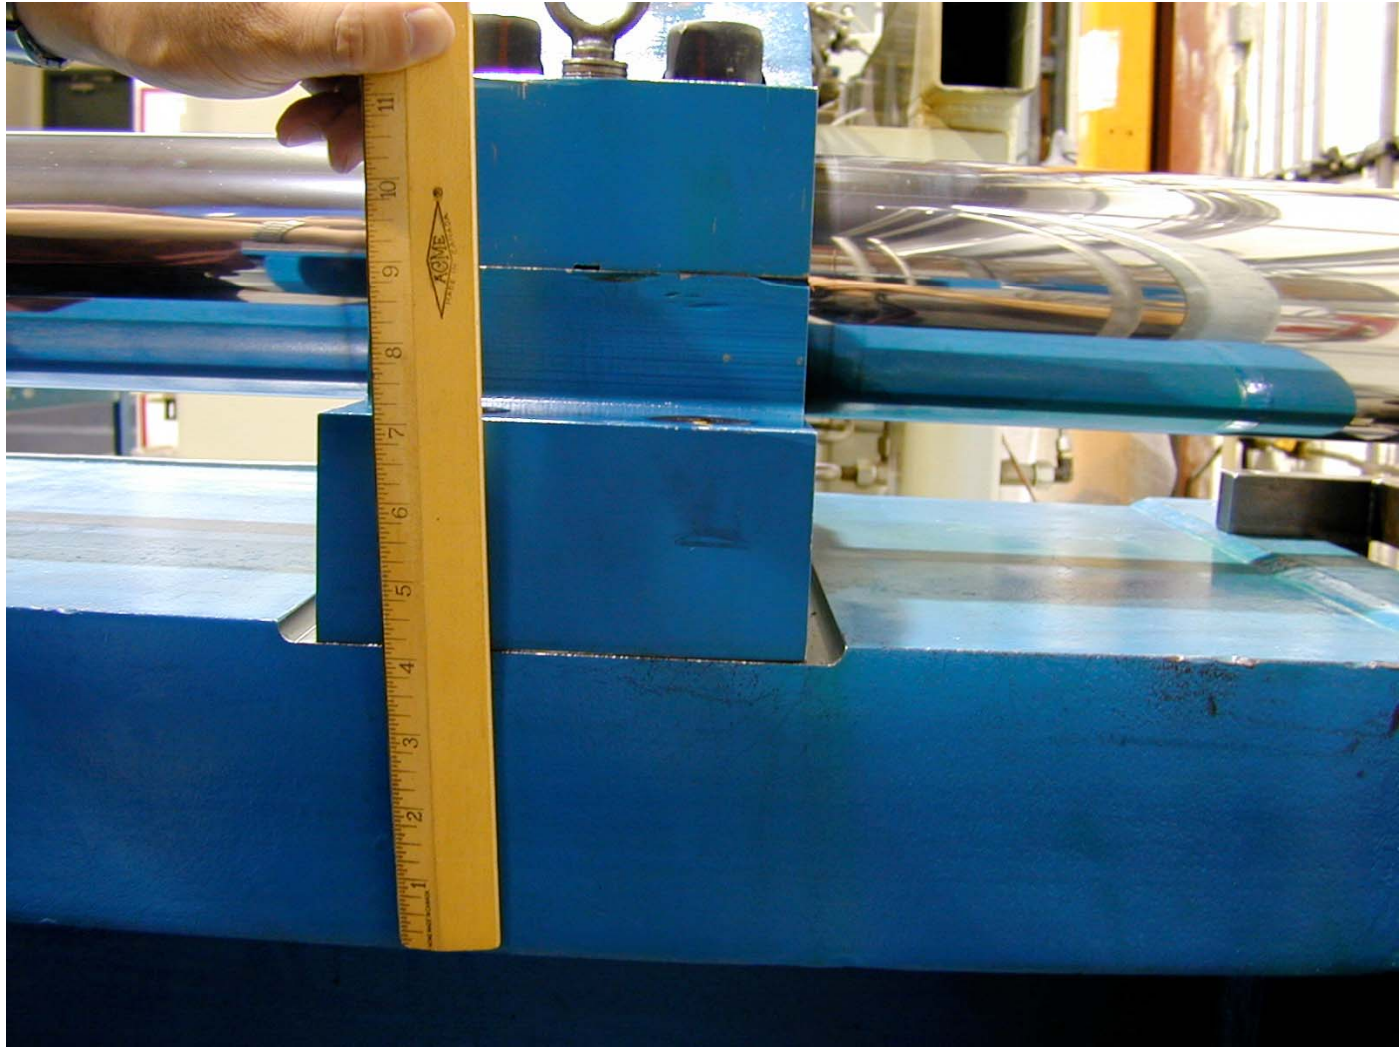
Test conditions too severe, not representative of LG.

Scope of test changed to simulate LG conditions - 10" test

- 10" Rig will be re-designed to represent LG lower bearing**
- Simple spectrum loading will be implemented**
- Representative bearing will be implemented**
