# STILLING BASIN MODIFICATIONS BULL SHOALS DAM WHITE RIVER, ARKANSAS

Hydraulic Model Investigation

TECHNICAL REPORT NO. 2-488

U. S. Army Engineer Waterways Experiment Station  
CORPS OF ENGINEERS

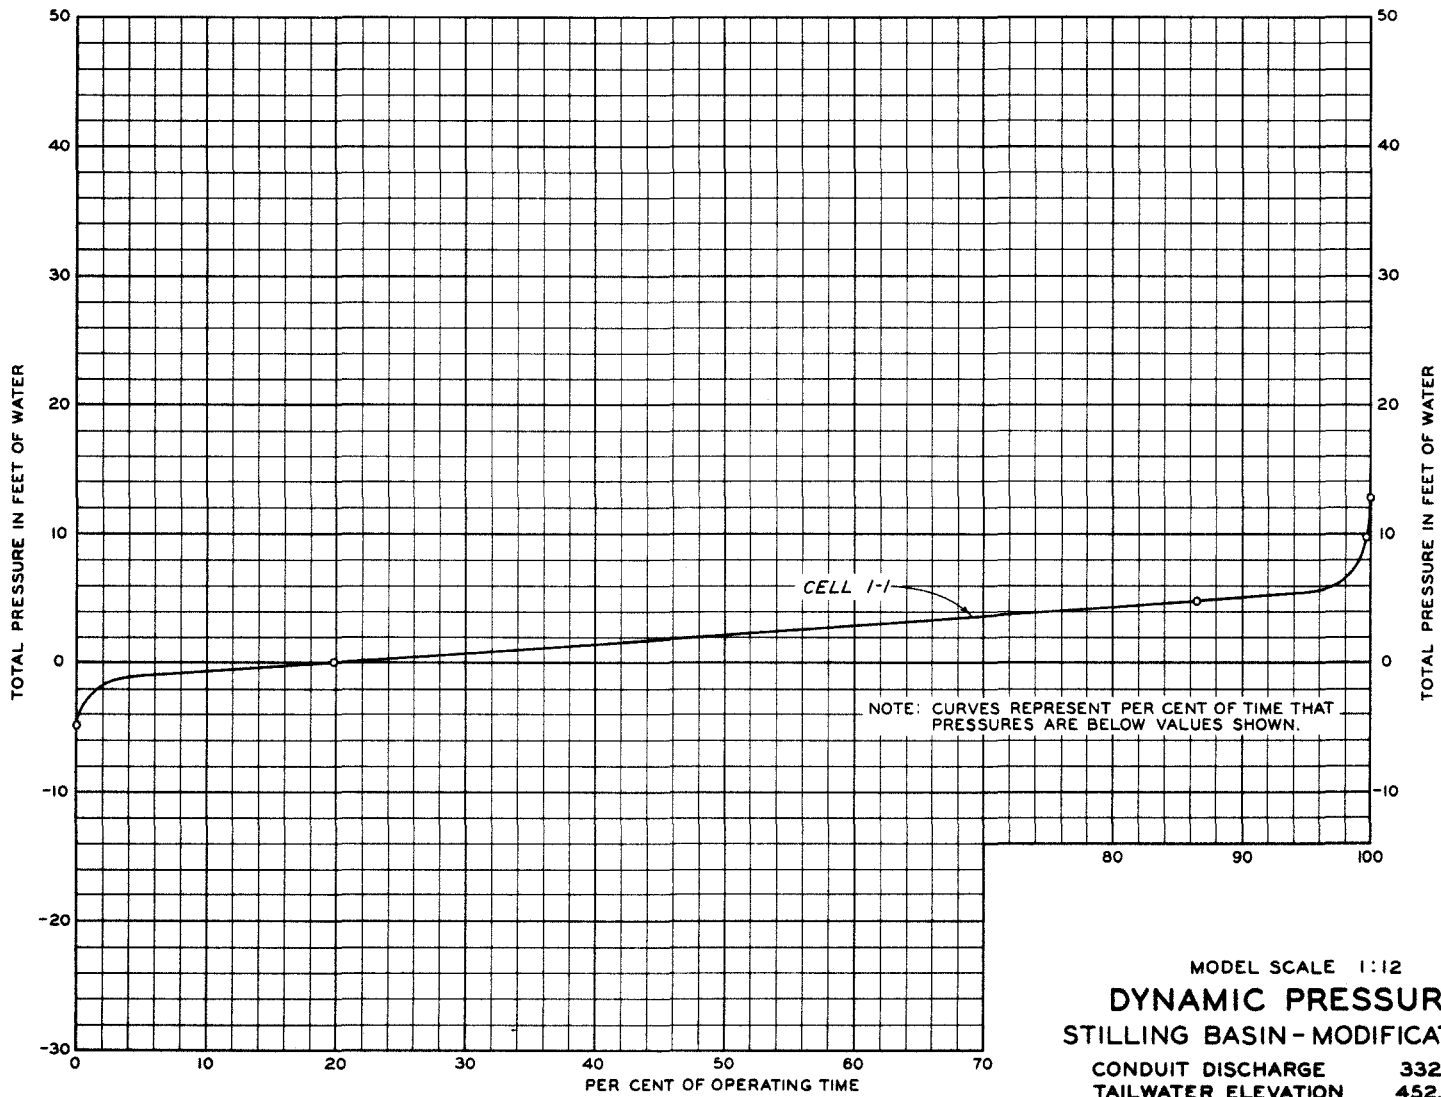
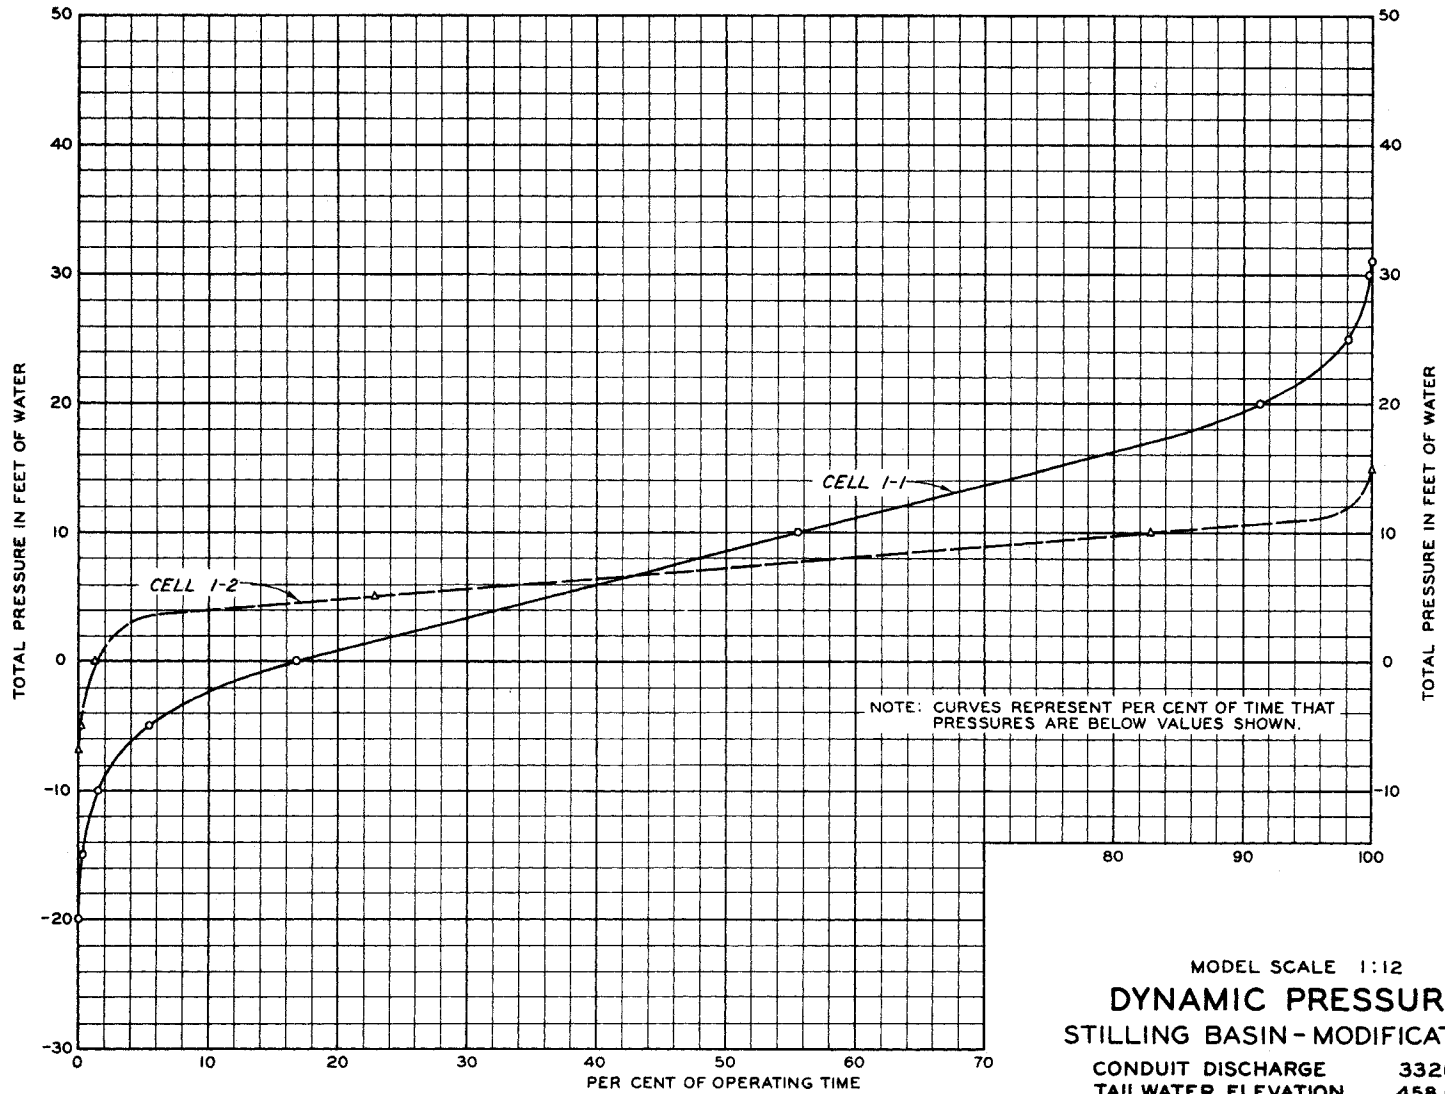
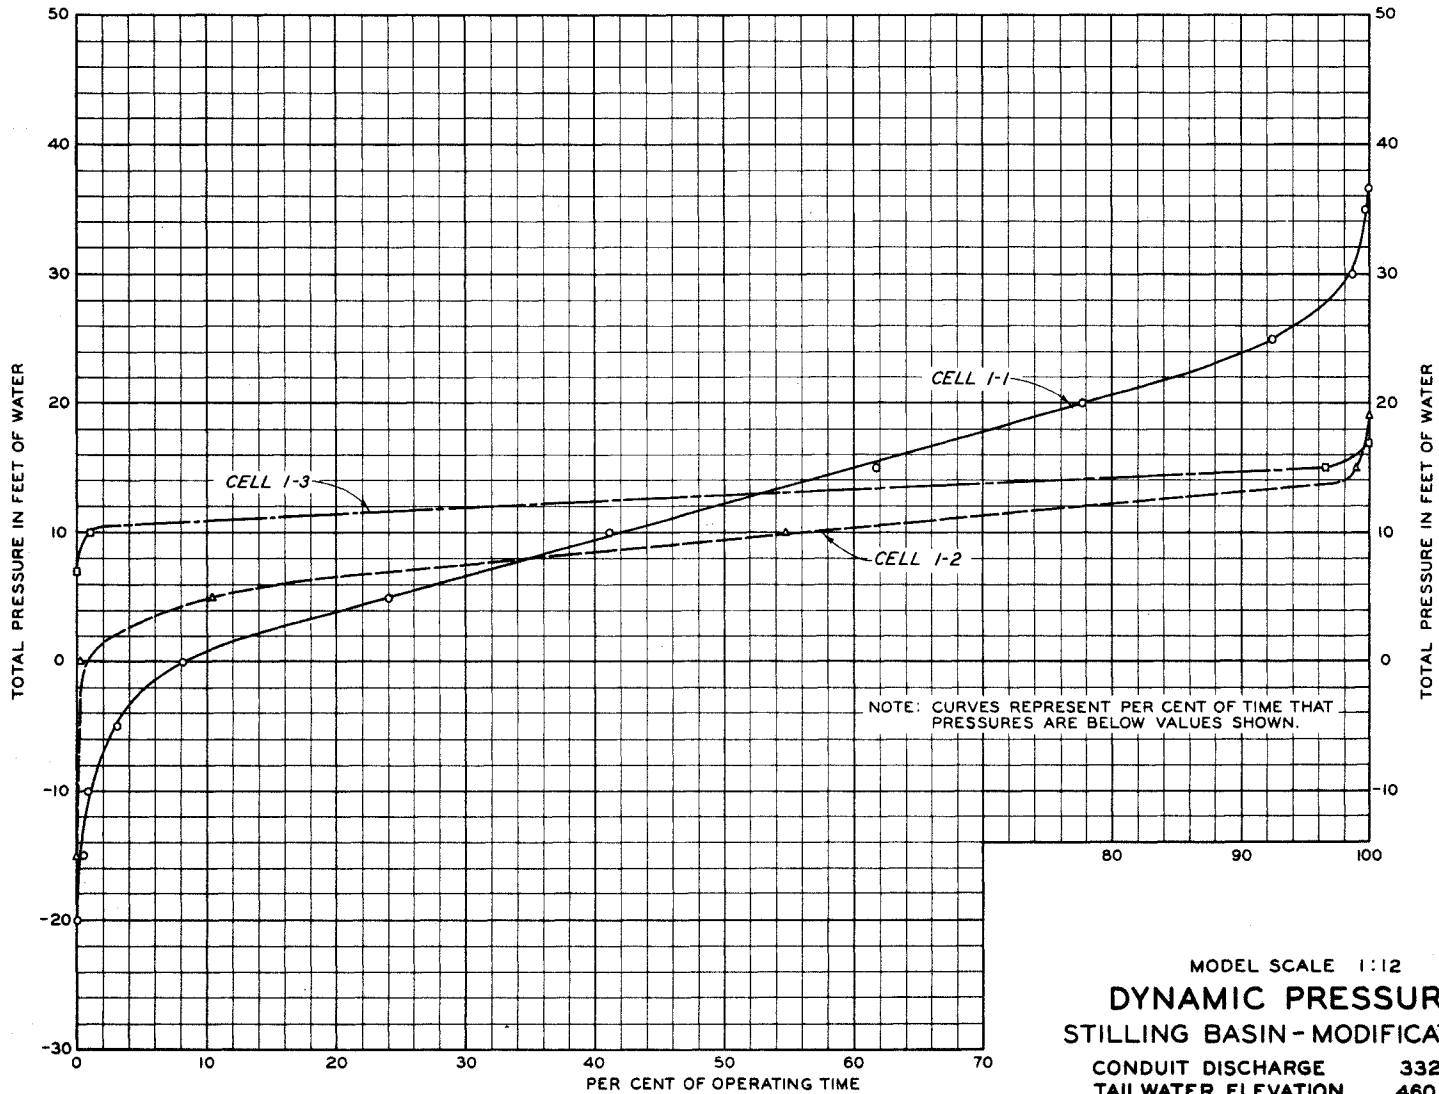
MODEL SCALE 1:12  
**DYNAMIC PRESSURES**  
STILLING BASIN - MODIFICATION B  
CONDUIT DISCHARGE 3320 CFS  
TAILWATER ELEVATION 452.8

MODEL SCALE 1:12  
**DYNAMIC PRESSURES**  
**STILLING BASIN - MODIFICATION B**  
 CONDUIT DISCHARGE 3320 CFS  
 TAILWATER ELEVATION 458.0

MODEL SCALE 1:12  
**DYNAMIC PRESSURES**  
 STILLING BASIN - MODIFICATION B  
 CONDUIT DISCHARGE 3320 CFS  
 TAILWATER ELEVATION 460.0

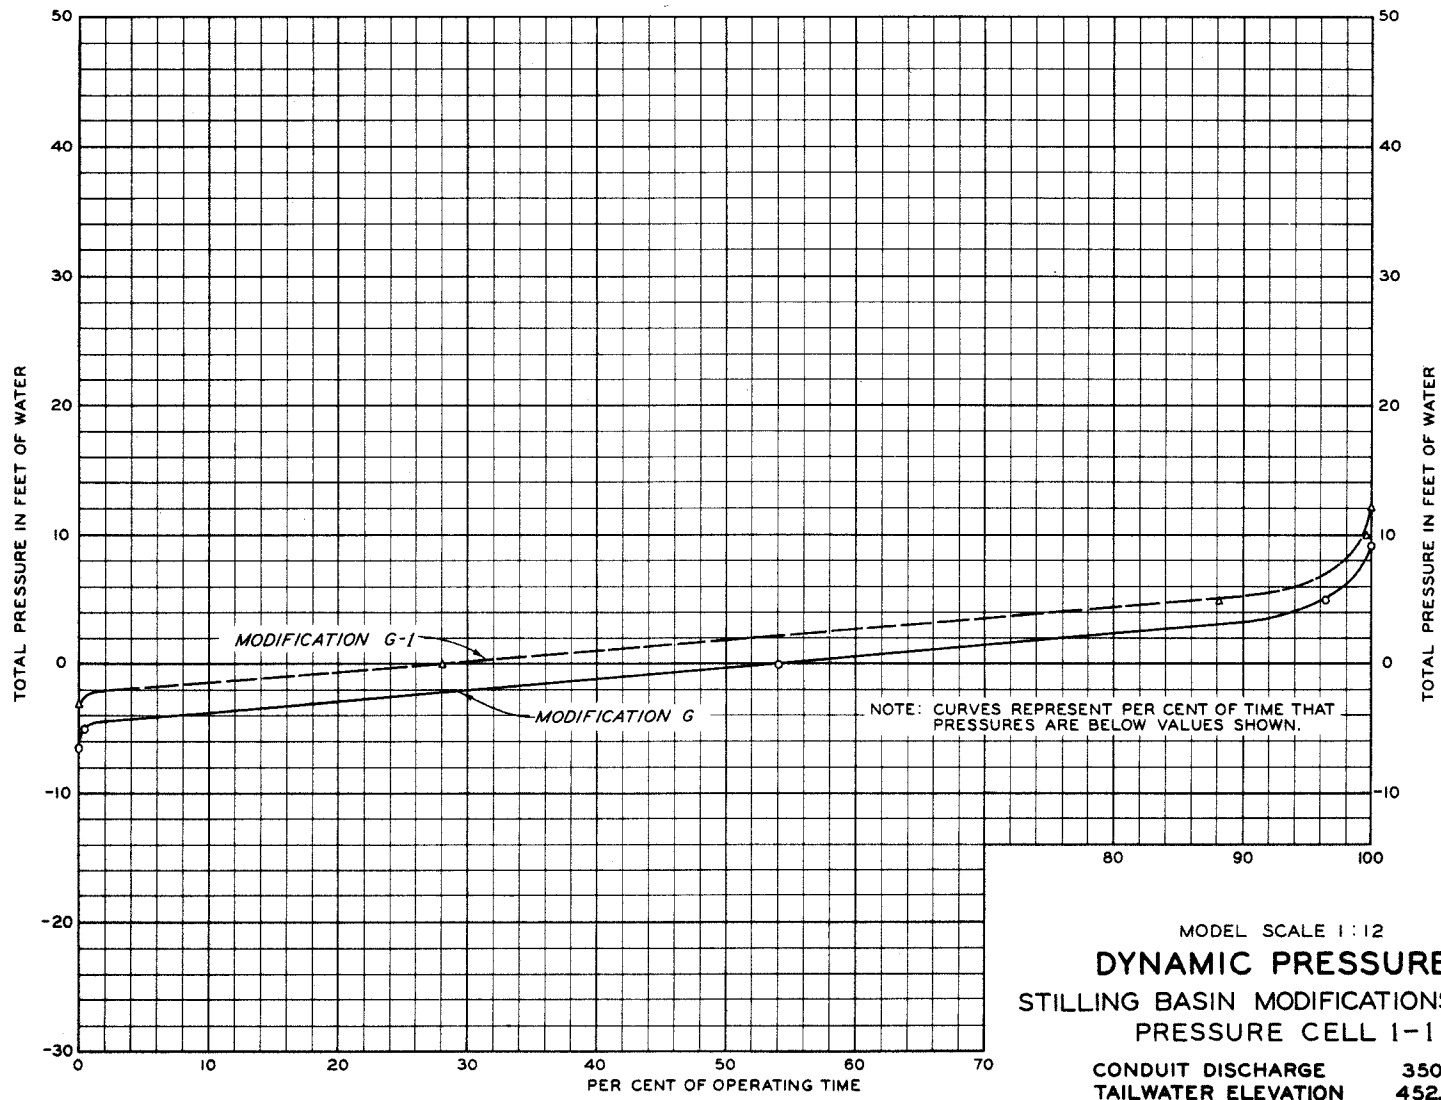
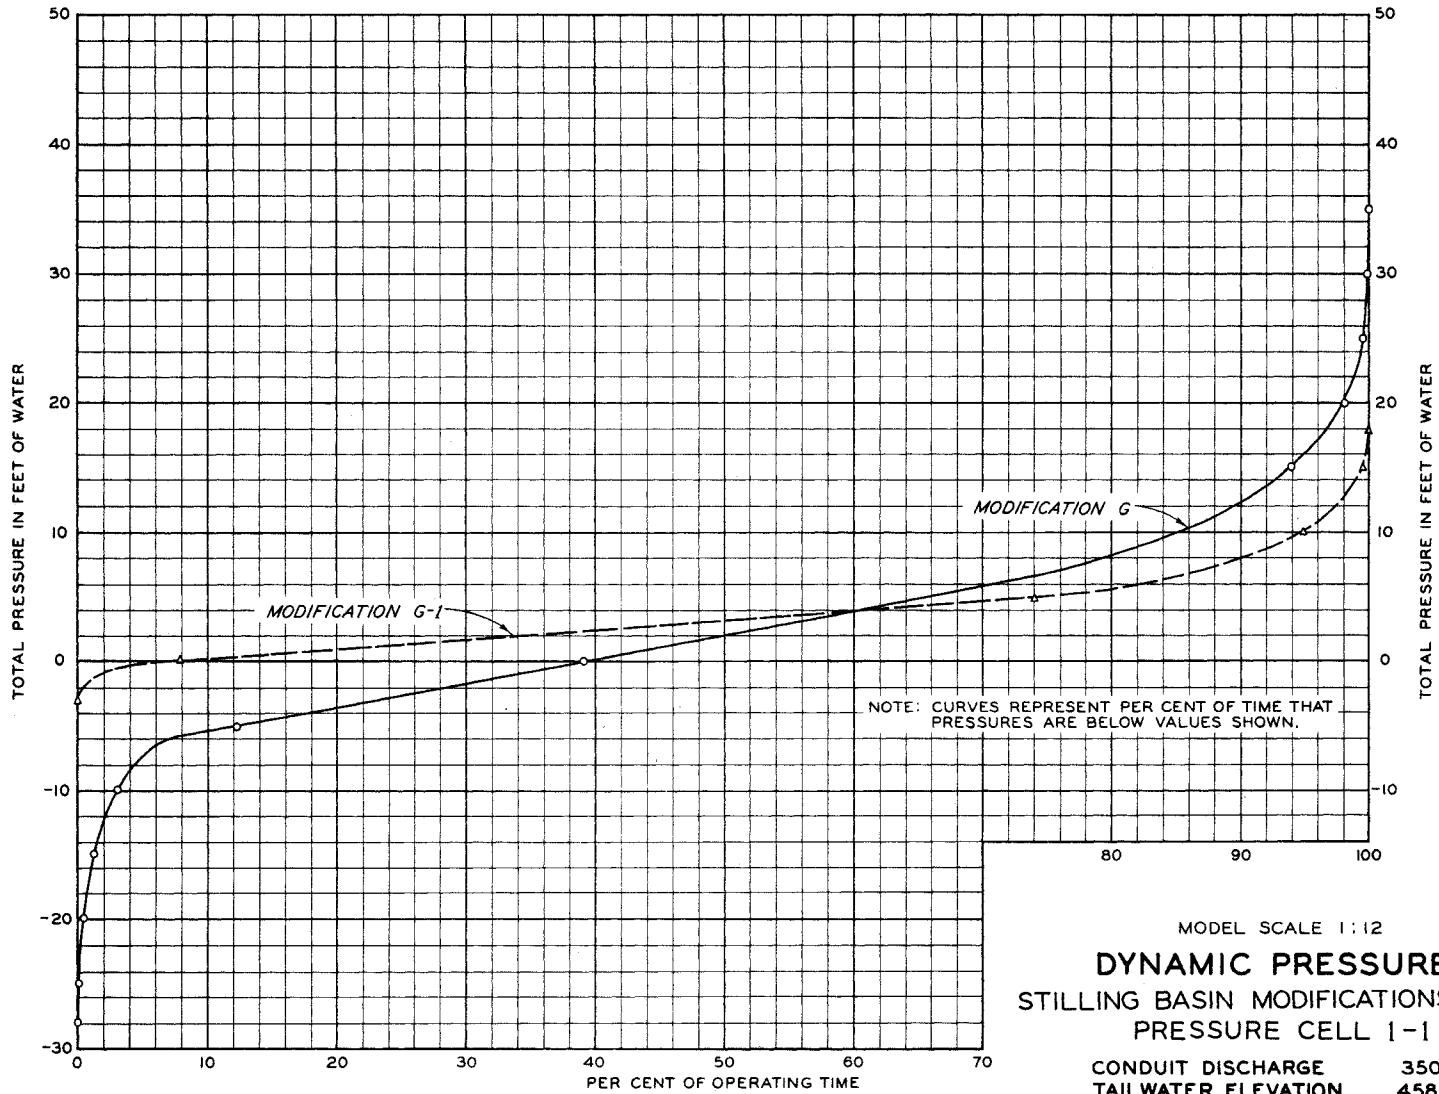
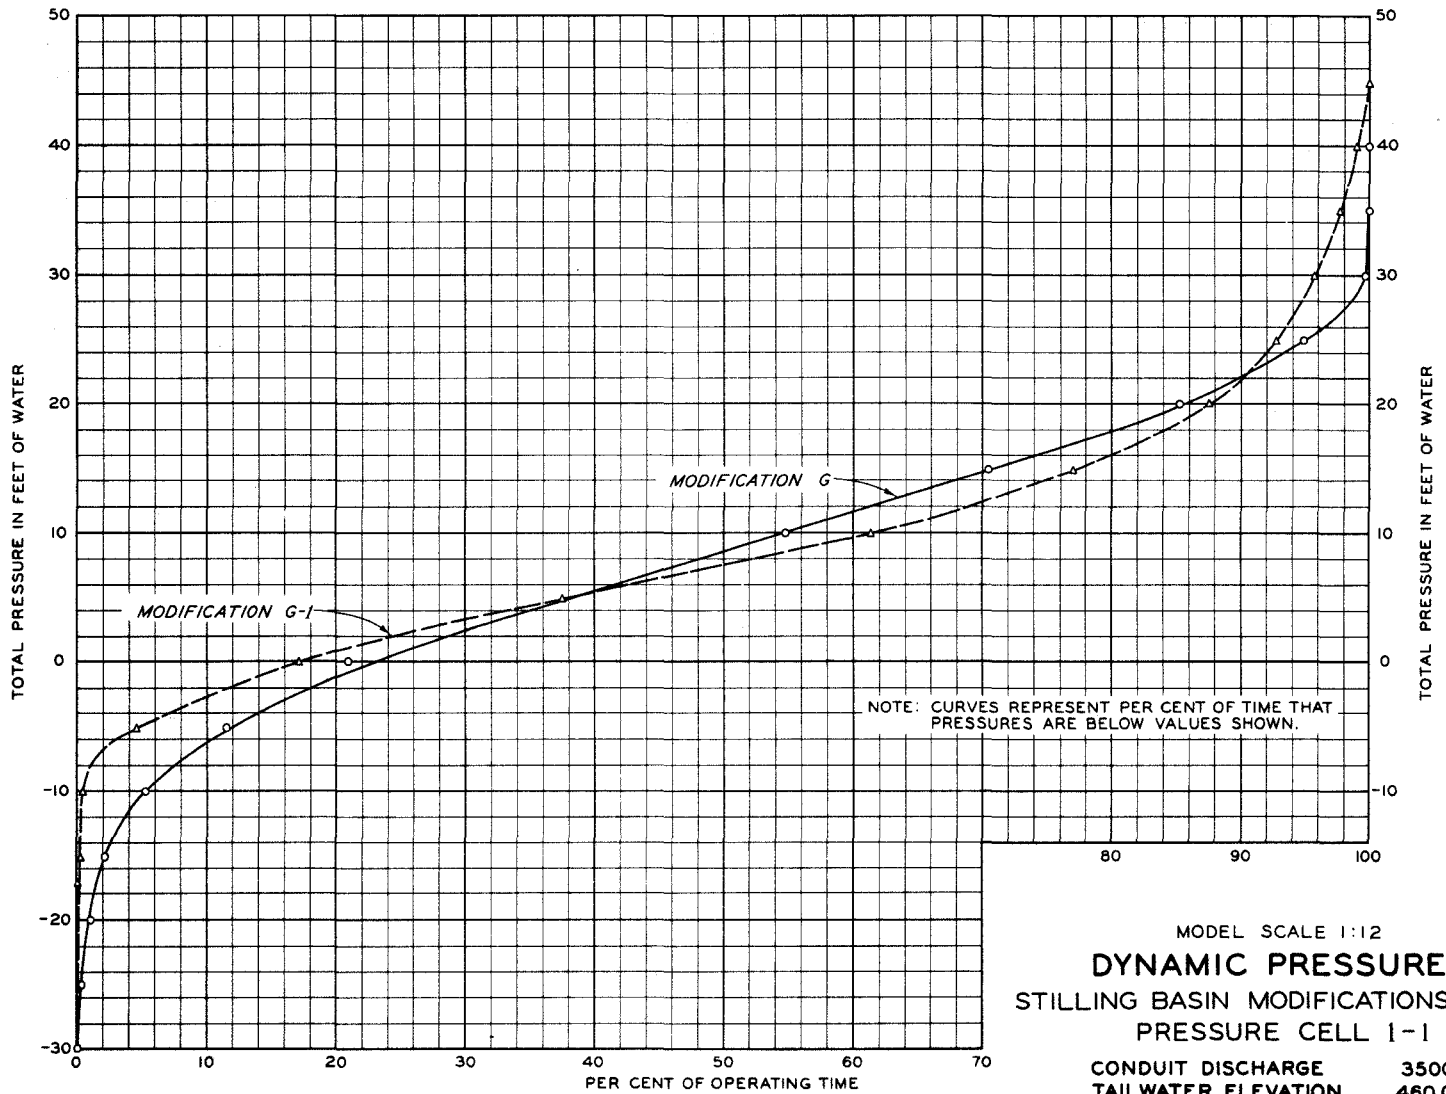
17. In an effort to improve conduit flow conditions and reduce impact upon the floor of the basin, an 80-ft-radius, vertical curve was inserted between the original floor and the upward-sloping ramp. This was designated modification G. This revision did not have the desired effect as pressure fluctuations were increased and the average pressures were decreased. Compare plates 15-17 and plates 19-21.

MODEL SCALE 1:12  
**DYNAMIC PRESSURES**  
 STILLING BASIN MODIFICATIONS G, G-1  
 PRESSURE CELL 1-1  
 CONDUIT DISCHARGE 3500 CFS  
 TAILWATER ELEVATION 452.8

MODEL SCALE 1:12  
**DYNAMIC PRESSURES**  
 STILLING BASIN MODIFICATIONS G, G-1  
 PRESSURE CELL 1-1  
 CONDUIT DISCHARGE 3500 CFS  
 TAILWATER ELEVATION 458.0

MODEL SCALE 1:12  
**DYNAMIC PRESSURES**  
 STILLING BASIN MODIFICATIONS G, G-1  
 PRESSURE CELL 1-1  
 CONDUIT DISCHARGE 3500 CFS  
 TAILWATER ELEVATION 460.0

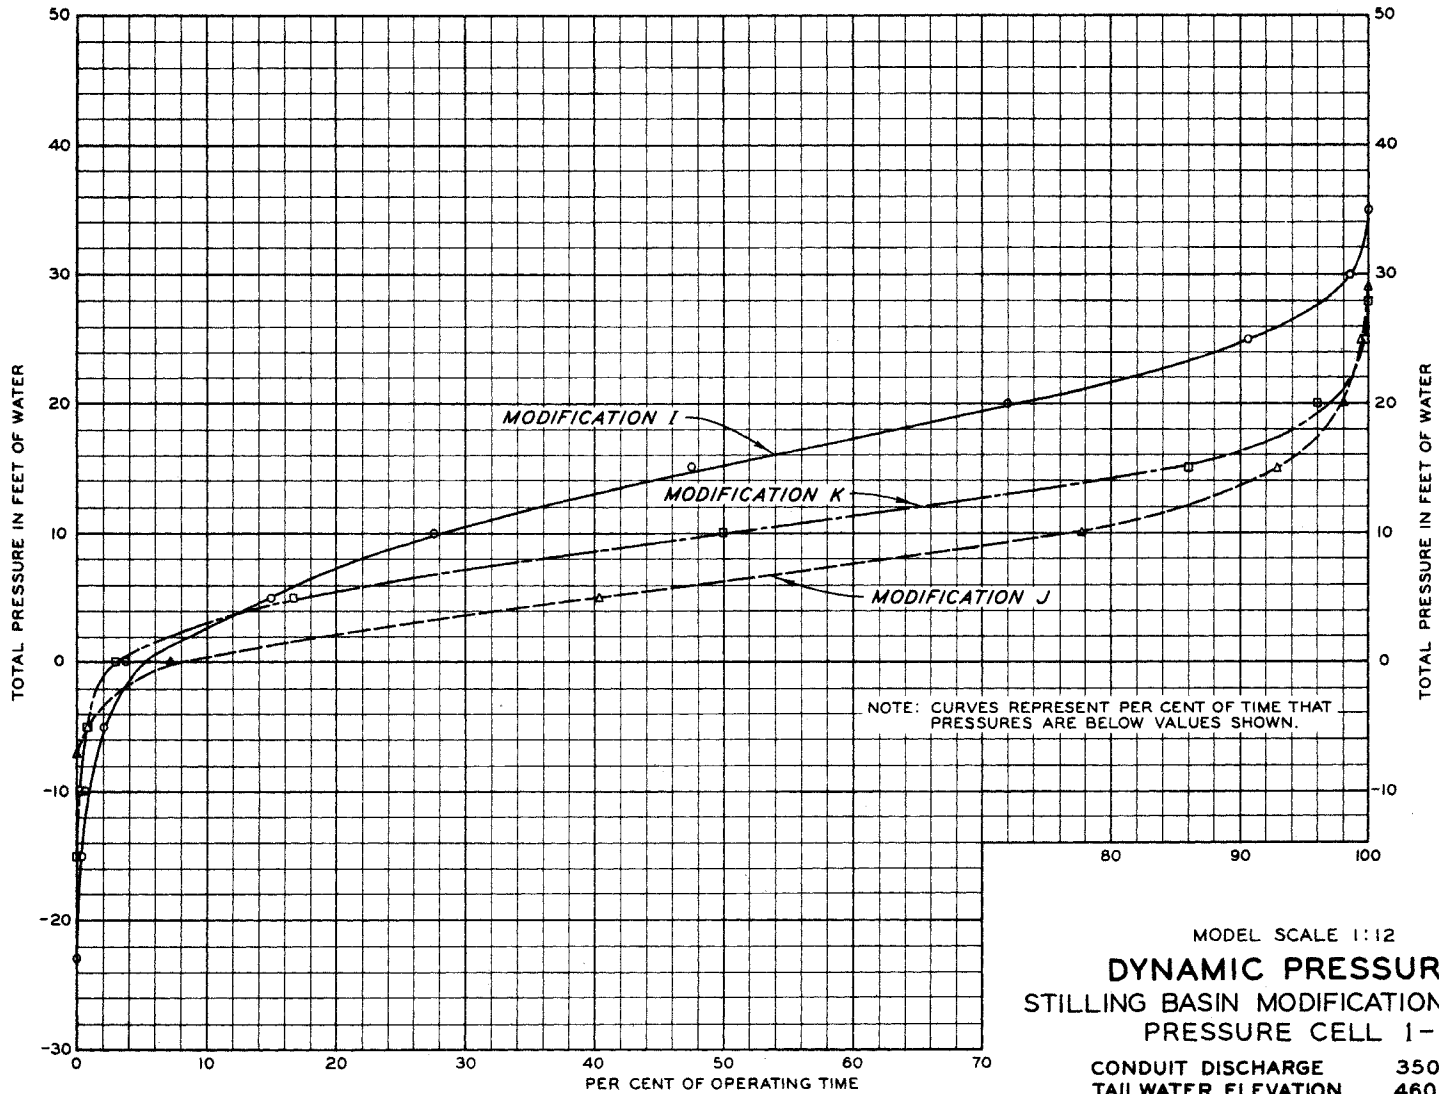
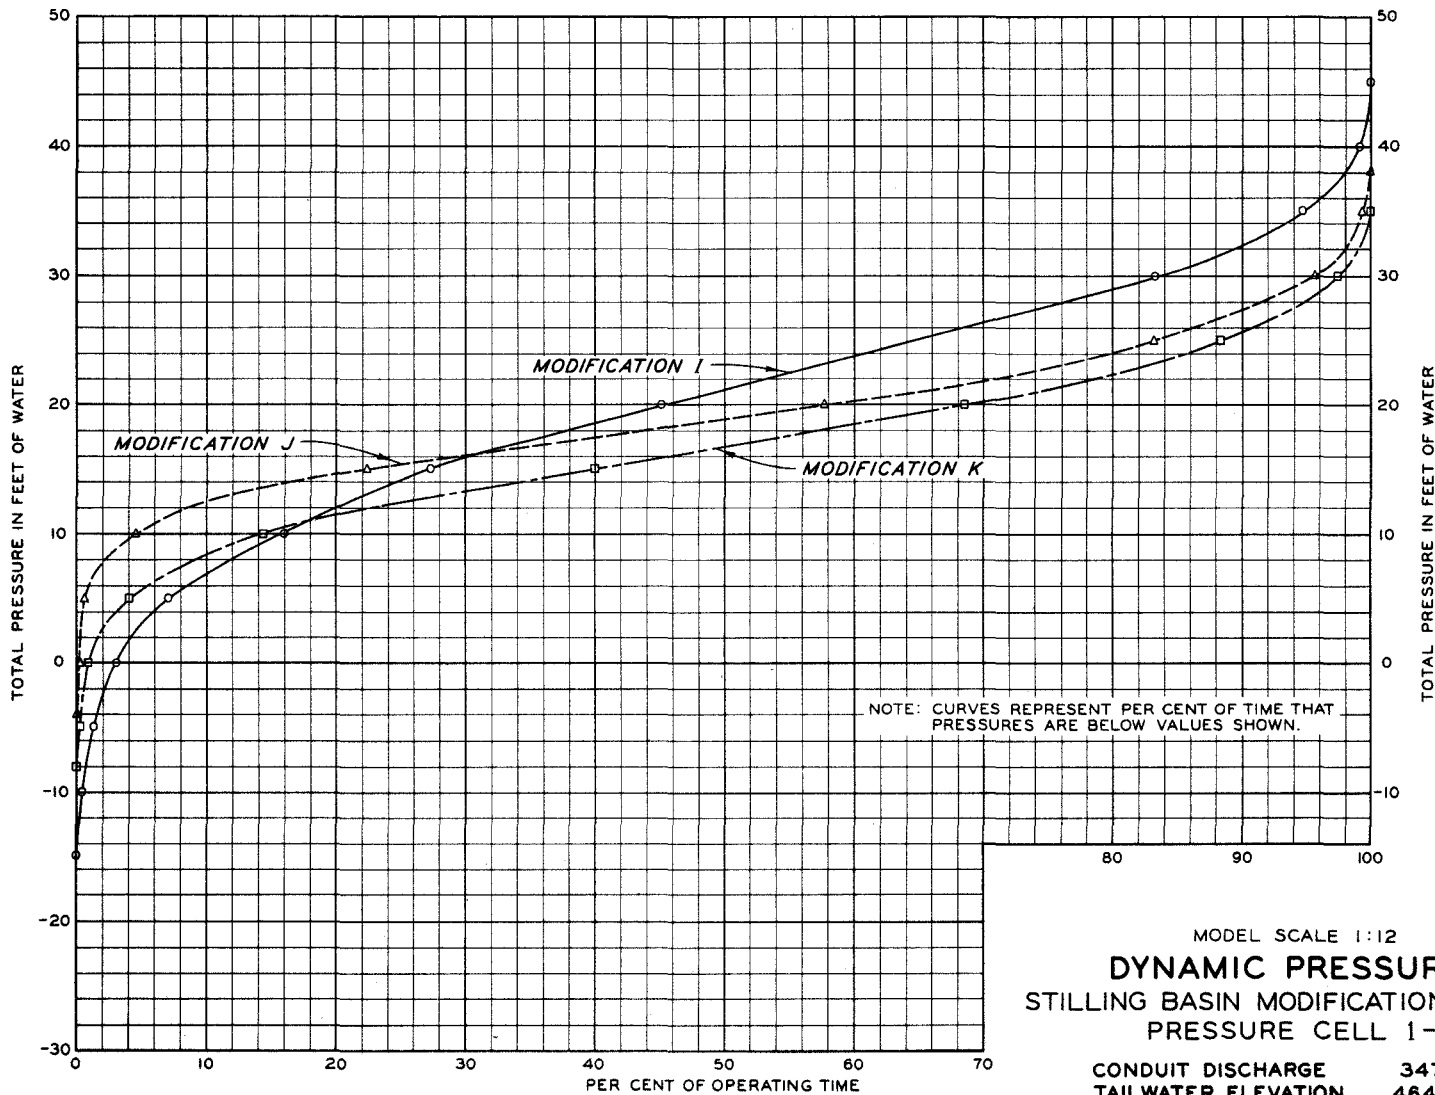
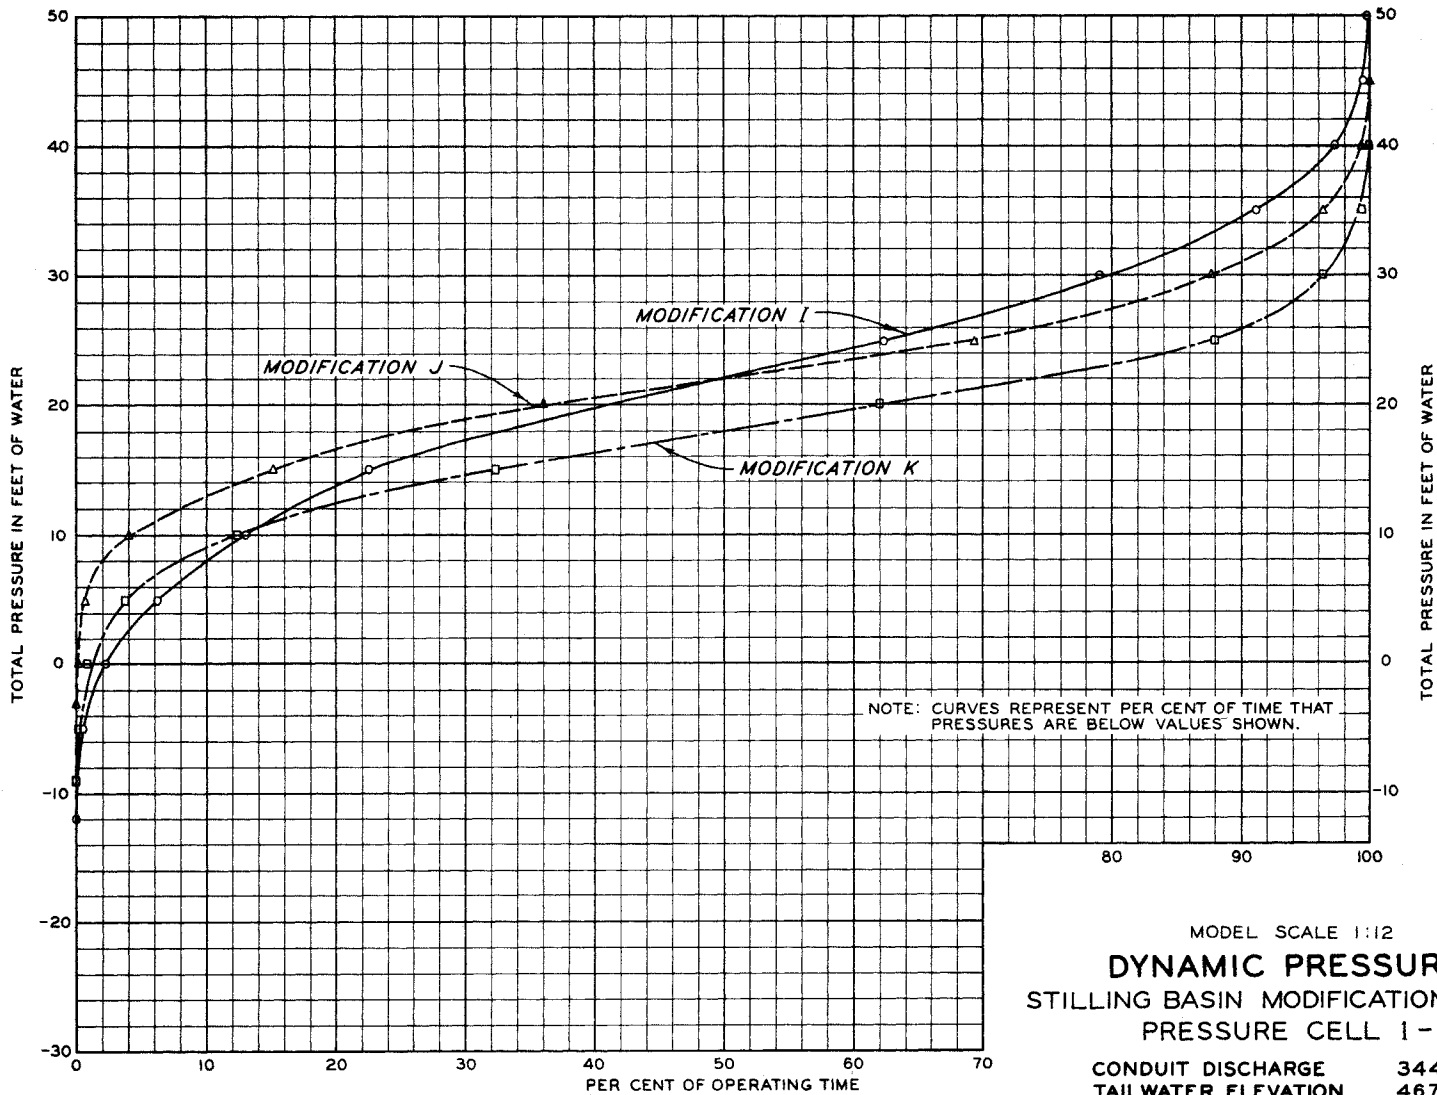
impractical for spillway flows, a long-radius, vertical curve was installed in the floor of the basin in place of the 80-ft-radius curve. It was thought that a long, gentle curve might improve flow conditions where the short, abrupt curve had failed. Accordingly, the dividing walls of modification G-1 and the floor ramp between the third and fourth steps were removed (modification I) and a 235-ft-radius transition curve was installed in the basin floor (modification J). The 235-ft-radius transition failed to decrease pressure fluctuations at cell 1-1 to any great extent as can be seen in plates 22-24.

20. In a final effort to improve pressure conditions on the basin floor, the roof of the conduit outlet was extended, parallel to the floor, about 18 ft downstream (modification K). It was thought that this might protect the conduit jet from interference by the inflowing back eddies, especially at high tailwater elevations. Again, the revision failed to accomplish any important improvement as shown by the curves in plates 22-24.

MODEL SCALE 1:12  
**DYNAMIC PRESSURES**  
 STILLING BASIN MODIFICATIONS I, J, K  
 PRESSURE CELL 1-1  
 CONDUIT DISCHARGE 3500 CFS  
 TAILWATER ELEVATION 460.0

MODEL SCALE 1:12  
**DYNAMIC PRESSURES**  
 STILLING BASIN MODIFICATIONS I, J, K  
 PRESSURE CELL 1-1  
 CONDUIT DISCHARGE 3470 CFS  
 TAILWATER ELEVATION 464.3

MODEL SCALE 1:12  
**DYNAMIC PRESSURES**  
 STILLING BASIN MODIFICATIONS I, J, K  
 PRESSURE CELL 1-1  
 CONDUIT DISCHARGE 3440 CFS  
 TAILWATER ELEVATION 467.3
