MADISON RIVER, MONTANA
REPORT ON
*FLOOD EMERGENCY
MADISON RIVER SLIDE*

*VOLUME I
MAIN REPORT*

U. S. ARMY ENGINEER DISTRICT, OMAHA
CORPS OF ENGINEERS
OMAHA, NEBRASKA
SEPTEMBER 1960

U. S. ARMY ENGINEER DISTRICT, GARRISON
CORPS OF ENGINEERS
RIVERDALE, NORTH DAKOTA

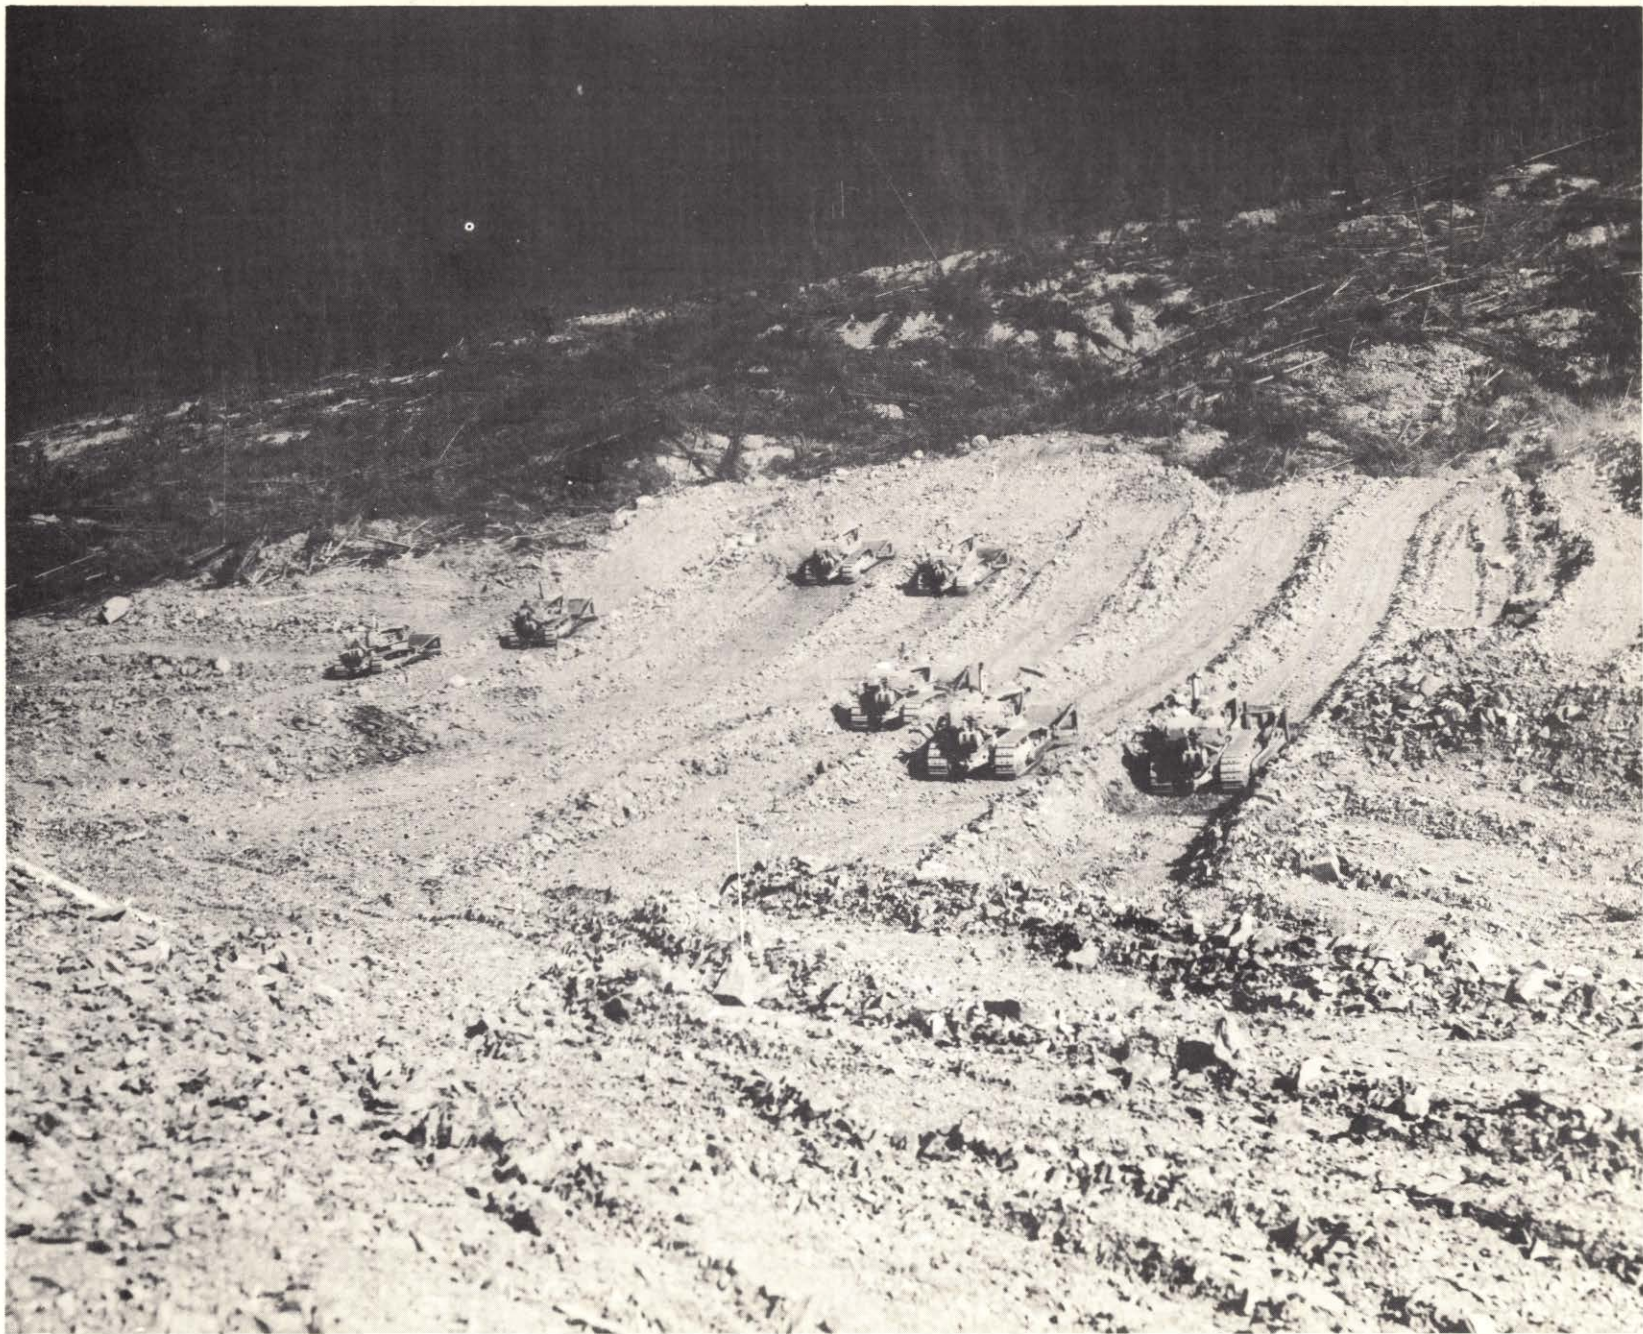
Photo 3. 27 August 1959. Bulldozers grading slide crest.

42. By the end of August, the level crest of the spillway was essentially completed to finish grade and most of the dozers were working on the downstream slope. Shovels and trucks were used to move some of the material, particularly along the right side of the channel at the crest. Typical views of these operations are shown in Photographs 3 and 4.

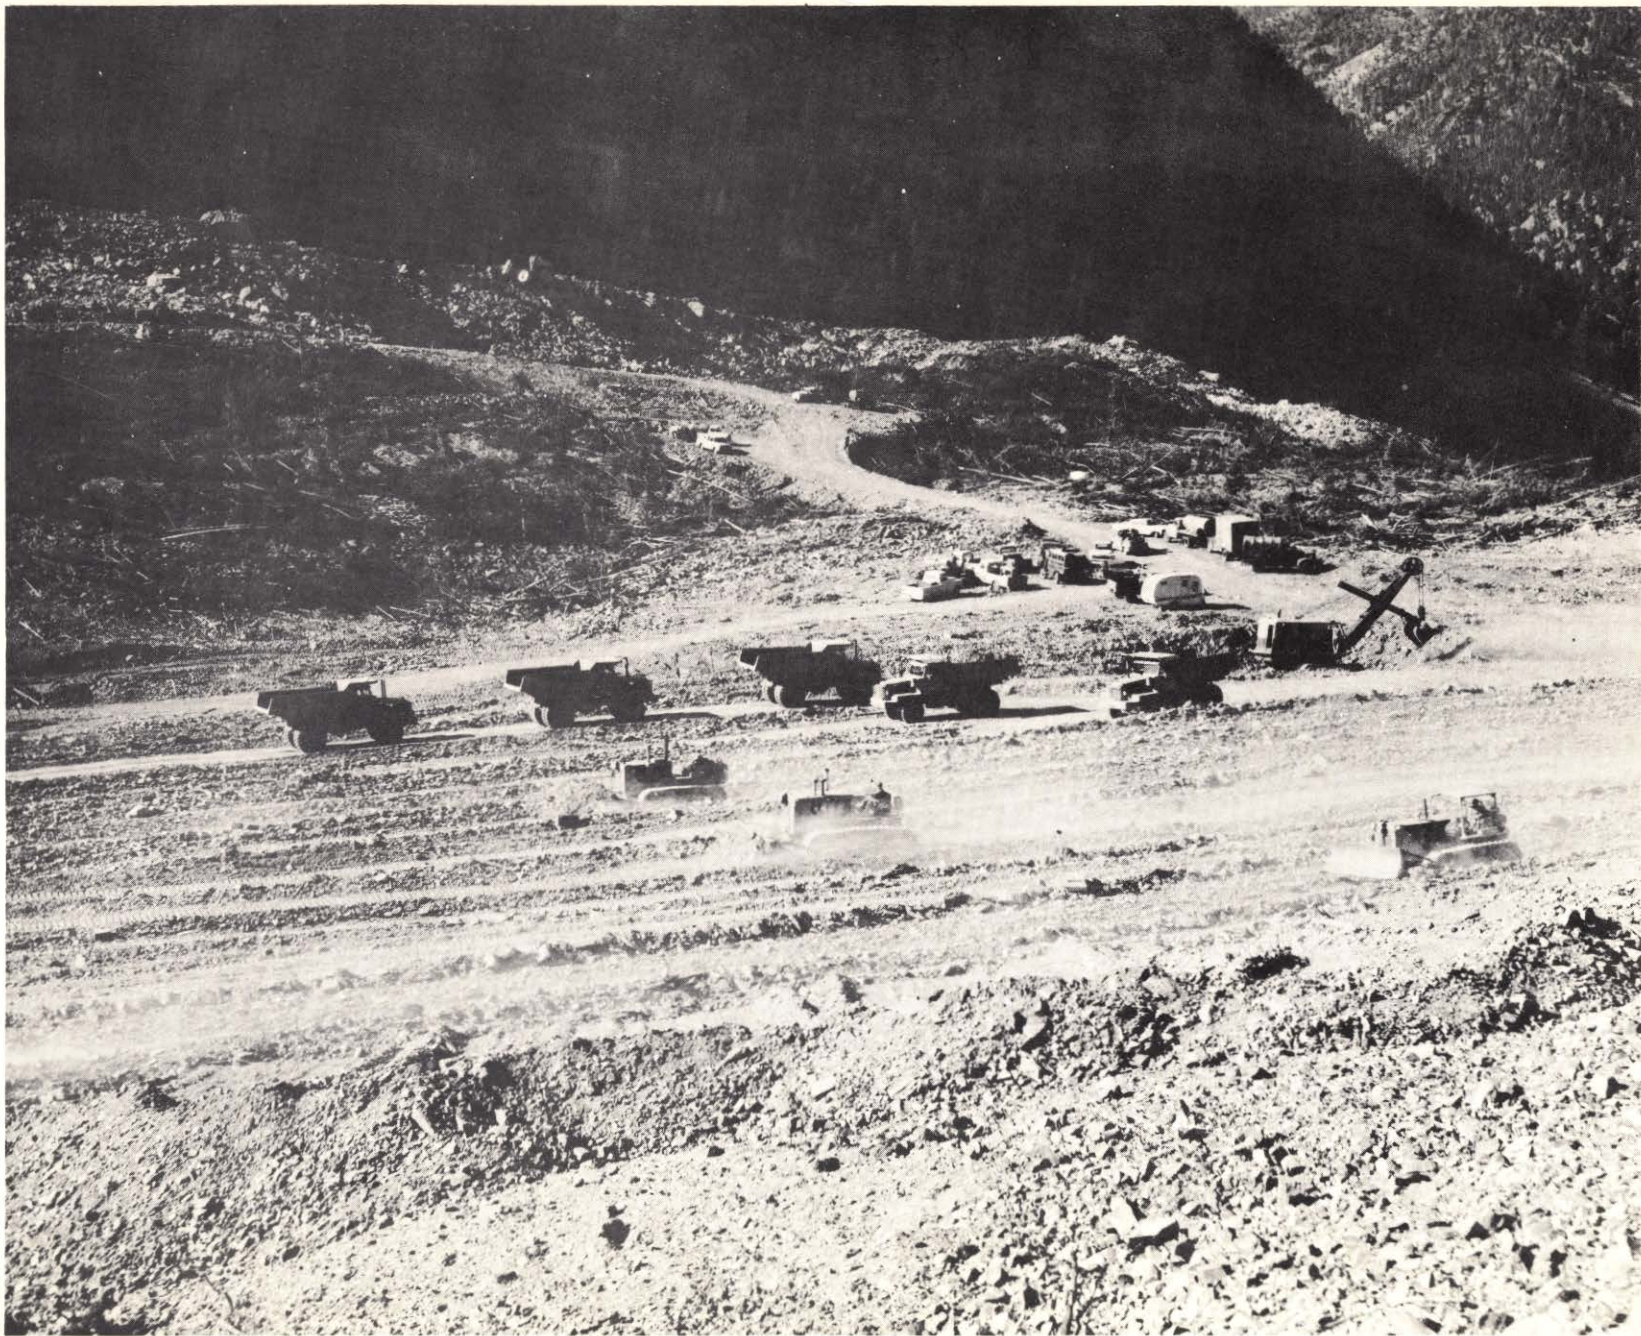
Photo 4. 28 August 1959. Equipment constructing initial spillway.

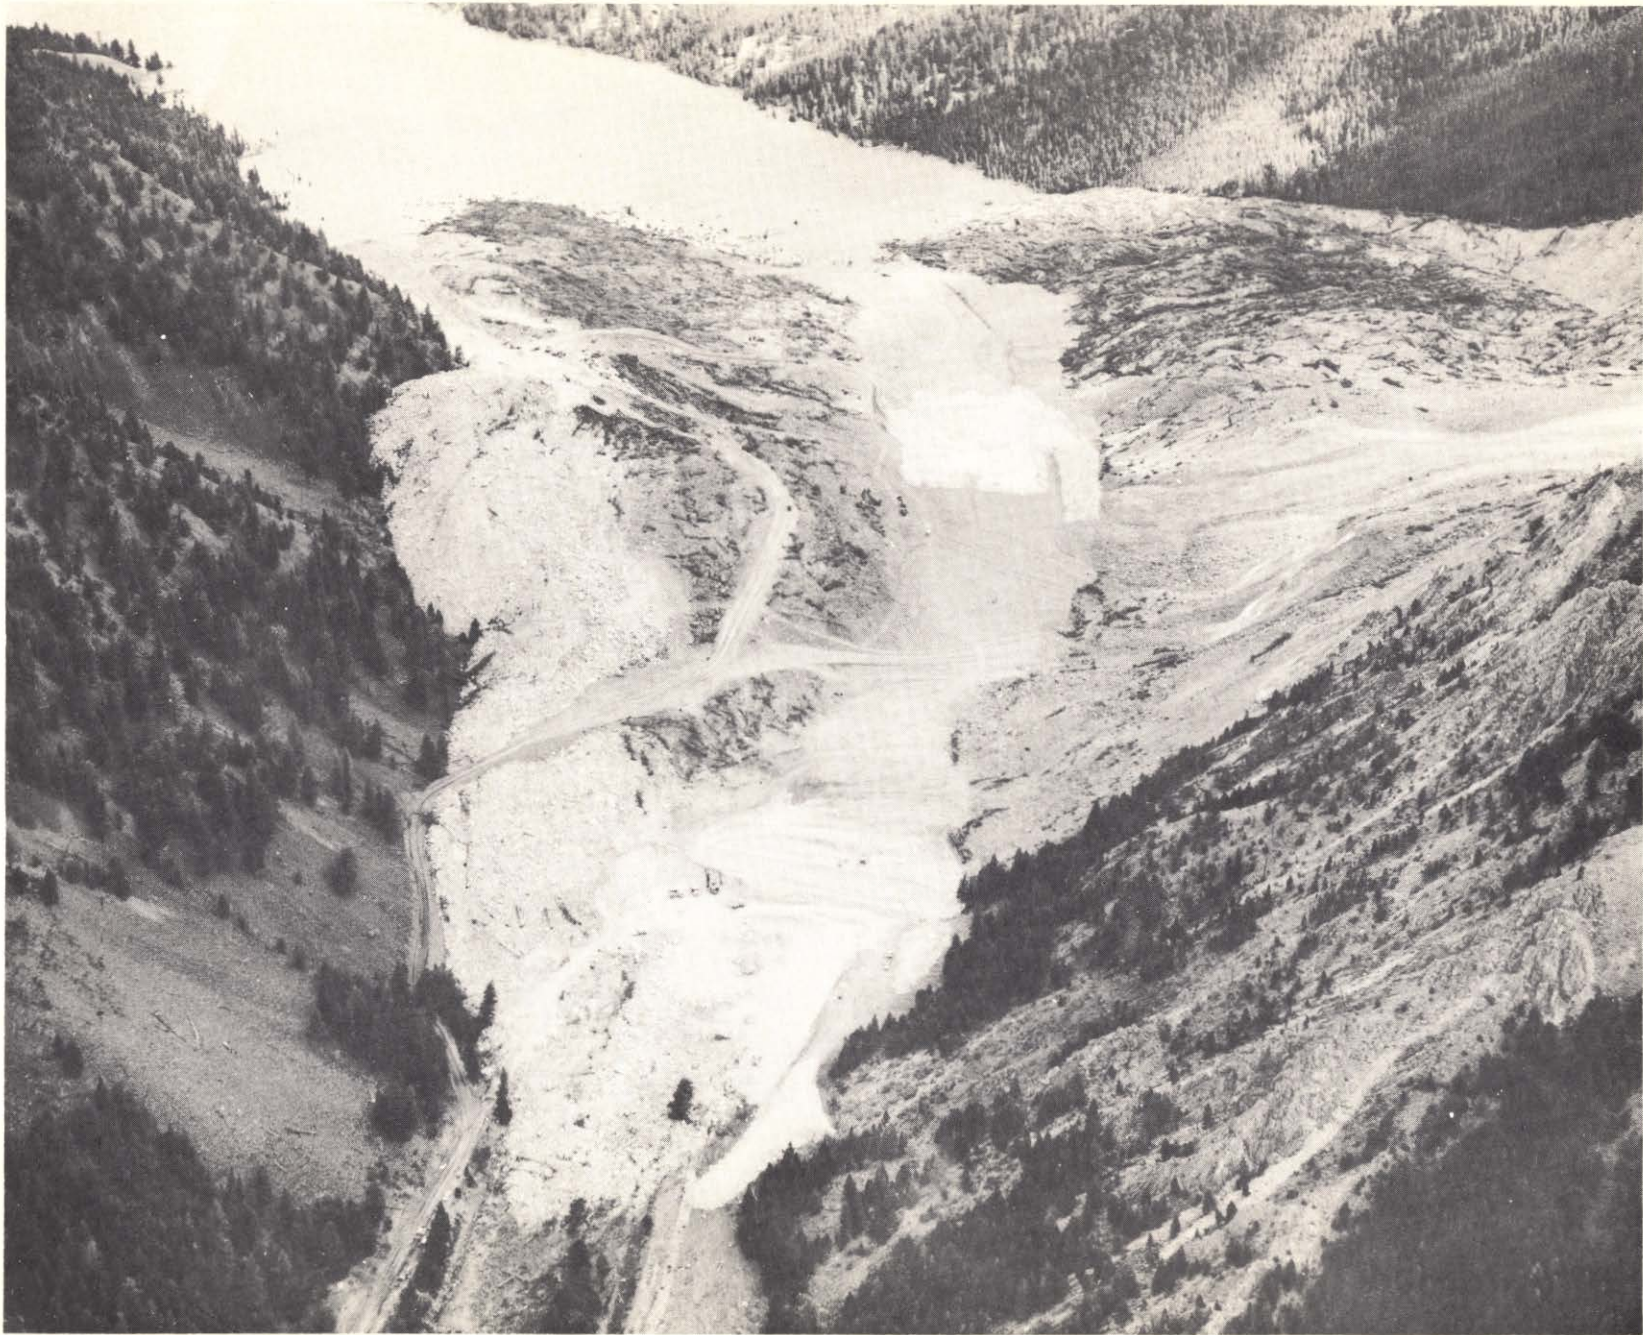
Photo 5. 3 September 1959. Aerial view of initial spillway construction.

40. Initial Spillway. In the first phase of spillway construction, the channel was excavated to a crest elevation of 6450, with a bottom width of 250 feet, and the left side and part of the downstream slope was lined with the best material that would be found in the slide. The white rock showing in Photos 5, 6 and 7 is the more competent Dolomite rock placed as channel lining. The excavation in the crest area was almost entirely a bulldozer operation. The upstream ridge, which was the highest of a series of ridges across the saddle, was cut off and the material pushed to the upstream slope. To minimize the possibility of losing control of the crest by an upstream slide, a large pocket just downstream from this ridge and about 50 feet lower in elevation was filled to an elevation about 20 feet below design crest elevation with the relatively fine material dozed from the ridges. The top 20 feet was filled with heavy quartzite borrowed from the layer on the right canyon wall.

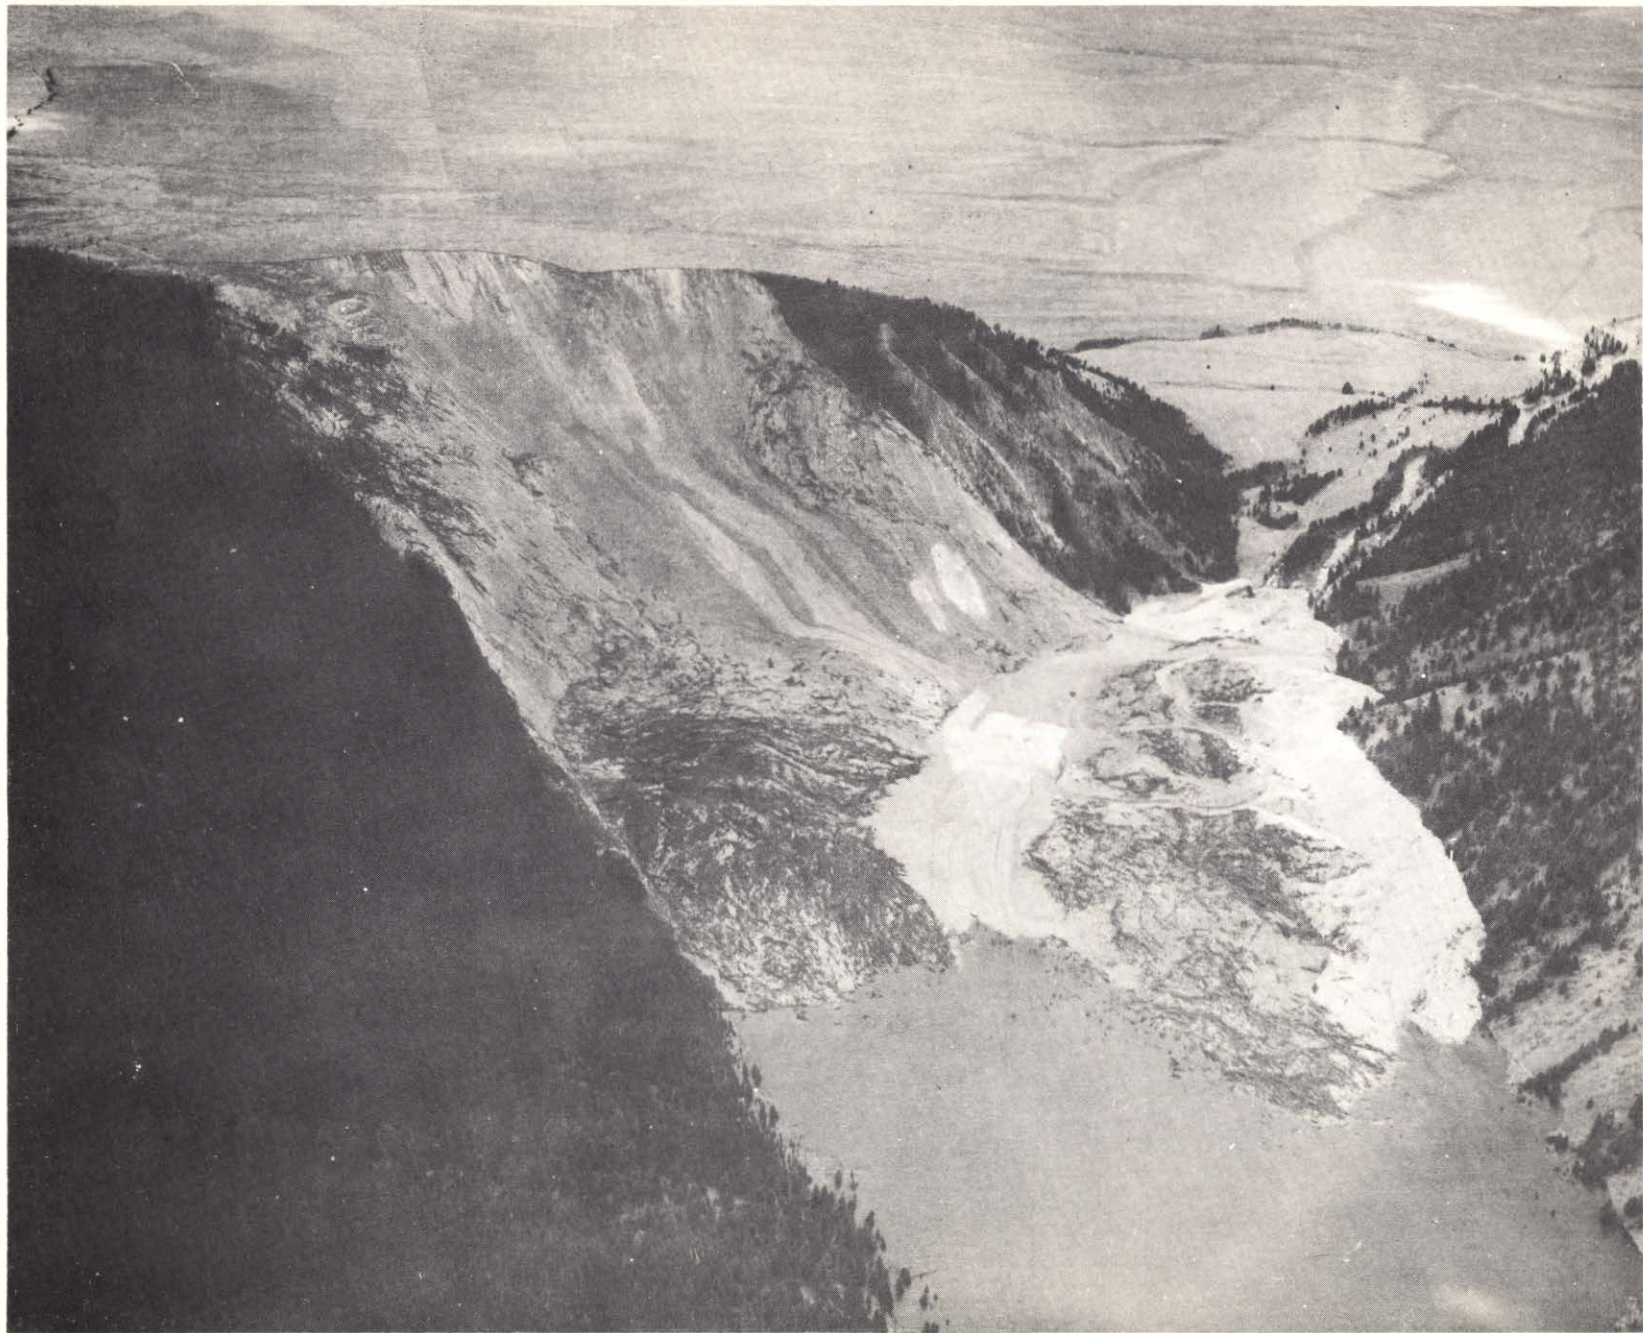
Photo 6. 3 September 1959. Over-all aerial view looking downstream showing initial spillway construction and a view of the slide scar.

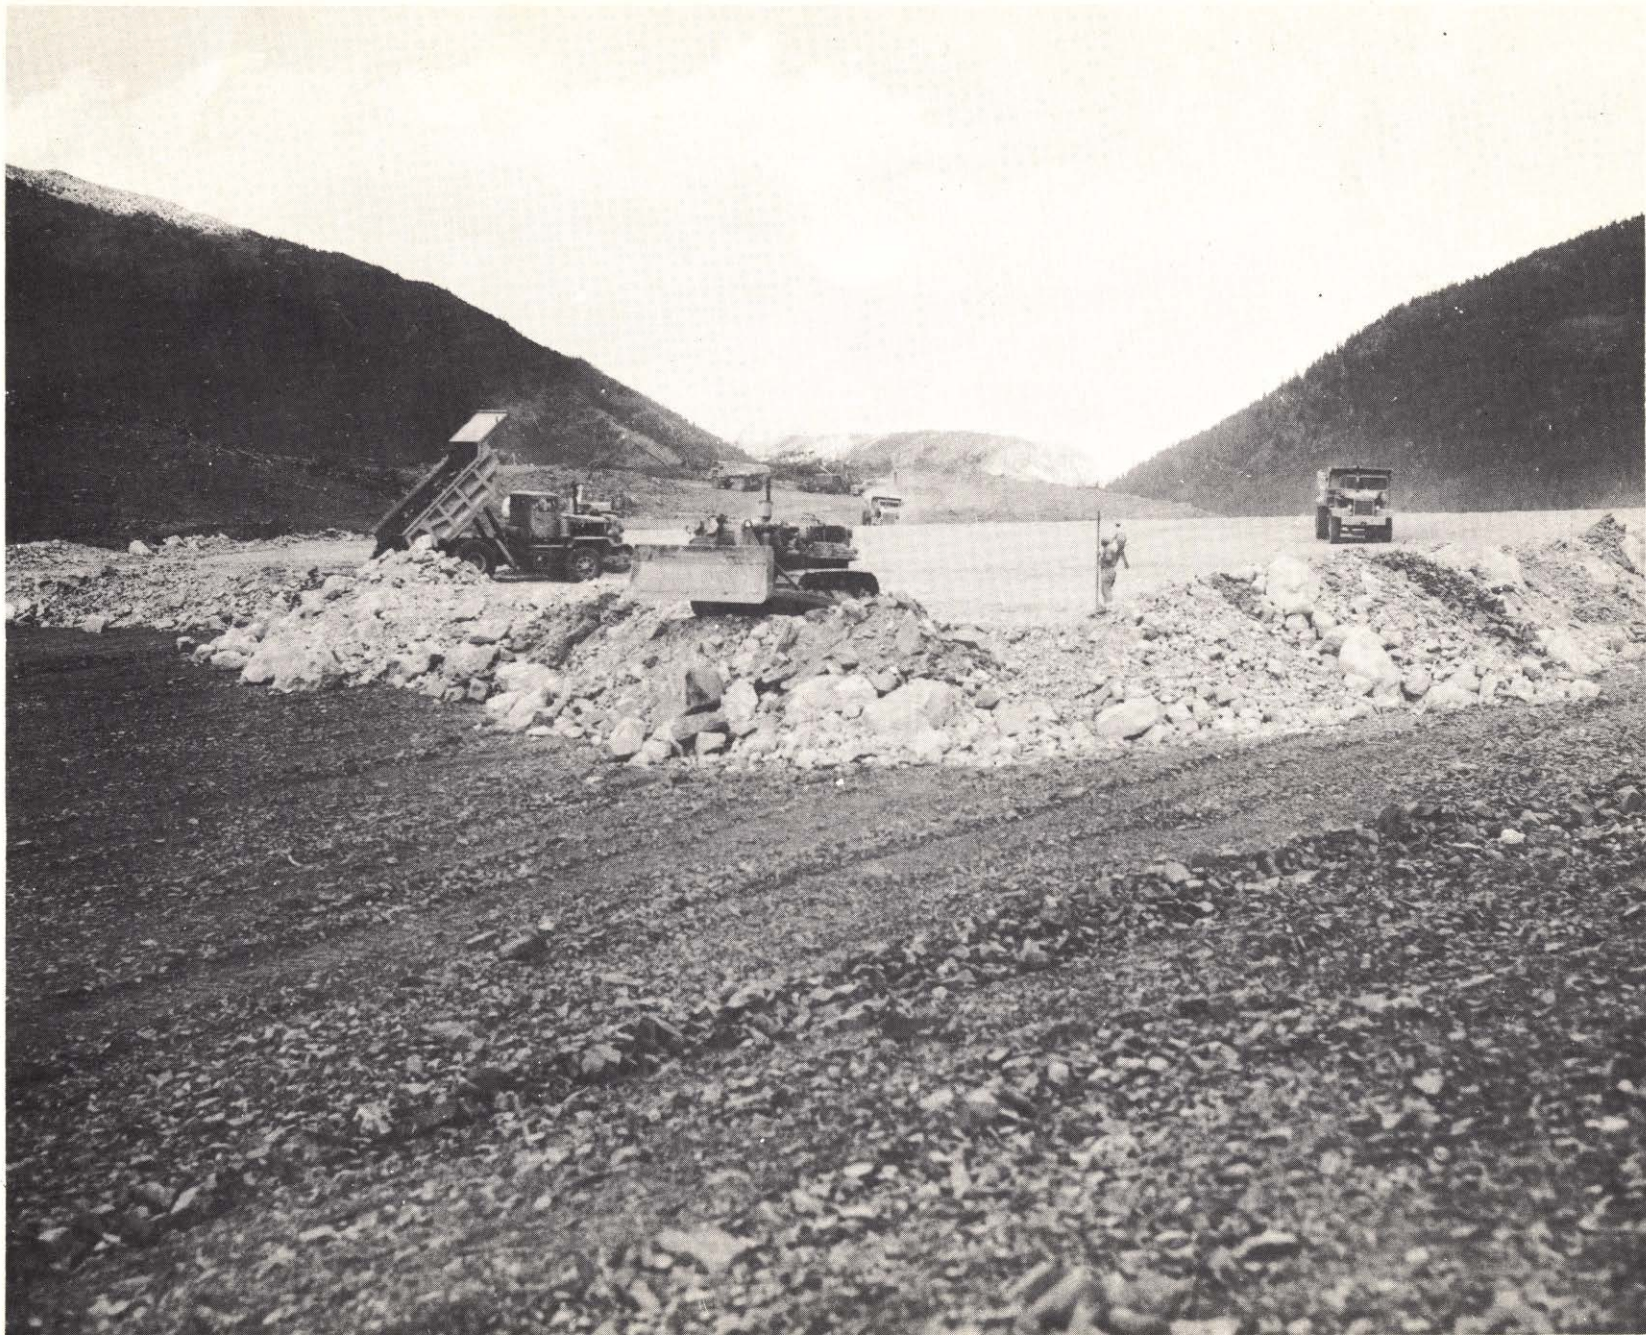
Photo 7. 4 September 1959. Placing spillway armor material in channel.

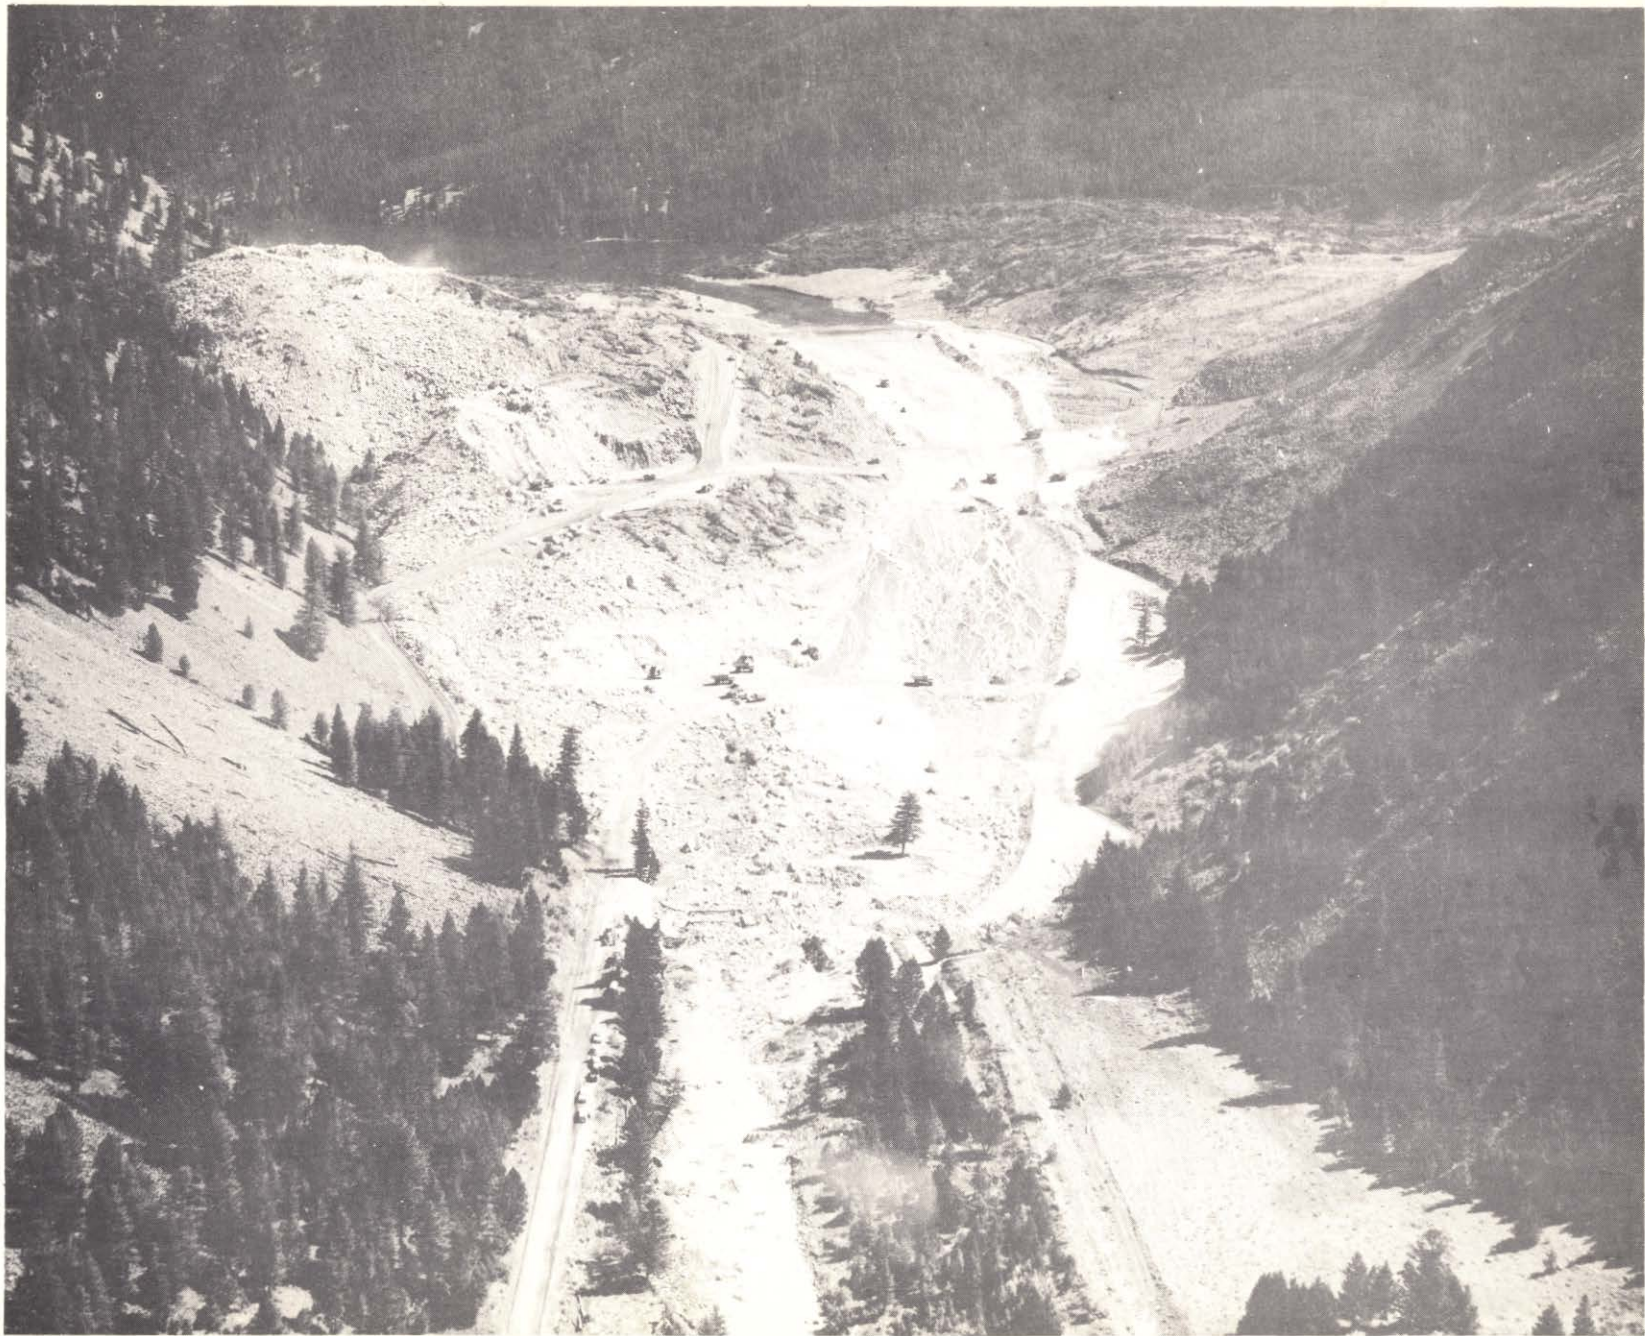
Photo 8. 10 September 1959. Upstream aerial view of spillway channel on first day water passed over slide.

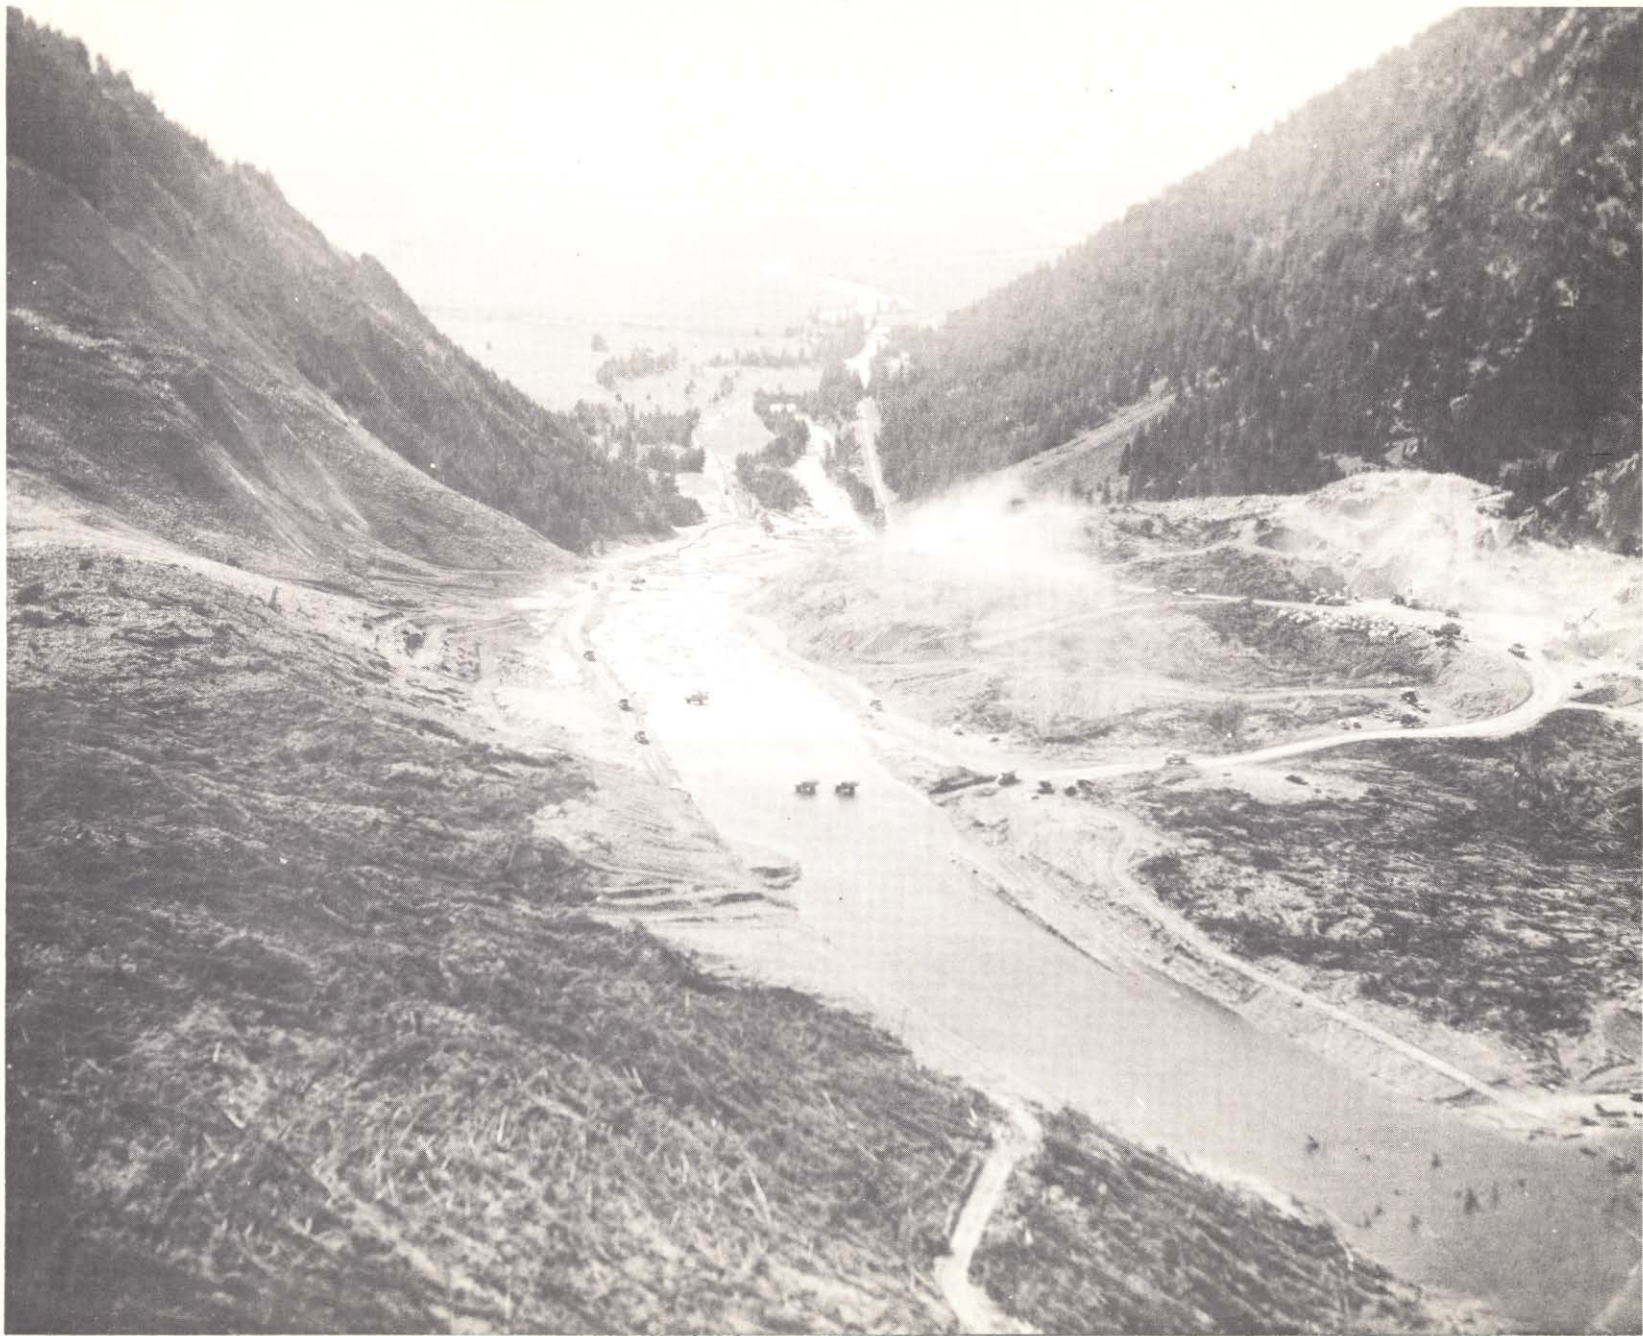
Photo 9. 11 September 1959. Downstream aerial view of water passing over slide in spillway channel.

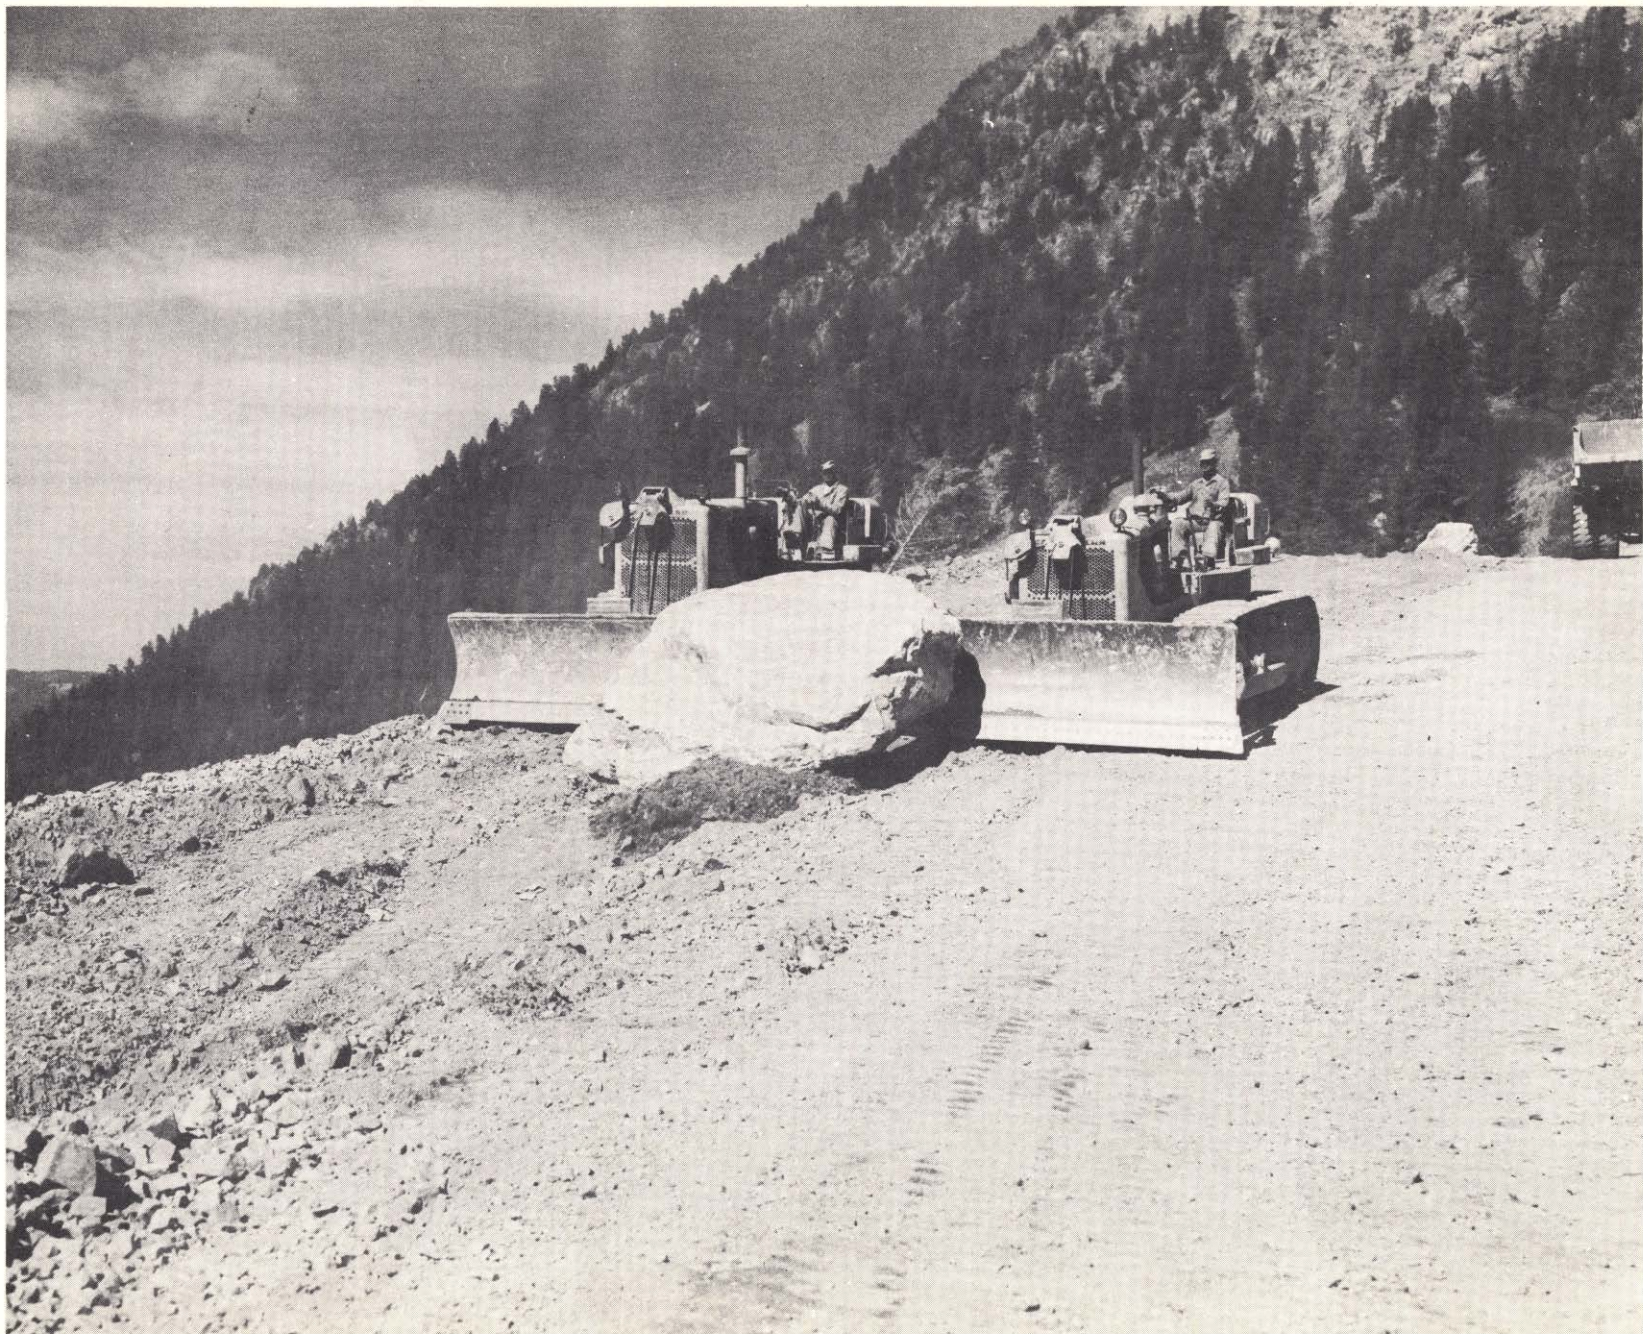
Photo 10. 11 September 1959. Two bulldozers pushing large rock.

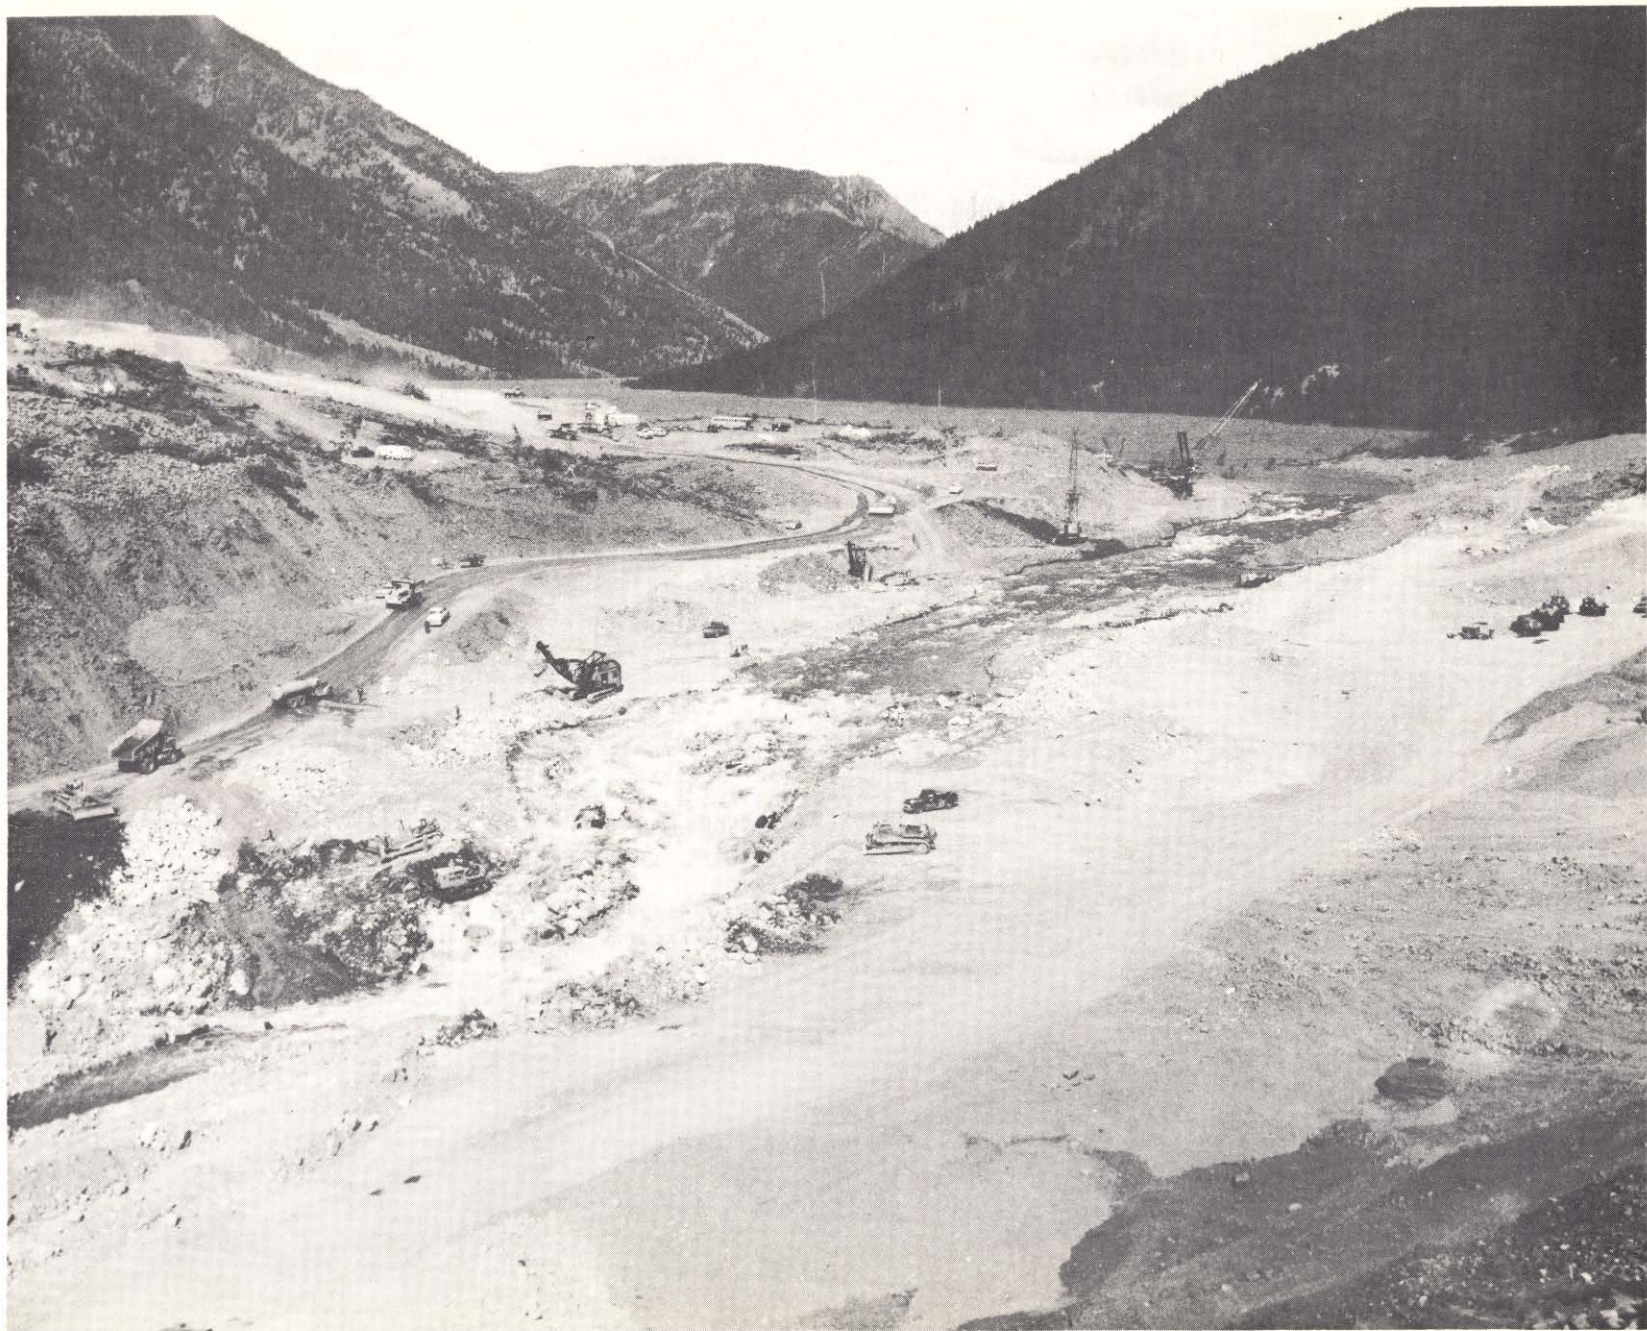
Photo 16. 5 October 1959. General view of spillway lowering operation. Draglines are working in channel and shovels are maintaining a work berm.

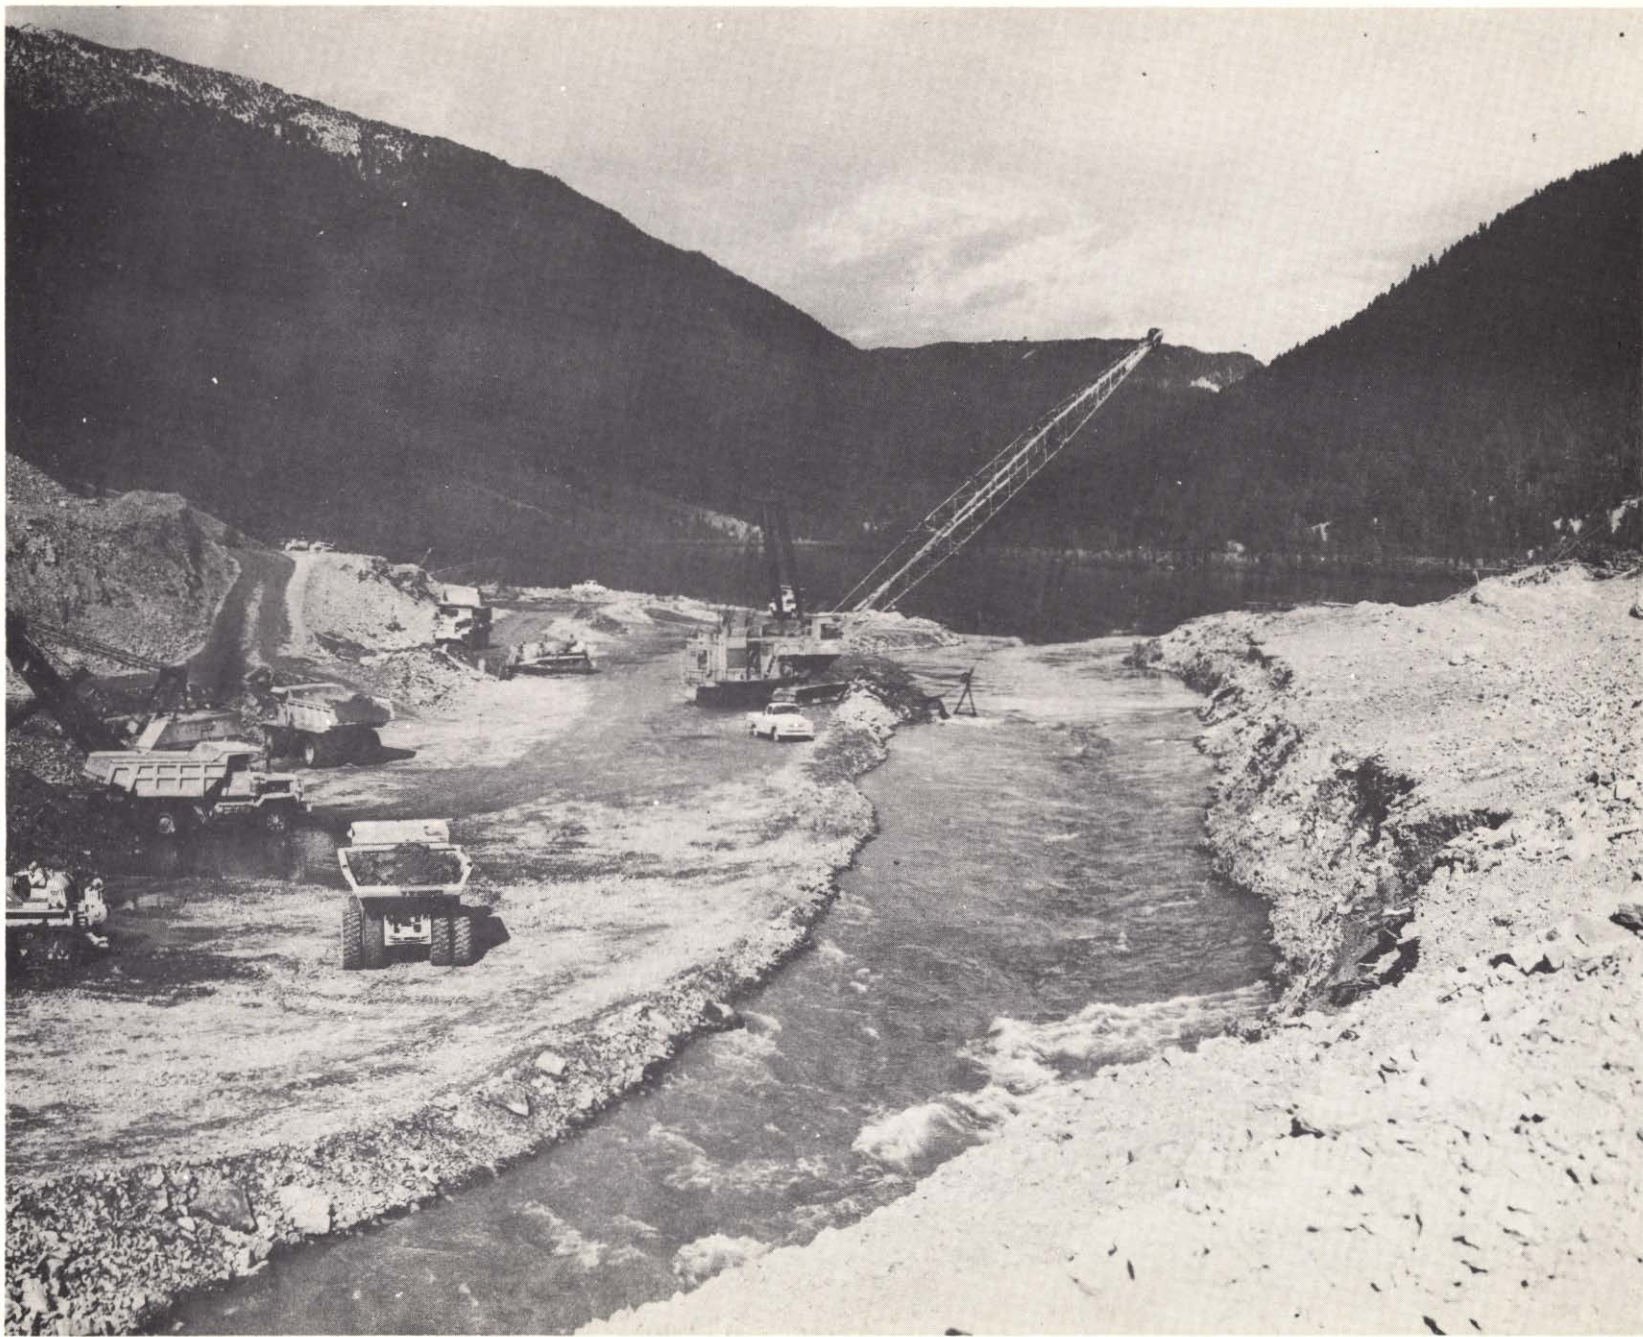
in rock movement in the spillway, at an estimated rate of 25,000 to 30,000 cubic yards per day. On the same day, two shovels arrived and were being assembled. By the following day, three shovels and eight end-dump trucks also were in operation. At the peak of activity, about mid-September, equipment working on the job included 27 dozers, 5 shovels, 29 end-dump trucks, 3 end-loaders, 1 patrol grader, 2 truck cranes, 5 light plants, 1 dragline, 1 water truck, 1 tractor-mounted drill, and one compressor, drill, and blasting outfit. A total force of 190 operators, oilers, foremen, and mechanics was required to keep the equipment in operation. Photos 3 and 4 show various pieces of the construction equipment in operation. Draglines brought in later show in photos 13, 21 and 22.

Photo 21. 11 October 1959. Large dragline lowering spillway channel near the outlet of Earthquake Lake.
