MADISON RIVER, MONTANA
REPORT ON
*FLOOD EMERGENCY
MADISON RIVER SLIDE*

*VOLUME I
MAIN REPORT*

U. S. ARMY ENGINEER DISTRICT, OMAHA
CORPS OF ENGINEERS
OMAHA, NEBRASKA
SEPTEMBER 1960

U. S. ARMY ENGINEER DISTRICT, GARRISON
CORPS OF ENGINEERS
RIVERDALE, NORTH DAKOTA

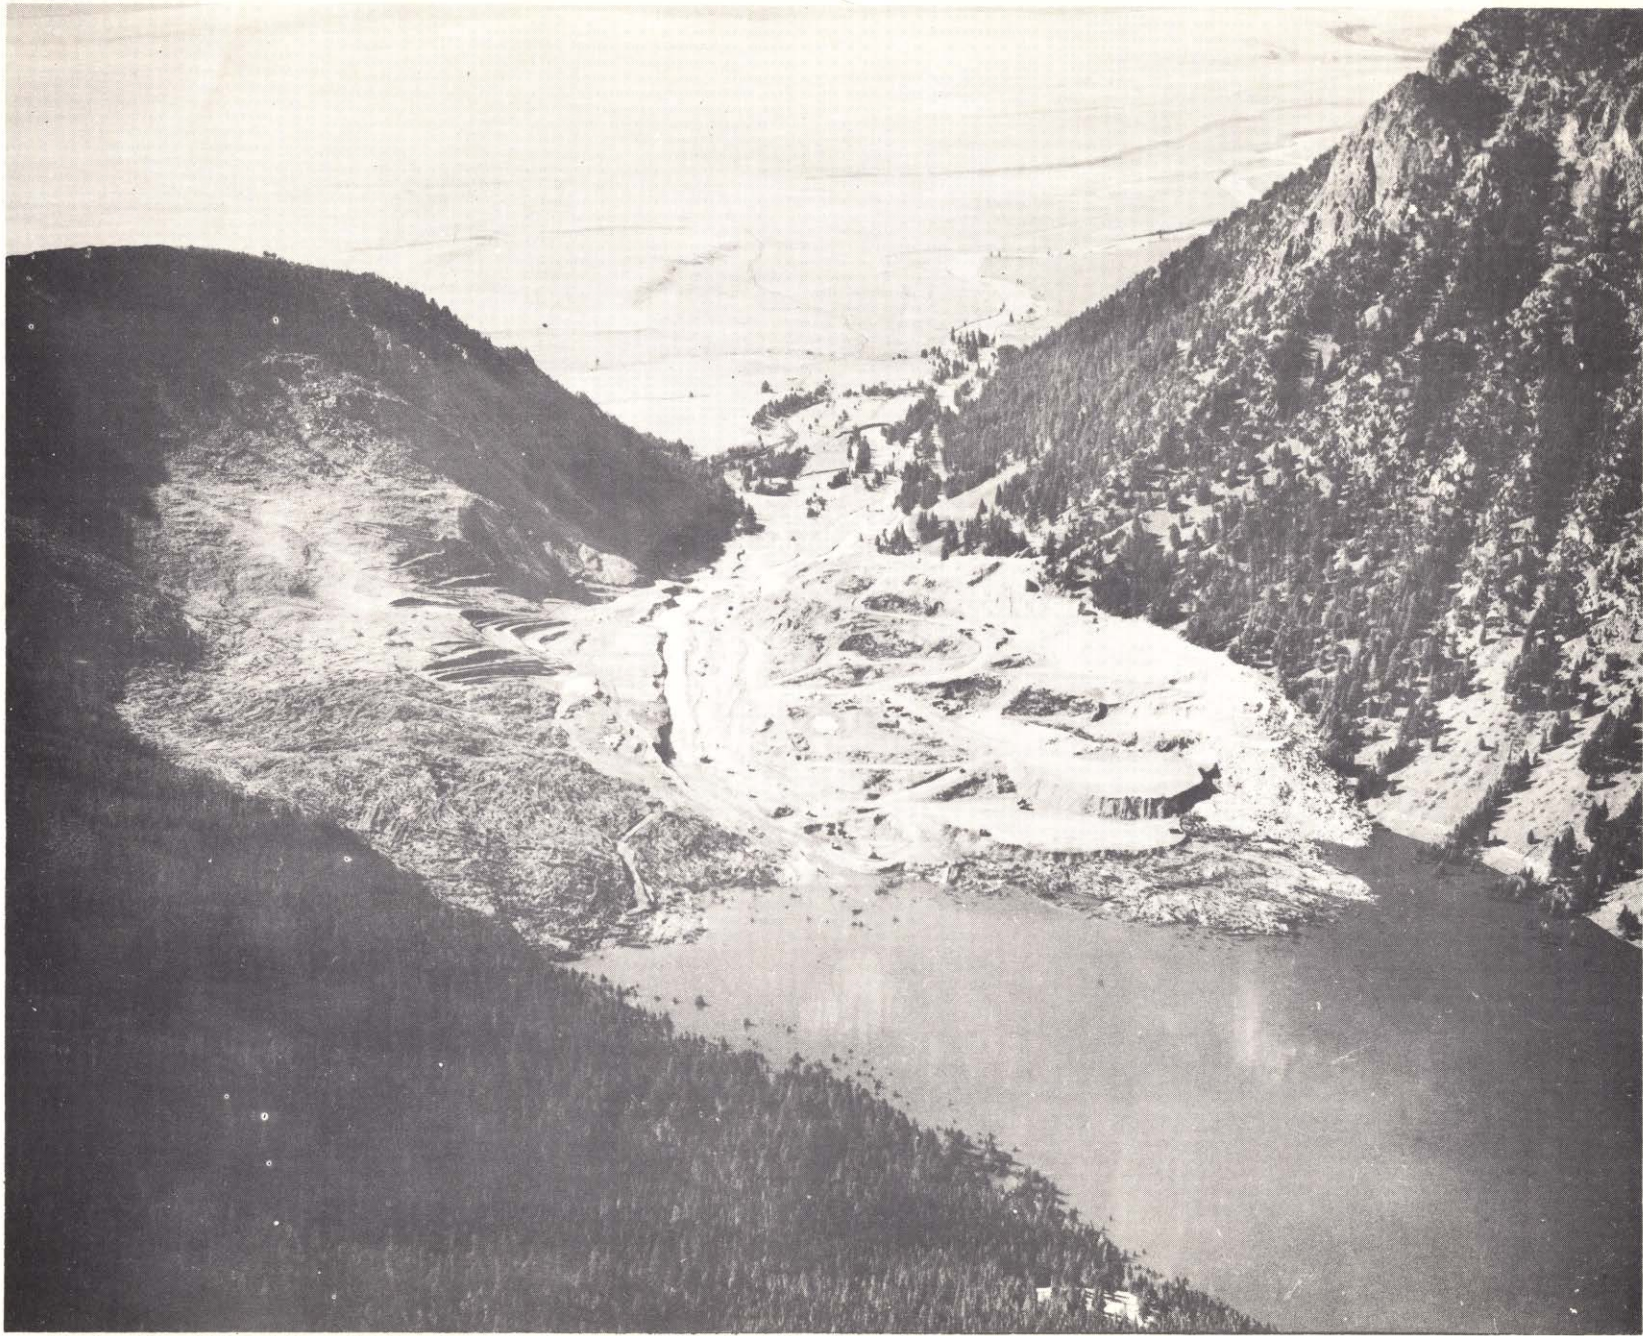
Photo 23. 17 October 1959. Aerial view of slide looking downstream.

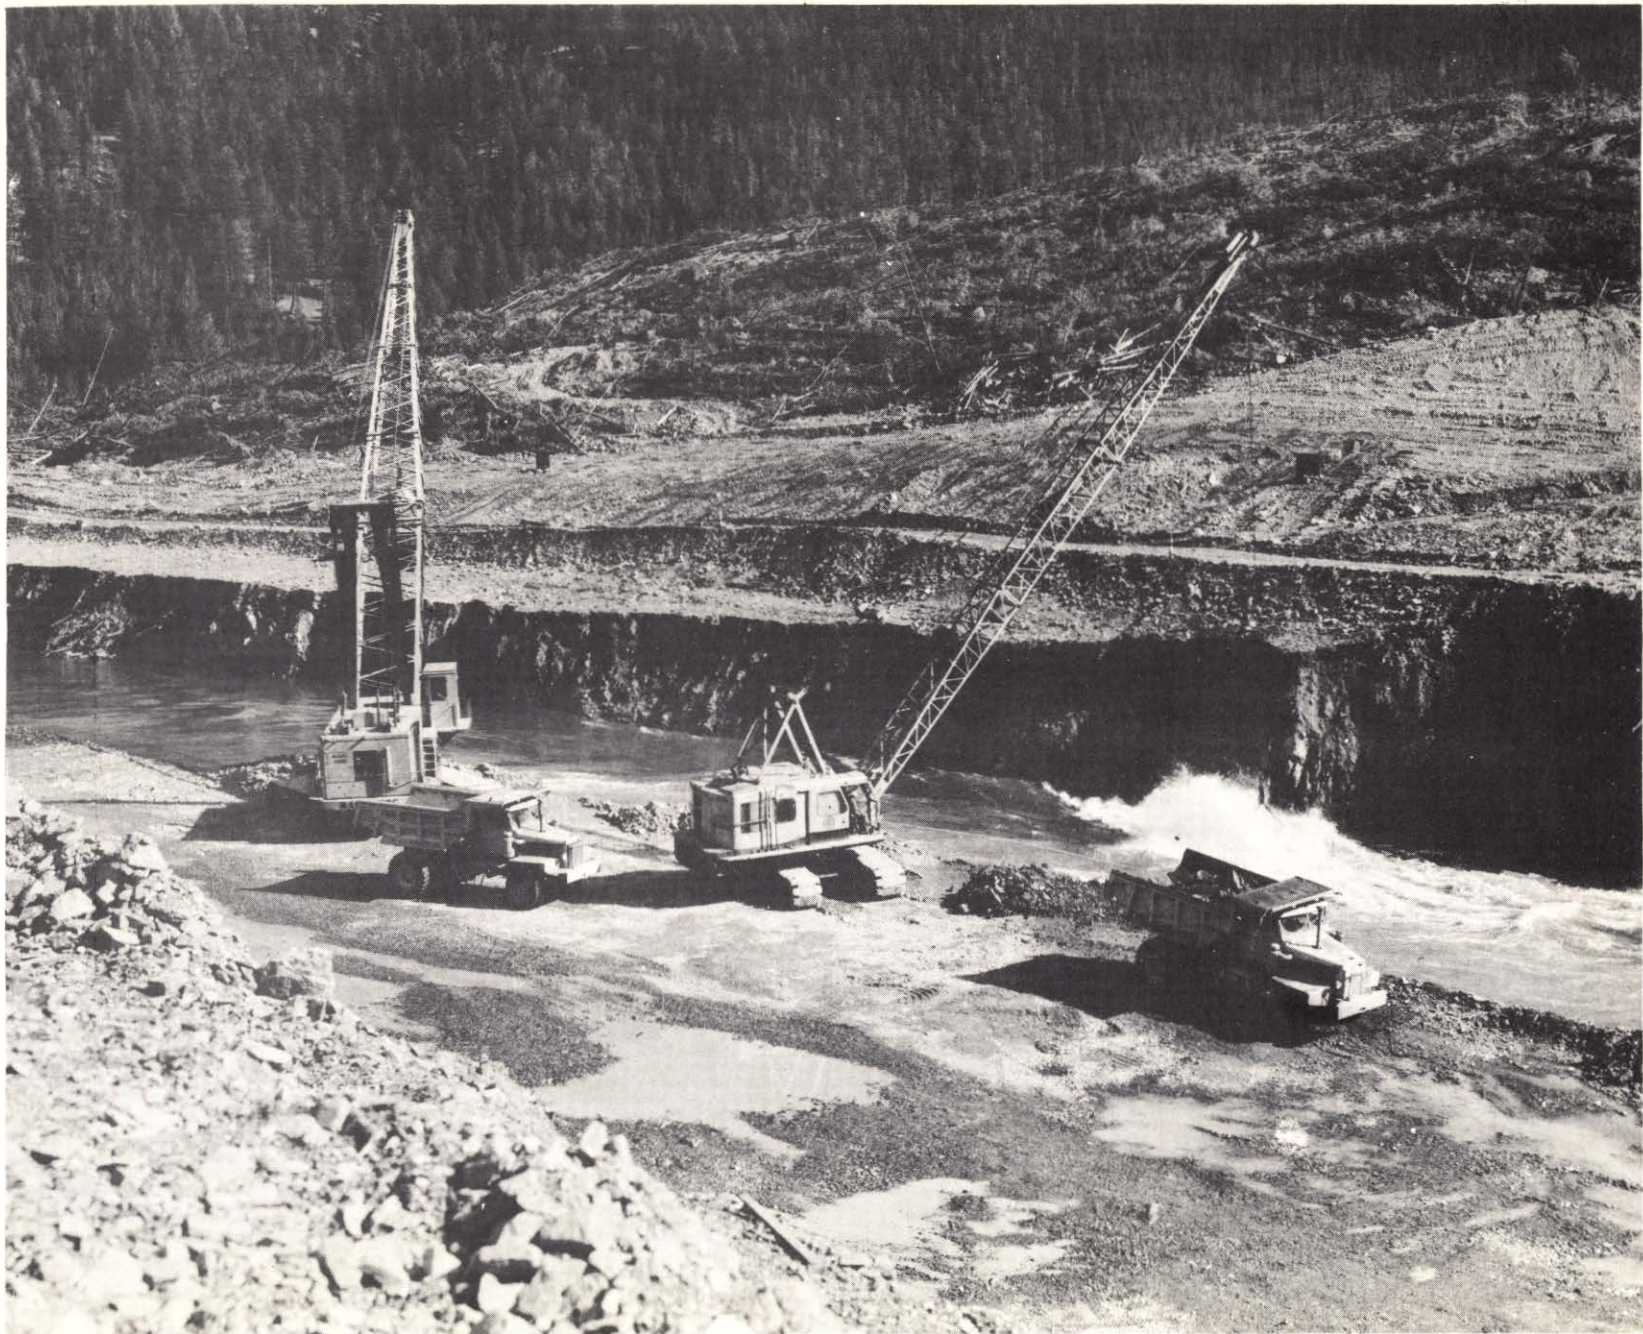
in rock movement in the spillway, at an estimated rate of 25,000 to 30,000 cubic yards per day. On the same day, two shovels arrived and were being assembled. By the following day, three shovels and eight end-dump trucks also were in operation. At the peak of activity, about mid-September, equipment working on the job included 27 dozers, 5 shovels, 29 end-dump trucks, 3 end-loaders, 1 patrol grader, 2 truck cranes, 5 light plants, 1 dragline, 1 water truck, 1 tractor-mounted drill, and one compressor, drill, and blasting outfit. A total force of 190 operators, oilers, foremen, and mechanics was required to keep the equipment in operation. Photos 3 and 4 show various pieces of the construction equipment in operation. Draglines brought in later show in photos 13, 21 and 22.

Photo 22. 14 October 1959. Draglines lowering spillway channel near Station 31+00.

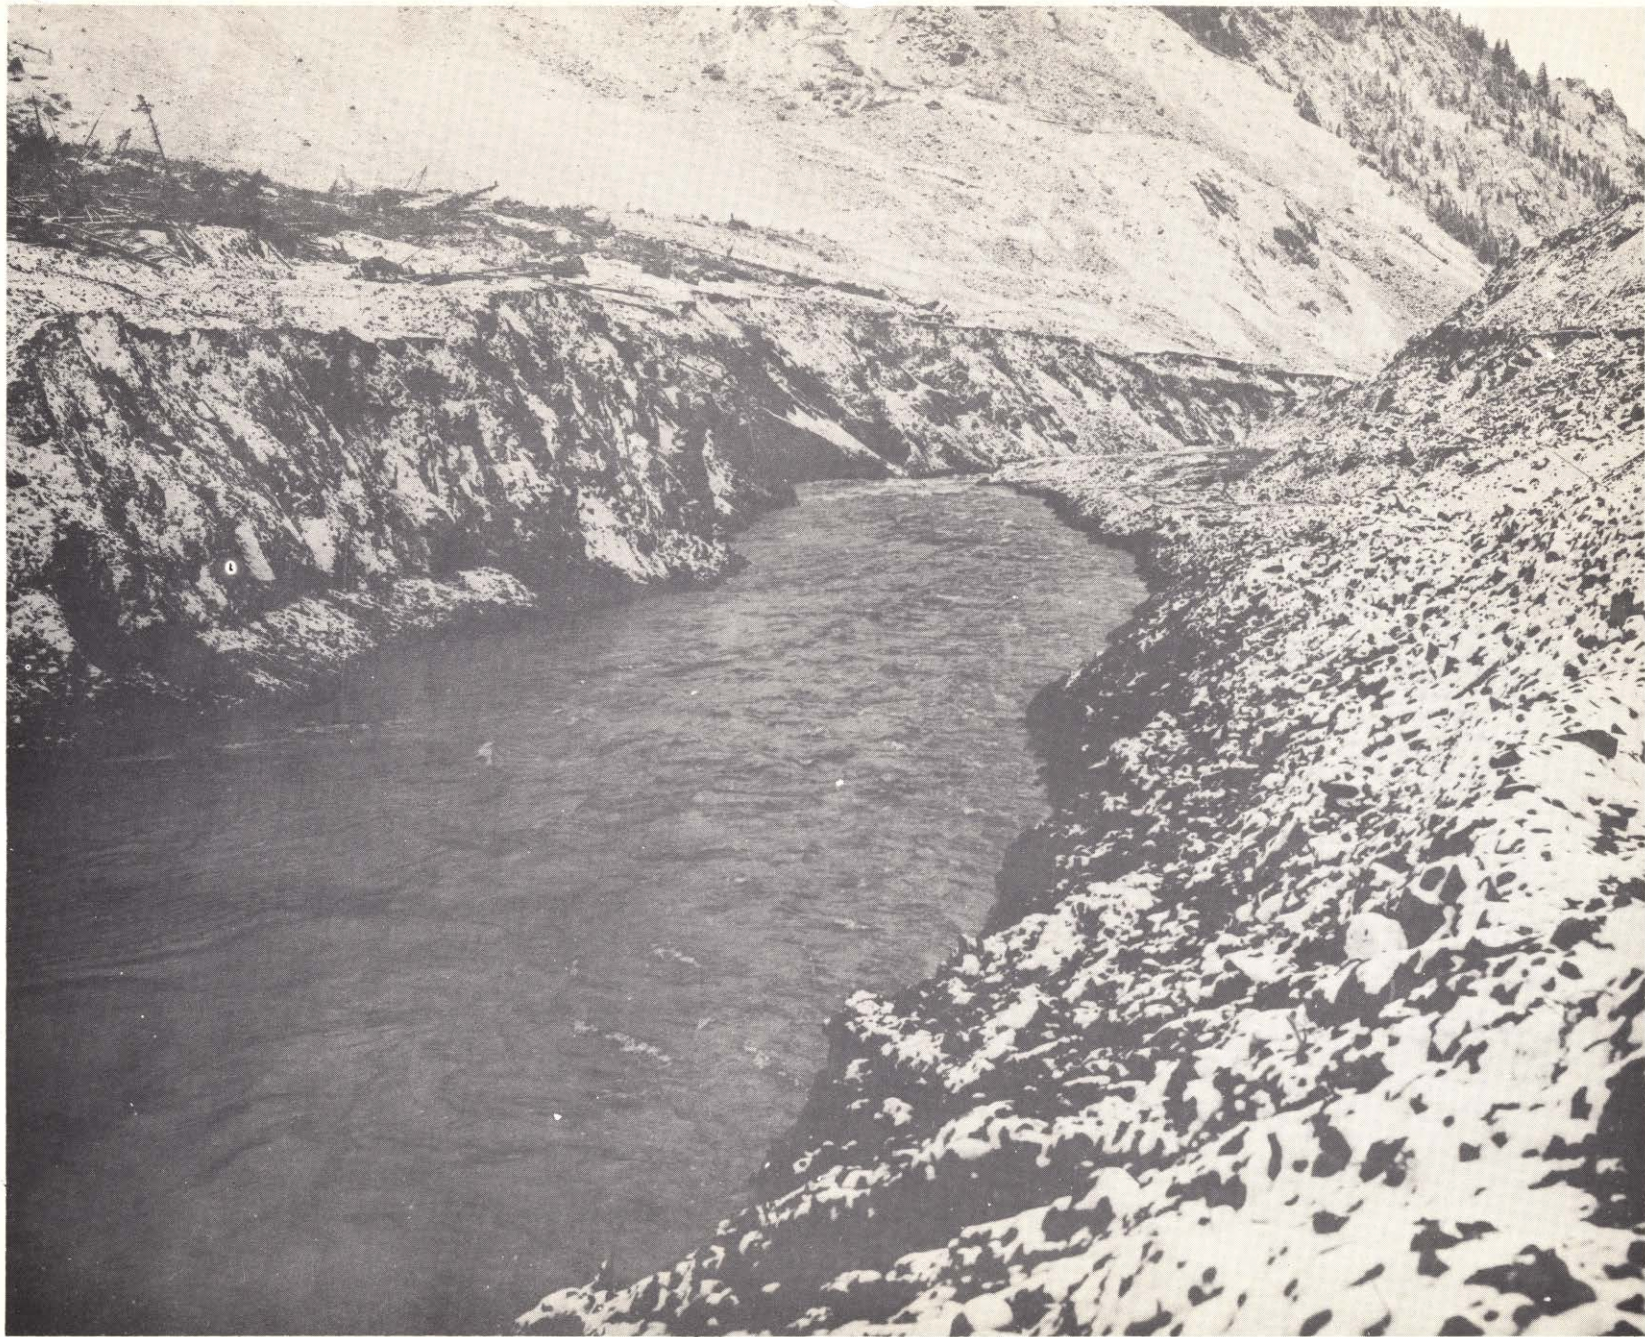
Photo 26. 29 October 1959. Completed spillway looking downstream from about Station 30+00.
