February 1944 as  
Advance Restricted Report 4B02

FLIGHT TESTS OF THE THERMAL ICE-PREVENTION  
EQUIPMENT ON THE B-17F AIRPLANE

By Bonne C. Look

Ames Aeronautical Laboratory  
Moffett Field, California

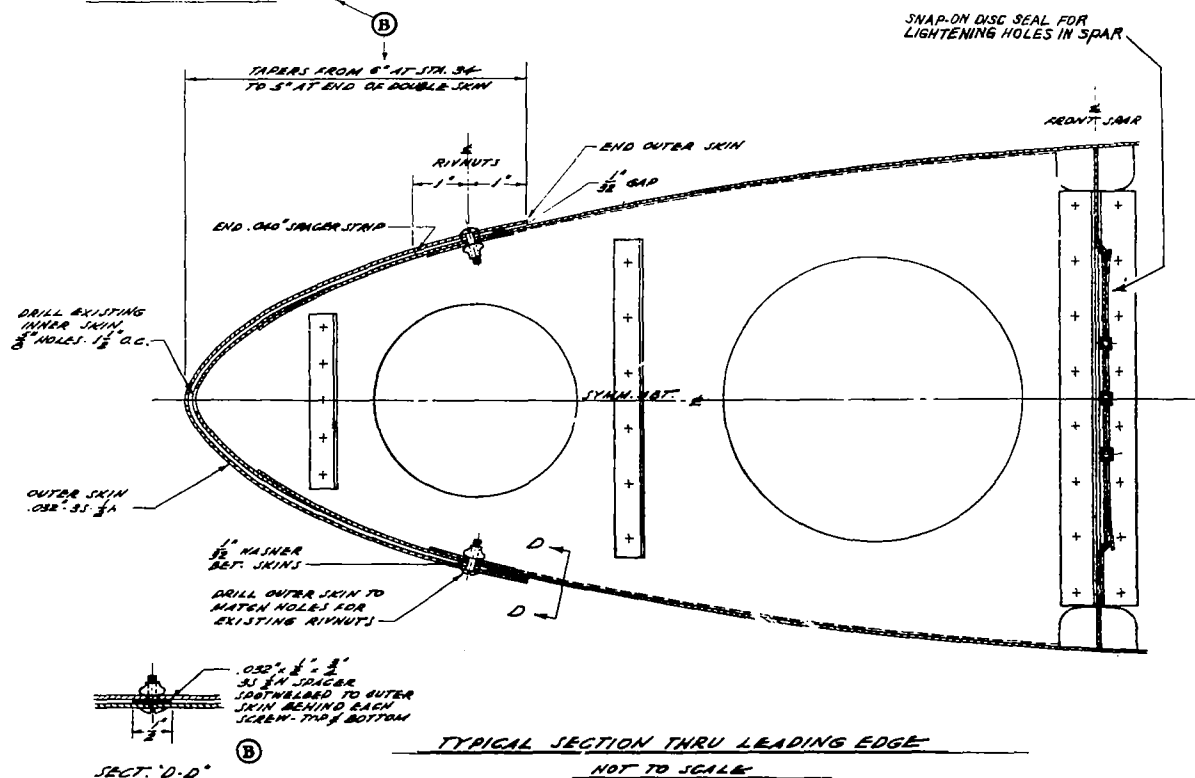
FIGURE 4.-WING-TIP DETAILS FOR B-17F THERMAL ICE-PREVENTION SYSTEM.

The heated air for the wing tip was obtained from the interior of the wing outer panel after flowing through the leading-edge chordwise passages. The air entered a gap between the wing skin and an added outer skin through holes in the leading edge of the inner skin and discharged at the end of the double-skin region on the upper and lower wing surfaces (fig. 4).

The protection afforded by the wing-tip system was not sufficient to prevent the formation of ice on the leading edge. Accumulations of ice were observed on the

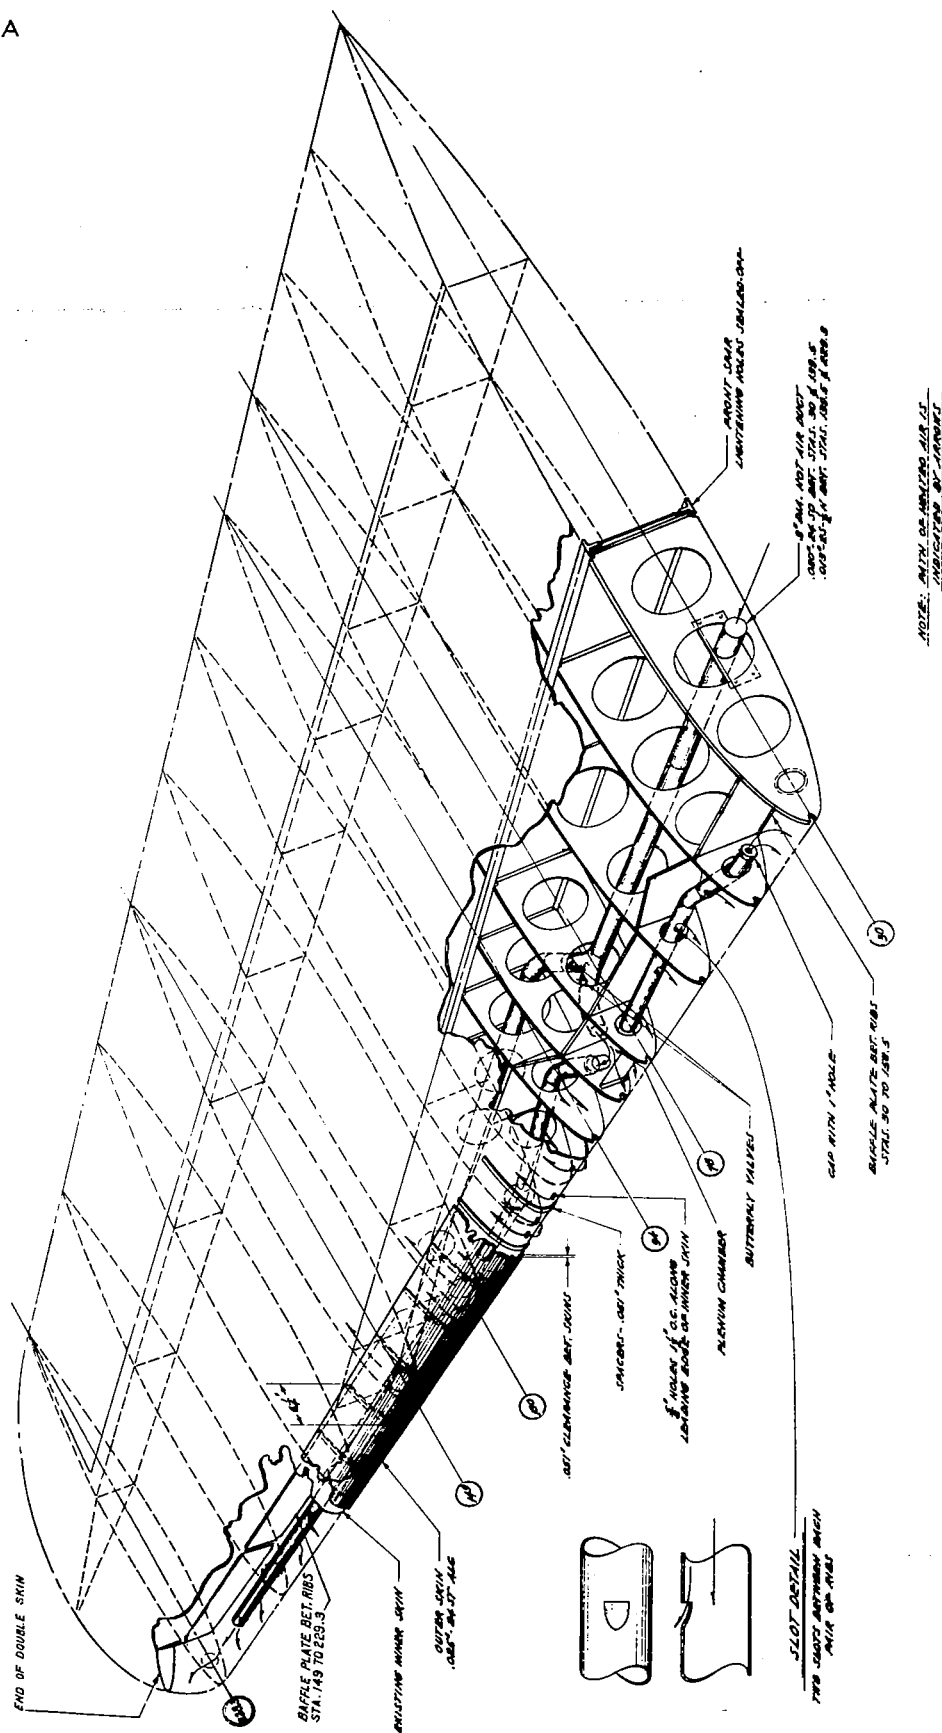
FIGURE 6.- HORIZONTAL STABILIZER DESIGN FOR B-17F THERMAL ICE-PREVENTION SYSTEM.

The ice formations which accumulated on the leading edge of the horizontal stabilizer were found to be at the inboard, midspan, and tip regions where the distribution duct had been discontinued and the heated air discharged into a chamber through a 1-inch-diameter hole in the end of the duct (fig. 6). The thermocouples which indicated the leading-edge skin temperatures were located in or near the regions where ice accumulated and, therefore, may not give a true indication of the temperature rise of the protected portion of the leading edge. The thermal data, given in table IV for the horizontal stabilizer, show an average skin temperature rise for the leading edge of approximately  $30^{\circ}\text{F}$  for tests 1, 3, 4, and 5, and  $65^{\circ}\text{F}$  for test 7. During the dry-air flights (tests 2 and 6) the average skin temperature rise was approximately  $40^{\circ}\text{F}$ . The increase in engine power conditions (test 5) did not materially affect the skin temperature rise or the degree of protection afforded by the ice-prevention system. The heated-air flow rate to the horizontal stabilizer was not obtained, but the total weight of air supplied to the empennage group was determined and the distribution of the air to the horizontal and vertical stabilizers was based upon the skin temperature rises.
