POST. Lab.  
WATERTOWN ARSENAL  
WATERTOWN, MASS.

REPORT NO. 710/197

A STUDY OF  
THE MECHANISM OF PENETRATION OF HOMOGENEOUS  
ARMOR PLATE

June 14, 1937

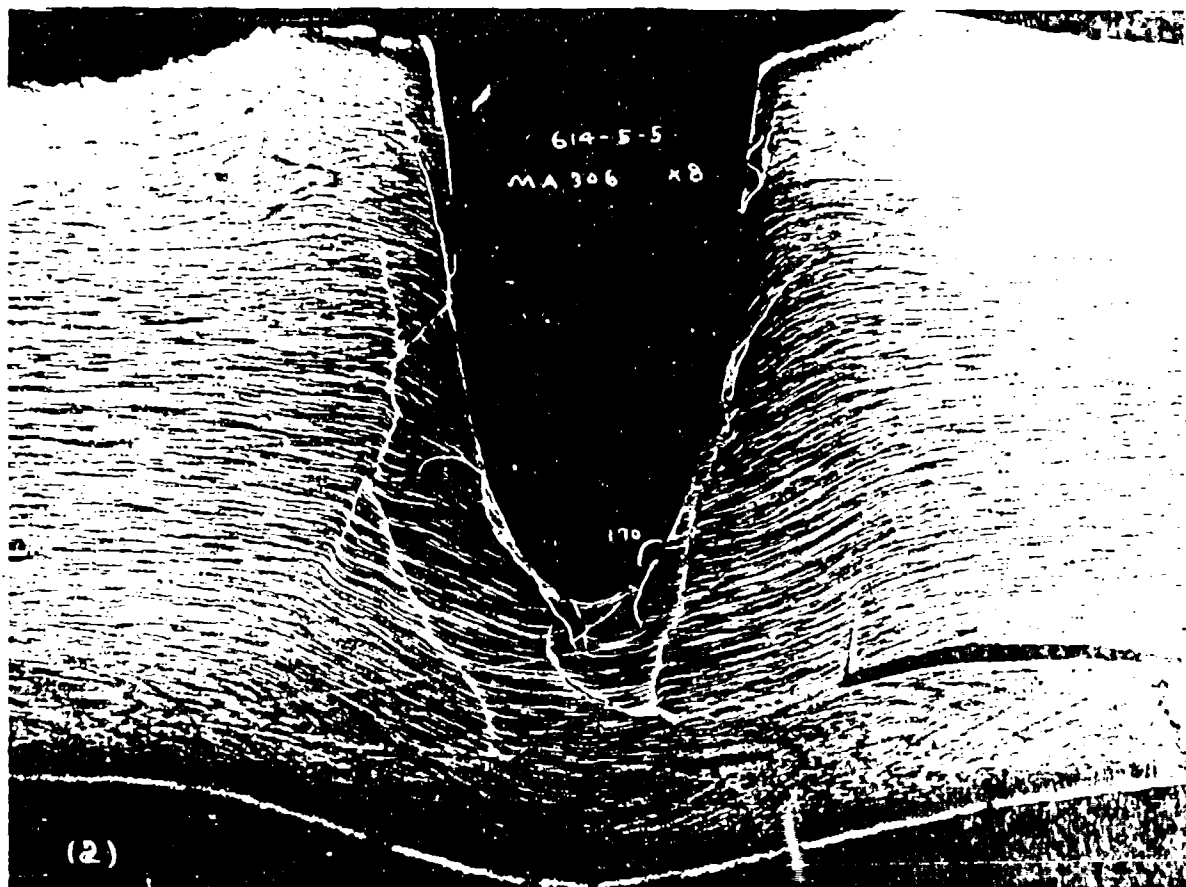
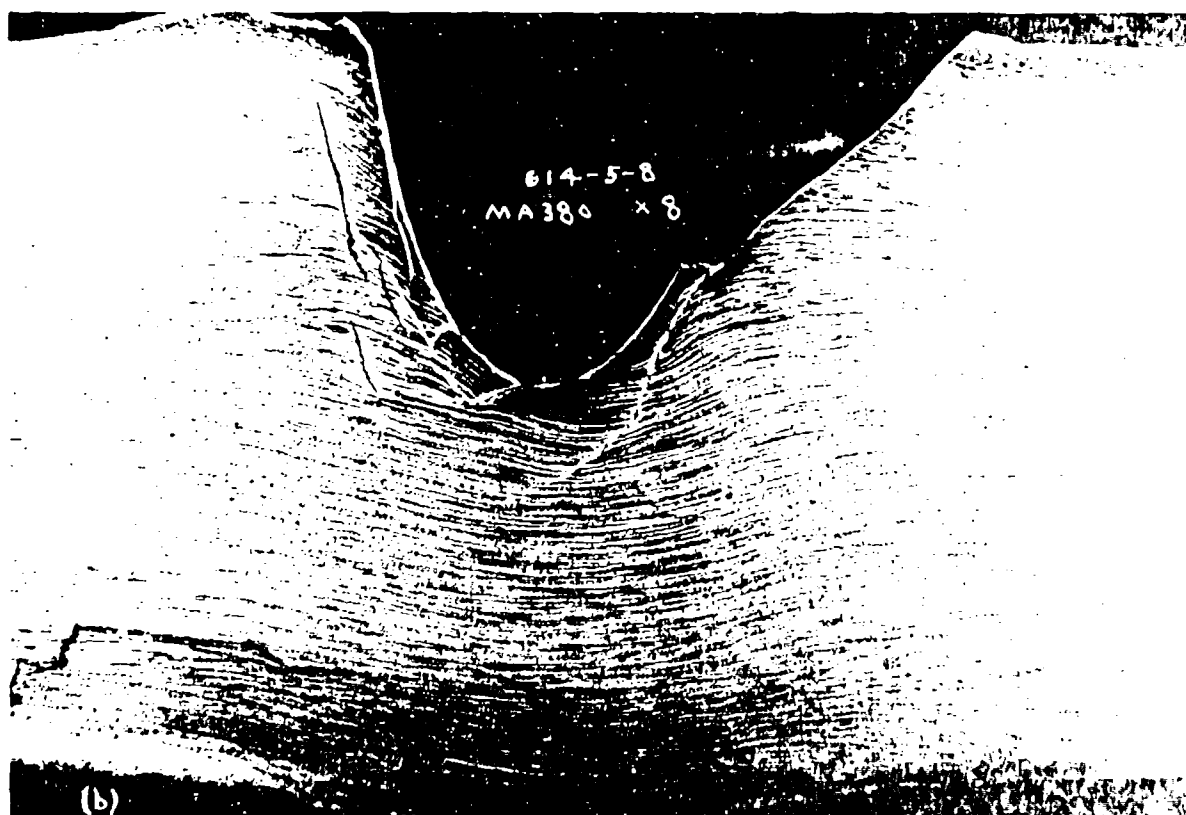
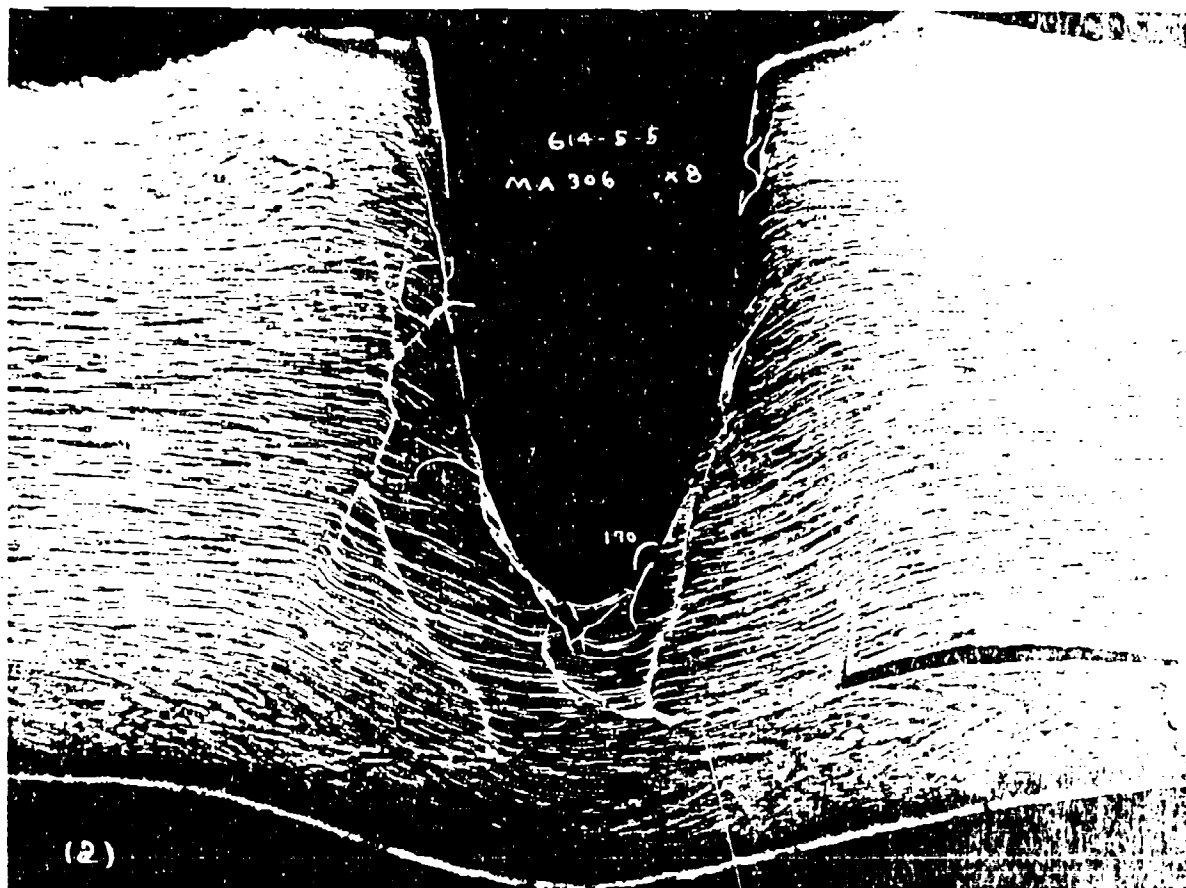
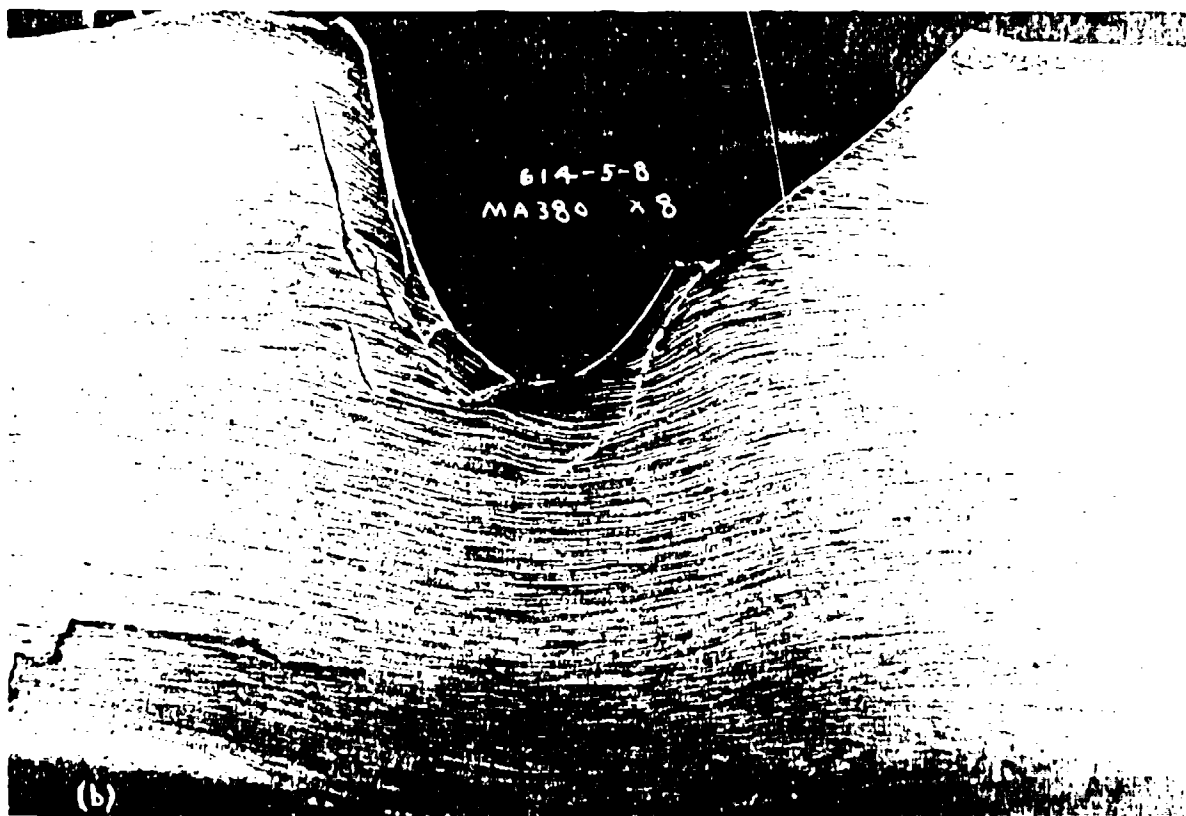
Figure 3

- (a) Shows cracking and slip of metal in a complete penetration of .30 caliber A.P. bullet into medium ballistic plate. This section is cut off-center from the axis of the bullet, and therefore appears to be only partial. Other penetrations in this plate buttoned badly, and in this macro study, the start of one is plainly shown.

- (b) Same plate as above, a partial penetration. Note another crack which, if propagated, would have caused a button.

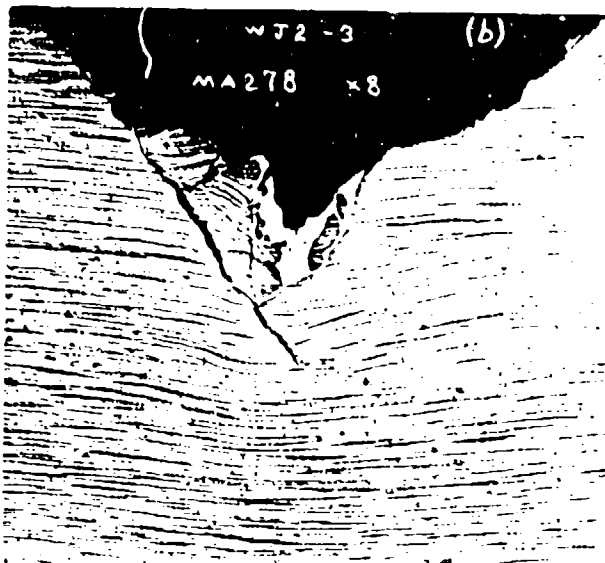
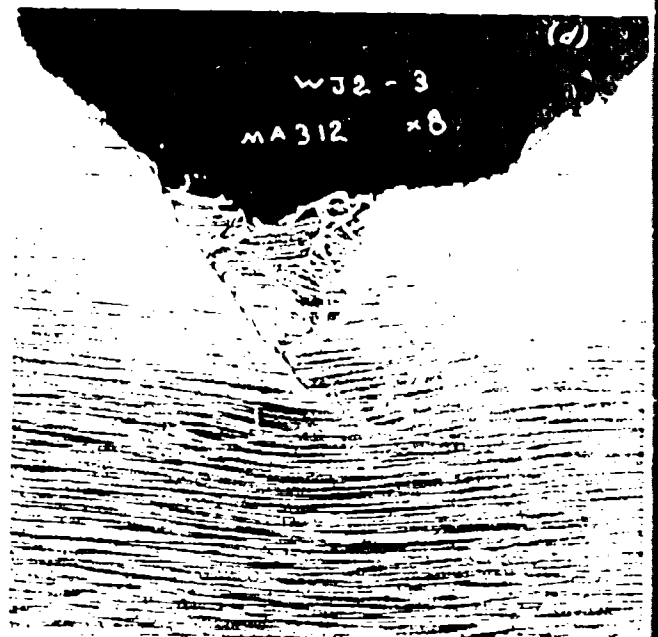
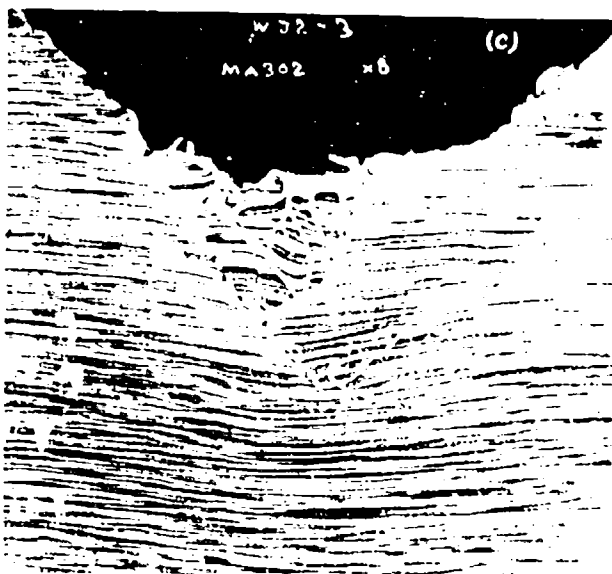
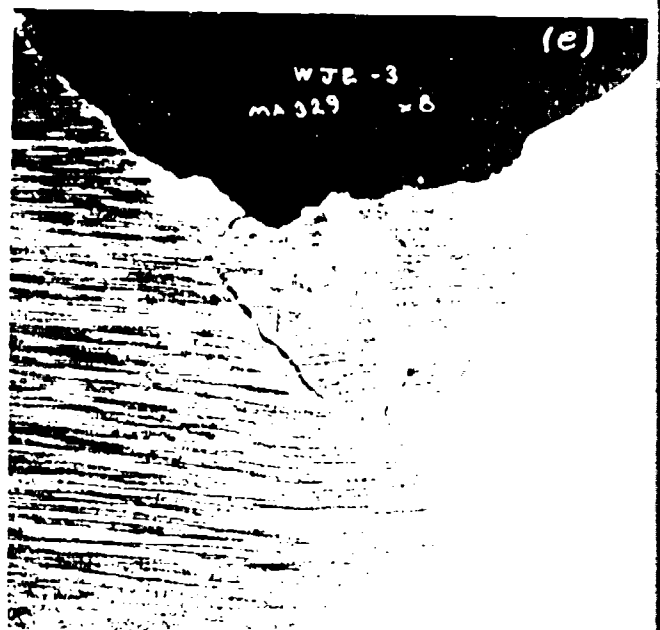
Figure 7 (a) illustrates graphically the contour of the area disturbed and twisted by the bullet.

Figure 7 (b) illustrates the hour glass shaped contour of the area affected by bullet impact.

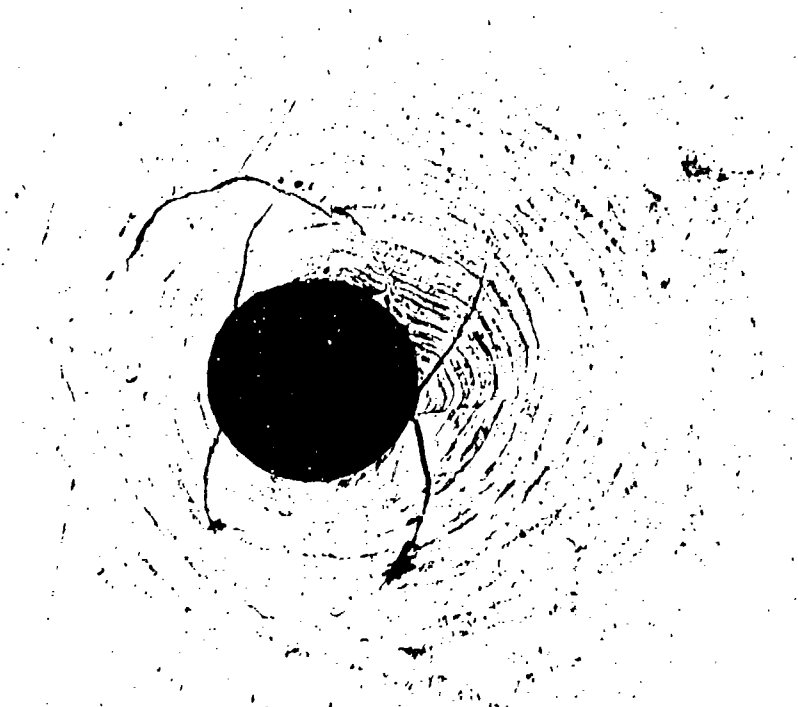
m. - .126" ABOVE BOTTOM OF BULLET HOLE.

- (l) Note crack forms at outer limit of swirl deformation. Corresponds to (c) above.

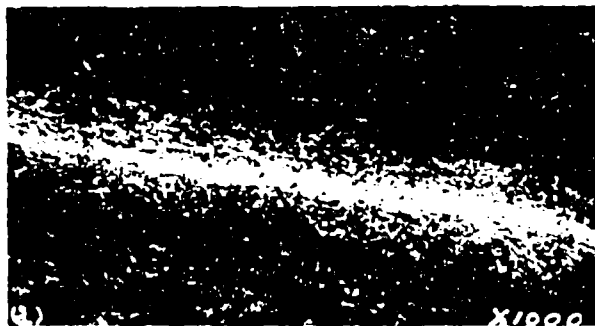
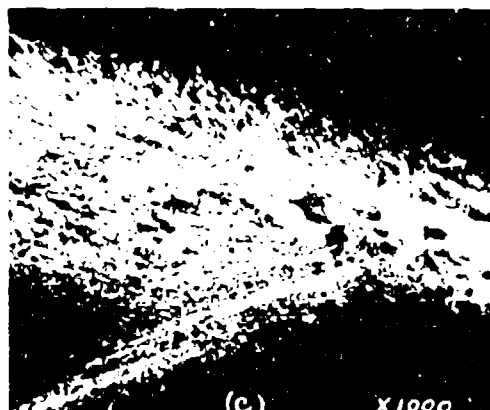
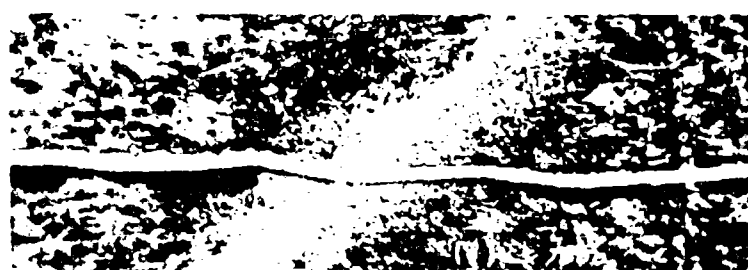
FIGURE 18

The "white layers" are resistant to the normal procedure of etching. Relatively deep etching reveals a fine acicular structure similar to martensite in "white layers" found in an armor plate containing 3.58% nickel and 2.01% silicon, Figures 18 (d), (e) and (f). The structure of the armor plate proper was martensitic. On the other hand, the layer appearance in a standard chromium-molybdenum-vanadium armor plate is similar to that of sorbite, Figures 18 (a), (b) and (c). Their failure to exhibit an acicular structure is no proof that they lack the characteristics of hardened steels since such steels do not necessarily have to assume one definite type of structural arrangement.

These micrographs show the best of the results from an exhaustive series of tests made to discover what, if any, method of etching would bring out the structure in these "white layers".

- (a) Very deep Nital etch. #614-5 Round 5. MA 238
- (b) Deep HCl etch. #614-5 Round 5. MA 307
- (c) Very deep HCl, HCl and  $\text{HNO}_3$ , and finally Rosenhain and Haughton applied in that order.  
#614-5 Round 10. MA 308
- (d) Deep Rosenhain and Haughton etch,  
#WJ2 Round 3. MA 303
- (e) Rosenhain and Haughton, re-etched deeper than (d).  
The blackened area in the lower right corner appears because the etch was so deep as to eat away the metal surrounding the "white layer".  
#WJ2 Round 3. MA 304
- (f) Same as (e), but a different location in the specimen.  
Note the appearance of layers within the layer.  
#WJ2 Round 3. MA 305
- (g) Scratch test, showing a considerable necking down of the scratch as it passes through the "white layer".  
#614-5 Round 5. MA 240

The relative hardness of the layer as compared to that of the surrounding metal is illustrated by the scratch test shown in Figure 18 (g). Moreover, the hardness of these layers is evident since they stand out in relief after metallographic polishing.

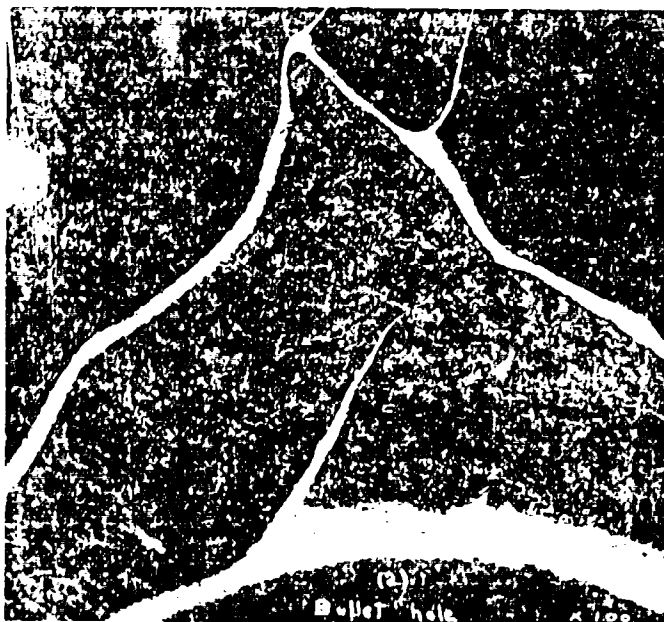
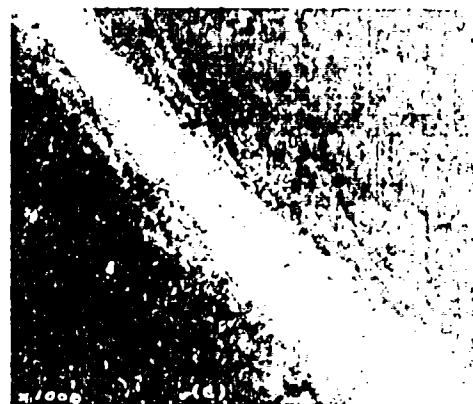
Tempering a standard chromium-molybdenum-vanadium armor plate at 200°C for half an hour causes a transformation at the borders of the "white layers" into a constituent which closely resembles troostite, see Figures 20 (a), (b), and (c).

Tempering this composition at 300°C for half an hour causes a nearly complete transformation of what is believed to be martensite in the "white layer" into troostite, Figures 20 (d), and (e). In several instances, the exact center of the layer was not fully transformed at the 300°C temper, see Figure 20 (e).

- (f) A different composition steel, also tempered at 300°C for 30 minutes. This also shows a carbide precipitation, but more uniformly than the other specimen. Troostite-sorbite.

Tempering a 3.58% nickel, 2.01% silicon composition at 300°C for half an hour promoted a complete transformation of the layer into a constituent resembling troostite-sorbite, Figure 20 (f).

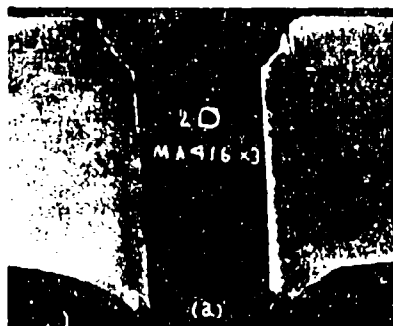
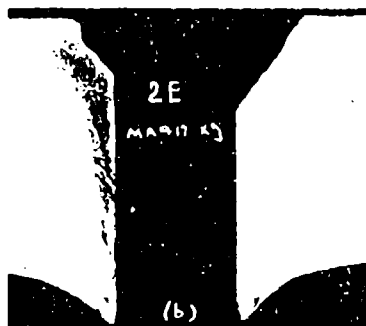
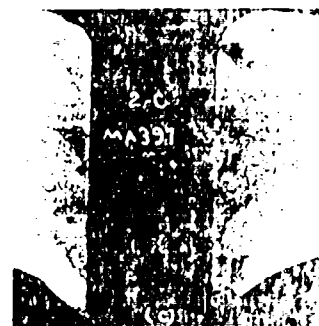
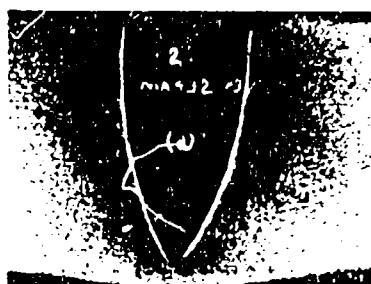
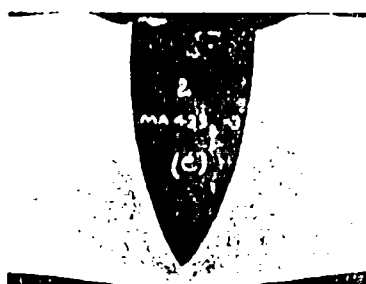
FIGURE 21.

Macroscopic examination of penetrated Hadfield's Austenitic Manganese Steel, containing 1.17% carbon and 11.40% manganese, revealed a darkened zone in the vicinity of the penetrations, Figures 21 (a), (b), (c), and (d).

Microscopic examination indicated that these darkened areas consist of carbide precipitation, deformed austenitic grains, and dark layers similar, with respect to orientation, to the "white layers" found in nonaustenitic steels, but which were darkened readily by the normal etching, see Figures 21 (e), (h), and (i).

The structure of the manganese steel plate at considerable distance away from the bullet penetrations consists of a normal austenitic grain with no evidence of carbides at the grain boundaries, Figure 21 (f).

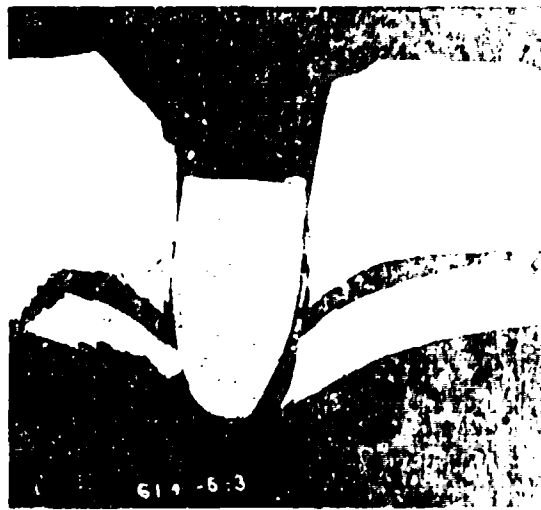
-f- X 1000

- (f) Unetched photo showing the locations of the micrographs.

A thin layer of jacket metal located between the bullet core and plate is shown in Figure 22 (a). Figure 22 (f) shows a cross section of this bullet core in plate.

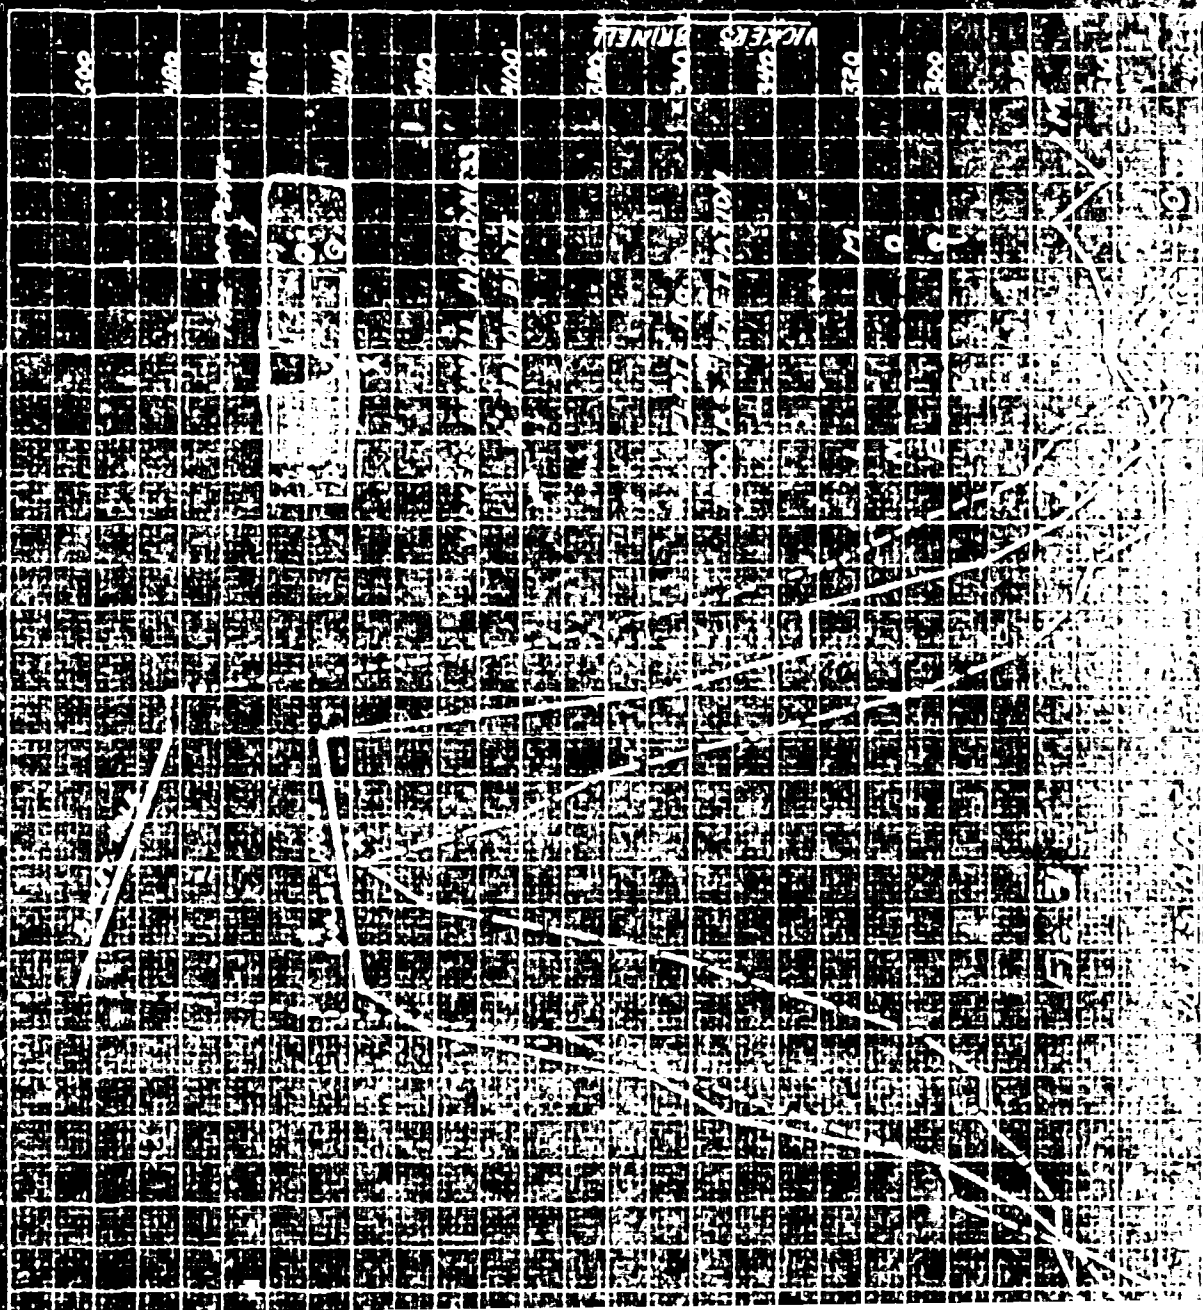
1043  
FIG 26

Partial Penetration - Str. Vel. 1500 f/s.

Complete Penetration - Str. Vel. 2300 f/s.
