AD-A953 799

WIAL-710/662

15 Jun '44

It is intended in this report to evaluate the metallurgical properties of the armor samples received by means of the two fracture and other tests, to determine the causes of failure in every case if possible, and by comparison of the ballistic results with the metallurgical data of the passing and failing plates to establish the characteristics which must be possessed by rolled armor, 1" to 2" in thickness, for successful ballistic performance at subnormal temperatures.

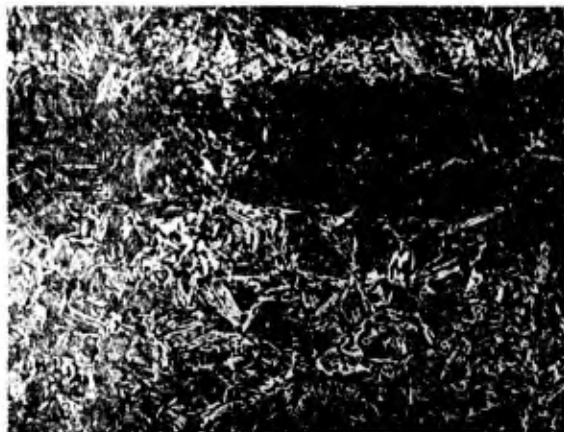
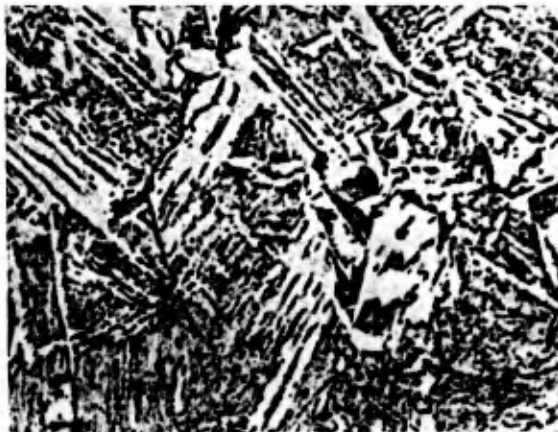
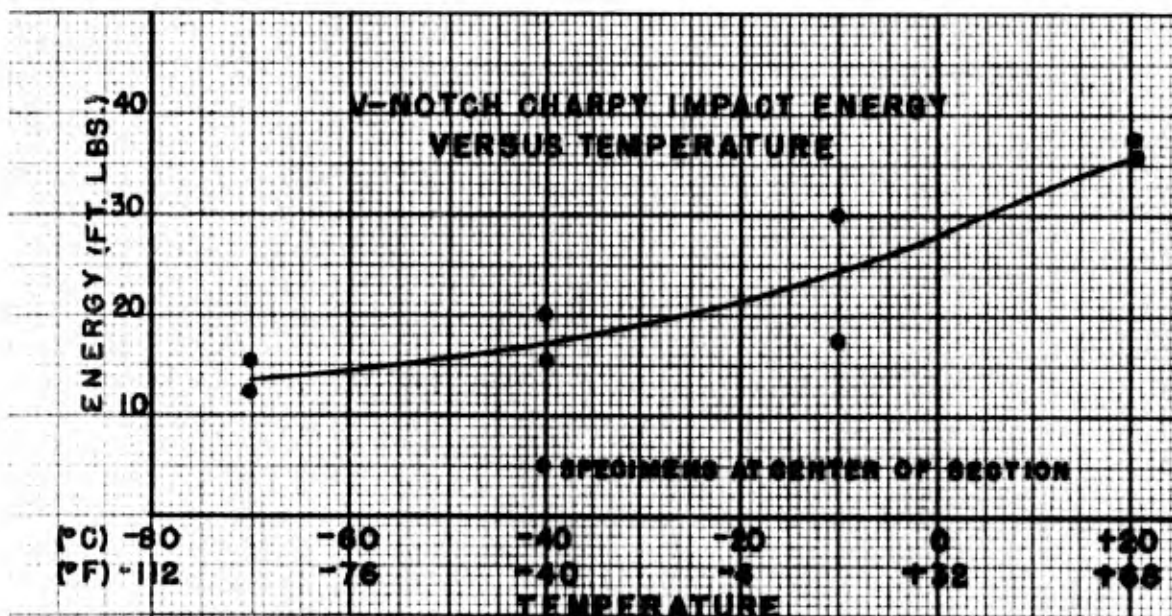
FIGURE 19

Disston 1st Plate No. 1
 (Microspecimen etched with 4% Picral)

Severe banding - The light etching bands consist of some intercritical ferrite and tempered martensite and a fairly large amount of tempered non-martensitic austenite decomposition products.

In addition to some ferrite resulting from the plate having been austenitized within the critical range, a fairly large amount of austenite decomposition products other than martensite is present at the center of the section. Resulting shock properties are poor; the fracture of the material is brittle and the center of section Charpy impact energy drops rapidly with decrease of temperature from room temperature. Ballistic shock performance of this series was therefore poor.

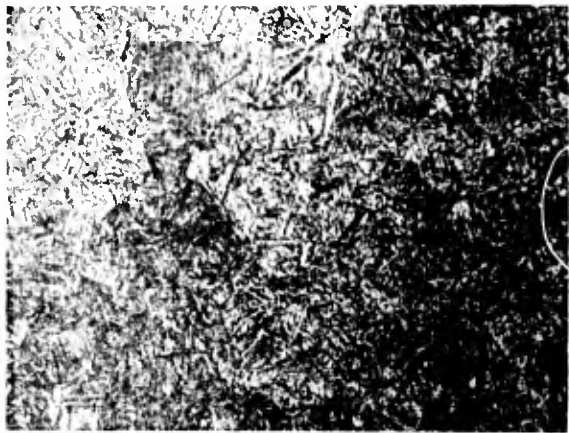
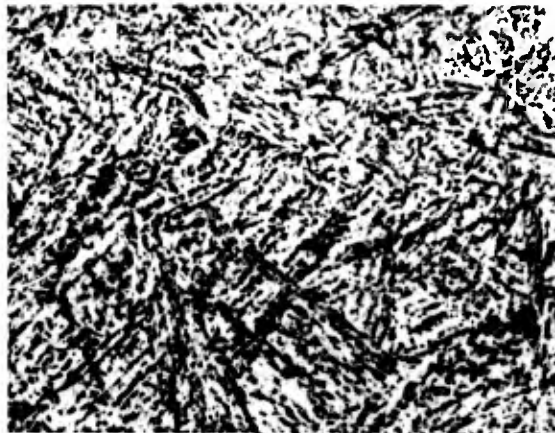
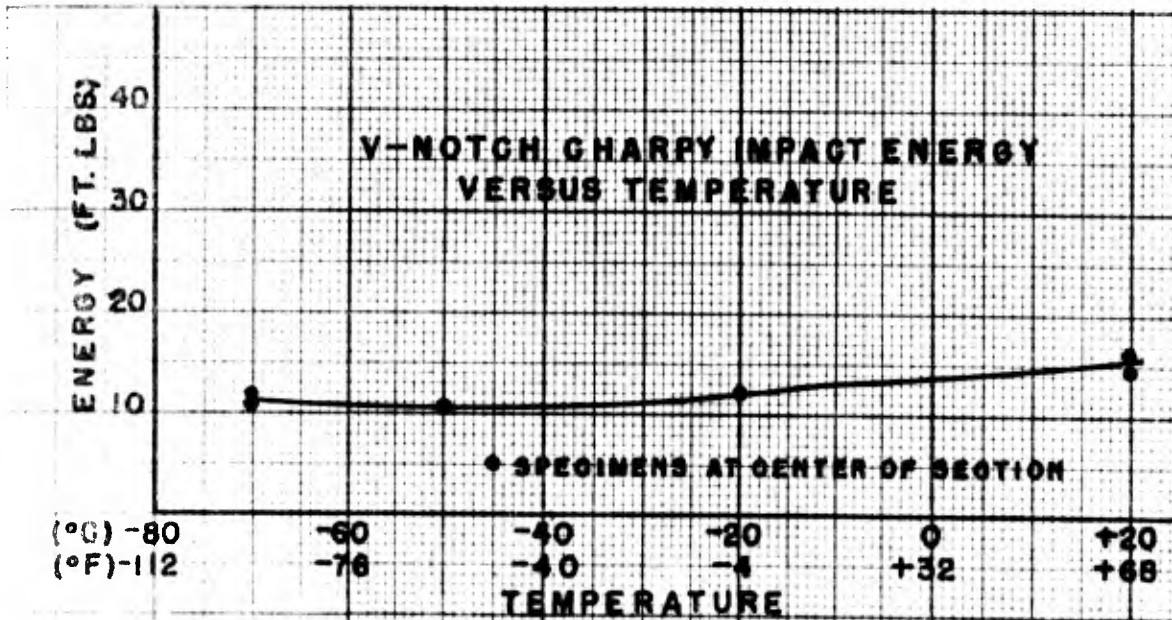
FIGURE 22

American Car and Foundry 1st Plate No. 1702-7
 (Microspecimen etched with Nital-Picral)

No banding - The structure resembles tempered martensite plus tempered low temperature bainite. Traces of a ferritic non-martensitic transformation product are present.

The excessive hardness is reflected in the PTP test by spalling of all the plates in the series.

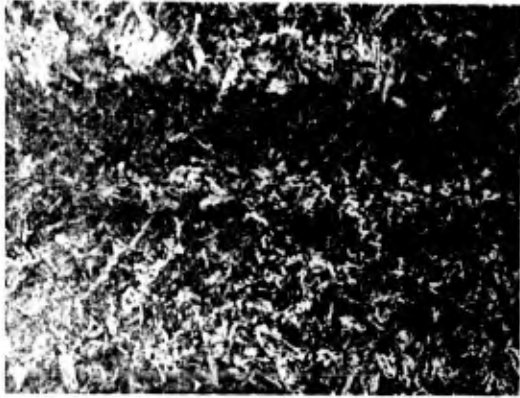
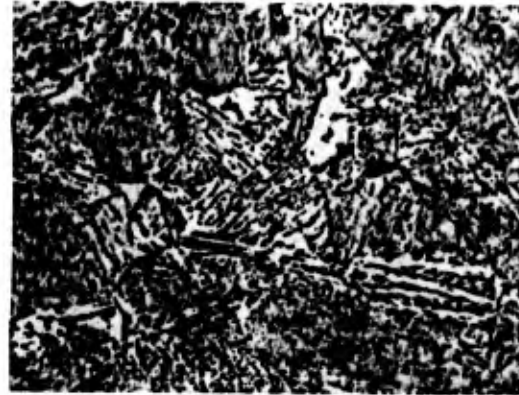
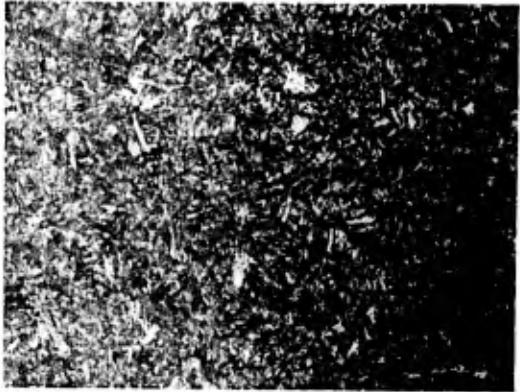
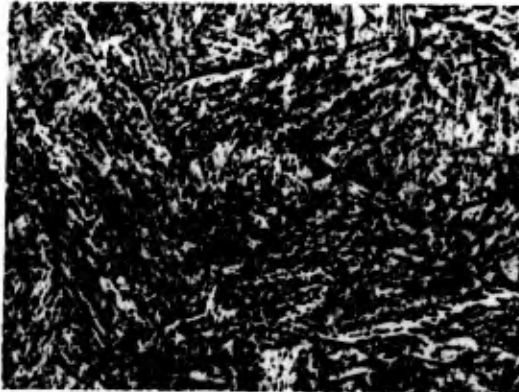
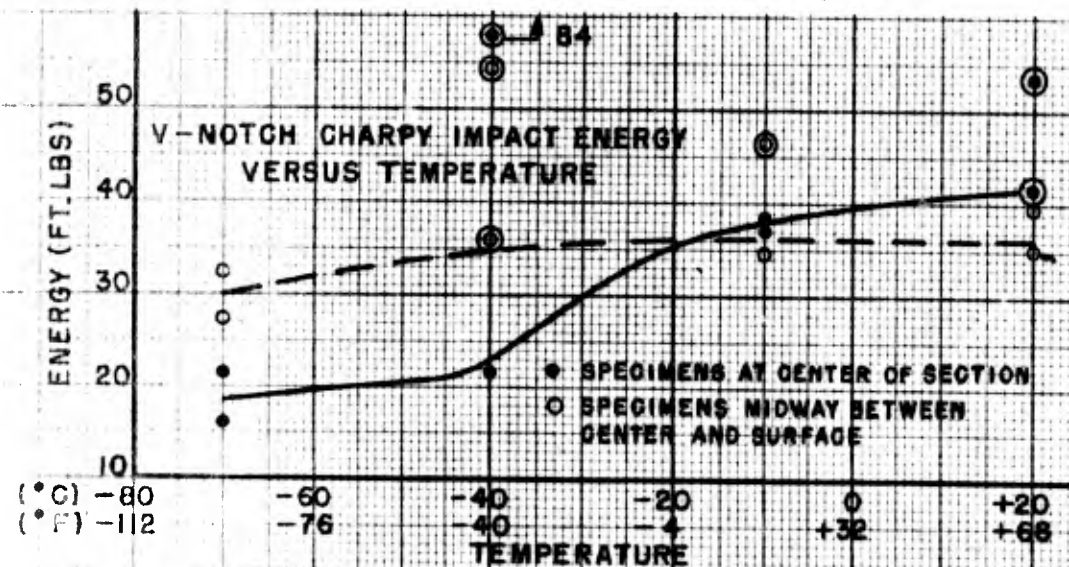
FIGURE 23

Carnegie-Illinois 1 $\frac{1}{2}$ " Plate No. 129438-CTB
(Microspecimen etched with 4% Picral)

Moderate banding - A fairly large amount of tempered non-martensitic products is present in the light-etching bands (X1000 photo.).

No banding - Typical microstructure consists of tempered martensite plus a very small amount of tempered non-martensitic products.

Since the plate failed the shock test by spalling, the failure is attributed to the poor steel quality and high hardness rather than to the poor microstructure at the center of the section. Poor steel quality, assisted by a Brinell of 311, is also considered responsible for the PTP spalling behavior of the series.

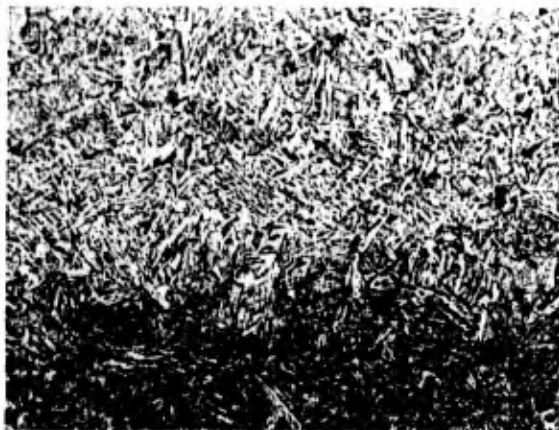
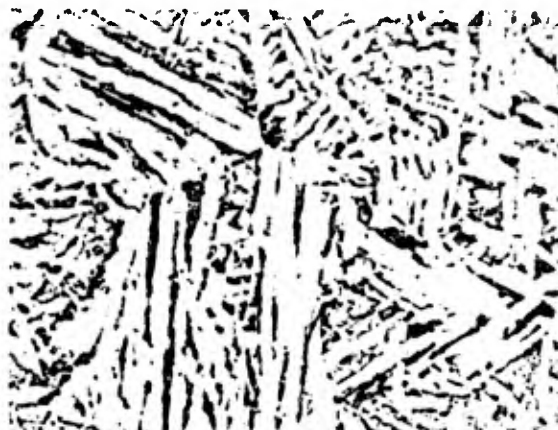
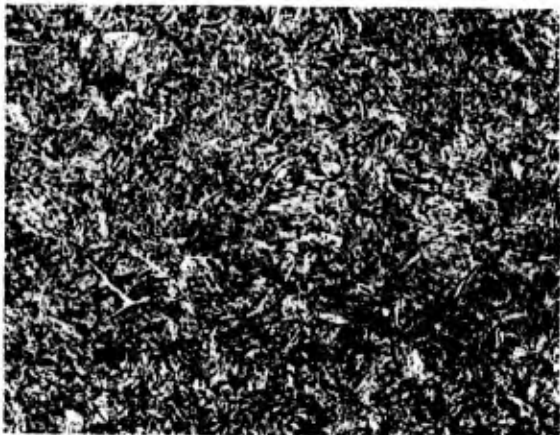
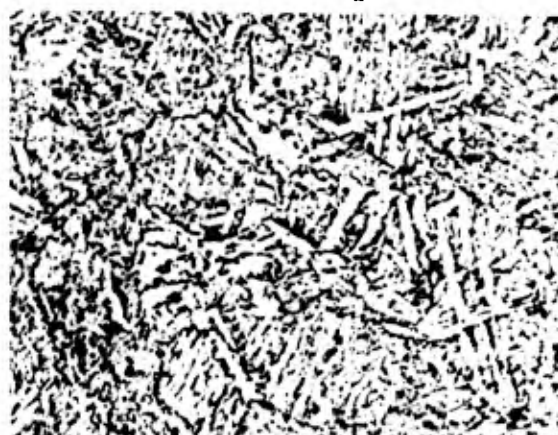
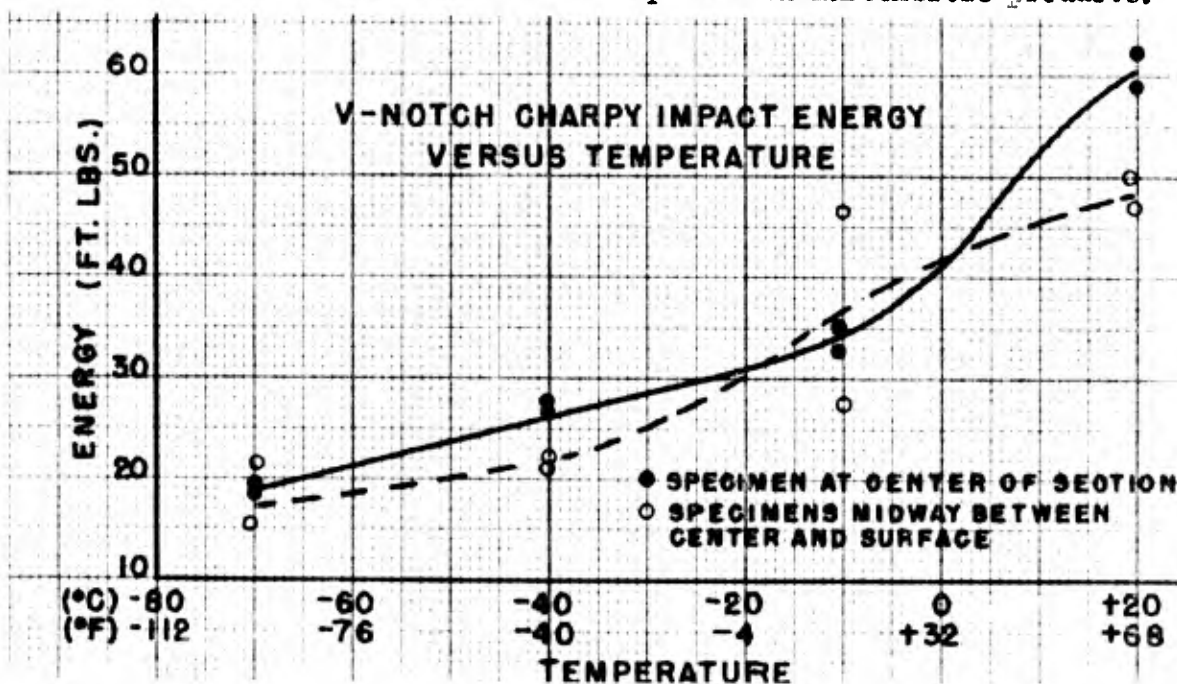
FIGURE 24

Disston 1 1/2" Plate No. 2
 (Microspecimen etched with 4% Picral)

Severely banded - The light-etching bands consist almost entirely of non-martensitic products and intercritical ferrite (X1000 photo.).

No banding - Typical structure is tempered martensite, intercritical ferrite, and a moderate amount of tempered non-martensitic products.

The excellent PTP behavior of the series is consistent with the excellent steel quality and proper hardness of the subject plate.

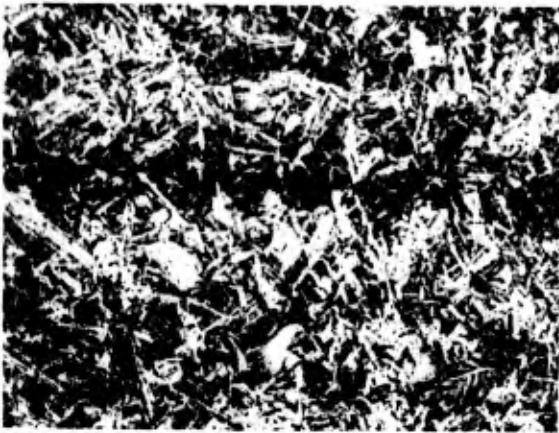
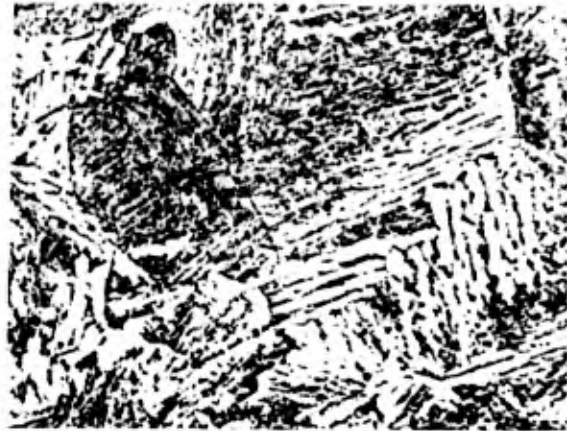
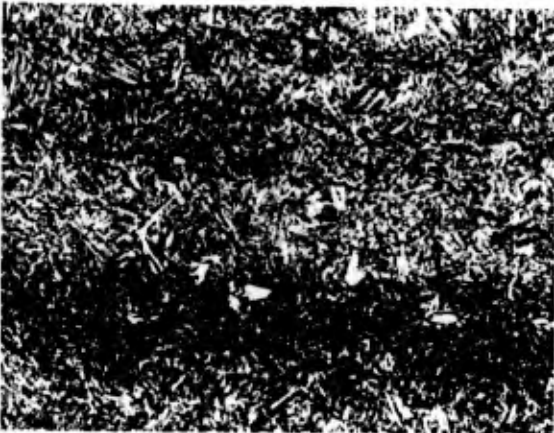
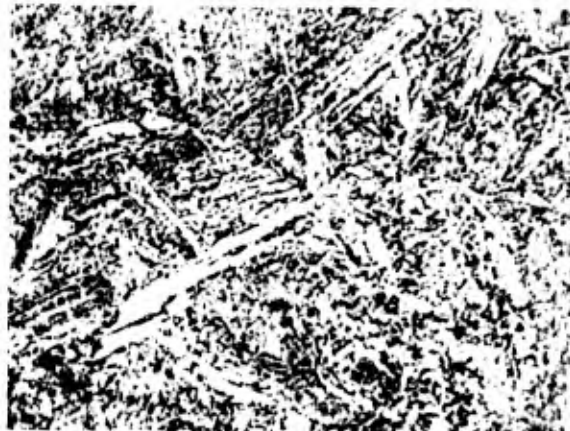
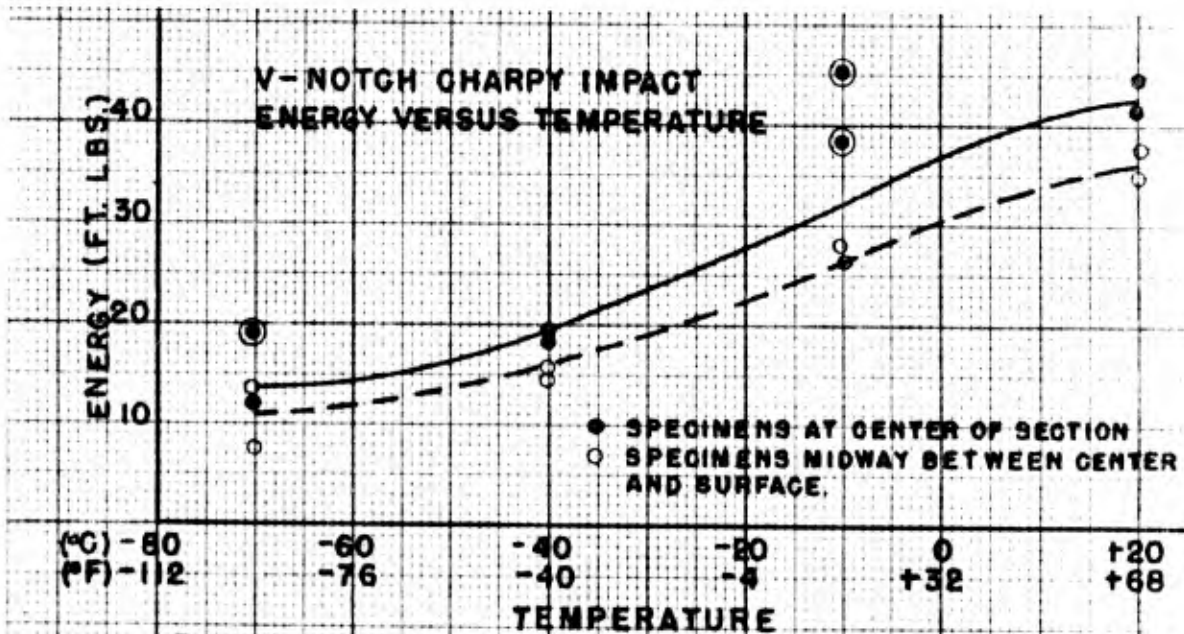
FIGURE 25

Standard (Great Lakes) 1½" Plate No. 1X4
 (Microspecimen etched with 4% Picral)

X200 Center of Section X1000
 Moderate banding - Typical field shows tempered martensite and a great deal of tempered non-martensitic transformation products.

X200 Midway Between Surface and Center X1000
 Slight banding - Typical field shows tempered martensite and some tempered non-martensitic austenite decomposition products.

It should be noted that two companion plates of the series passed the PTP test at -17°F although the steel quality of the series, judged by that of the subject plate and Plate No. 1X5, was very poor.

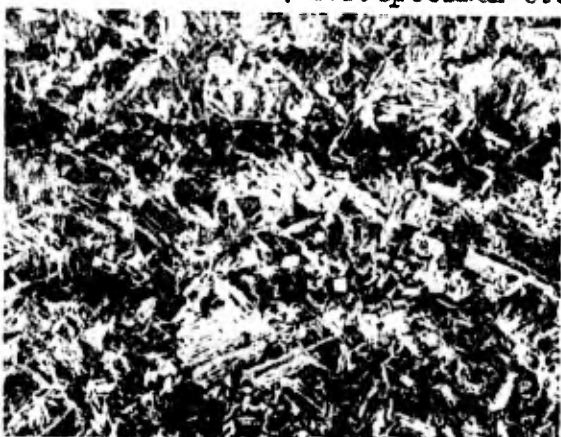
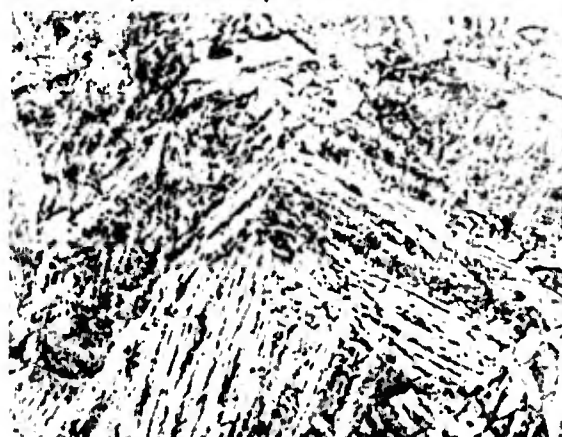
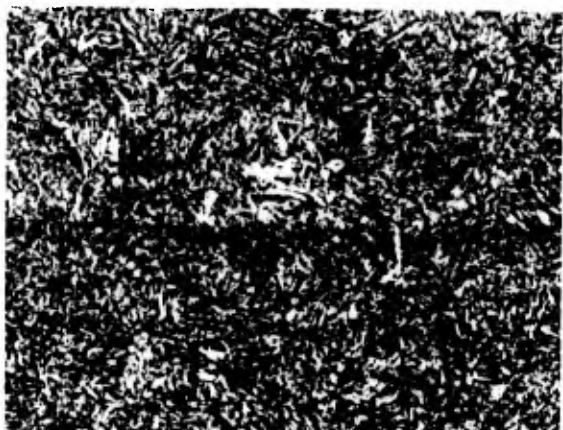
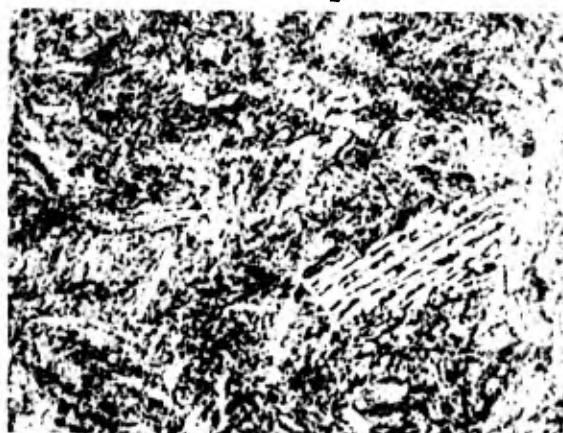
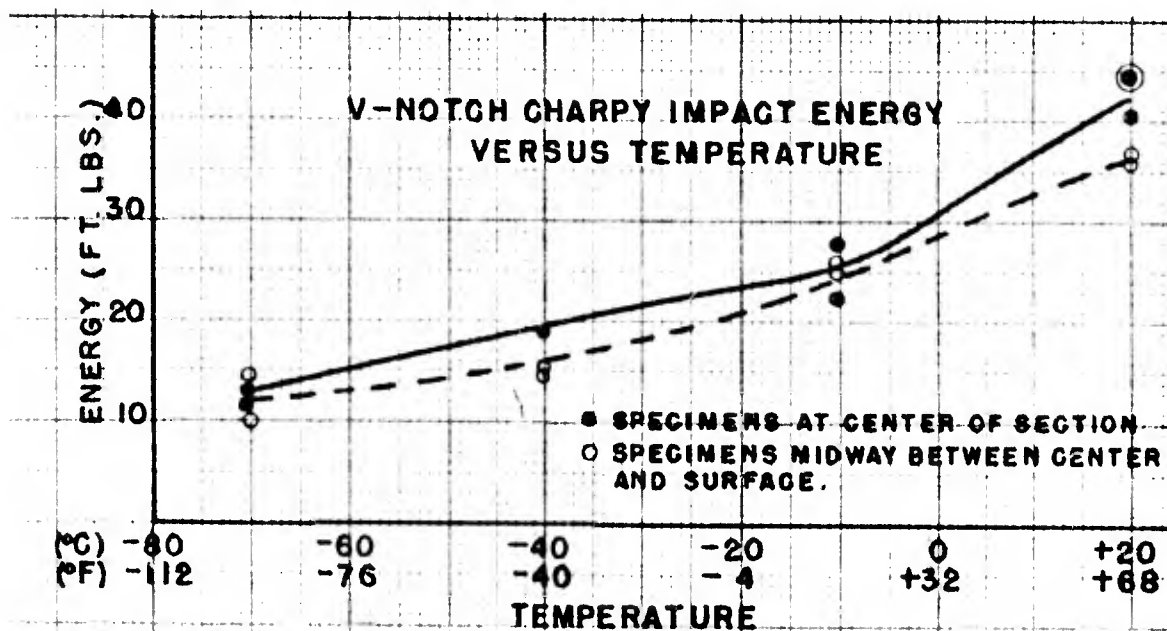
FIGURE 76

Standard (Great Lakes) 1 1/2" Plate No. LX5
 (Microspecimen etched with 4% Picral)

Moderate banding - Typical microstructure is tempered martensite and a great deal of tempered non-martensitic transformation products.

Slight banding - Typical microstructure is tempered martensite and some tempered non-martensitic transformation products.

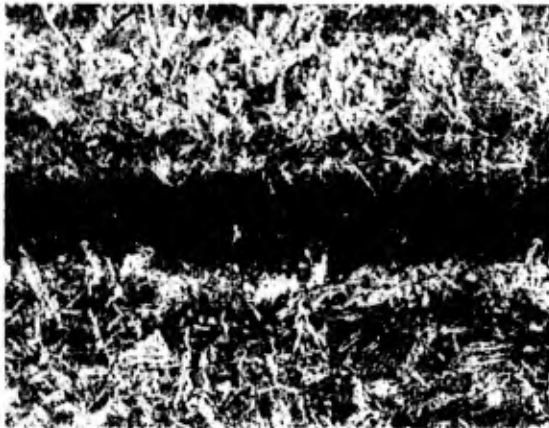
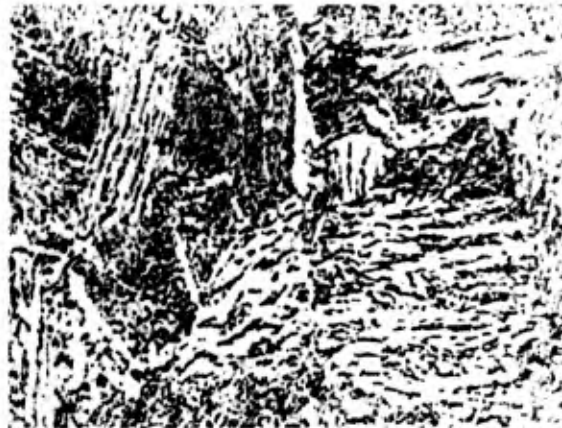
Center of Section

Republic 1 1/2" Plate - Heat No. RH-50307G
 (Microspecimen etched with 4% Picral)

Severe banding - Light-etching matrix consists of tempered martensite and a great deal of tempered non-martensitic products (X1000 photo.).

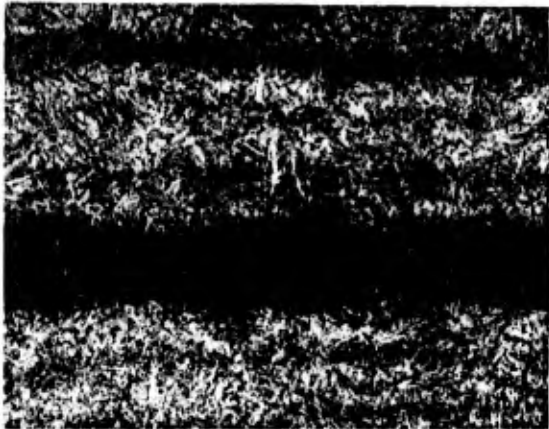
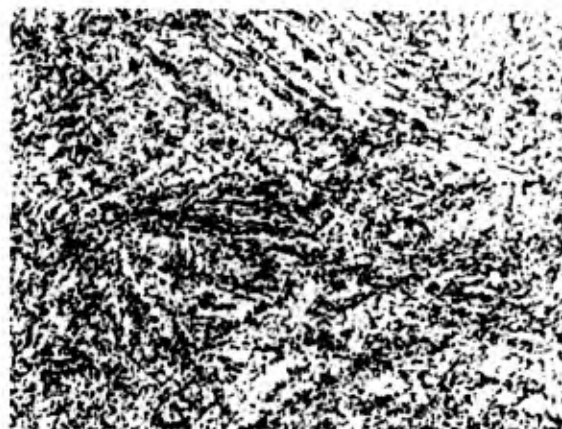
Midway Between Surface and Center

Severe banding - Light-etching matrix consists of tempered martensite and a small amount of tempered non-martensitic products (X1000 photo.).

The steel having inadequate hardenability, a great deal of nonmartensitic transformation products occurred at the center of the section. The low hardness (220 Brinell) at this region (perhaps assisted by the excessive nonmetallic content and unidirectional properties, and resulting very "woody" fracture) was sufficient to counteract the poor microstructure, however, and the material retains its room temperature impact properties down to almost -40°C. The Charpy impact values midway between the surface and center are consistent with the apparently predominantly tempered martensite structure at this location in that the room temperature Charpy impact energy is retained almost down to -70°C. The Charpy level, on the other hand, is much lower than expected for completely quench hardened armor of the same Brinell (245-226) and mechanical treatment, but this may be due largely to the unusual "woodiness" of the fractures. With room temperature Charpy values being retained down to about -40°C throughout the section, the fibre fracture was completely fibrous and ballistic shock performance of the series was excellent.

The failure of this plate to pass the PTP test at -34°F is attributed to the oxide stringers in the material. It should be noted that spalling did not occur in the series until the testing temperature had been lowered to -33°F.

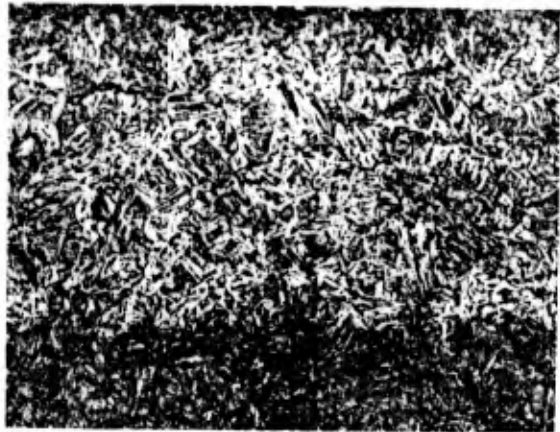
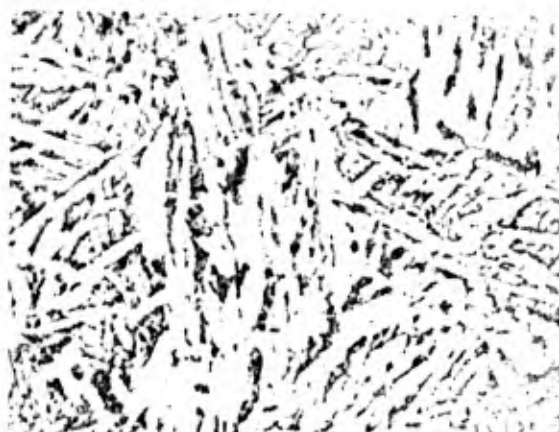
Center of Section

Disston 1¹/₂" Plate No. 5
(Microspecimen etched with 4% Picral)

Severely banded - Light-etching bands consist almost entirely of non-martensitic products and intercritical ferrite (X1000 photo.).

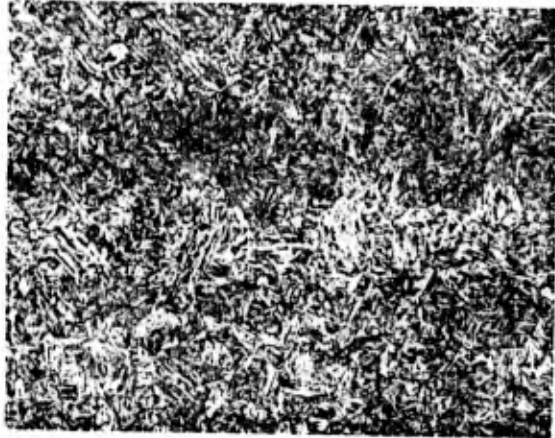
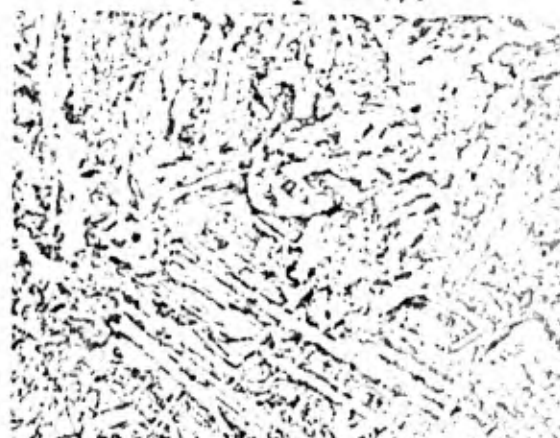
Midway Between Surface and Center

Some banding - Microstructure of the light-etching bands is intercritical ferrite, tempered martensite, and non-martensitic products.

Microstructure, V-notch Charpy impact properties, and fibre fracture of this plate and its companion plate No. 2 are similar. (See Data Sheet No. 6.) From this investigation no reason is evident for the different behaviors of the two plates when shock tested ballistically. In view of the poor shock properties possessed by the subject plate, it would be expected that it also would have failed to resist the slug, and it should be noted that in this series two out of four plates did give unsatisfactory ballistic shock performance.

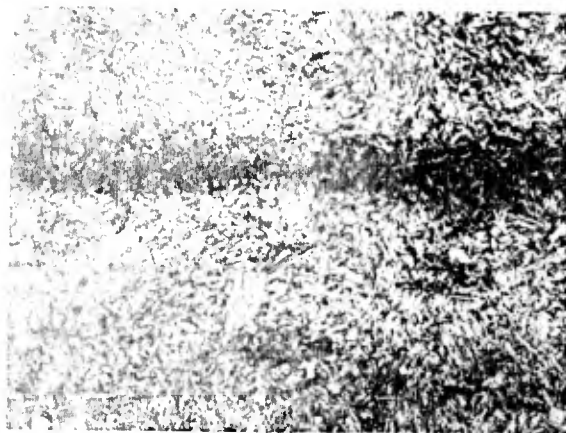
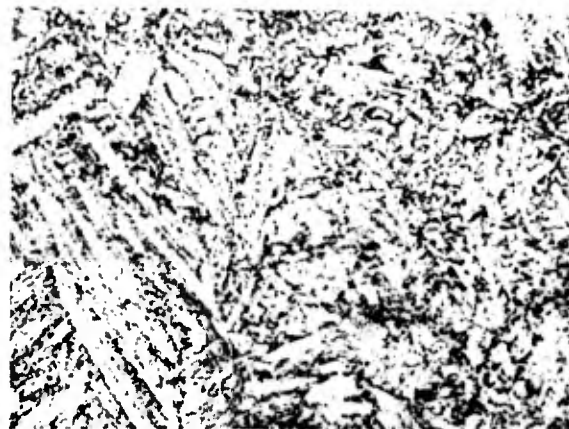
Center of Section

Standard (Youngstown) 1½" Plate No. 1X5
 (Microspecimen etched with 4% Picral)

Moderate banding - Typical microstructure appears to be only acicular tempered martensite and traces of a ferritic non-martensitic transformation product.

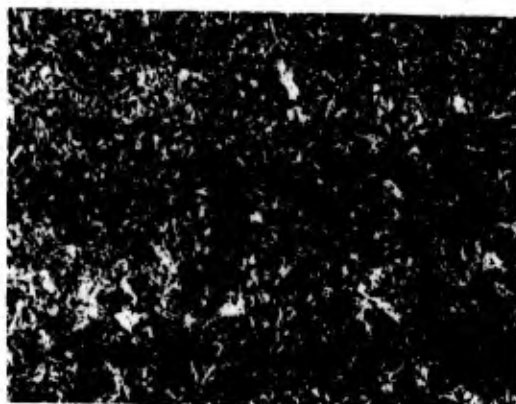
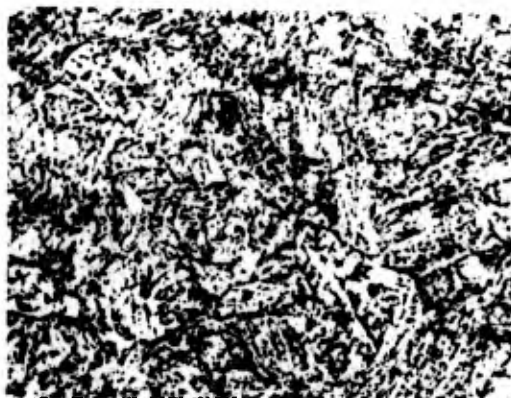
X200 Midway Between Surface and Center **X1000**
 Slight banding - The light etching bands contain tempered martensite and a small amount of tempered non-martensitic products (X1000 photo).

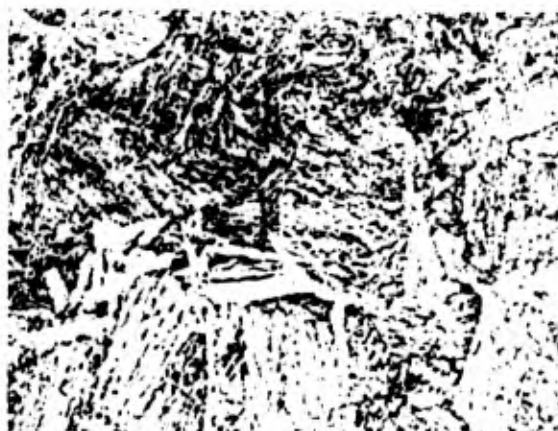
Midway Between Surface and Center

Some banding - Typical microstructure is tempered martensite and a large amount of tempered non-martensitic products.
