Watertown Arsenal Laboratory  
Report Number WAL 710/539  
Problem Number B-4.12

25 October 1943

Metallurgical Examination of Eleven Sections of Enemy Armor  
Including Homogeneous, Flame-Hardened,  
Carburized, and Welded Components

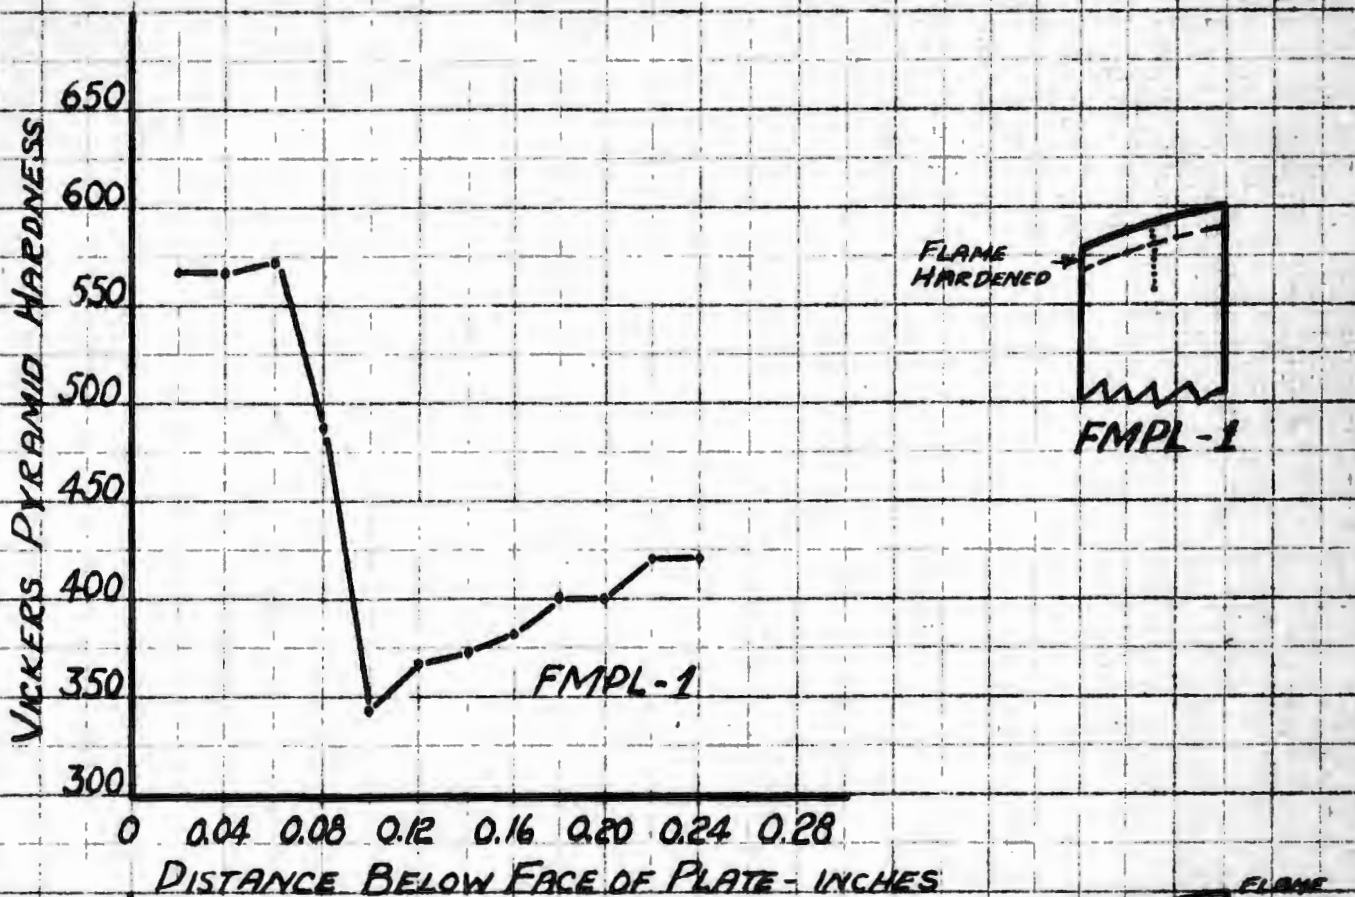
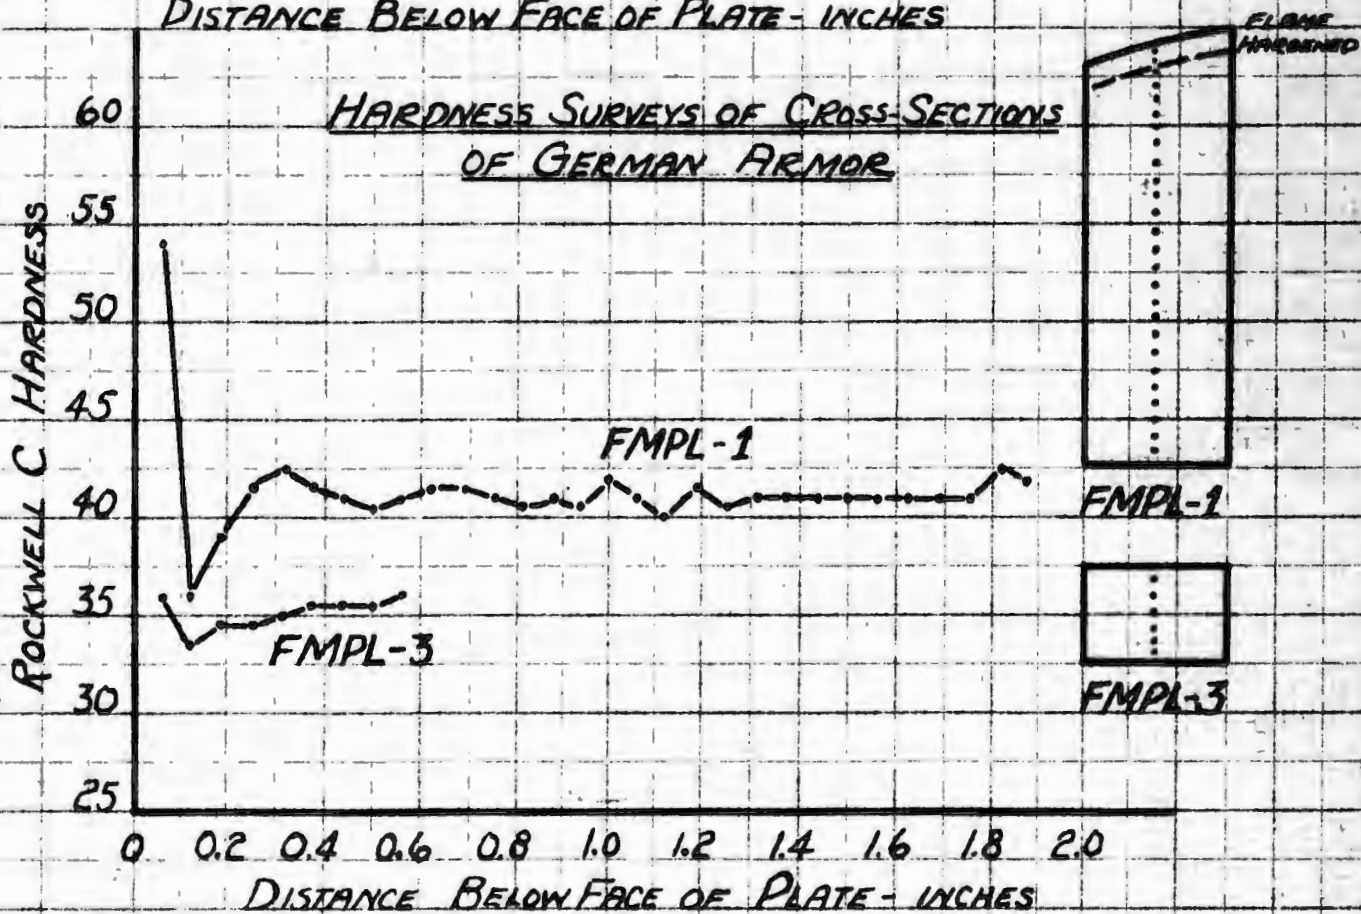
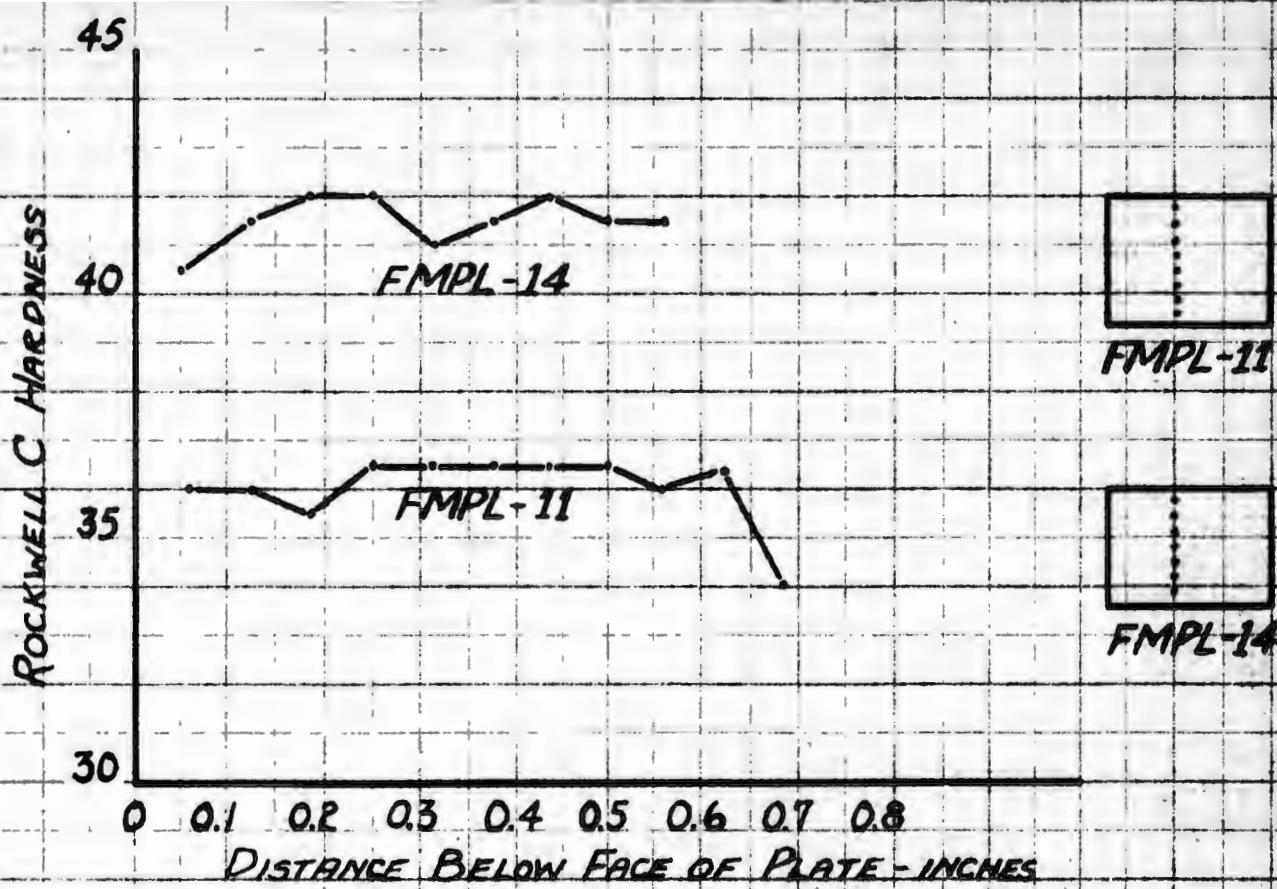
FIGURE 1

Rockwell C and Vickers hardness surveys were made upon cross-sections of the flame-hardened armor components. The graphs of the hardness patterns of plates FMPL-1, 20, and 21 are contained in Figures 1 and 3, and the data summarized in Table II. Brinell hardness impressions were also made on the face and the core of the plates.

Rockwell C hardness surveys were made upon cross-sections of the homogeneous plates, and Brinell impressions were made on both surfaces and on cross-sections cut from the plates. Graphs of Rockwell C hardness surveys of the homogeneous armor are contained in Figures 1, 2, and 4, and the data summarized in Table V.

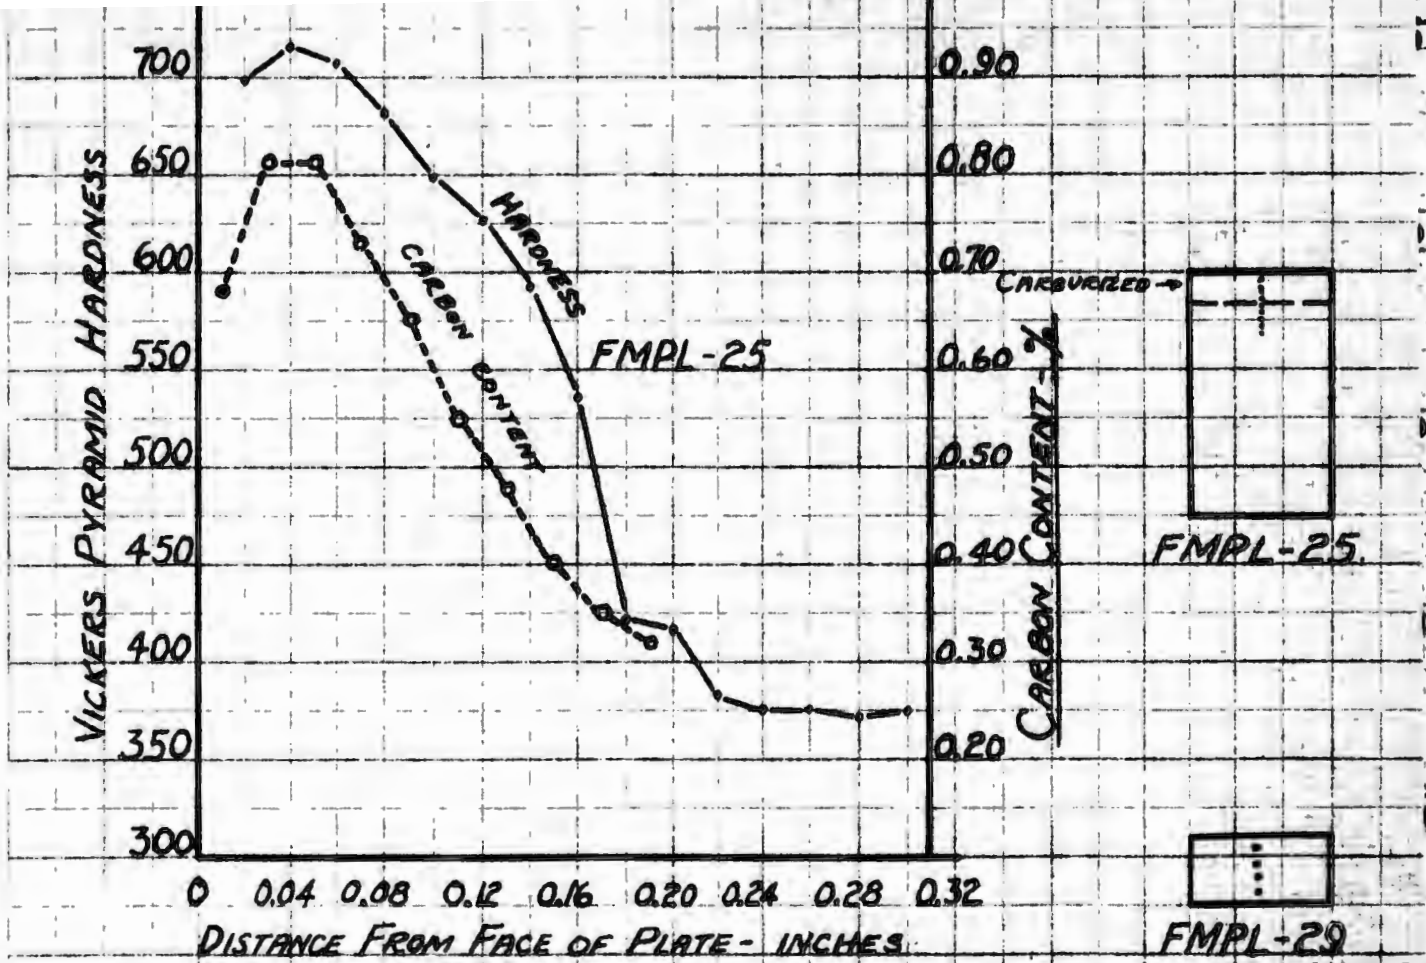
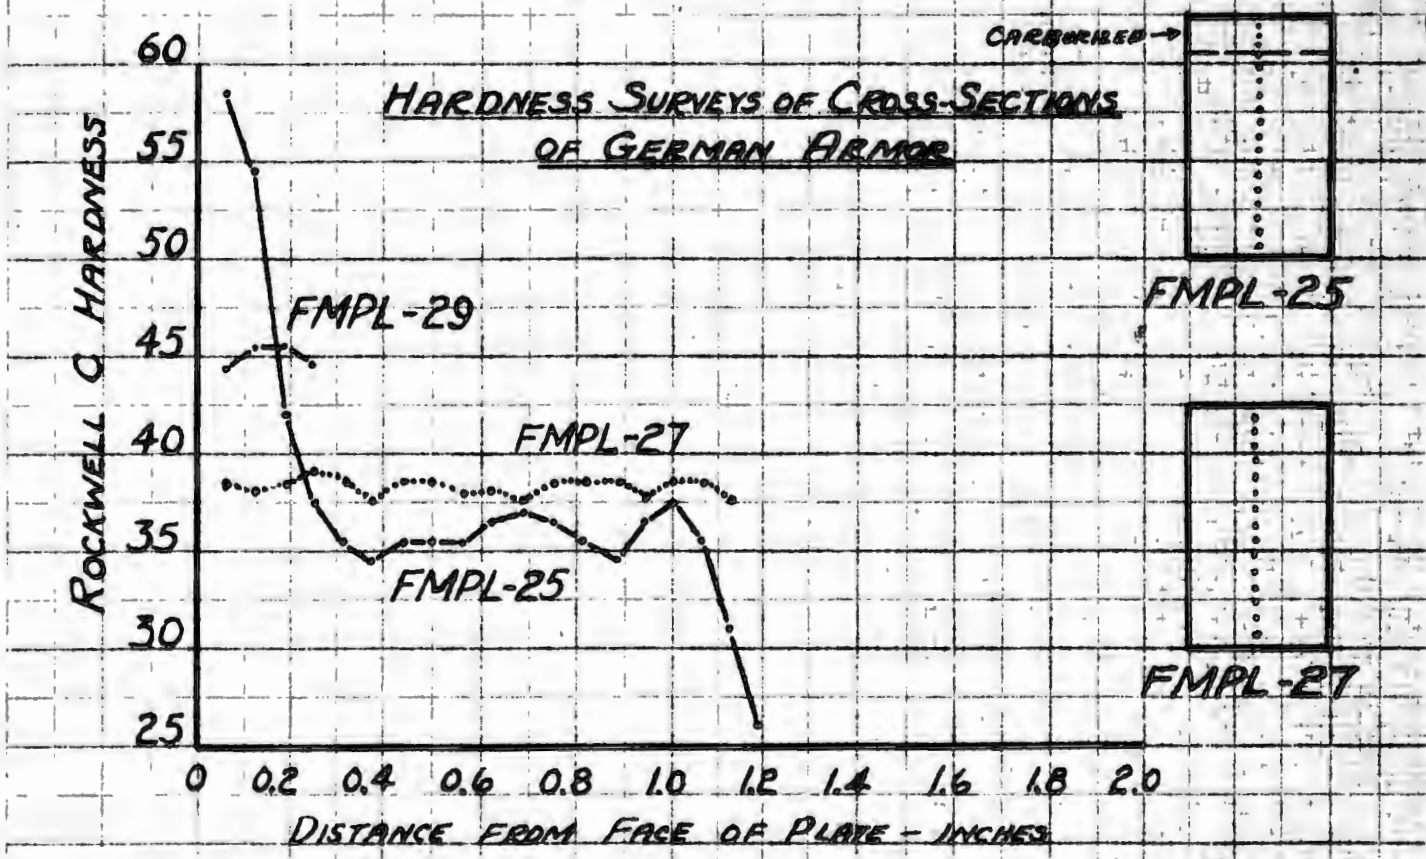
FIGURE 4

A piece of plate FMPL-25 was annealed, and chips were milled from ten consecutive layers, each 0.020" thick, and analyzed for carbon. The curve of the carbon gradient is shown in the upper portion of Figure 4. The surface is slightly decarburized, with the first 0.020" layer having a carbon content of 0.68%. The maximum carbon content of the case is 0.81%, with a gradual decrease to 0.32% C at a distance of 0.180-0.200" below the plate surface.

Vickers and Rockwell C hardness surveys through the cross-section of plate FMPL-25 are shown in Figure 4 and, together with Brinell surveys, are summarized in Table III.

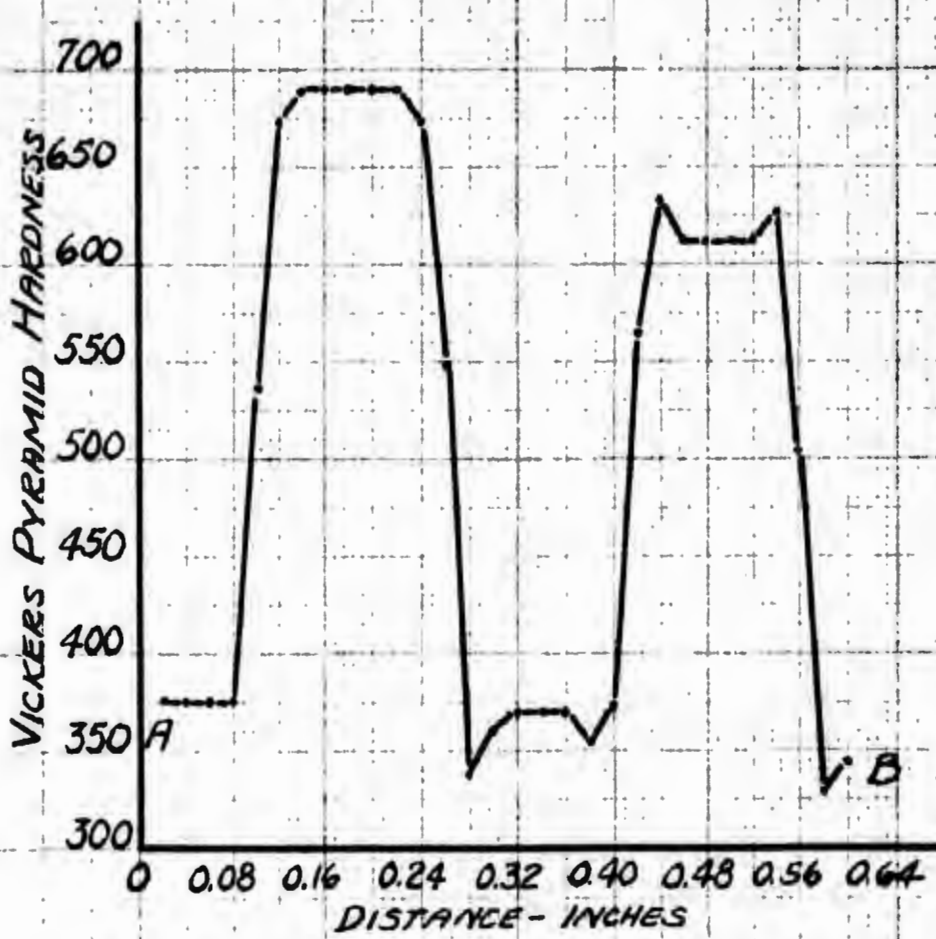
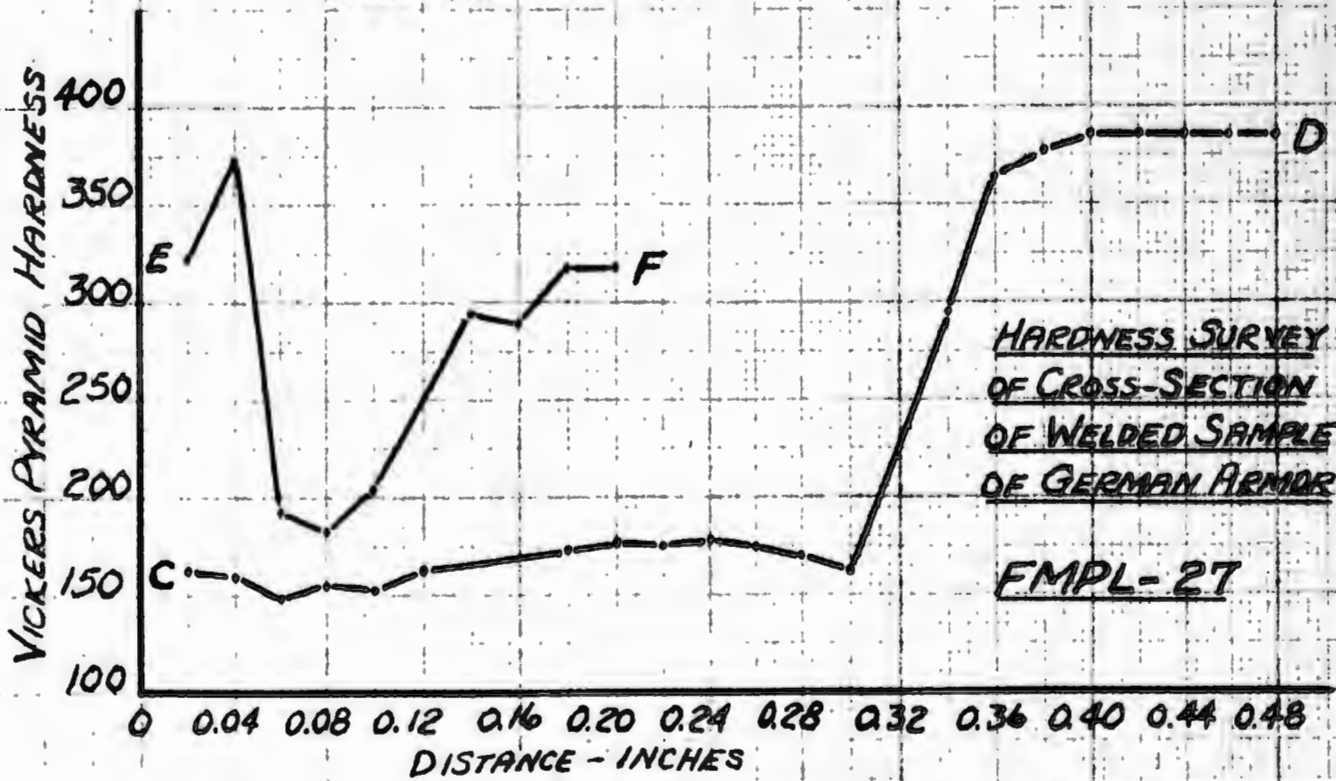
FIGURE 5

Vickers hardness surveys made across the weld deposits, heat affected zones, welded attachments, and base metal of the weldments on plates FMPL-27, 28, and 29 are shown graphically in Figures 5, 6, and 7 respectively. Pertinent data are summarized in Table VII.

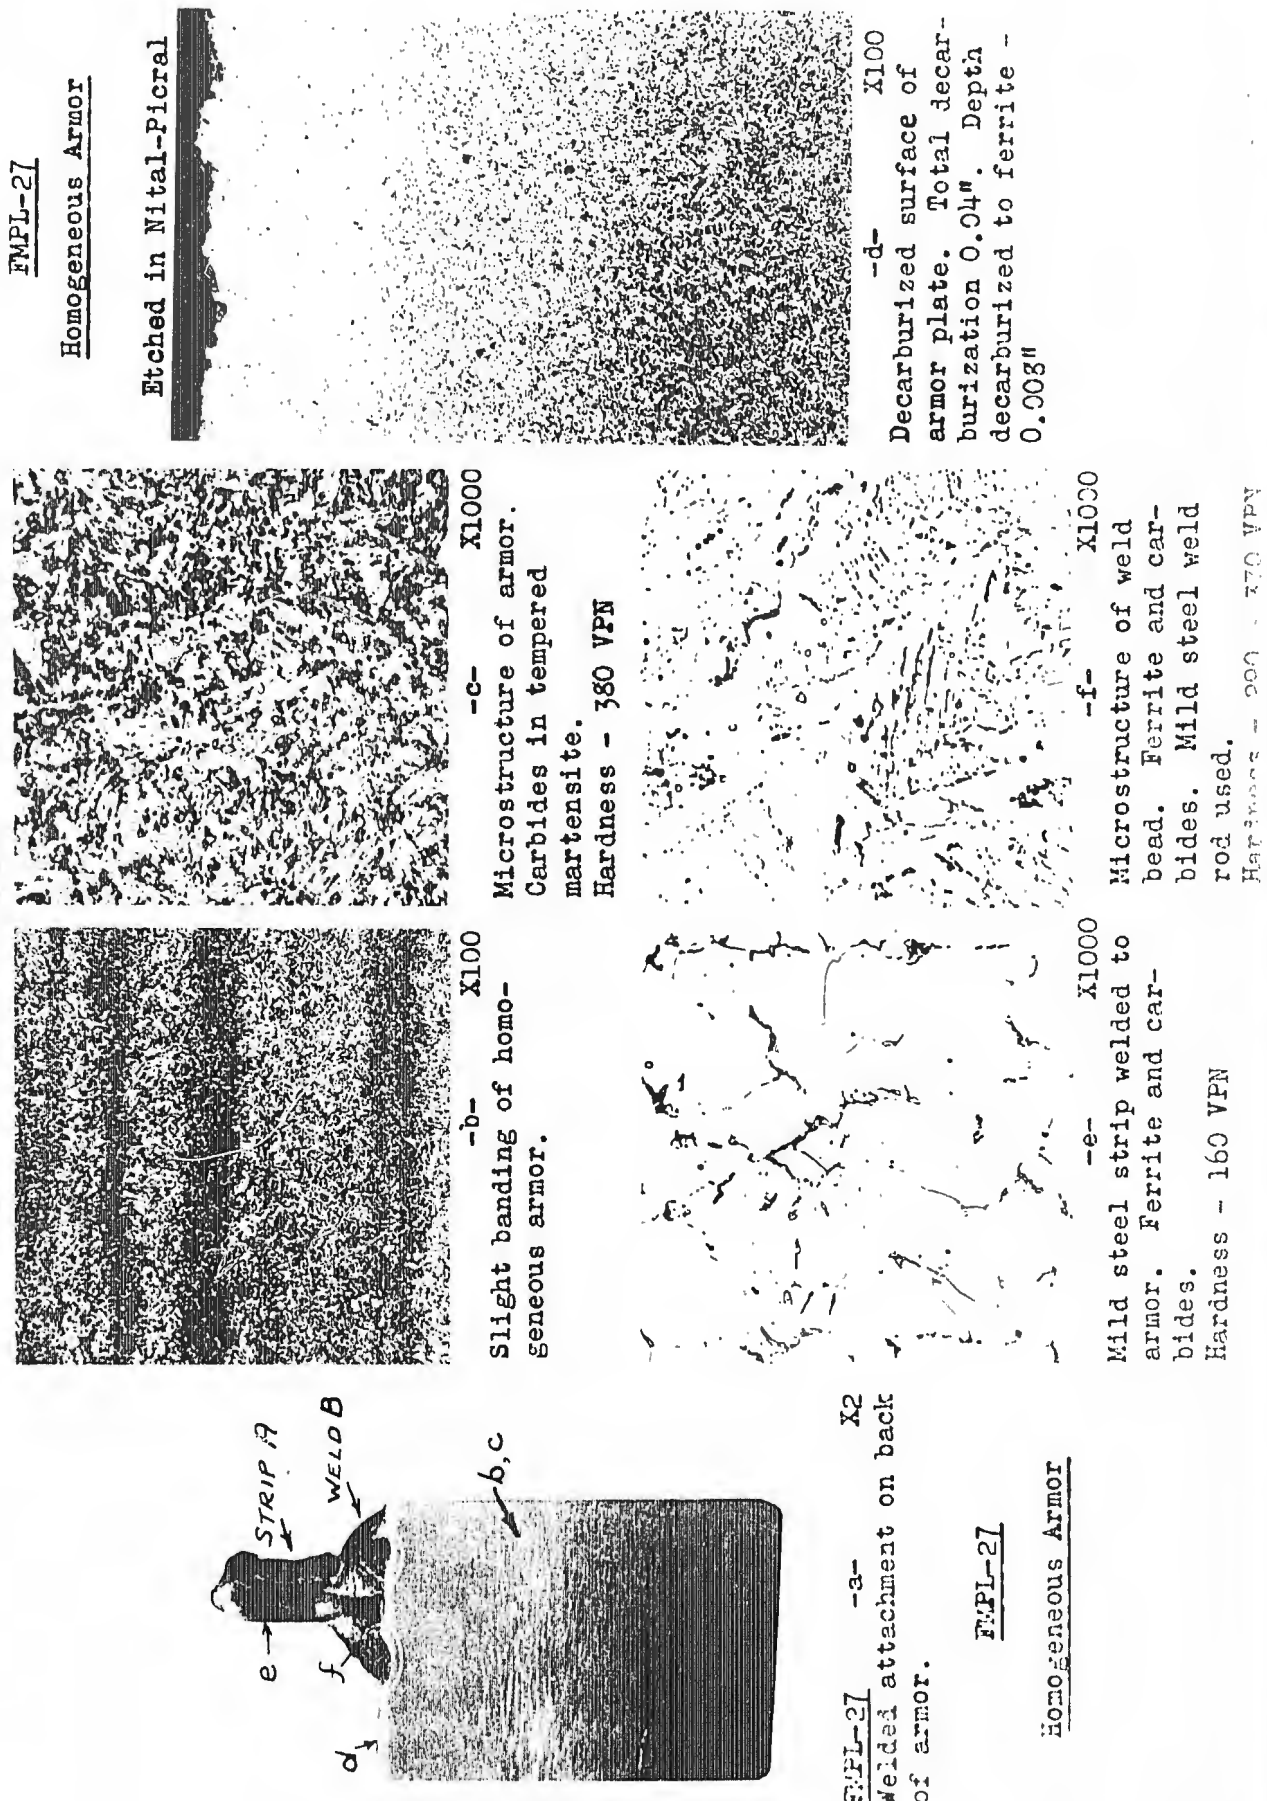
FMPL-27

-c- X1000  
Microstructure of armor. Carbides in tempered martensite. Hardness - 380 VPN

-f- X1000  
Microstructure of weld bead. Ferrite and carbides. Mild steel weld rod used. Hardness - 200 - 370 VPN
