Watertown Arsenal Laboratory
 Report No. WAL 710/608
 Problem No. D-2.3

4 April 1944

ARMOR AND WELDING

Metallurgical Examination of Armor and Welded Joints
 from German PzKw IV Tank, Model GF-2

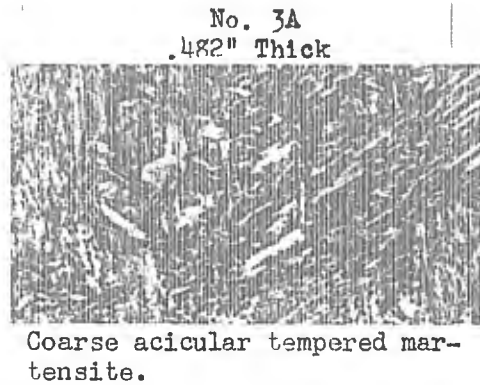
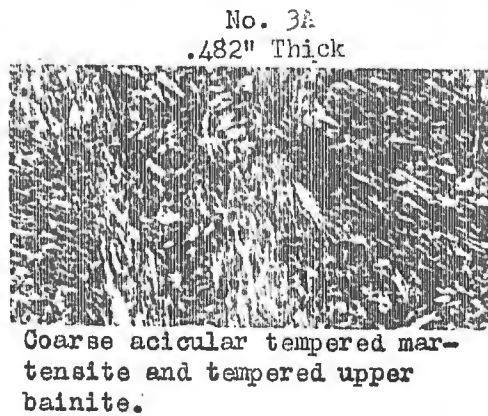
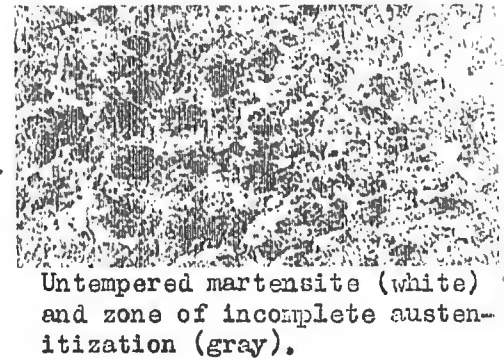
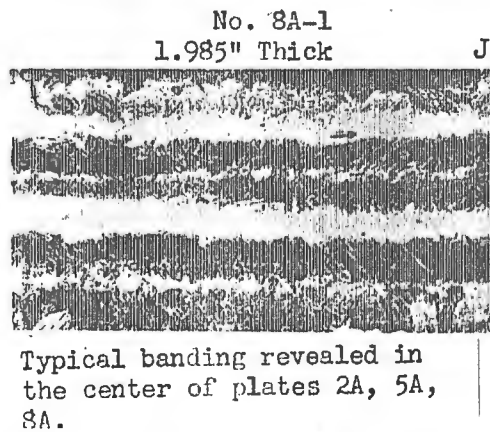
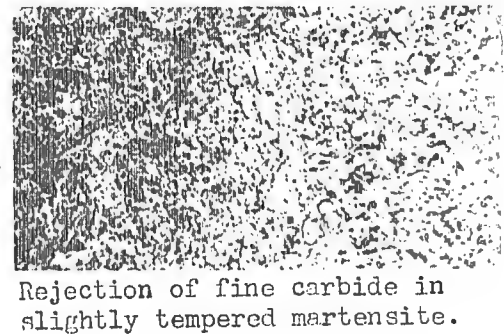
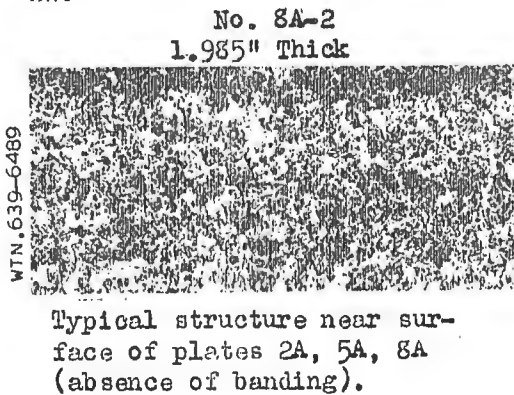
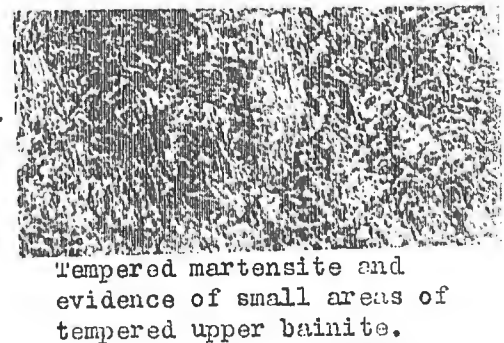
FIGURE 7

The hard cases of Plates Nos. 1A, 2A, 5A, and 8A, were typical of flame-hardened plates. The outer cases consisted of untempered white martensite and the center cases showed the presence of a martensitic matrix with remnants of the prior tempered structures. The microstructures of the junction of case and core revealed the presence of fine carbides in tempered martensite. The microstructure of the steel bases in all cases consisted of coarse tempered martensite and tempered upper bainite (Figures 6, 7 and 8). This microstructure of the tempered base steel is associated with crystalline fractures and poor V-notch impact properties discussed previously.

Pronounced banding of metallic segregation indicated by the Oberhoffer etch was revealed in the center sections of Plates Nos. 2A, 5A, and 8A, while the areas near the surfaces of these plates were relatively free from this type of segregation (Figure 7). The grain size of the steel bases varied from ASTM No. 1 to No. 8, while the hard faces of the samples had a grain size of ASTM No. 7 to No. 8 (Figure 9).

Microstructure of Samples from PZKW 1V Model G F-2 German Tank

All photomicrographs X1000 - Picral etch, nos. 8A-1 & 8A-2 were taken at X100 - Oberhoffer etch.
