DDC
07
2
REPORT NATF-EN-1135

EVALUATION OF BAK-14 HOOK-CABLE
SUPPORT-SYSTEM MODIFICATIONS

Waldemar Wastallo
Recovery Division, Engineering Department
Naval Air Test Facility
Naval Air Station
Lakehurst, New Jersey 08733

FINAL REPORT

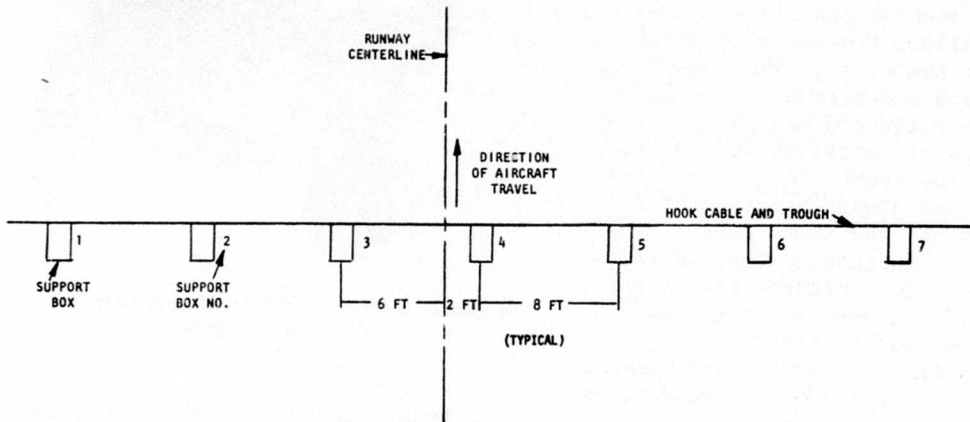
FIGURE I - SKETCH OF THE BAK-14 RETRACTABLE HOOK-CABLE SUPPORT SYSTEM

2. The most frequently damaged components of the BAK-14 system were contained in runway support boxes 2, 3, 4, and 5 (see Figure 1) which are located near the runway centerline. The support blocks at these locations sustained the highest number of aircraft tire impacts and near impacts which severely damaged the support mechanisms within the boxes. Damage to support mechanisms within boxes 1, 6, and 7 by comparison was negligible.

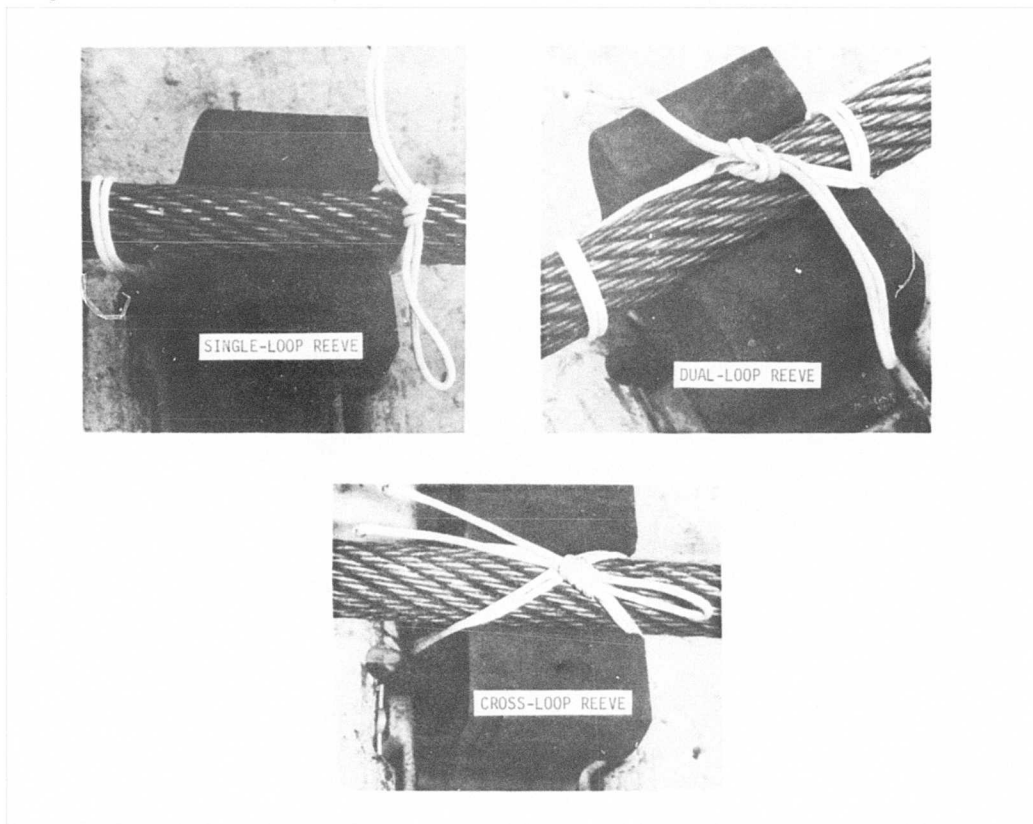
FIGURE 7 - THE STANDARD SINGLE-LOOP-REEVE, THE DUAL-LOOP-REEVE, AND THE CROSS-LOOP-REEVE RESTRAINTS

1. STANDARD SINGLE-LOOP-REEVE RESTRAINT (Figure 12): The axial movement of the hook cable caused by the aircraft trample shifted the looped cord away from the side of the support block. The extended loop was then exposed to chafing contact against the support-box cover when the support arm was depressed by the aircraft trample. Seven single-loop-reeve restraints failed or were damaged in this manner during the 18 aircraft tramples.

2. DUAL-LOOP-REEVE RESTRAINT (Figure 13): Two failures occurred during completion of 30 aircraft tramples with the dual-loop-reeve restraint; namely, a failure of the restraint cord, and a failure to retain the hook cable in the modified open-top support block although the restraint was still intact. Both failures may have been caused by the decreased strength and the increased elasticity of the dual-loop reeve which divides the hook-cable restraint load among four cords compared to eight cords in the standard single-loop reeve and the cross-loop reeve.

3. CROSS-LOOP-REEVE RESTRAINT (Figure 14): The cross-loop-reeve restraint was not shifted out of position by the axial movement of the hook cable as was the standard single-loop-reeve restraint. It, therefore, was not subject to chafing by the support-box cover. By comparison, only minor chafing damage was experienced during the completion of 77 aircraft tramples with this restraint configuration. High-speed motion-picture coverage indicates that the most effective restraint and retention of the hook cable was provided by the cross-loop reeve.
