TECHNICAL REPORT 4842

DYNAMIC ANALYSIS OF THE SAFING AND ARMING SYSTEM FOR PD FUZE M572E2

EDWIN B. ENTIN

MARCH 1976

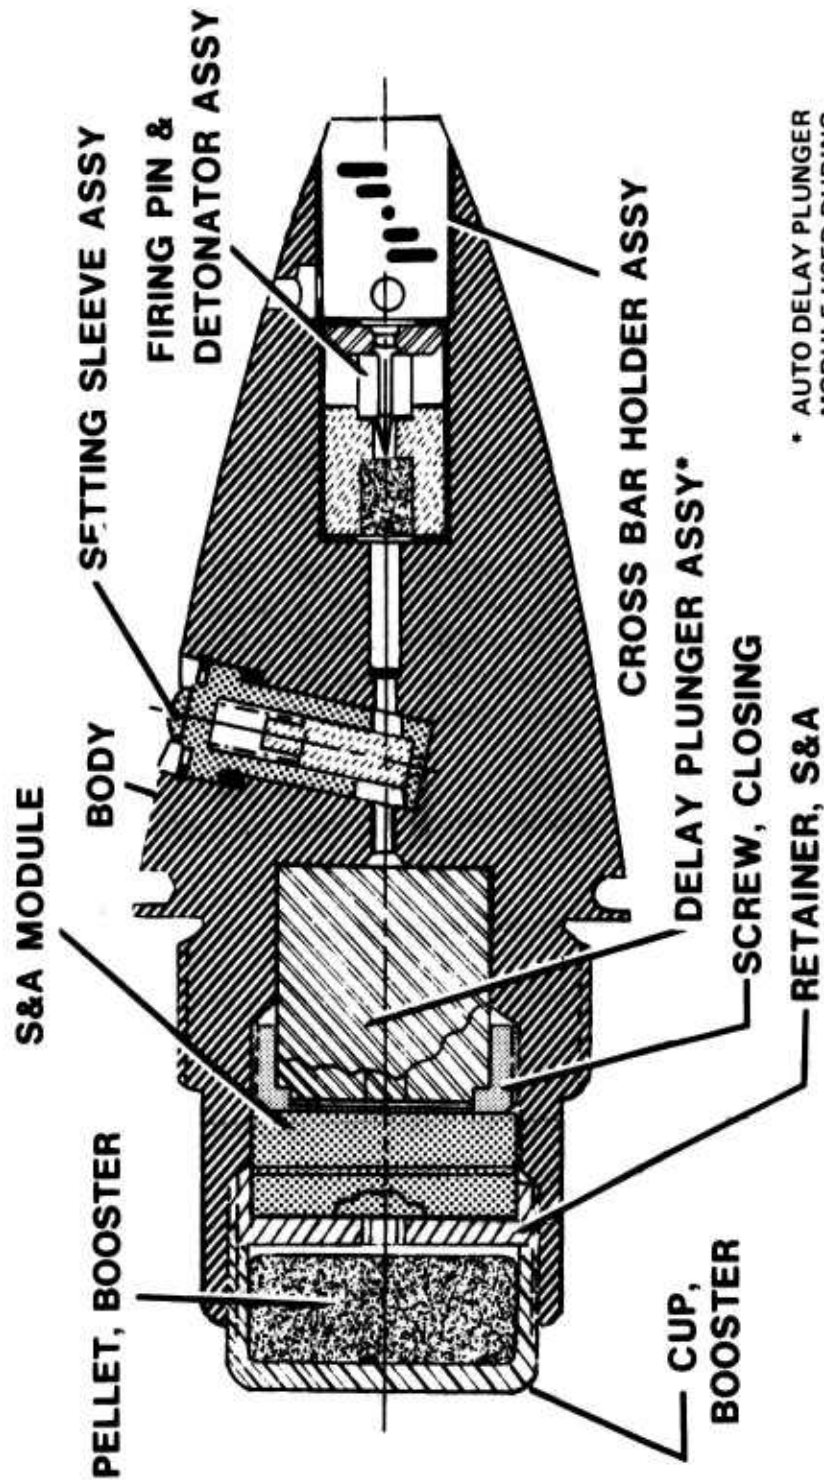
Fig 1 Cross section of fuze M572E2

* AUTO DELAY PLUNGER
MODULE USED DURING
1972 & 1973 ET/ST
TESTING

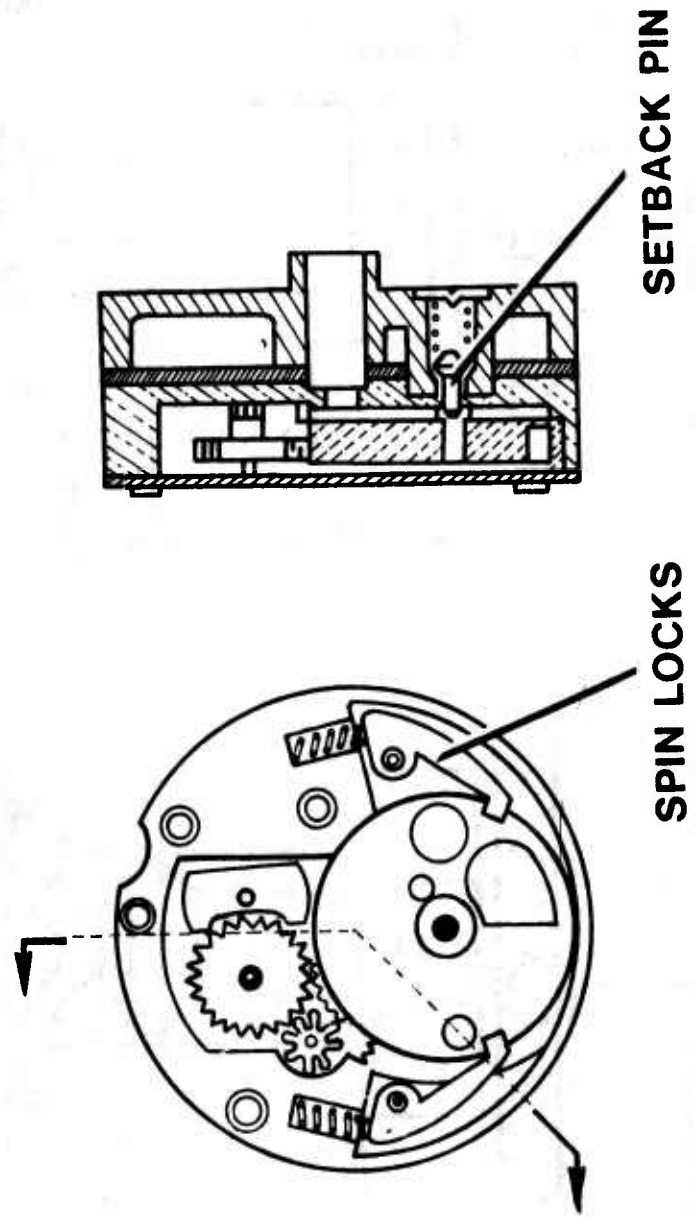
Fig 3 Safety features in S&A module

7. An illustration of the S&A module, indicating the safety features, is shown in Figure 3. The final changes made to the setback pin and cavity area of the S&A, and to relocate the rotor gear stake are shown in Figures 4 and 5, respectively.

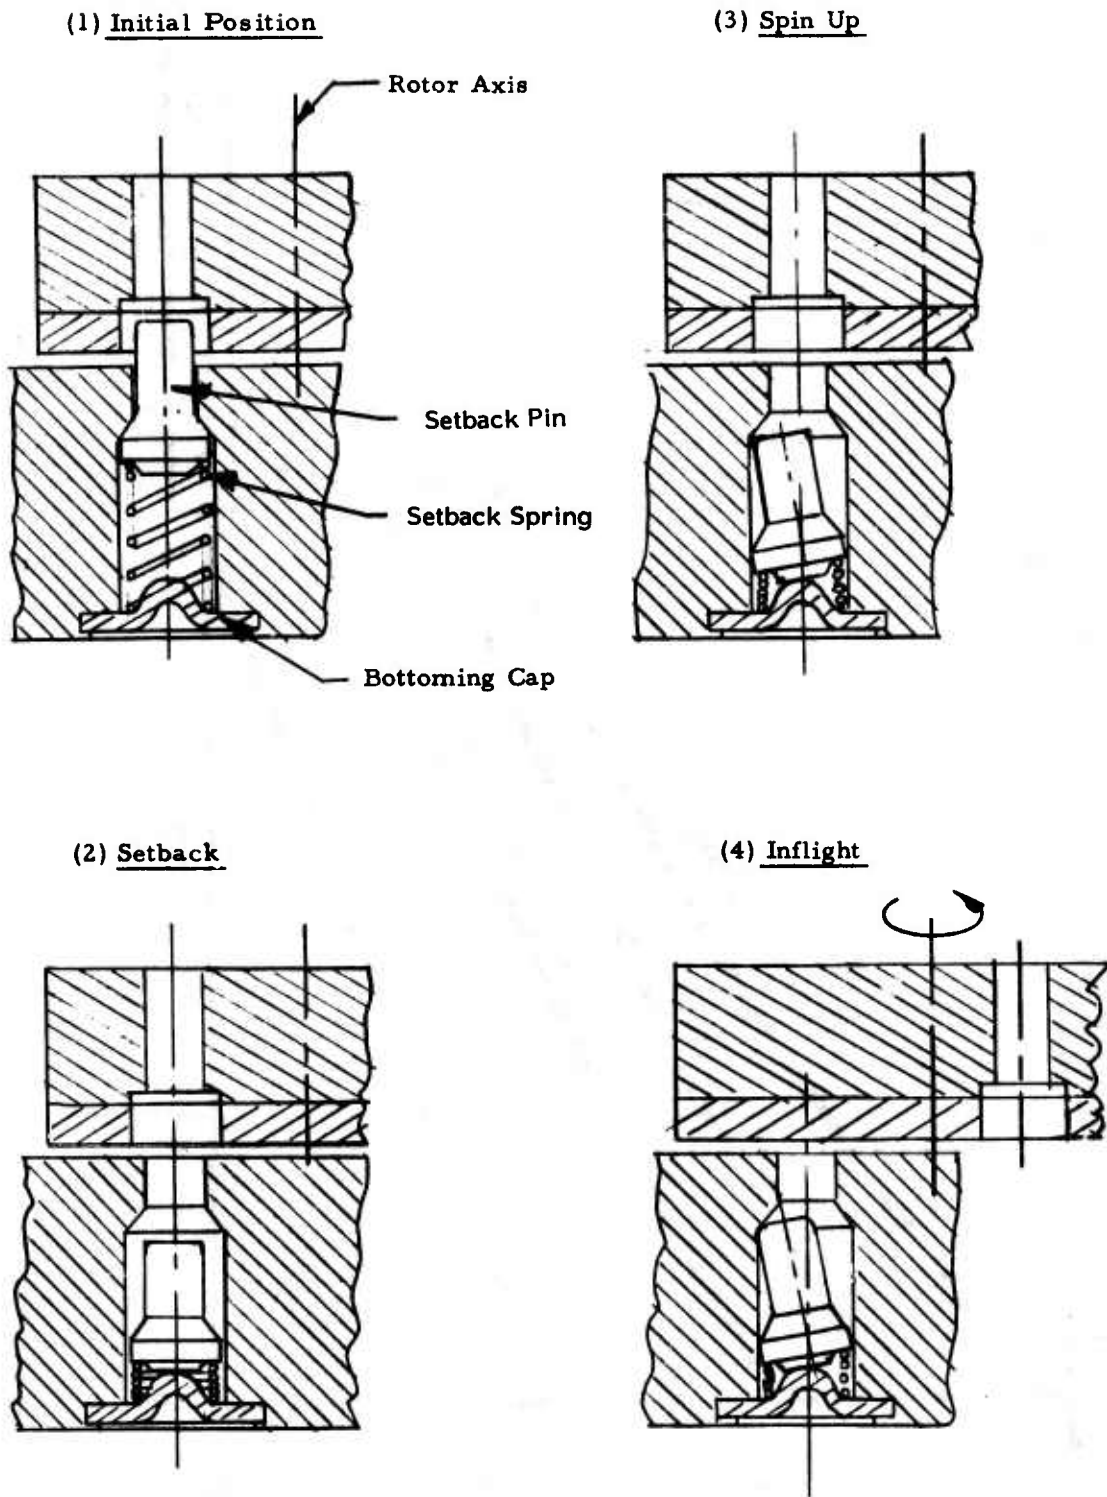
Fig 6 Setback-pin functioning sequence

the onset of setback, the pin moves aft and releases the rotor. With side forces arising from balloting or tube vibrations neglected for the moment, the pin, after several initial axial bounces, is expected to remain aft throughout most of the setback curve. As spin increases (Fig 6), the pin may pivot on the rather pointed top of the aluminum dimpled disc toward the cavity sidewall. When the muzzle is cleared, the spring force is insufficient to slide the pin forward against the retarding forces introduced by the side and ramp of the cavity, if the spin is high enough. Under most firing conditions, the setback pin apparently behaves as expected and the rotor is permanently released. The duds, though, were limited to low-zone firings of the 155 mm and 8-inch howitzers.

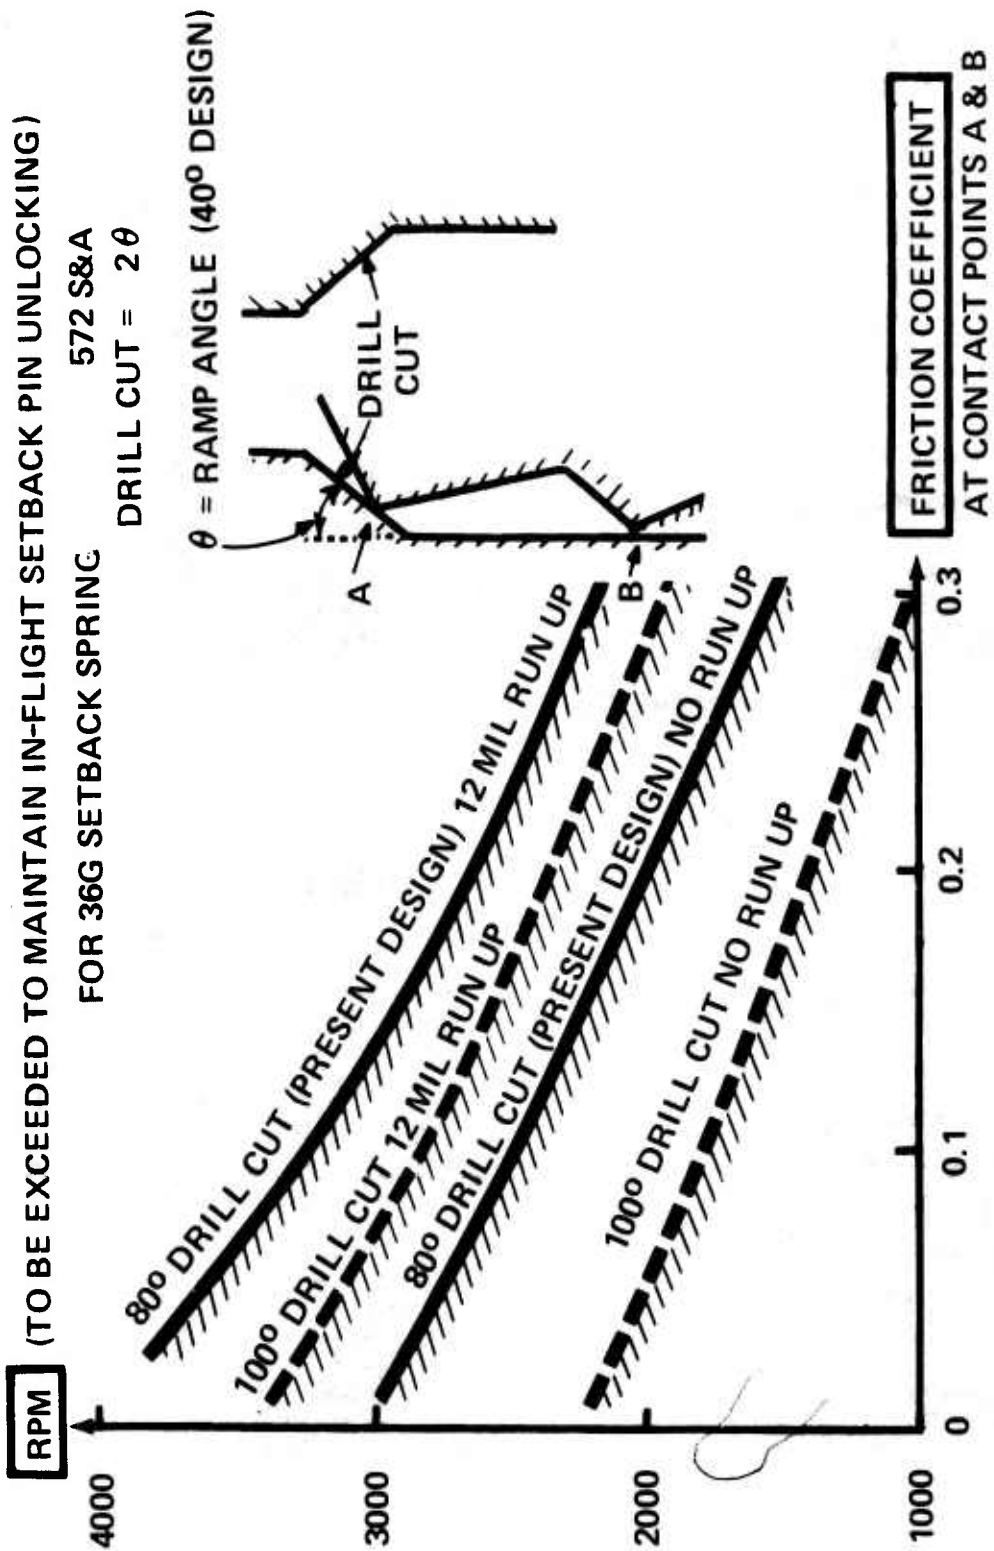
Fig 7 Setback-pin analysis

The dynamic analysis showed that for low-zone firings after the shell exited the muzzle, a degree of marginality was being reached in the design considered if the friction coefficient between pin and cavity began reaching a low value of about 0.15. The model considered pin motion up along the cavity wall and ramp under the influence of spring and spin forces. With the initial conditions of the pin in the bottomed, tilted position upon muzzle exit, the pin ordinarily did not reinsert; if it did, it occurred in about seven milliseconds after muzzle exit. Figure 7 shows this demarcation. Axial tolerances can allow the pin some "run up" distance along the wall before the ramp is engaged. Any introduction of appreciable side forces just at muzzle exit can produce temporary separation of the pin from the sidewall, resulting in an "effective" lowered friction coefficient.

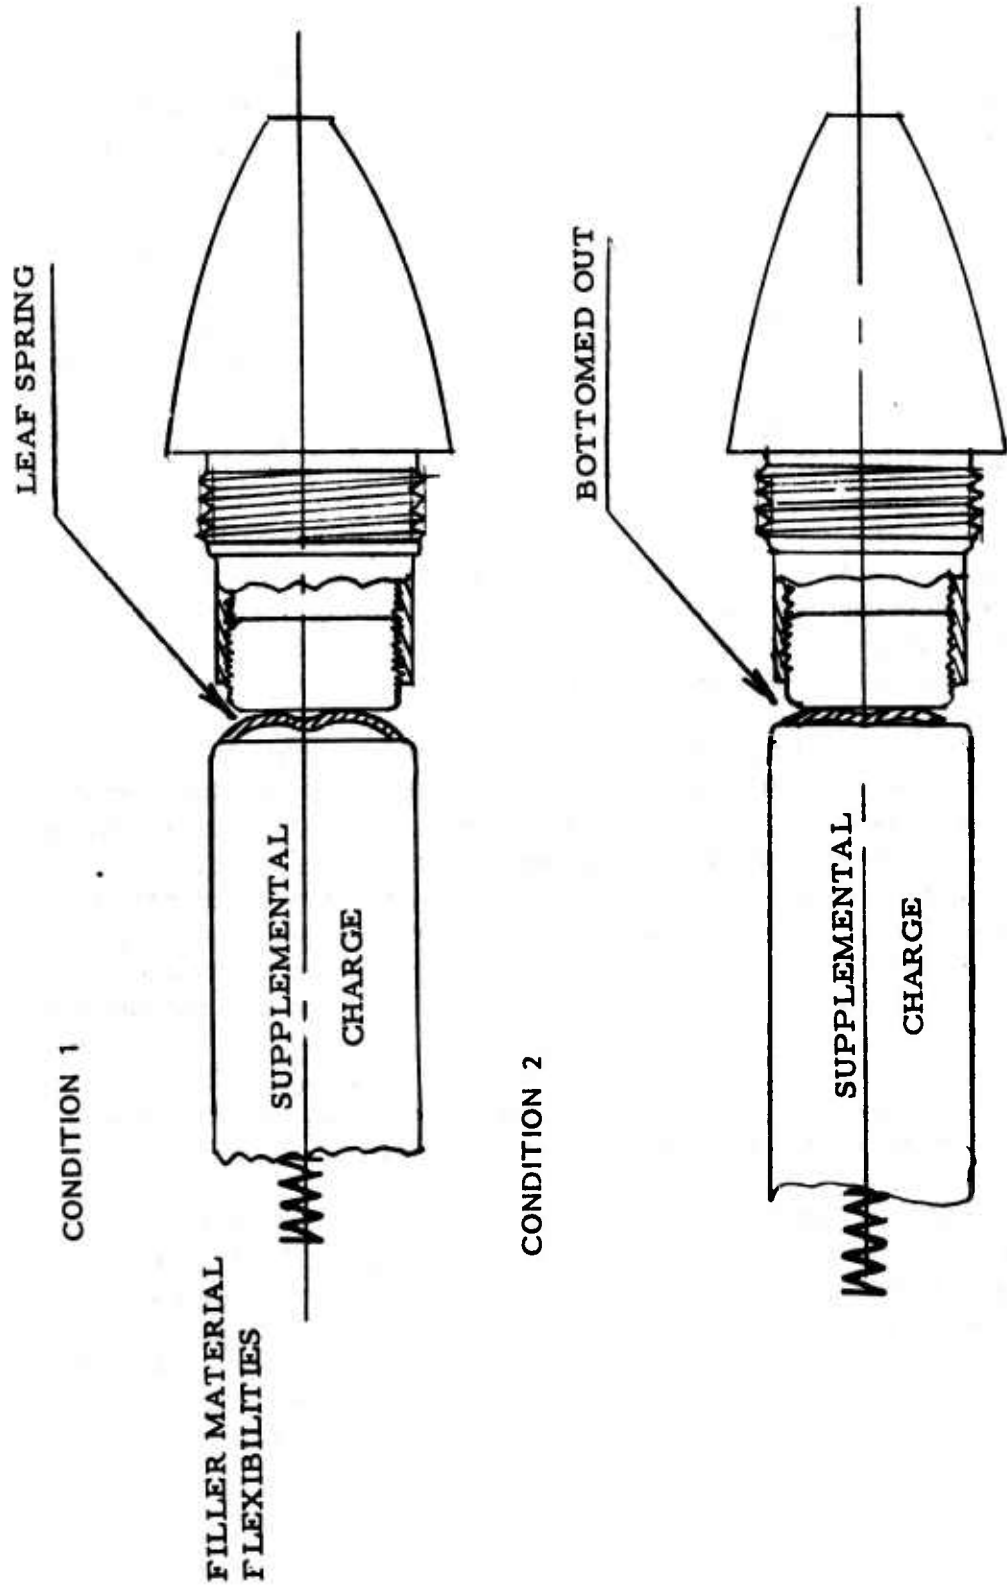
Fig 12 Supplemental charge model

The model includes elastic collisions of the pin in bottoming out and reseating impacts. Another subsystem included in the model is the supplemental charge in its relative motion within its cavity toward the fuze. The retaining leaf spring operates in two stiffness zones due to the bottoming out of the center section. This sudden change in stiffness can result in an impulse being applied directly to the boosting charge cap which, in turn, could excite unwanted setback-pin response (see Fig 12).

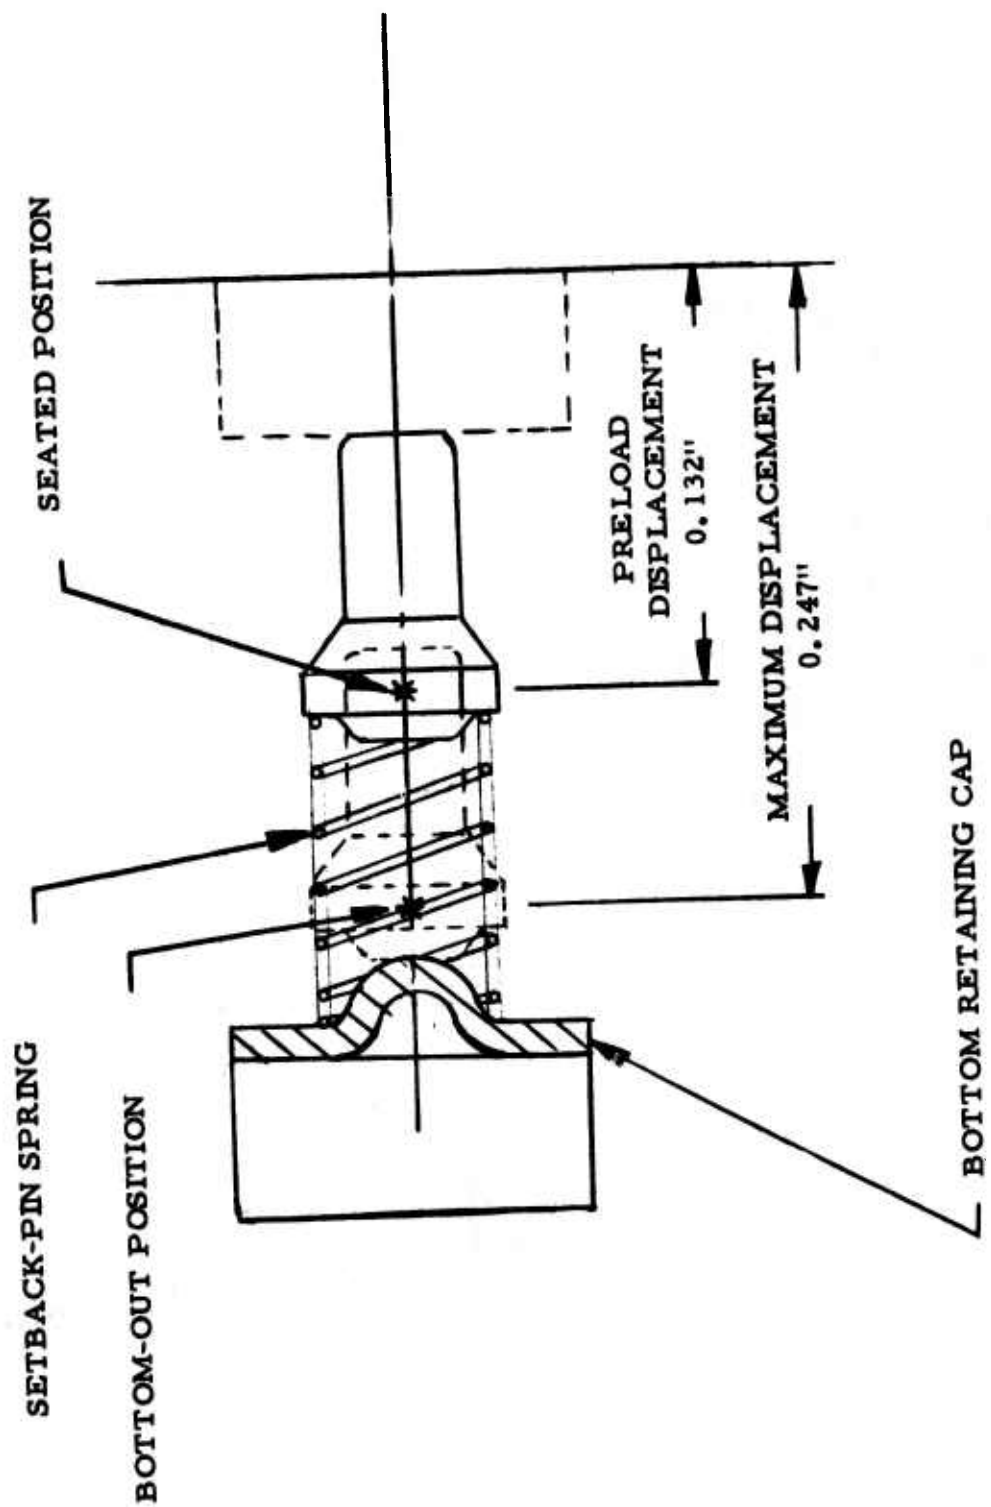
Fig 13 Setback-pin model

In view of the fact that the structural flexibility appeared negligible for the zone 1 simulation, this model was downgraded to a much simpler model consisting of only three degrees-of-freedom (Fig 13). This model was exercised for the same conditions in order to compare setback-pin responses. The response was essentially identical to the response generated by the 33 degrees-of-freedom system. Consequently, the simpler model was used to investigate pin response as a function of simulated engineering design changes.

Five runs were made with increased damping for the setback-spring motion between boundaries, while keeping boundary collisions with zero damping (perfectly elastic). This was recognized to be a very conservative assumption. The rationale involved searching for a positive fix to the problem which would effect a solution under the worst conditions. (These conditions included perfectly elastic rebounding and continuous lateral alignment.) Relative damping ratios of 25-, 50-, 100-, 1,000-, and 10,000- percent critical were investigated. The time for initial reseating ranged from almost immediately after muzzle exit for 25 percent critical, to about five milliseconds for 100 percent, to about 54 milliseconds for 1,000 percent. One of the pertinent results demonstrated by these solutions is that if the pin comes to a position of alignment for any of the reasons discussed above, even without rebounding motion, the setback-pin spring itself can cause reseating shortly after muzzle exit. The 25-, 50-, 100-, and 1,000-percent critical conditions are illustrated in Figures 14, 15, 16, and 17, respectively, where muzzle exit occurs at 29.5 millisecond (0.0295 time). The ordinate "0.25" represents pin bottoming, and the ordinate "0.13" represents seating of the pin in the rotor. For pin motion unrestrained by friction forces along the cavity wall, it was apparent that significant dash-pot type damping is required to guarantee successful operation after the shell leaves the muzzle.

1. Added damping to the motion of the setback pin while the pin is moving between its axial boundaries.
2. Changing the stiffness of the setback-pin spring.
3. Increasing the setback-pin stroke.

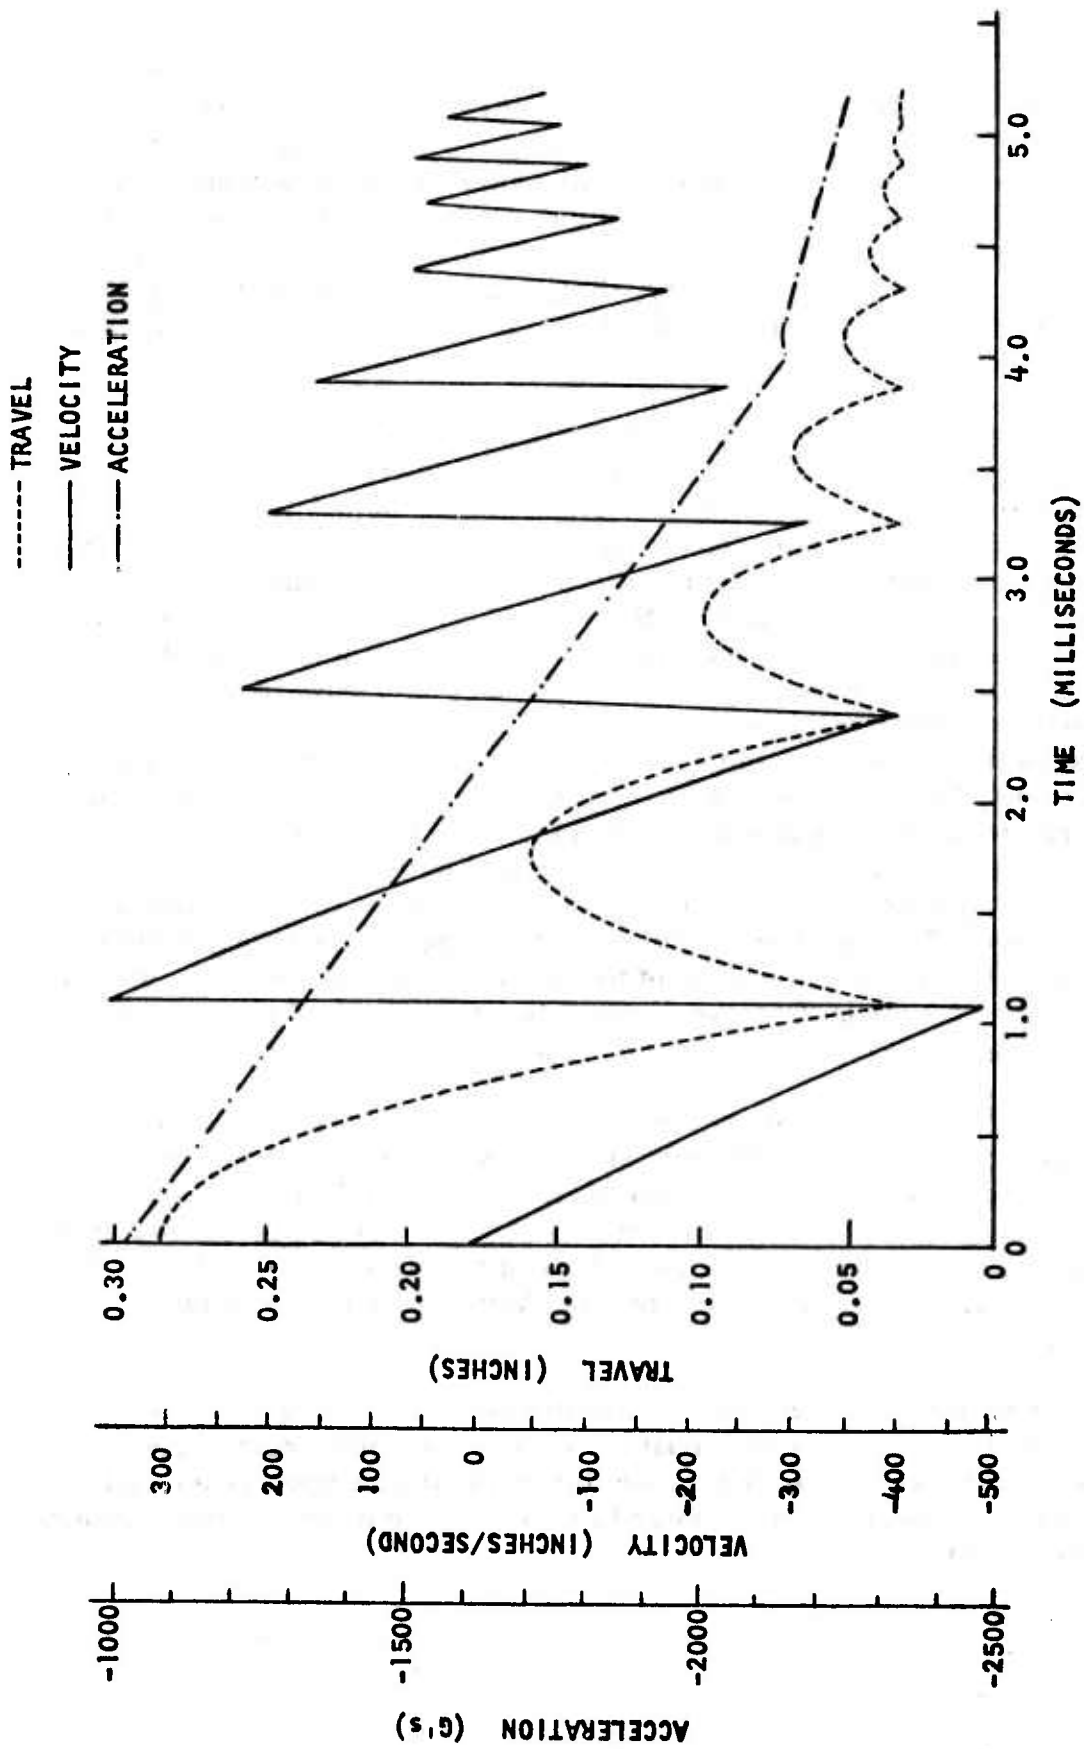
Fig 20 Parabolic-type bounce for tungsten setback-pin design (PA-34)

surface, centrifugal acceleration is insufficient to cause the pin to tilt toward the wall while the projectile is still in the barrel. Thus, for such a configuration, the pin will remain bottomed, but upright. On exit, the setback acceleration disappears, and centrifugal force will act to tip the pin. The model showed that six of the eight pins will tip over in about two milliseconds. The slide program, discussed below, indicated that in most cases, for a long cavity, the pin will not have reached the ramp position by that time; therefore, the tip of the pin will be trapped behind the ramp.
