IMPROVED WINDSHIELD AND CANOPY PROTECTION  
DEVELOPMENT PROGRAM

H. EDWARD LITTELL, JR.  
PPG INDUSTRIES, INC.  
PITTSBURGH, PA. 15238

TECHNICAL REPORT  
AFFDL-TR-74-75

JUNE 1974

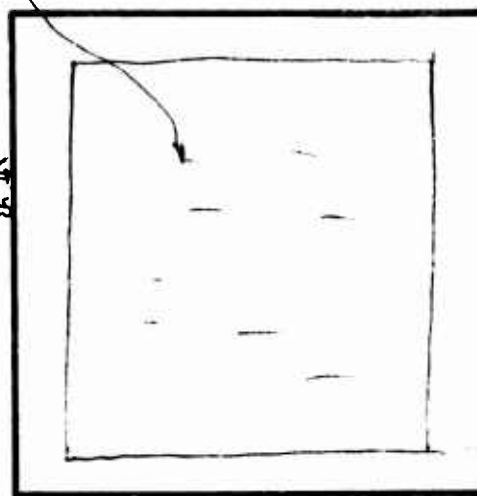
| FIGURE | | PAGE |
|---|---|---|
| 22 | Bubbles in Acrylic Polycarbonate-Faced Panel No. 11 After Completion of Test D-2 | 49 |
| 23 | Resistance to 150 gm Missile Penetration | 53 |

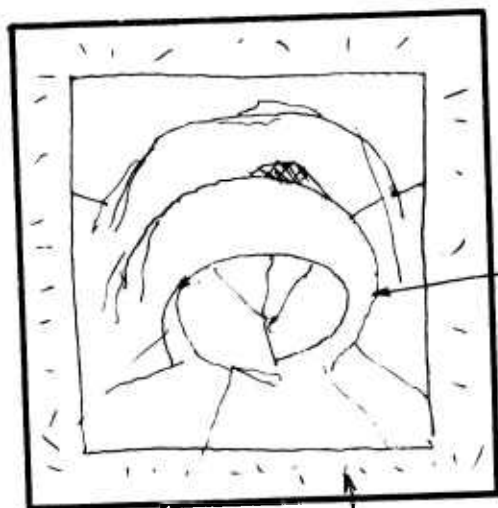
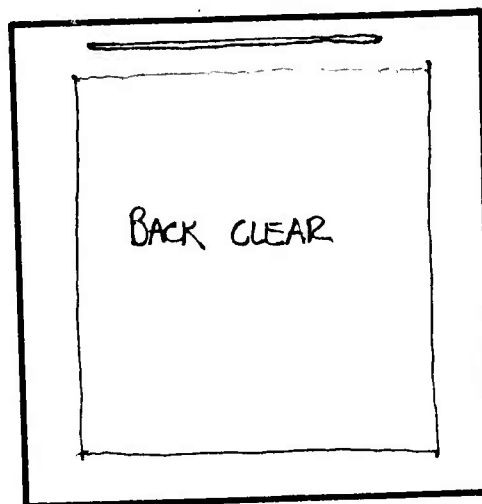
EDGE SCRATCHES FROM  
HANDLING - NO EFFECT

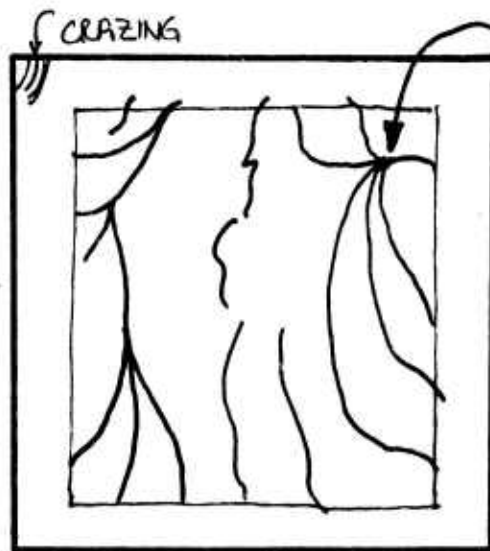
LIGHT CRACKING IN FRONT  
PLY ONLY.

ORIGIN  
???

BIRD PENETRATED. ENTIRE CENTER SECTION BLOWN OUT.  
SHEARING ON TOP EDGE APPROX. 75 % COINCIDENT WITH BACK  
FUSED SECTION. FUSION VERY GOOD. NO APPARENT DE-LAM.  
CRACKING ON BACK SIDE SEVERE BUT NO PIECES BLOWN LOOSE.

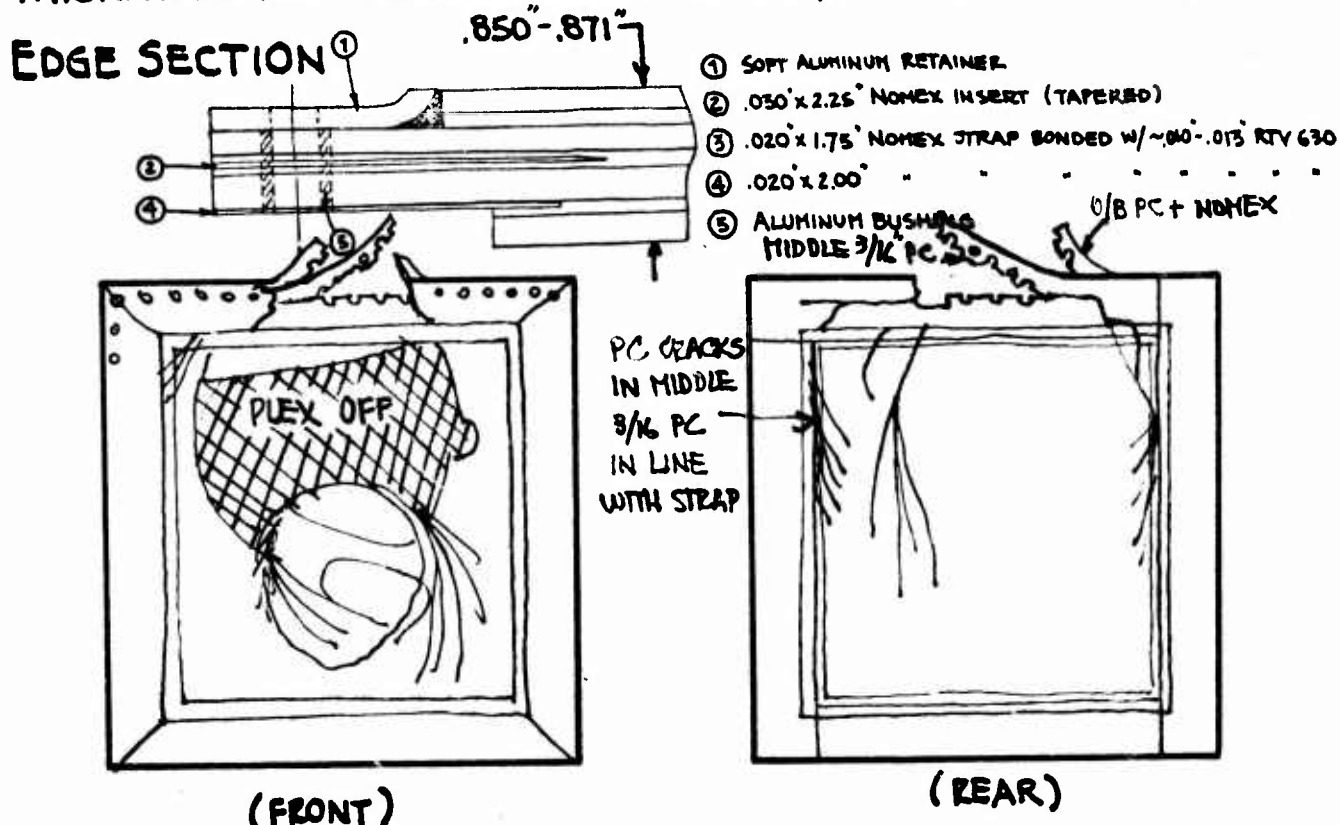
BIRD PENETRATED. TOP EDGE SHEARED 18". RETAINER PEELED BACK & REMOVED OVER 8" ON TOP EDGE. 1/8" PC PLY SHEARED IN LINE WITH BOLT HOLES AROUND PENETRATION. COHESIVE FAILURE OF INSERT IN PENETRATION AREA. 3/16" PC PLY FAILED GENERALLY IN LINE WITH FRAME AT TOP. FLOATING PC OK. SIDE PC CRACKS IN LINE WITH STRAPS, NOT INSERT OR FLOATING PLY.

NO CRACKS VISIBLE THRU .090" & .060" INTERLAYERS.

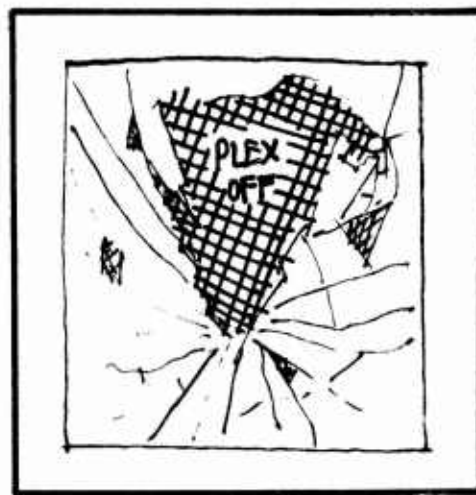
BIRD DID NOT PENETRATE. NO SERIOUS DAMAGE TO PANEL. NO PC CRACKS. SIX BOLTS REMOVED ALONG TOP EDGE BUT NO TISSUE THRU HOLES. BOLTS FAILED, AS BEFORE, AT SHANK-THREAD TRANSITION. 50% OF ACRYLIC OFF INBOARD AS SPALL. POSSIBLE THAT ACRYLIC PREPARATION NOT COMPLETE (NO CEMENT)

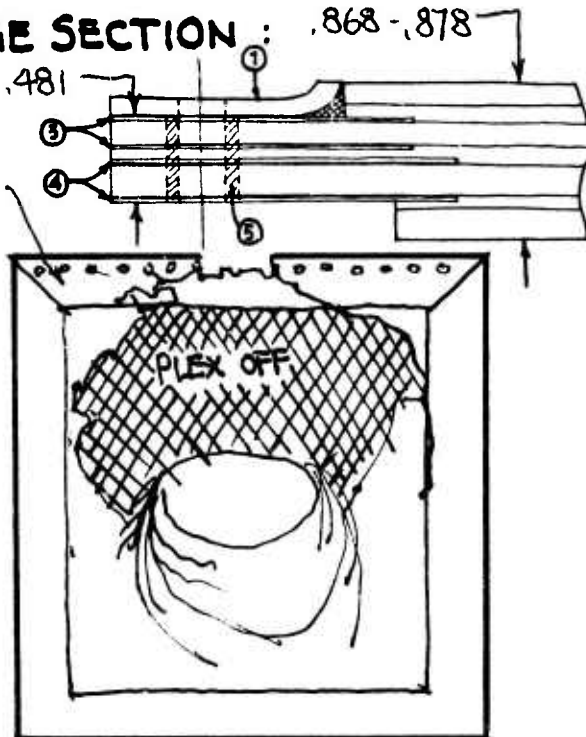
BIRD PENETRATED. ENTIRE TOP EDGE SHEARED. CENTRAL IMPACT PORTION OF TOP EDGE AND PORTIONS OF TOP HALF OF SIDES SHEARED IN LINE WITH FRAME. FAILURE WORSE THAN 18A (WT-21) WHICH HAD A RETAINER ON TOP EDGE.

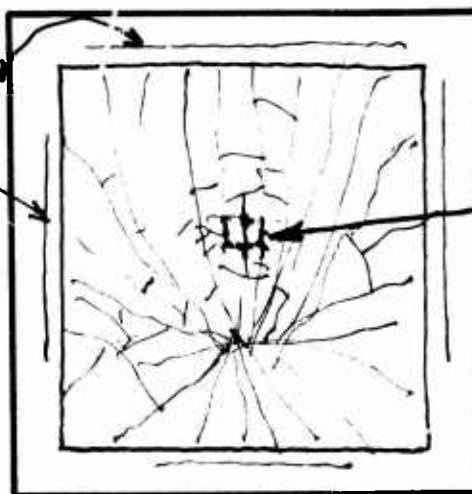
IMPRESSION  
FROM  
BENDING  
OVER  
FRAME

BIRD DID NOT PENETRATE. NO EDGE DAMAGE EXCEPT CRACKS IN OUTBOARD NOMEX DUE TO MAX STRESS FROM BENDING OVER FRAME. 3" INTERLAMINAR SEPARATION OF O/B-FACING STRAP ON 1/B PC PLY VISIBLE AT CENTER OF TOP EDGE.

NO ACRYLIC SPALL. 1"-1 1/2" RESIDUAL BULGE. IN MAXIMUM BULGE AREA PLEX CRACKS OPENED SLIGHTLY AND THERE APPEARS TO BE SOME ELONGATION OF IIZ UNDER PLEX CRACKS WITH ACCOMPANYING MINOR DELAMINATION AS SHOWN. →

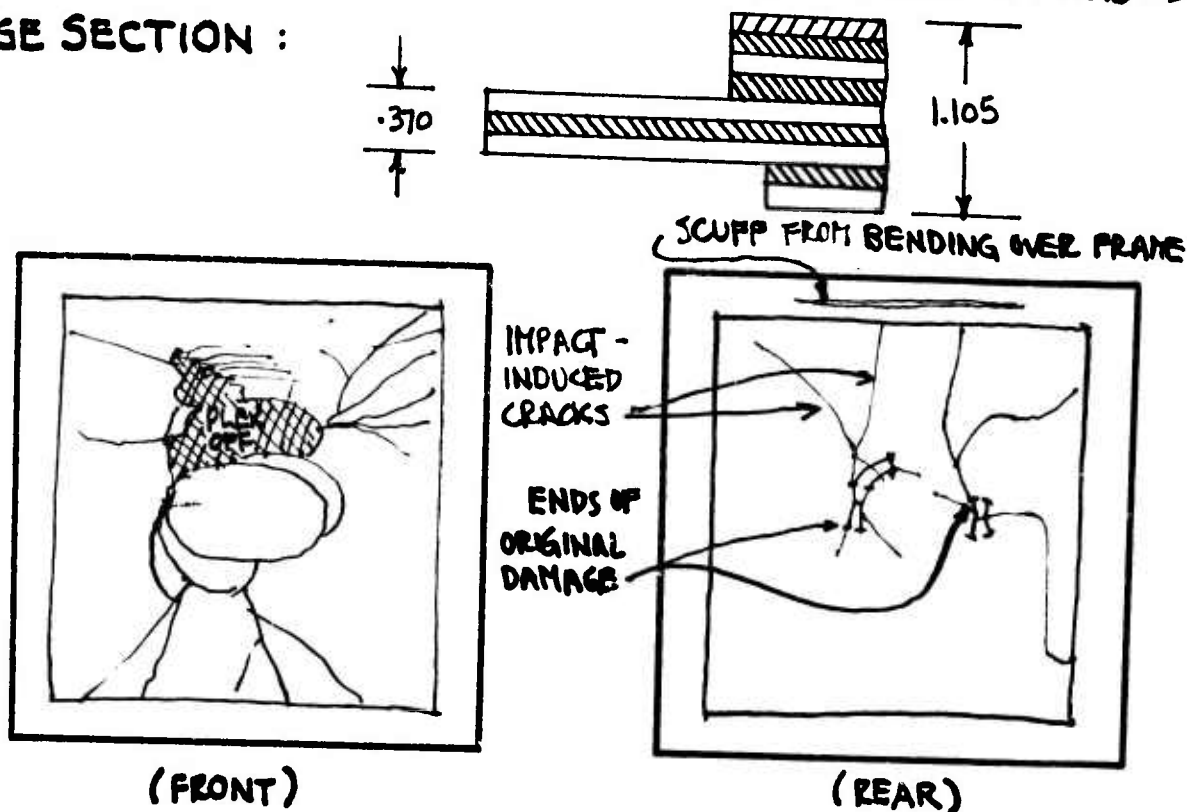
BIRD DID NOT PENETRATE. ALTHOUGH 5 BIRDS WERE REMOVED FROM TOP EDGE, THERE WAS NO SHEARING OR STRUCTURAL DAMAGE.

ADDITIONAL CRACKING OF INBOARD PC PLY DID OCCUR DURING IMPACT AS SHOWN IN SKETCH. CRACKS WHICH DEVELOPED DID STOP AT 112 SURFACE WITH VERY SLIGHT LOCAL DELAM.

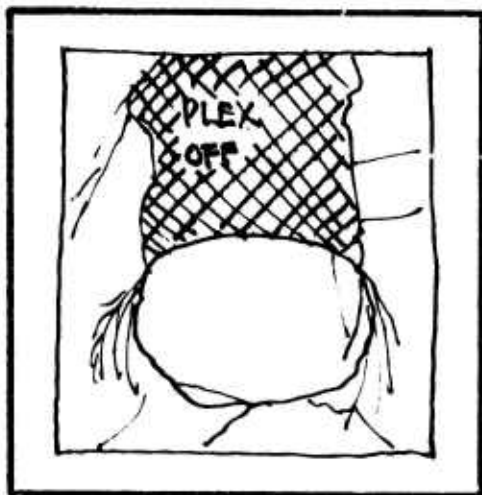
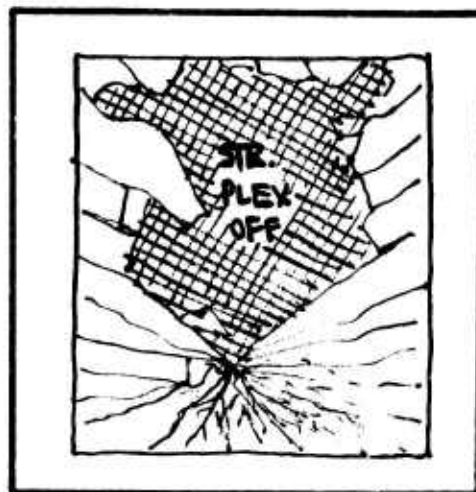
BIRD DID NOT PENETRATE . NO SHEARING OR STRUCTURAL DAMAGE .  
CONSIDERABLE STRETCHED ACRYLIC SPALL . LARGE SHARP PIECES .  
APPROXIMATELY 50% OF S/A OFF .

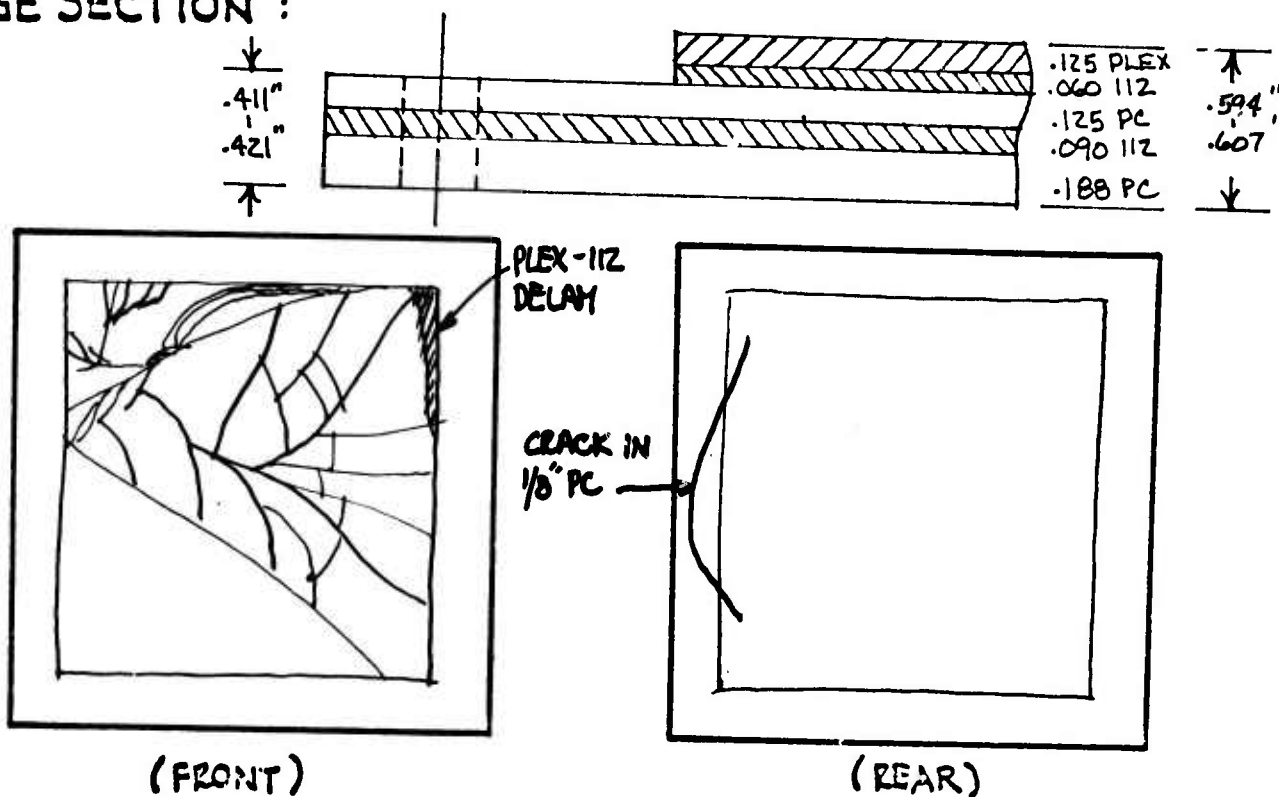
BIRD DID NOT PENETRATE. IMPACT OF PKG. JUST AT BOTTOM EDGE  
ALTHOUGH LOAD NOT SUFFICIENT TO FORCE TISSUE UNDER EXTENDED  
SECTION. NO BOLTS REMOVED & NO BOLT HOLE DAMAGE.

NEGLIGIBLE ACRYLIC REMOVED FROM IMPACT FACE. ONE  
CRACK IN 1/8" PC AS SHOWN. NO RESIDUAL BULGE.

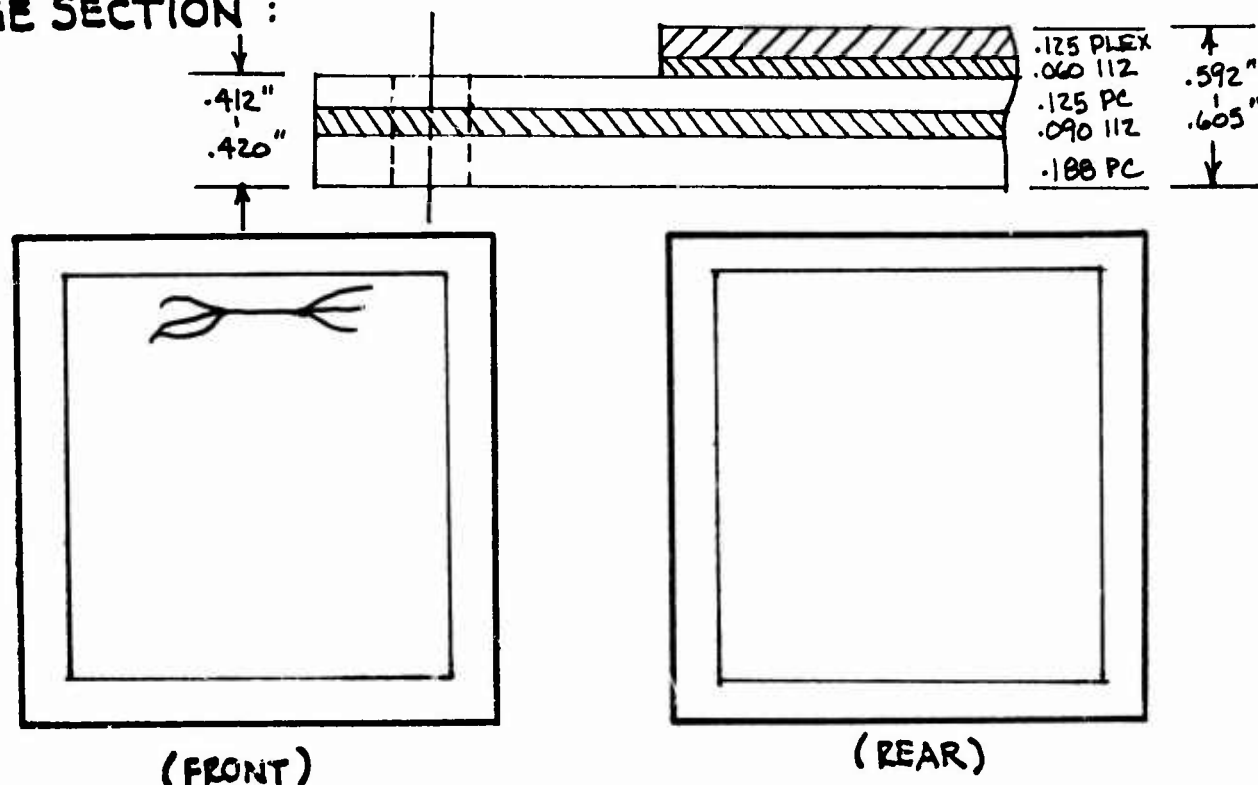
BIRD DID NOT PENETRATE. ESSENTIALLY NO STRUCTURAL DAMAGE TO PANEL. NO DAMAGE TO IMPACT SURFACE OR INBOARD PC PLY. SECOND PLY OF LAMINATE DAMAGED AS INDICATED. EXCELLENT RESIDUAL VISIBILITY. NO BOLTS BLOWN OUT BY IMPACT.

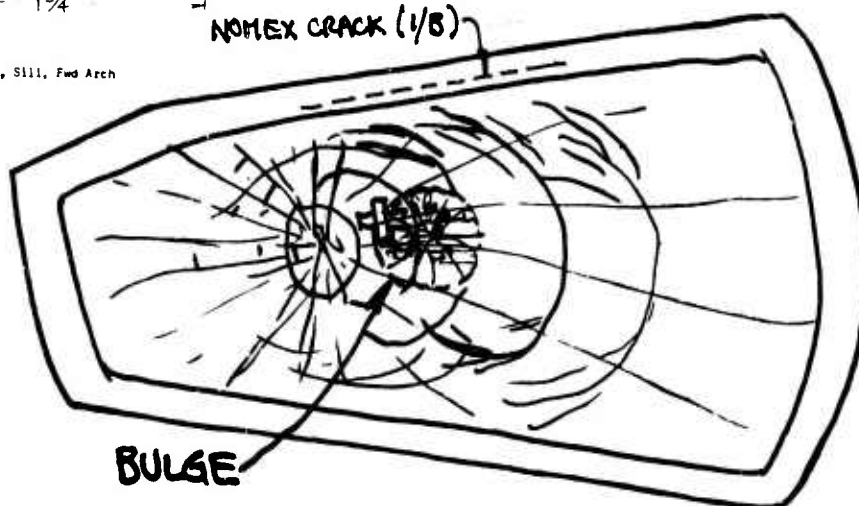
SAME IMPACT POINT  
AS WT-39.

BIRD DID NOT PENETRATE. RESIDUAL BULGE (3" DEEP, 7" DIAMETER) LOCATED 4" BEHIND TARGET "X". ACRYLIC SPALL OFF 5"x4" AREA AT MAXIMUM BULGE (90% OFF) NEITHER 1/8" OR 3/16" PC CRACKED, EVEN IN EXTREME BULGE.

CRACK (26" LONG) IN INBOARD BEAM EDGE REINFORCEMENT IN LINE WITH BENDING OVER FRAME. REMOVAL OF STRAP SECTION SHOWS THAT THE CRACK IS ONLY IN THE NOMEX (WITH 1 PLY STILL OK) AND NO DAMAGE TO THE PC.

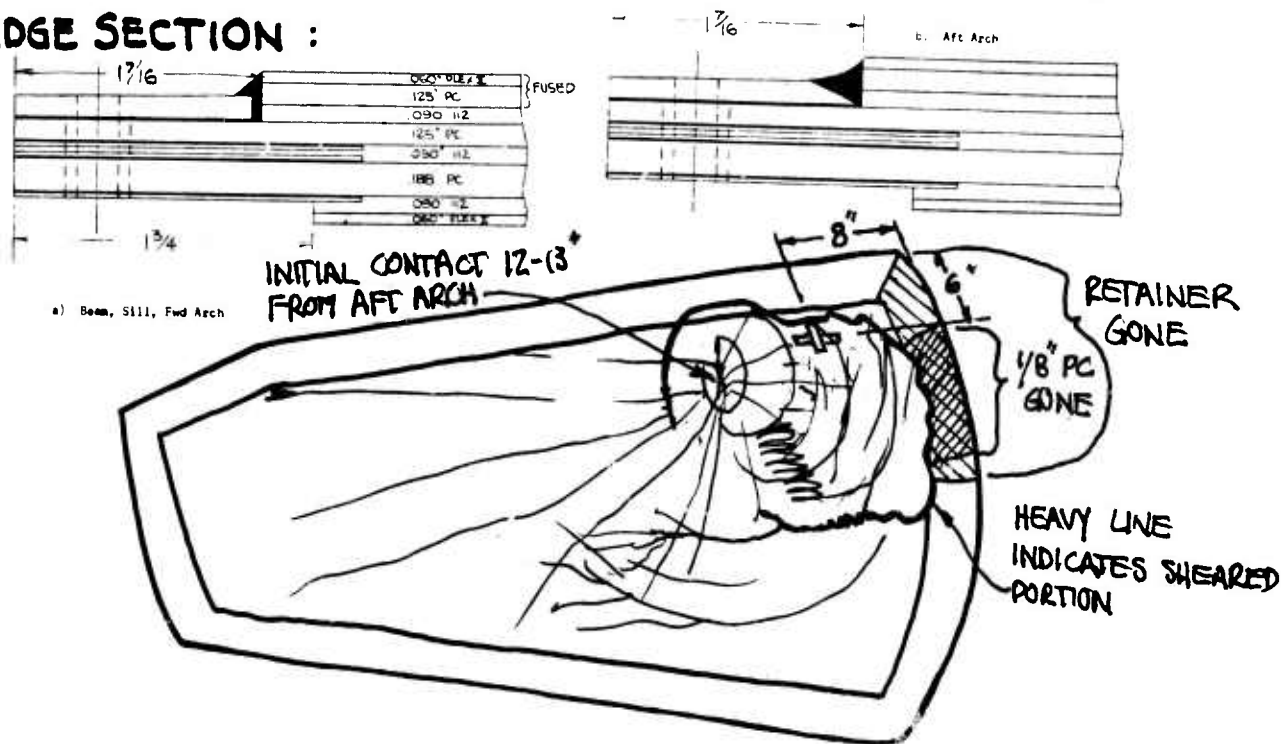
BIRD PENETRATED. CORNER OF AFT ARCH AND BEAM SHEARED AND OPENED AS SHOWN. SECTION OF RETAINER BLOWN OFF, BUT NOT PEELED, INDICATING NO TUNNELING. ELEVEN BOLTS OFF; FIVE BOLTS STILL IN RETAINER. RETAINER BOLTS BENT BUT INTACT WITH FAILURE BY PULLING OUT OF NUTS.

SHEAR LINES IN PENETRATED CORNER VARY IN LOCATION FROM PLY TO PLY. EXACT MODE OF FAILURE CANNOT BE DETERMINED. SOME PLEX SPALL FROM BULGE/FLAP. IN STRIPPED EDGE SECTION, POOREST RTV/630 ADHESION WAS TO THE PC. APT 18" OF BEAM EDGE WARPED OUTWARD ~ 3/8".

LITTLE DAMAGE TO REMAINING 3/4 OF PANEL.

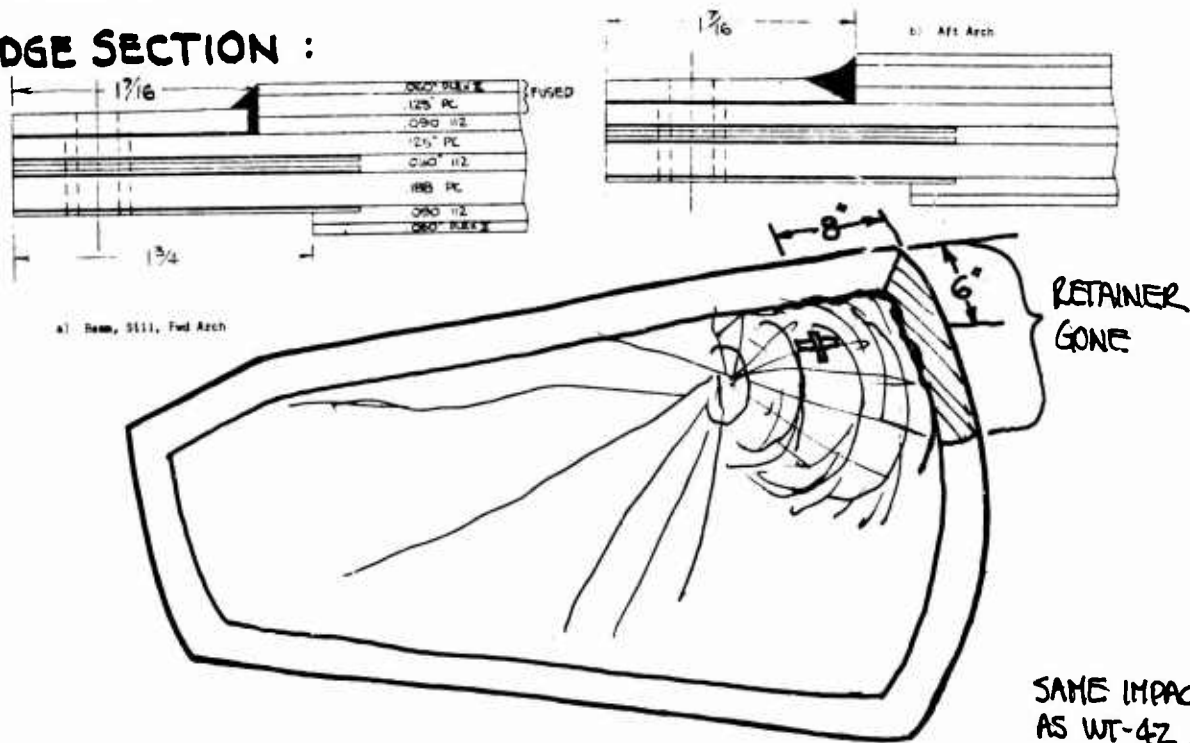
BIRD PENETRATED. FAILURE SIMILAR TO 9030-23 (WT-42) ALTHOUGH LESS SEVERE. SECTION OF THE AFT ARCH RETAINER REMOVED AND BOLTS PULLED OUT OF THE NUTS. IMPACT SLIGHTLY CLOSER TO THE BEAM THAN 9030-23. AFT PORTION OF BEAM EDGE DEFLECTED O/B ~ 3/8".

SHEAR FLAP AND DAMAGE TO REMAINDER OF WINDSHIELD LESS THAN 9030-23. CLOSE TO LIMIT. WOULD PROBABLY PASS WITH LESS RIGID FRAME.

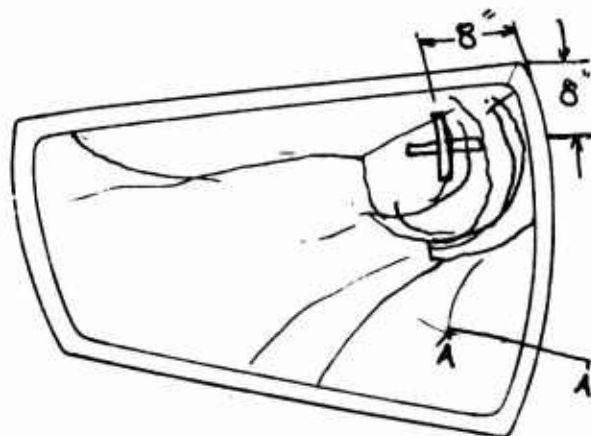
BIRD DID NOT PENETRATE, OUTBOARD PLY CRACKED BUT NO OBSERVABLE FRACTURING OF STRUCTURAL PC PLYS. TITANIUM STRIP BENT OVER LEDGE DURING DEFLECTION BUT NO SHEARING. NOMEX CRACKED UNDER STRIP, IN LINE WITH END OF LEDGE. DEFORMATION OF PC UNDER NOMEX CRACK BUT NO FRACTURE. NUMEROUS "STRESS CRACK" CRACKS IN INBOARD NOMEX IN AREA OF MAX. DEFLECTION.

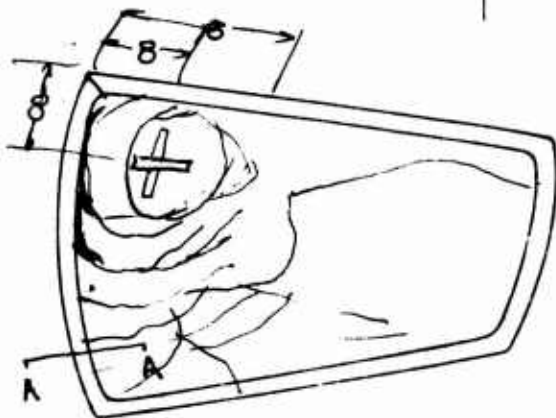
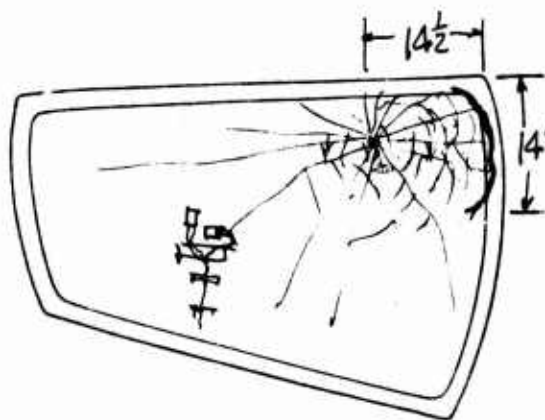
ARCH CORNER, AFT OF IMPACT POINT, "SHEARED" AND PERMITTED TISSUE TO PENETRATE. PC PILES FAILED GENERALLY COINCIDENT WITH ARCH SUPPORT LEDGE END, ALTHOUGH FAILURE OF THE I/B WAS NOT A CLEAN SHEAR AS WITH WT-44. FAILURE WAS PRACTICALLY IDENTICAL TO WT-47 (9030-31) WITH ESSENTIALLY THE SAME PC FAILURE PATTERN IN BOTH. THE PC PUSHED PAST THE STAINLESS STEEL STRIP WHICH WAS YIELDED IN BENDING OVER THE ARCH PLUS ELONGATED LONGITUDINALLY, BUT NOT SHEARED. THE FWD. EDGE OF AFT RETAINER WAS PUSHED DOWN

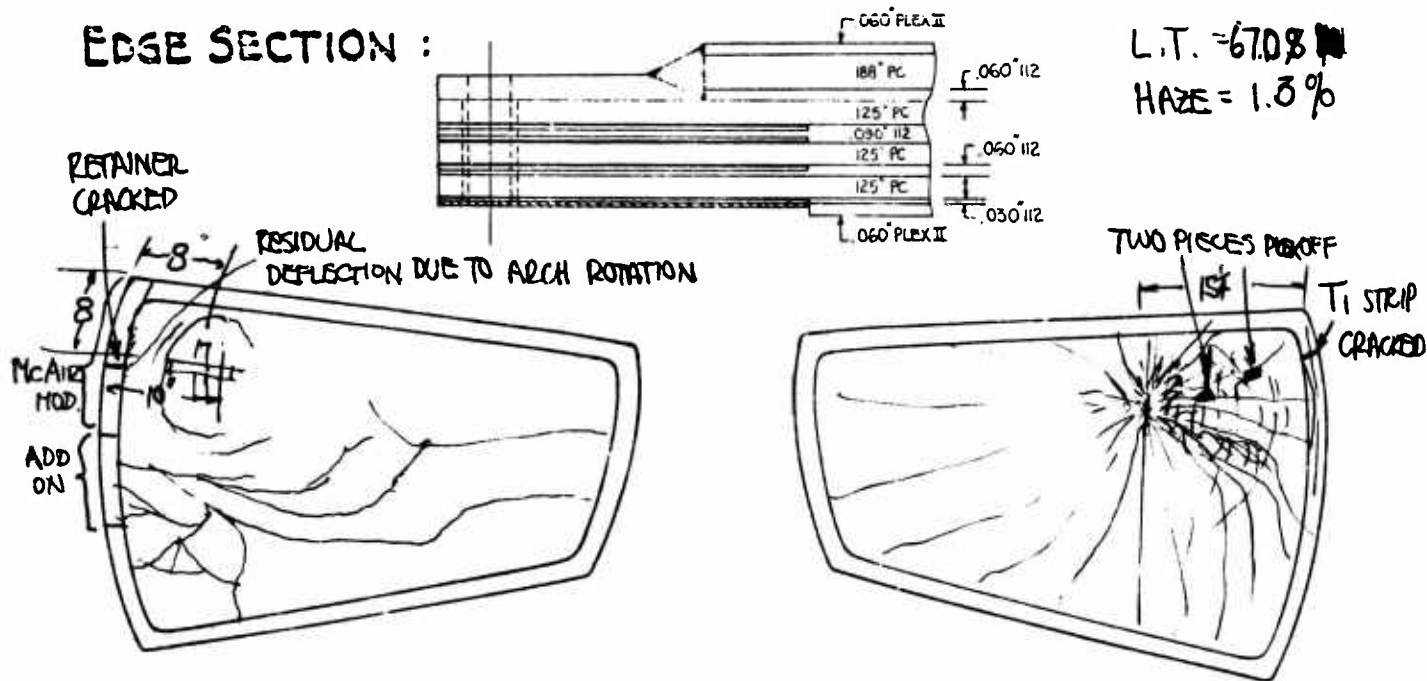
BIRD DID NOT PENETRATE. NO APPARENT DAMAGE TO PC STRUCTURAL PLIES. TYPICAL FRACTURES OF O/B AND I/B FACES. RESIDUAL DEFLECTION IN IMPACT AREA, MAXIMUM AT RETAINER/PLEX INTERFACE. " RETAINER ROTATION.

TWO PIECES PLEX SPALL AS SHOWN. CONSIDERABLE PC DEFORMATION OVER ARCH FLANGE BUT NO FAILURE (GOOD ADHESION OF I/B RTV 630 TO PC) MORE PC DEFORMATION OVER ARCH FLANGE EDGE THAN 9030-36 (WT-54). LESS "STRESS-COAT" CRACKING OF I/B NOMEX THAN WT-54 OR WT-48. MAXIMAL RTV 630 ADHESION TO RETAINER.

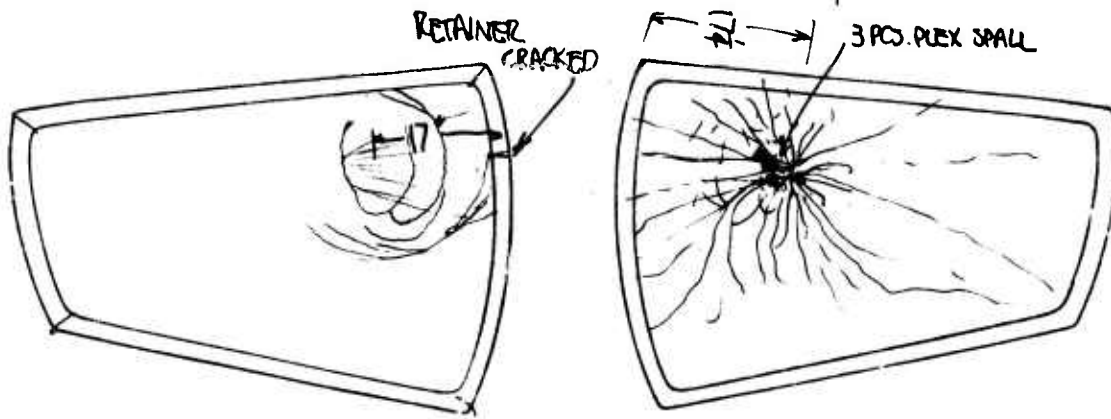
BIRD DID NOT PENETRATE. NO APPARENT PC DAMAGE. MORE DEFORMATION OF TI SUPPORT STRIP THAN WT-53. REMOVAL OF SUPPORT STRIP SHOWS PC SHEAR DISPLACEMENT COINCIDENT WITH ARCH FLANGE BUT NO PC FRACTURE UNDER NOMEX CRACKS. "STRESS COAT" CRACK PATTERN (LIKE WT-48) IN NOMEX IN IMPACT AREA. RETAINER ROTATED & CRACKED AS SHOWN. POOR ADHESION OF 1/8 NOMEX. CONSIDERABLE STRUCTURAL DAMAGE TO MODEL. ARCH FLANGE CRACKED.

CONSIDERABLE STRUCTURAL DAMAGE TO MODULE. ARCH FLATTENED & ROTATED IN IMPACT AREA, WITH CRACK IN FLANGE. REINFORCEMENT YIELDED IN IMPACT AREA. ARCH-SILL FILLET BROKEN. ARCH COMPLETELY LOOSE AT SILL END. NOT SUITABLE FOR ANOTHER O15 SHOT.

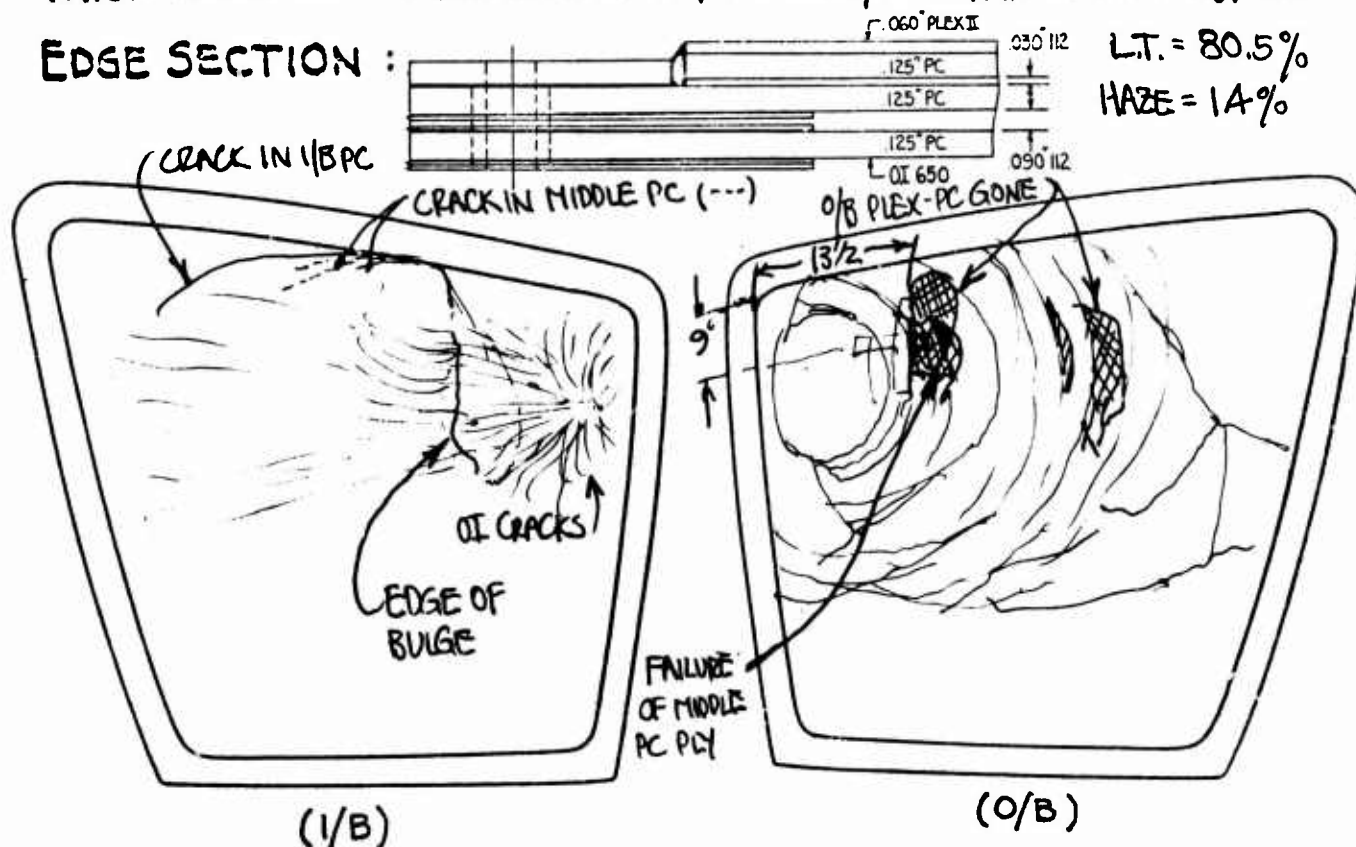
BIRD DID NOT PENETRATE. CONSIDERABLE DAMAGE IN THE IMPACT AREA. THE FUSED FACING PLY IS GONE IN SEVERAL PLACES AND THE MIDDLE PC PLY IS CRACKED AND PENETRATED. THERE IS A SHARP, IRREGULAR BULGE IN LINE WITH THE DAMAGED AREA. THE 1/8 PC PLY'S OI650 COATING HAS MANY SMALL CRACKS RELATED TO THE IMPACT STRAIN BUT THIS HAS NOT CAUSED ANY FAILURE OF THE PC. BOTH PC STRUCTURAL PLYS DO HAVE CRACKS ORIGINATING AT THE BEAM EDGE CLOSE TO THE MAXIMUM BULGE.
