NWC TP 5942

# F-14A Fire Protection Test Program

by  
George E. Moncsko  
and  
Herman J. Hoffman  
*Systems Development Department*

FEBRUARY 1977

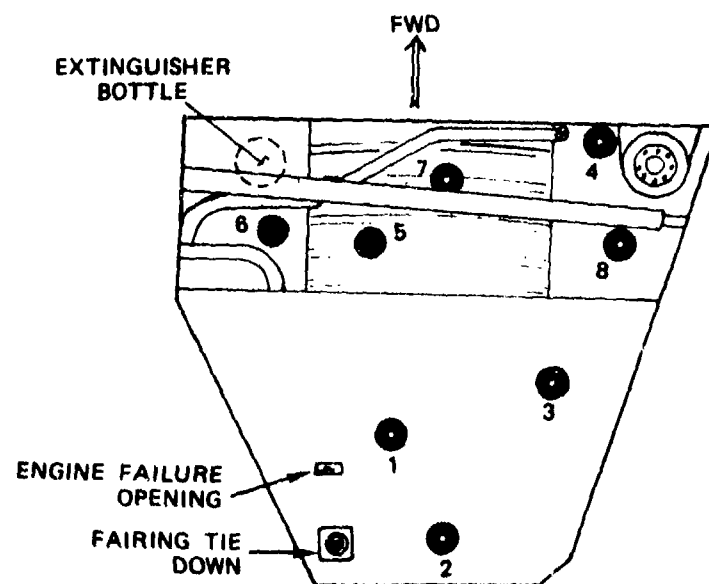
FIGURE 24. Sensor Pickup Locations, Overwing Fairing Volume.

Results of this test show that nacelle concentrations were still more than adequate while overwing fairing concentrations were on the order of 4 percent in a small volume. Very little agent went forward of the failure hole (see Figure 24 for location) and none was detected at sensor 6 or 7. This test did not utilize a bottle in the accessory bay as would be used in later fire tests. It did show the additional agent flow to be expected from the nacelle into the accessory bay.

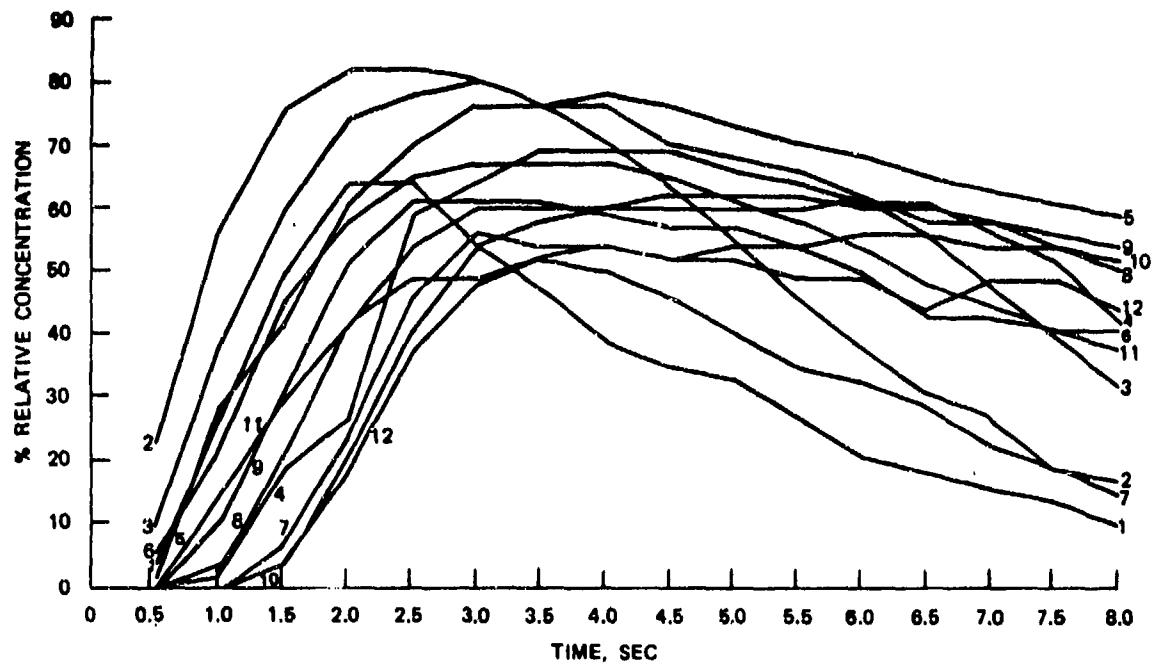
FIGURE 26. Agent Concentration, Nacelle Under Normal Flight Conditions.

In the nacelle under normal flight conditions, where only cooling airflow is provided, the agent concentrations are greatest for the longest duration. As more airflow is introduced and the top deck ruptured, these values decrease as would be expected. Under normal flight conditions the agent concentration was maintained above 15 percent for 5.35 seconds which exceeds the test requirement by 4.85 seconds. The maximum concentration for 0.5 second was 47 percent which exceeded the requirement by 32 percent. As test conditions were changed to introduce fan-case failure airflow and then add the top deck rupture, time duration of agent concentration above 15 percent and maximum concentration percent for 0.5 second was; 3.10 seconds at 26 percent, and 3.30 seconds at 16 percent, respectively. The last condition is the most severe, and the values were still above minimum specification requirements.

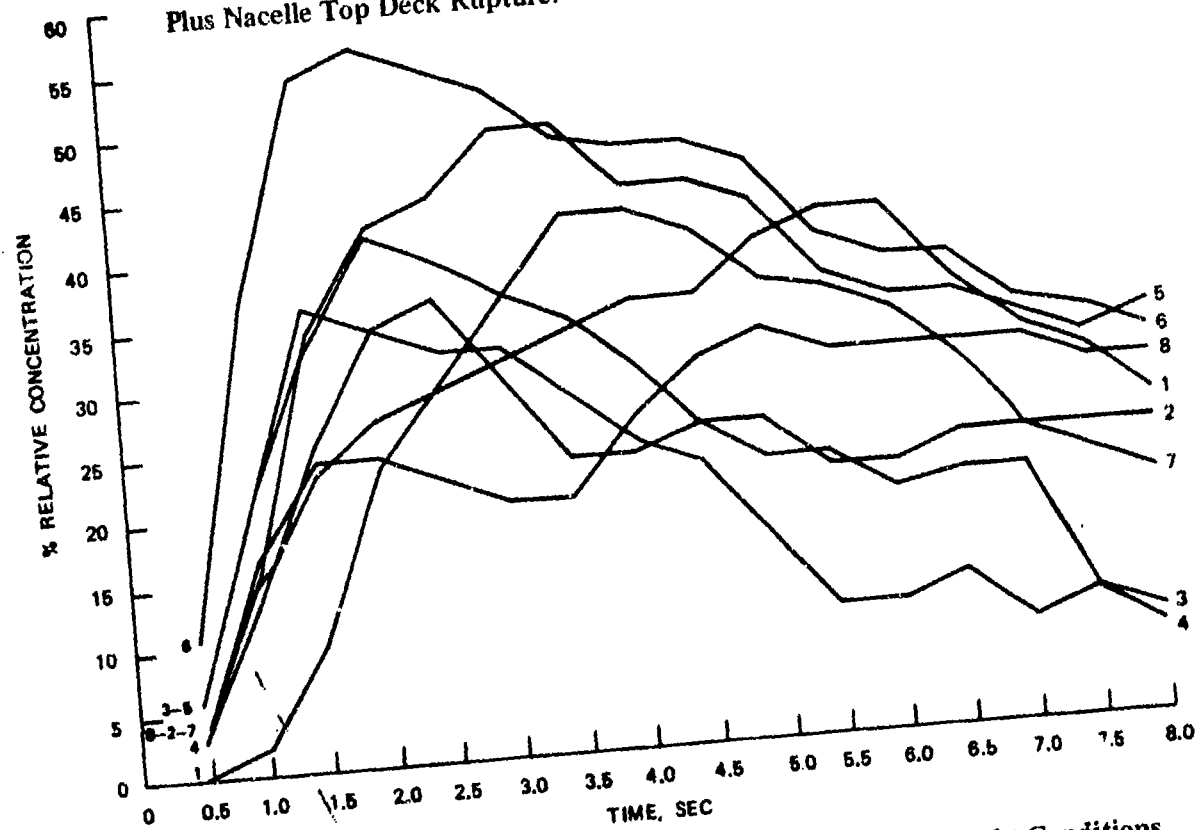
FIGURE 29. Agent Concentration, Accessory Bay Under Normal Flight Conditions.

In the overwing fairing accessory bay, the problem was to get agent into the rear area of the volume. With the discharge nozzle up forward, the aircraft equipment installed in the volume inhibited flow of the agent. The final nozzle design directed the agent forward to deflect off the wing box structure, diffusing around the forward part of the volume, and upward and aft to deflect off the underside of the overwing fairing into the rear portion of the volume. The discharge nozzle design is shown in Figures 30 and 31. This configuration produced a concentration above 15 percent which was maintained for 3.40 seconds, exceeding the time requirement by 2.90 seconds, and a maximum concentration of 23 percent for 0.5 second which exceeded the requirement by 8 percent under a normal flight condition at 250 knots.

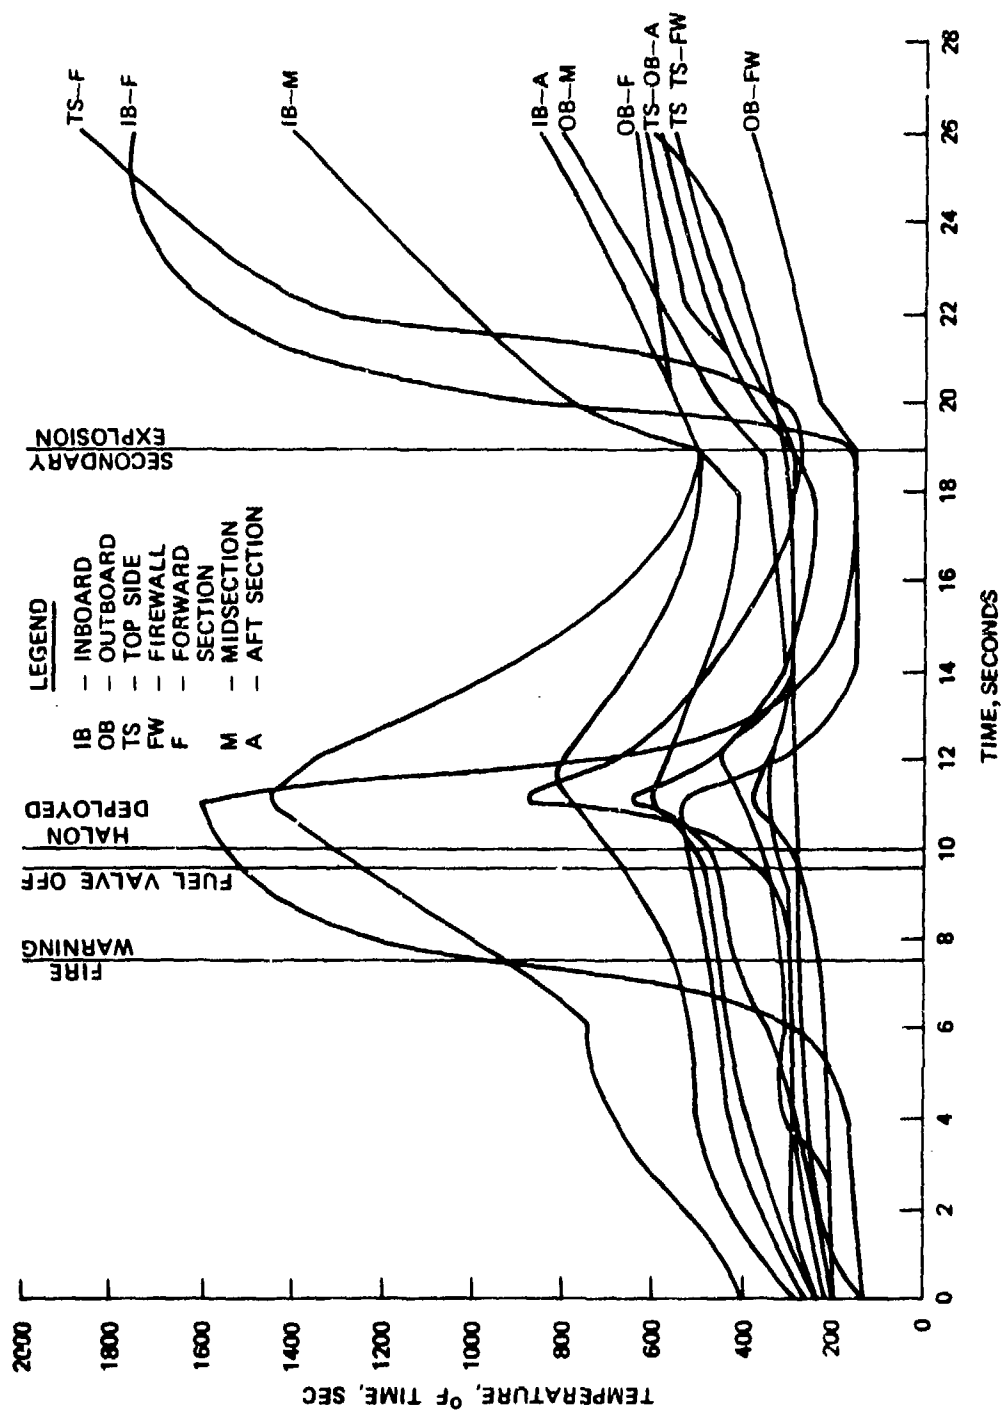
FIGURE 32. Nacelle Temperature Data Plot, Full-Scale Fire Test.

The thermocouple temperature data plots of Figures 32 and 33 show that the on-board fire extinguisher system extinguished the nacelle and overwing fairing fires after the initial 10-second burn. The data plot shows that maximum temperatures were reached approximately 10 seconds after fuel ignition. Correlating the curves with thermocouple position in the test article shows the fire started in the forward nacelle and spread aft in the nacelle, following the airflow circulation from front to rear. At the same time the fuel which was blown through the nacelle top deck rupture by the fan case rupture airflow ignited and burned in the accessory bay. Infrared camera pictures show heat being forced upward along the buttline 10 fire barrier and exiting the overwing fairing as well as being forced out along the outboard (wing pivot) area of the fairing. Temperatures inside the center trough remained approximately ambient. Fire did not cross the center trough fire barrier. The Halon 1301 extinguished the fire in the accessory bay which later reignited (from the test pad residual fire) and was subsequently extinguished by the facility CO<sub>2</sub> system. Concurrent with deployment of the Halon 1301, the temperatures in the nacelle also showed a rapid decrease in temperature indicating the fire had been extinguished.

Analysis of the temperature history in the nacelle shows that the fire started at the failure point then followed the airflow pattern down and aft. It appears that this flow pattern makes just short of one loop

axially about the engine before exiting via the aft nacelle vent. The volume of air was sufficient to cause combustion temperatures to be maximum about 6 feet (2 meters) aft of the failure opening. From this point, aft temperatures drop until reaching exit temperature which, in the initial part of the test, never exceeded 400°F (204°C).

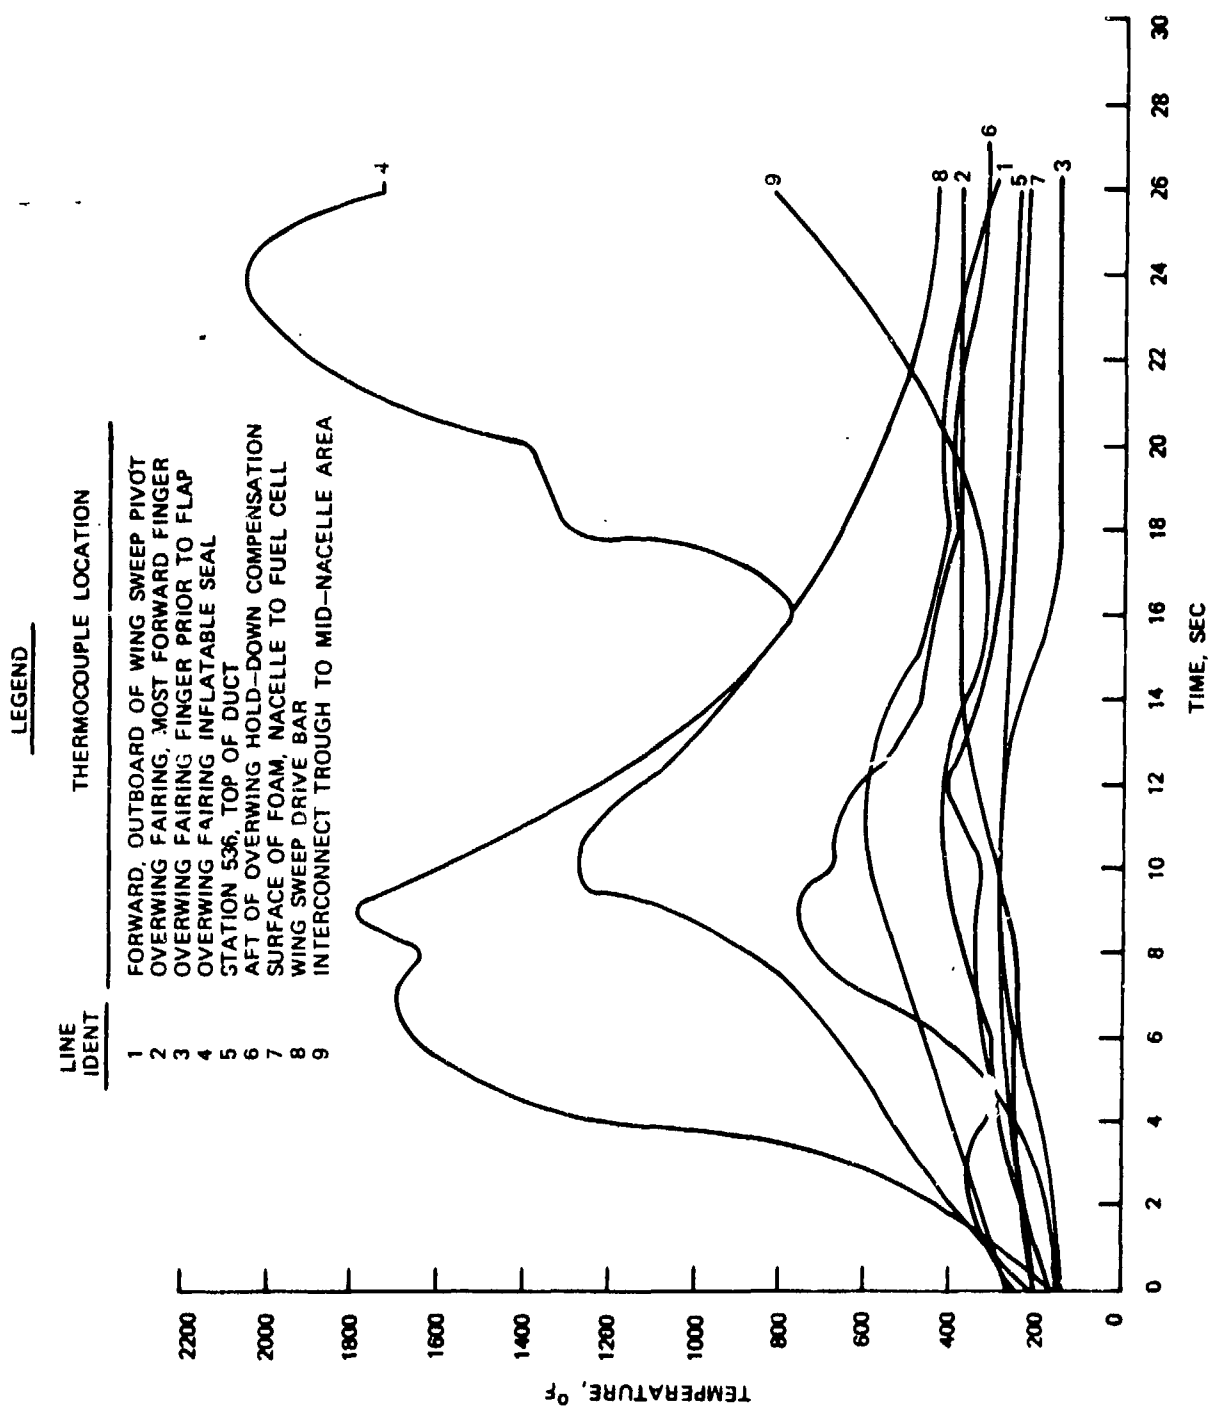
FIGURE 33. Accessory Bay Temperature Data Plot, Full-Scale Fire Test.

Thermocouples in the volume under the overwing fairing show heat penetration first at the aft end then quickly forward from the failure hole past the wing actuator bar and outboard to the wing pivot and the inflatable seal. Temperature of the upper surface of the wing sweep actuator bar reaches 1300°F (700°C) before the extinguishant is deployed. This temperature never increases again during the test. Temperature just forward of the wing pivot reaches just over 600°F (315°C) before the extinguishant released. The sloping deck temperature (top surface of fuel cell 5) never increased much over ambient.

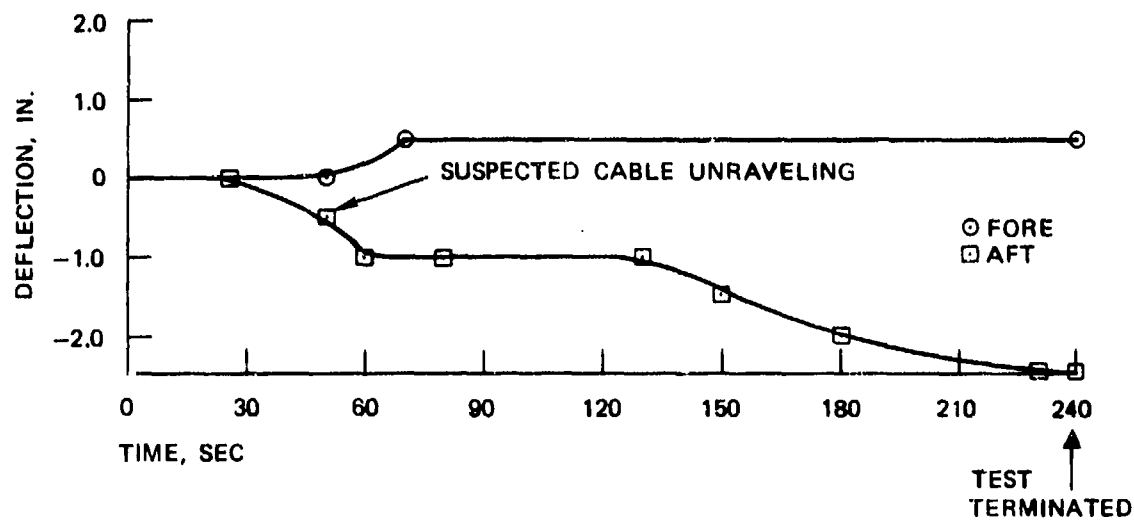
FIGURE 46. Weight Deflection Data Plot, Left Nacelle.

A post-test damage assessment of the unprotected left nacelle showed the aft assembly (rudder control) failed after 4 minutes of burn. The aluminum support brackets evidenced major damage, being cracked in four places. The skin and former ribs which support the aluminum brackets showed buckling and cracks which allowed the assembly to move inward and aft; these were essentially destroyed as shown in Figure 45. The forward assembly showed only a charring of the surfaces.

Deflections of the left nacelle test weights are plotted in Figure 46. This plot is derived from the video tape data. Final deflections after the structure cooled down were: fore, 0 inch; aft, - 2.0 inch (-50 mm). The aft weight was observed revolving from 40 to 90 seconds. It is suspected that the 1-inch (25.4-mm) weight drop during this time was due to heat expansion and unraveling of the cable.

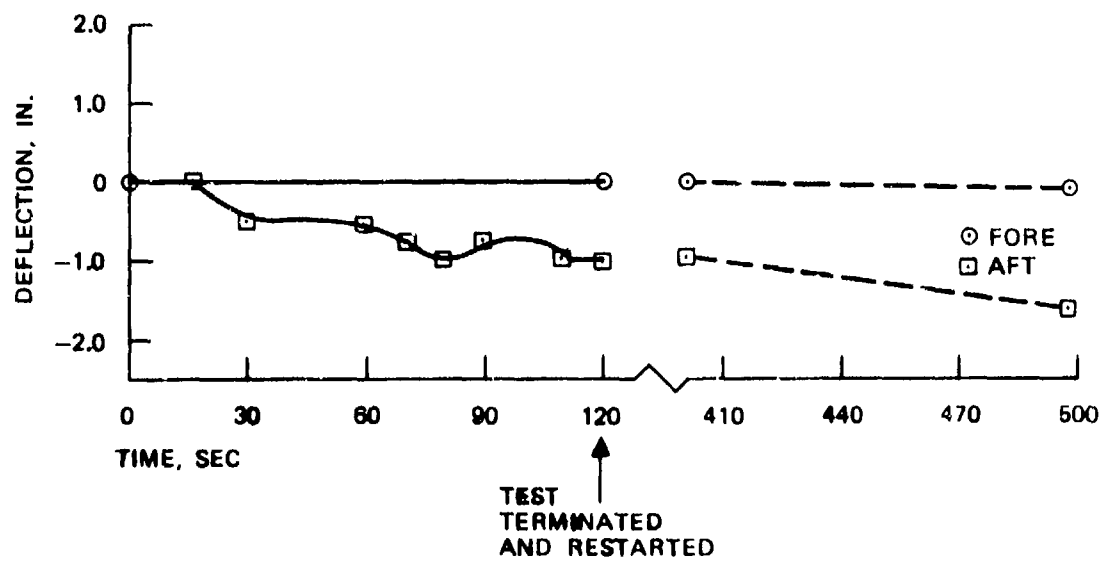
FIGURE 47. Weight Deflection Data Plot, Right Nacelle.

Weight deflections in the right nacelle are plotted in Figure 47. Final deflections after structure cool-down were: fore, 0 inch; aft, 0.56 inch (14.288 mm). The same cable was used for the aft weight in both the left and right nacelle tests. During this burn the cable did not unwind further.

The aft bellcrank assembly was not damaged. However, a deflection of 0.56 inch (14.3 mm) was achieved. This deflection is believed to be caused by the buckling of the aircraft skin and former ribs. The observed oscillation of the aft weight (see Figure 47) could also be caused by the skin buckling. The condition of the aft bellcrank is shown in Figure 48.
