TECOM PROJECT NO: 6-EE-TRC-117-005

PUBLICATION NO: USAEPG-FR-922

6 PRODUCT IMPROVEMENT TEST

RADIO TERMINAL SETS AN/TRC-117/151 AND AN/TRC-145

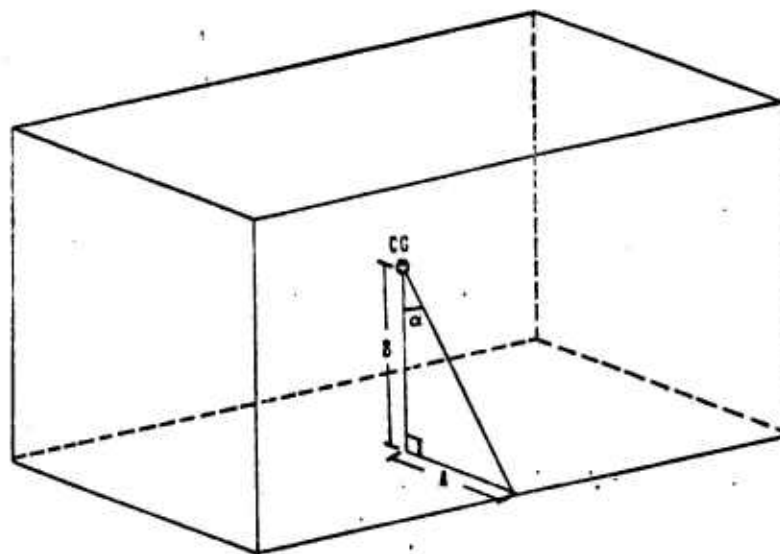
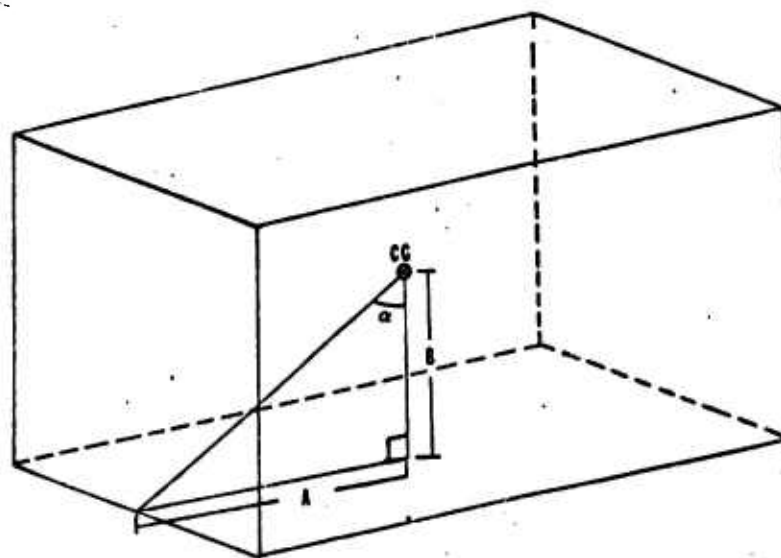
Figure 3. Center of gravity/lateral stability.

a. Two lines were then drawn from the center of gravity as shown in figure 3. One was drawn from the center of gravity to the nearest outer base ground contact point and the other perpendicular to the baseline. The angle formed between the lines was calculated as follows:

Angle  $\alpha$  for both test items exceeds the minimum of  $25^{\circ}$ . The criteria is met.

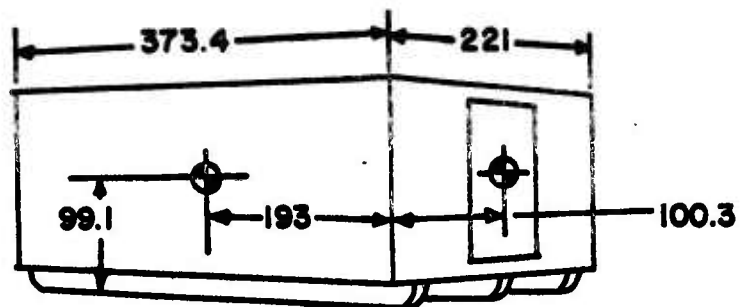
Figure 4. AN/TRC-117/151 dimensions.

b. AN/TRC-117/151. Angle  $\alpha$  was calculated from figure 4 as follows:

a. AN/TRC-117/151. The distribution of weight longitudinally (L) and transversely (T), using the dimensions in figure 4, subtest 2.5, was calculated as follows:

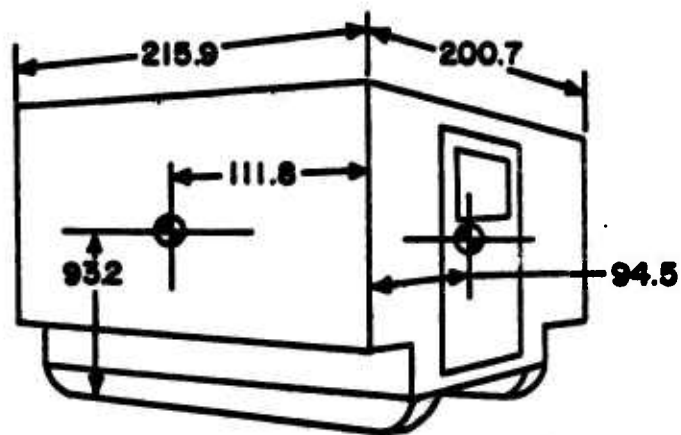
Figure 5. AN/TRC-145 dimensions.

c. AN/TRC-145. Angle  $\alpha$  was calculated from figure 5 as follows:

b. AN/TRC-145. The distribution of weight longitudinally (L) and transversely (T), using the dimensions in figure 5, subtest 2.5, was calculated as follows:

$$0 \leq T \leq 0.050 \quad \frac{c - d}{c + d} = \frac{106.2 - 94.5}{200.7} = 0.058$$

$$0 \leq L \leq 0.050 \quad \frac{a - b}{a + b} = \frac{111.8 - 104.1}{215.9} = 0.035$$
