Report No. 131500-603  
14 January 1977

INTERIM TEST REPORT  
ON THE SHOCK-DROP TEST  
OF THE  
AN/TRN-41 TACAN NAVIGATIONAL SET

✓ Contract No. F19628-75-C-0200  
CDRL Item A00Y

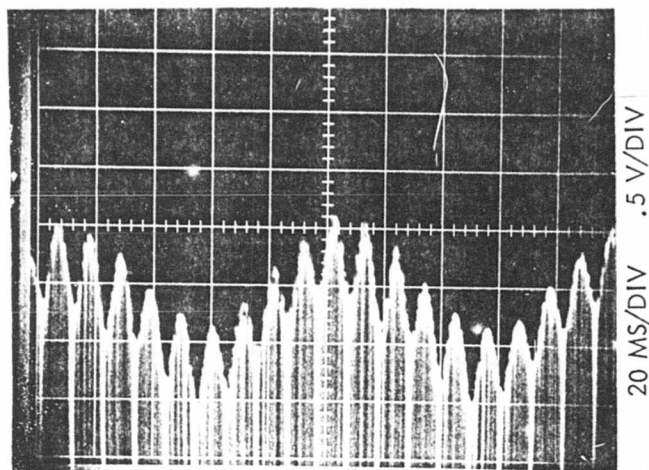
PRE SHOCK TEST - RADIATED DET SIGNAL 12/15/76

ANT S/N 001 WITH RT S/N 002

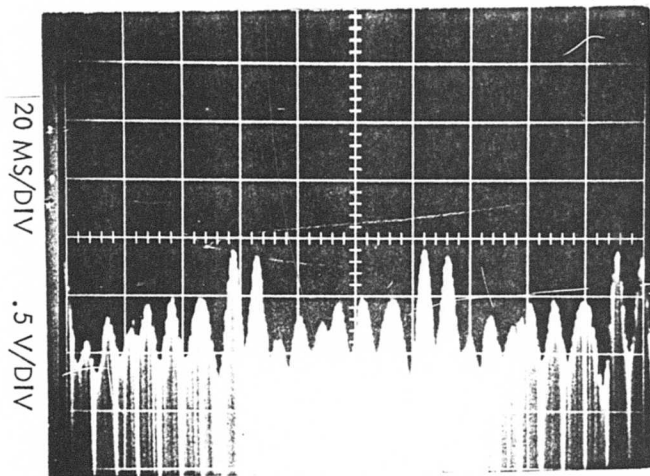
POST SHOCK TEST - RADIATED DET SIGNAL 12/16/76

System Failed Shock Test so these tests will have to be re-run.

ANT S/N 001
