AFML-TR-78-160  
Volume I

## **COST EFFECTIVE REPAIR TECHNIQUES FOR TURBINE AIRFOILS**

GENERAL ELECTRIC COMPANY

TECHNICAL REPORT AFML-TR-78-160, Volume I

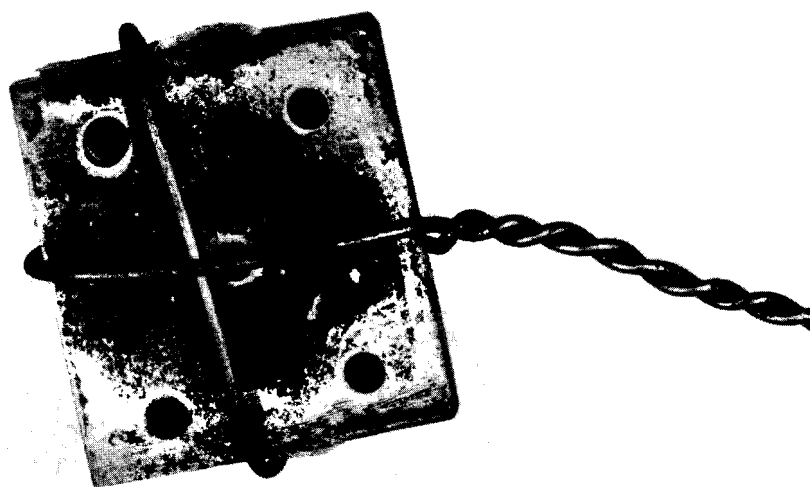
A Rene' 80 control coupon shown in Figure 26 was used as a quick means for determining the effectiveness of the F<sup>-</sup> cleaning run. Coupons were preoxidized at 1950°F for 16 hours in air prior to cleaning. The degree of cleaning was determined by visual measurement of the clean area on the side extending radially from the five drilled holes. At least 0.020 inch of peripheral cleaning around each hold was required to assure satisfactory part cleaning. Although used with some success, it is felt that other coupon designs may more nearly represent a crack configuration and provide a measure of cleaning effectiveness for subsequent ADH repair.

Figure 26. Rene' 80 Control Coupon for Effectiveness of F-Cleaning

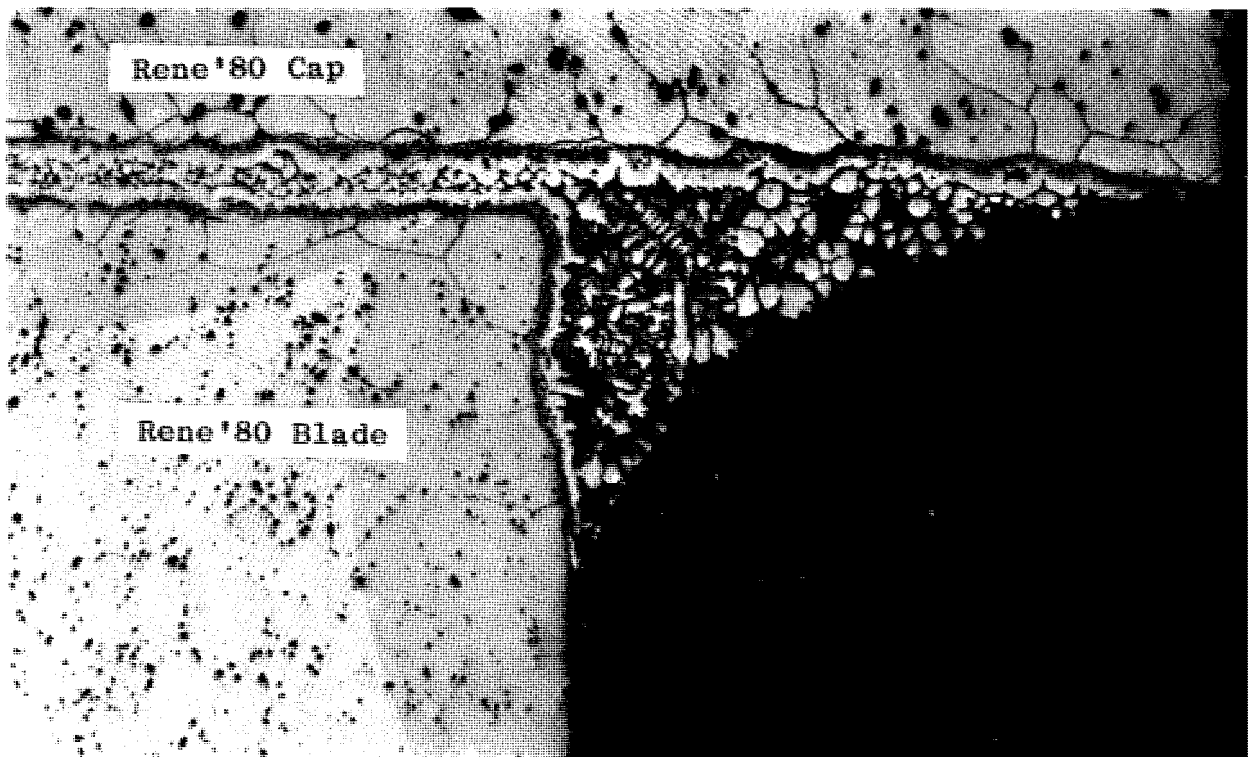
Figure 42. Blade to Cap Joint As-Bonded Prior to a Heat/Diffusion Cycle

Figures 42 and 43 show a typical joint in the as-bonded condition after being run through the diffusion cycle. Bond gap measurements from photomicrographs of the joint are more easily read in the as-bonded condition than after the post diffusion cycle. However, it is useful to see the high quality of the joint after the diffusion cycle has been run. From these photomicrographs the true bond gap can be measured using 100X magnification of these joints. As a result of this comparison it was shown that the new configuration of the fixture accurately measured the true bond gap. Thus, this new fixture configuration shall be used on future blade runs through the pilot line. Unfortunately blades already processed using the original fixture cannot have the bond gap re-measured using this fixture due to the technique involved.

100x

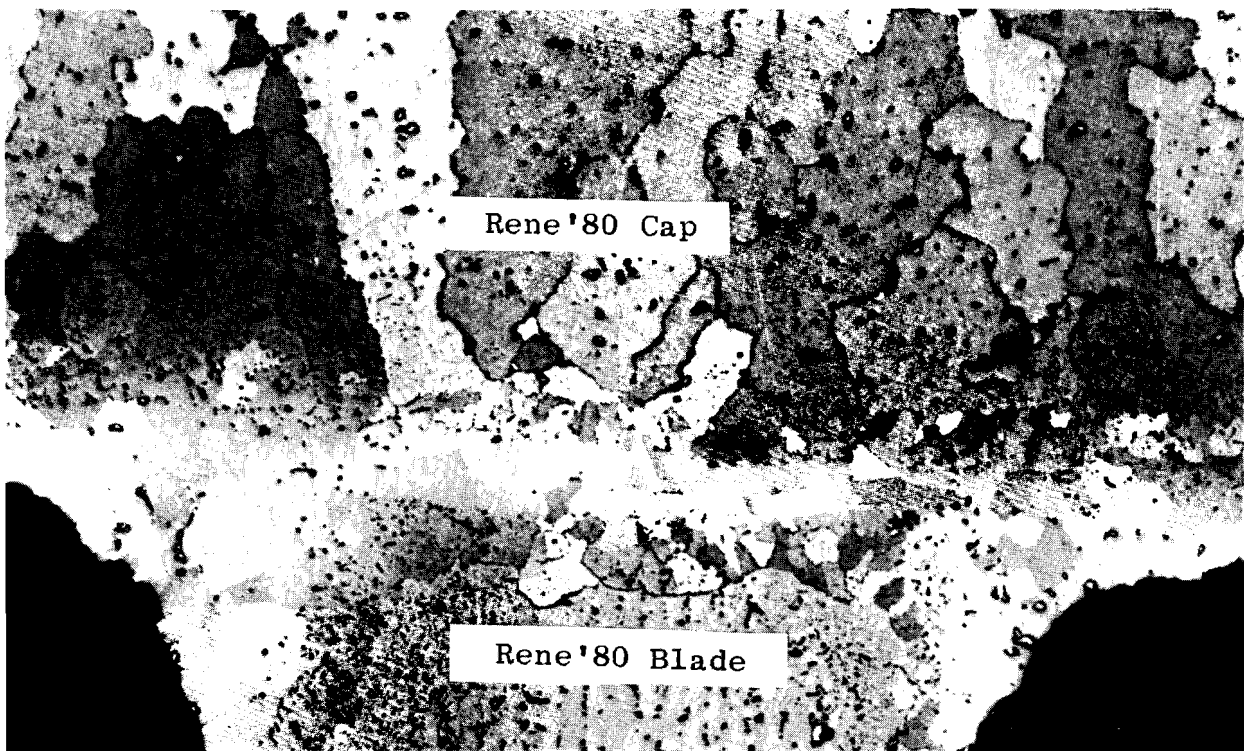
Figure 43. Blade to Cap Joint After a Heat Treat/Diffusion Cycle

100x
