AFFDL-TR-79-3040

LARGE AREA COMPOSITE STRUCTURE REPAIR

J.D. Labor
S.H. Myhre

Final Report For Period January 1976 - February 1979

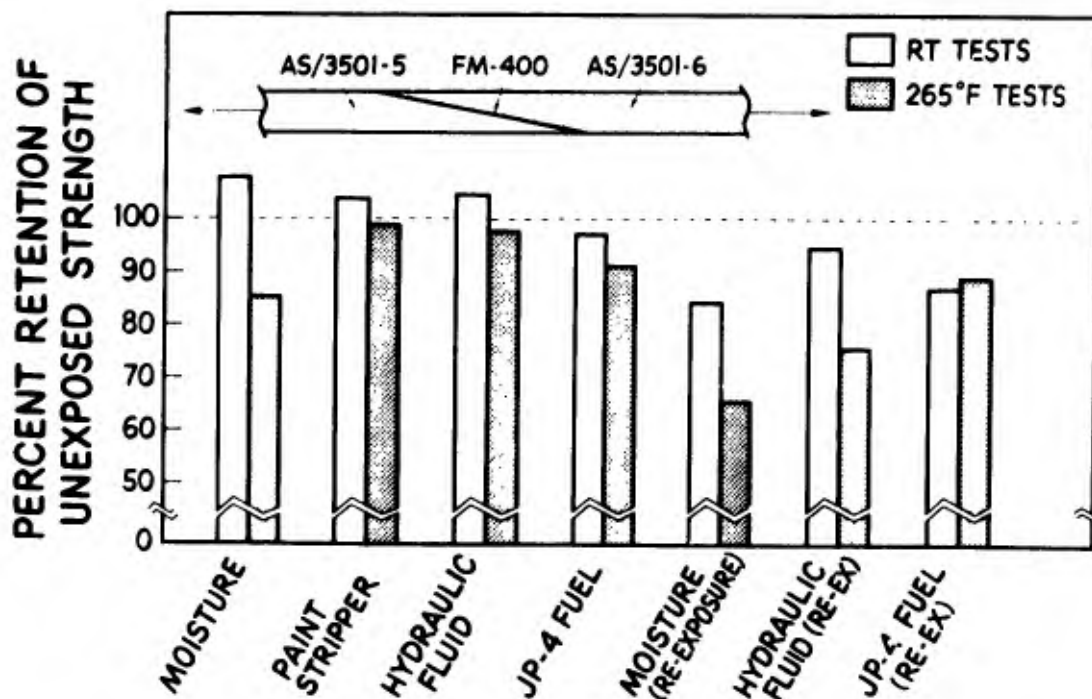
Figure 2. Scarf Joint Compatibility Test Results

Moisture had a significant effect on the strength of precured scarf joints made with FM-400 adhesive and graphite/epoxy adherends. In the specimens in which only the parent material was exposed to moisture, the room temperature strength was unaffected but the 265°F strength was reduced by about 17 percent. In the re-exposed specimens, where the bonded specimen was exposed to environmental fluids, the reduction in strength due to moisture was 38 percent. This is believed to be an effect mainly on the adhesive. There was no degradation due to paint stripper. There was degradation in some tests due to JP-4 and hydraulic fluid.

Complete data are tabulated in the first interim progress report (4). Results are summarized graphically for precured scarf joints in Figure 2. Because moisture was the most severe environment, many of the specimens tested subsequently in the program were exposed to moisture prior to evaluating the strengths of the repairs.

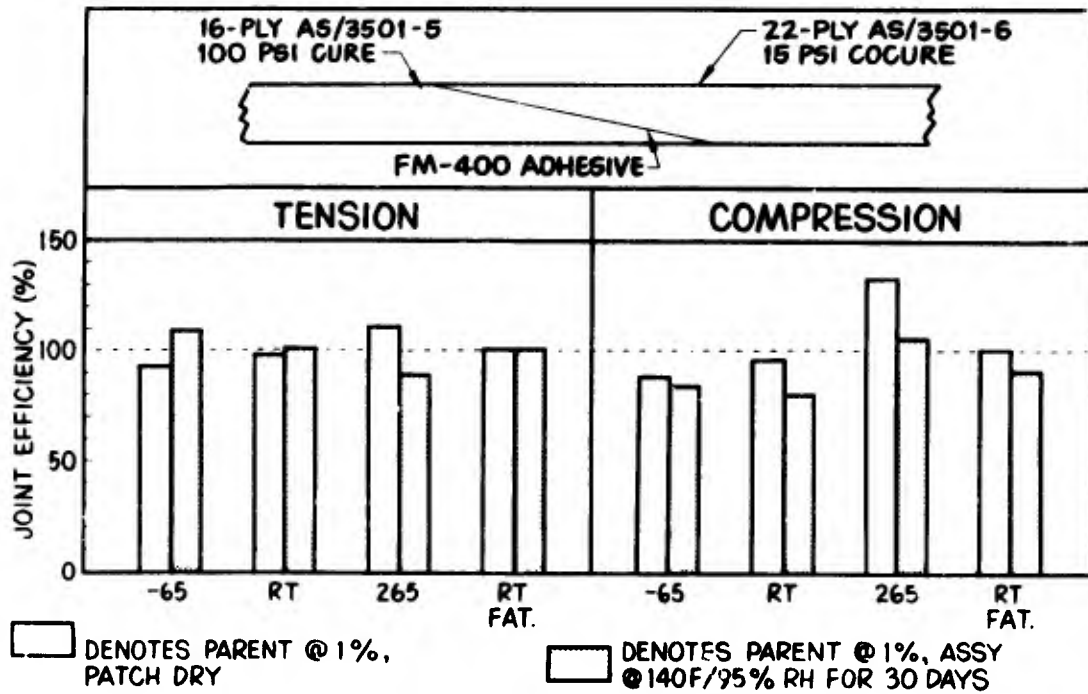
Figure 12. Single Scarf Joint Results

Test results are tabulated in Table 6 and compared graphically in Figure 12. Note that room temperature tension tests (Series II) were done on both Splice Details G1 and G2. The increased strength of Detail G2 resulted in a joint efficiency increase from

83 percent to 97 percent. For test series I and IV, tested on Detail G1 only, failures were tension in the repair plies. Since Detail G2 added strength by lengthening these plies, higher joint efficiencies would be expected approximately in the same ratio as the room temperature results, i.e. 97/83. The joint efficiencies shown in Figure 12 for series I and IV have been increased by this ratio so that all results are on a common basis for a 22-ply patch represented by either Detail G2 or Detail H.

Moisture conditioning of the repair assembly deteriorated the splice for compression results only, where identical specimens were used. Splice failures predominated in the wet tension group also, indicating deterioration of the splice. The prior fatigue loading caused no deterioration in strength. The results plotted are the average of the lower of the two fatigue loaded groups.

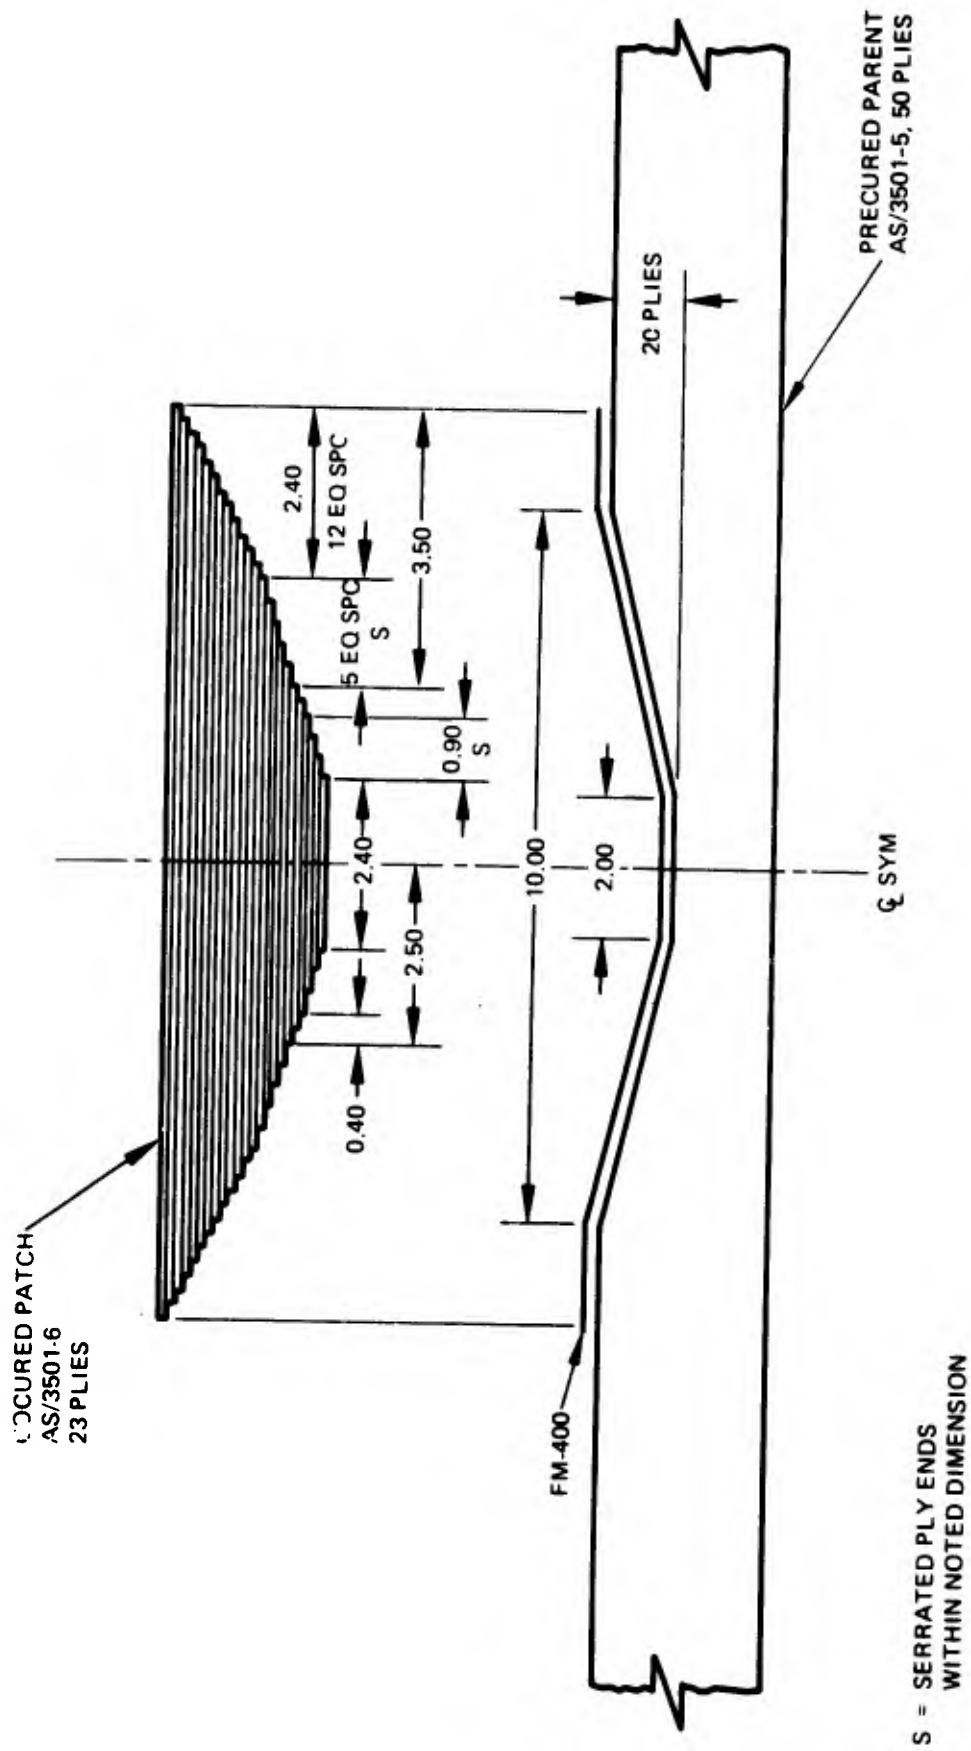
Figure 14. Repair of a Partially-Damaged 50-Ply Graphite Epoxy Laminate
Specimen Type (3)

The first three of the panels were repaired as shown in Figure 14, using the usual cure with vacuum pressure and 350°F for 2 hours. After the repair cure cycle, it was discovered that local delaminations (blisters) had appeared in the parent laminates adjacent to the repair in all three panels, varying from one to eight plies deep.

was repaired using the same cure cycle. Blisters again occurred, but much deeper, near the mid-thickness. The remaining laminates were dried for longer periods, up to 68 days. To assess the possibility of using a lower cure temperature for the repair, panels were fabricated using a 300°F cure temperature and tested for physical and mechanical properties. The properties of the panel cured at 300°F were slightly better than the values for a 350°F cure. As a result, the repairs for the last two panels were cured at 300°F for 4 hours, after drying the parent laminates for up to 68 days. No blisters occurred in these panels.

The moisture condition which caused blistering during these repairs is considered to be a more severe condition than would normally be found in service. Many panels up to 32 plies thick containing 1 percent moisture had been cured previously without blistering. The 50-ply panels which did blister had a very non-uniform moisture distribution through the thickness because of the water immersion method of conditioning which was used. Long time exposure to humidity under actual service conditions would tend to produce a more uniform distribution through the thickness and, except for a few possible worst cases, a lower total moisture content.

The remaining panels were then dried in an air circulating oven at 180°F. A moisture desorption analysis was made to determine the through-the-thickness moisture profiles, using the procedure of Reference 10. After 16 days of drying, one panel

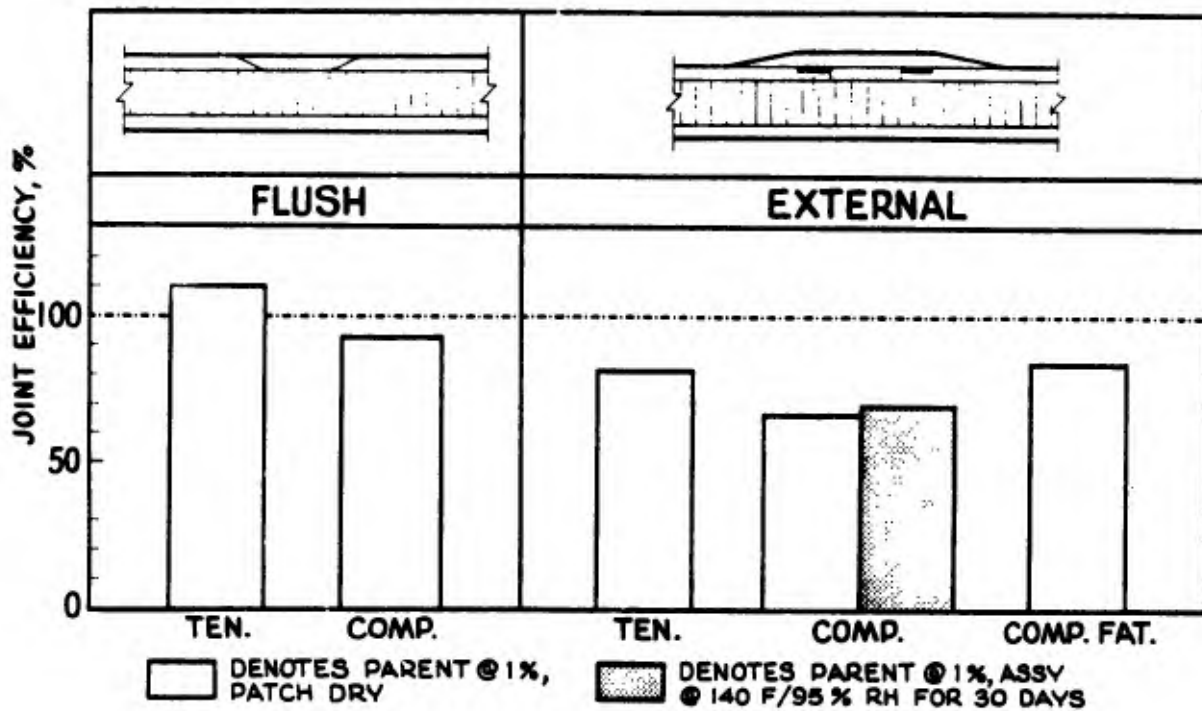
Figure 23. Intermediate Size Panel Results

Four panels were repaired with a nearly flush patch on a scarfed hole. The tension loaded panels performed very well at 109 percent joint efficiency. All failures were in parent laminate tension beyond the end of the patch. Only the usual faintly

The one flush scarf repair tested in compression achieved 92 percent of the parent compression allowable. Failure occurred suddenly with no audible or visual signs of incipient failure or early deterioration of the repair. The failure tore the patch away before finally crushing a section through the 4-inch diameter hole.

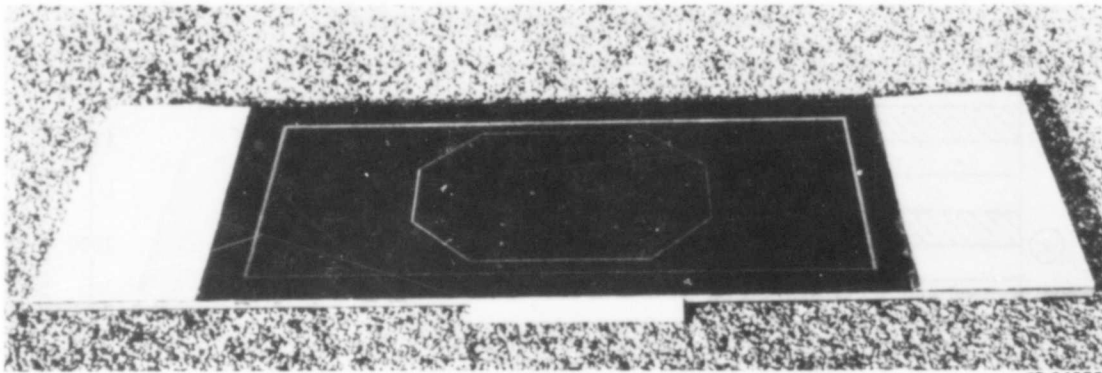
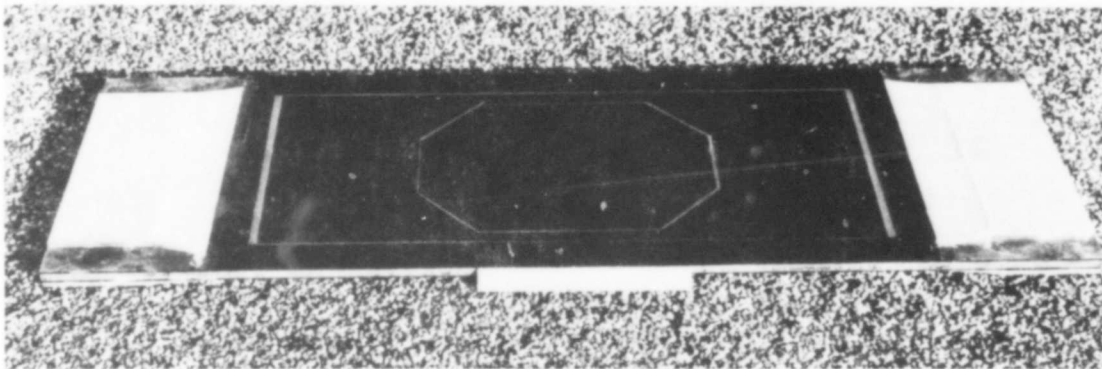
Figure 25. Repaired Panel One

The repair and testing of Panel One is described in detail in reference (6) and is summarized here. An oval hole 6.6 x 12.0 inches completely through the panel was repaired with access to both sides. The core was replaced and spliced. Then both faces were repaired with a bonded and cocured patch which replaced the removed material $(\pm 45/0/90)_S$ and added five additional plies $(\pm 45/0/\pm 45)$. The patch was designed to restore axial load and shear capability. The panel faces were scarfed adjacent to the hole on 36/1 slope using a portable drum sander. A track was provided to guide the tool and the scarf angle was fixed by the track and tool construction. The sanding drum was shrouded and provided with a vacuum source to remove the dust. The completed repair is shown in Figure 25.

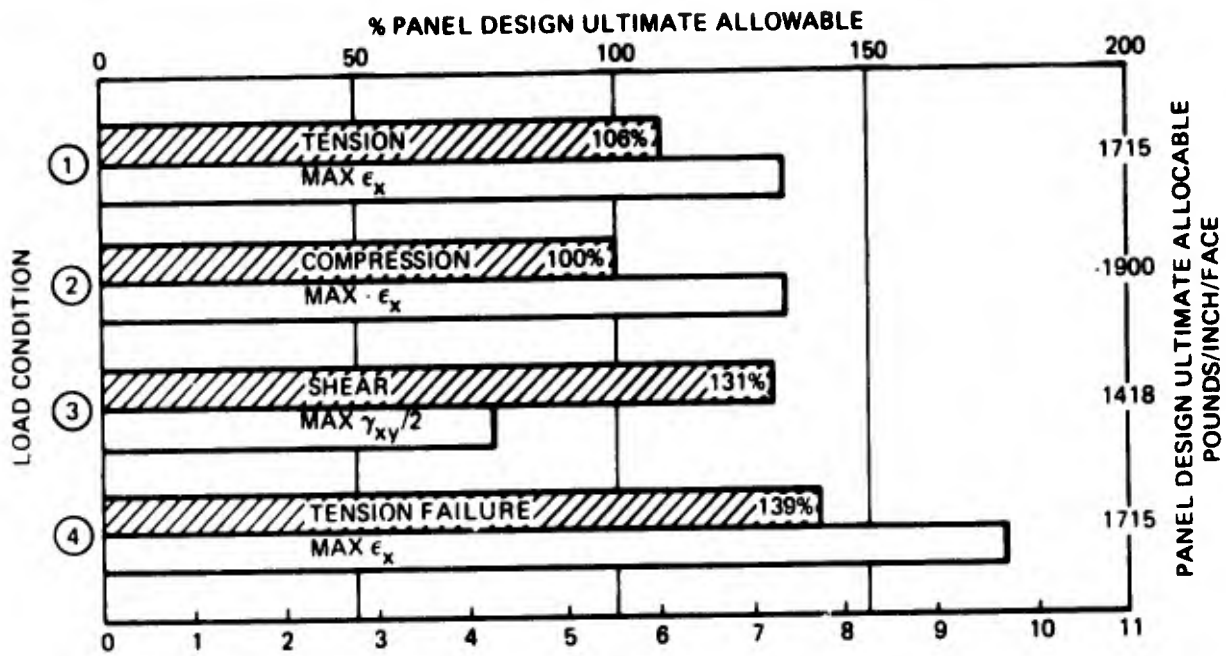
Figure 26. Panel One Test Results

Bending was again applied to the box beam in load condition four, until tension failure of the panel. Failure loading in the 8-ply outer face was 2390 pounds per inch. The maximum axial strain at failure was $9670 \mu\text{in./in.}$ The results of all load conditions are shown in Figure 26 in terms of percent of allowable load and strain. The nonuniform strain distribution, shown in Figure 27, became an advantage in this particular case since it reduced strain along the panel edge where the attachment holes are located. The failure, shown in Figure 28, occurred remote from the patch.

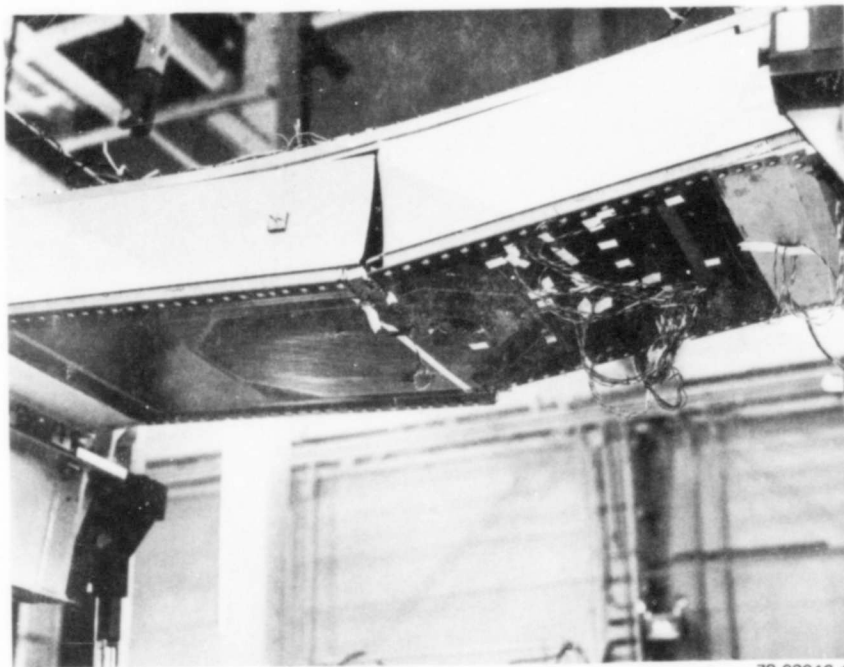
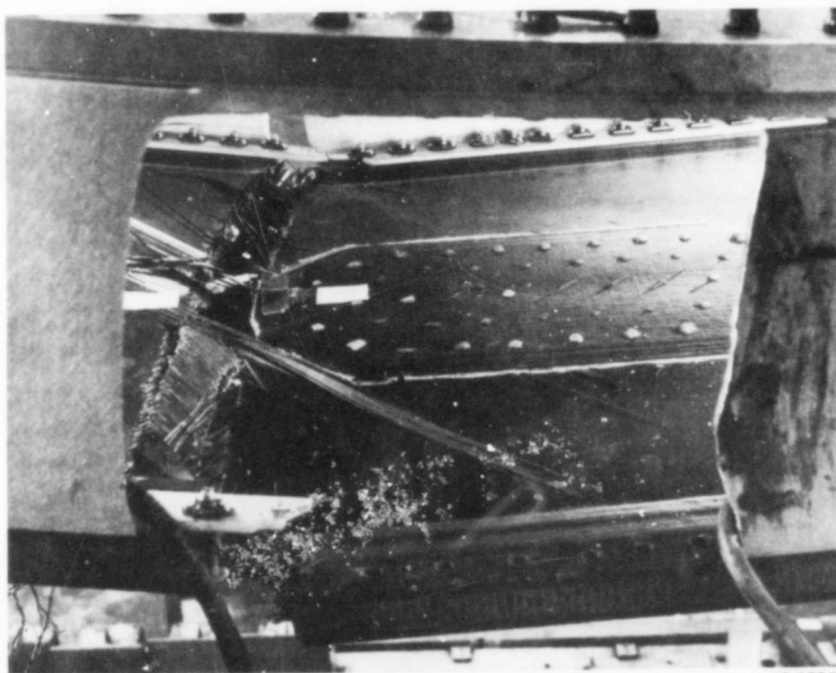
Figure 33. Panel Two Failure at 122% of Design Ultimate Allowable

Panel Two was loaded to failure in tension resulting from positive bending on the box beam. The panel design ultimate allowable was defined in the same way as for Panel One, i. e. 1715 pounds per inch per face. Panel Two failed at 2095 pounds per inch in the outer face or 122 percent of design ultimate allowable. Maximum strain at failure was $8925 \mu\text{in./in.}$ on the parent laminate just off the end of the patch. Noises and strain gage readings during loading indicate some deterioration of the bond of the blind side patch. However, the failure occurred outside this area and the bond deterioration appears to have had no effect on the ultimate failure. Photos of the failure, viewed from the outside and inside are shown in Figure 33. The test results and the mode of failure demonstrate that even an imperfectly bonded repair, made simulating on-aircraft conditions with access from one side only, can restore strength well beyond ultimate design load requirements. By using a repair method which is capable of high strength restoration a considerable margin is available to allow for reduced quality standards.

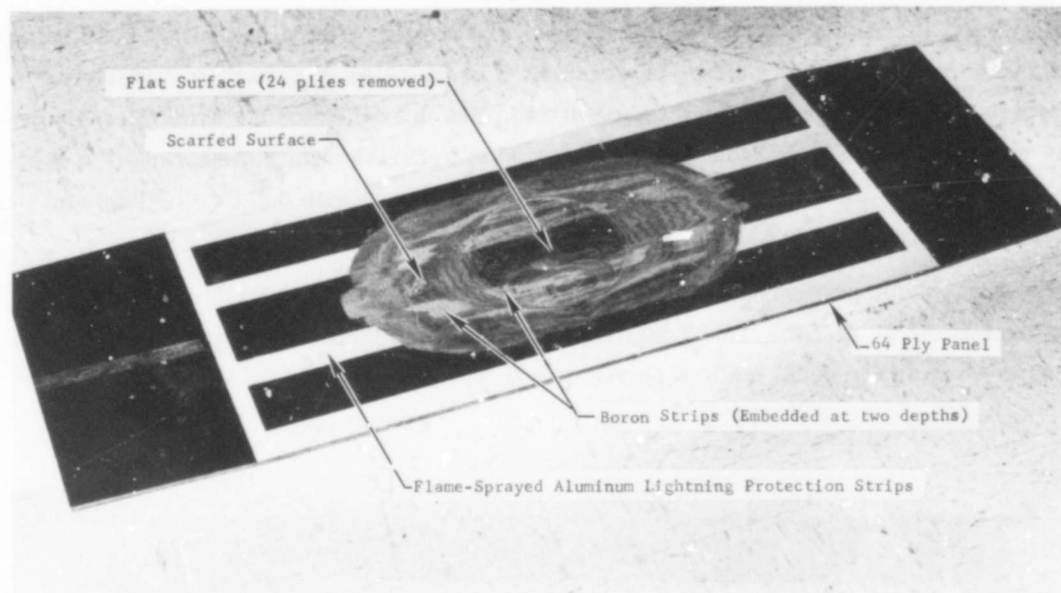
Figure 39. Panel Five After Material Removal

Panel Five was an exact representation of a section of the horizontal stabilizer skin of the B-1 airplane with local build up over spar caps using unidirectional boron/epoxy strips. The typical cross section is seen in section B-B on sheet 2 of drawing SR-013041 presented as Figure 38. The assumed damaged extended 24 plies deep as shown in the transverse section F-F on sheet 3. This cutout removed 11 of the 28 plies of boron over the two interior spar caps plus all the associated graphite between the spar caps as shown in section F-F. The scarf in this section involved two slopes to minimize cutting of shear plies in the panel. Ideally, only the 13 plies were to be cut by the transverse scarf on a slope of 0.10 inch per ply. The longitudinal section through the damage removal area is shown in section E-E on sheet 3. The scarf length is 7.20 inches or 0.30 inch per ply. The panel after material removal is shown in Figure 39.

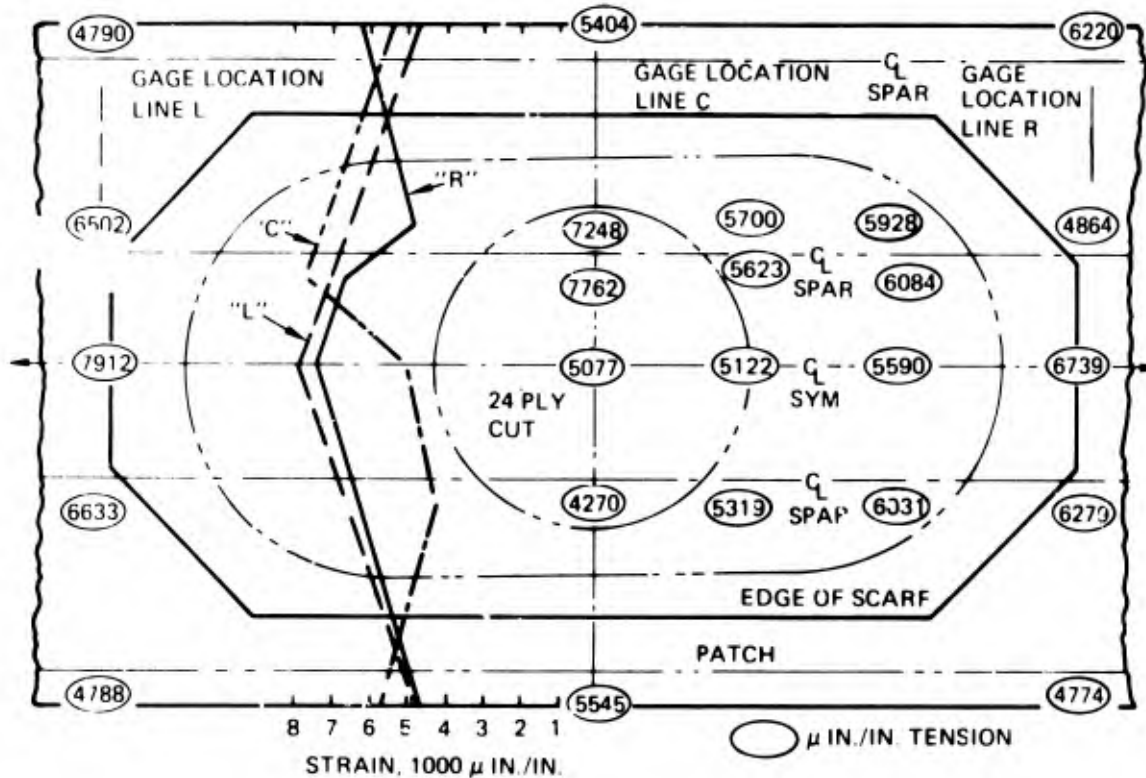
Figure 42. Failure Strains on Panel No. 5

The strain gage data was found to be linear with load, essentially to failure. Strains at failure (scaled from the last value read) are shown in Figure 42. On the left end, the distribution is linear from edge to center. Therefore, the mean strain between the edge and the center is taken as the value to be compared to the strain allowable. This mean failure strain is 6300 μ in./in. Hence, the panel failure occurred at 151 percent of the design ultimate allowable. Maximum strain in the parent laminate was 7912 μ in./in.

The strains in Figure 42 are not doubly symmetrical as might be expected. Since the strain distribution remains the same during loading, the spatial strain variations are due to stiffness variations, not local failures. Local fiber waviness is suggested as the cause of the stiffness variation. In determining the maximum strain at a fastener hole, only the gages outside the patch were used since the high strains on gages 6A and 7A were considered to be unusually high, but did not influence the failure. Hence, the maximum strain level at a hole was 6900 μ in./in. at failure interpolated between gages 1R2 and 3A.

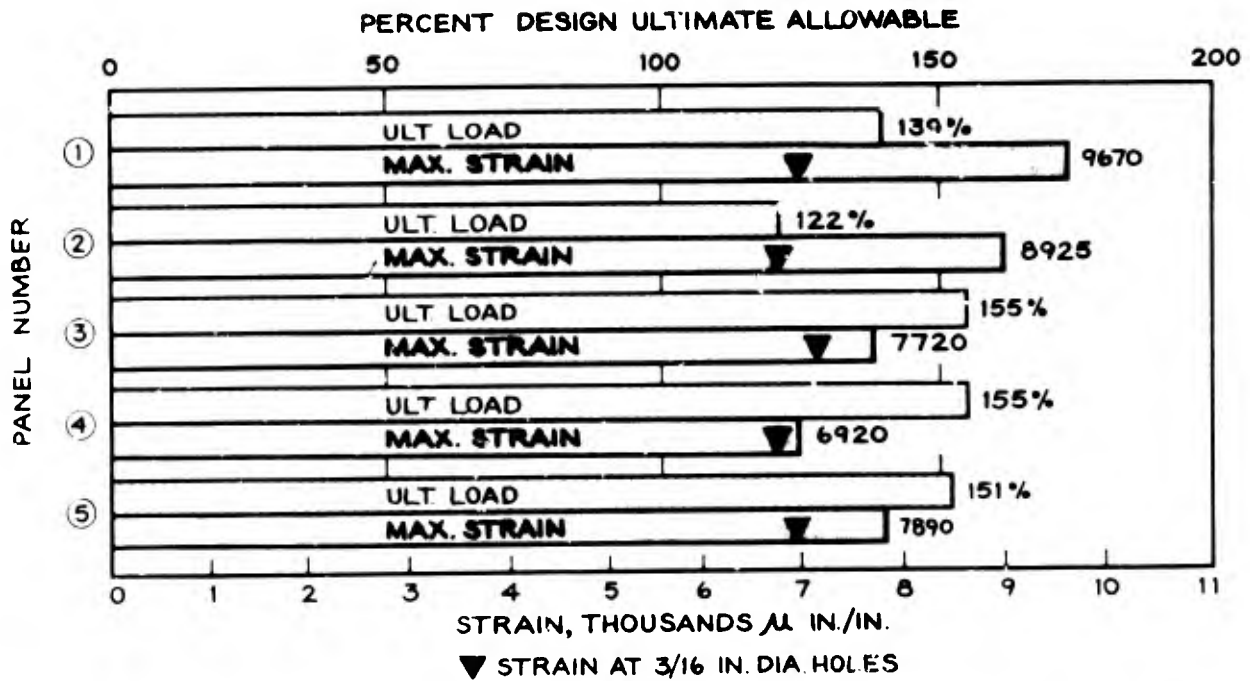
Figure 43. Summary of Demonstration Panel Results

A summary of the test results of Panels One through Five is shown in Figure 43, giving the percent of design ultimate allowable and the maximum strain at failure. The mark on the strain bar indicates the strain extrapolated or interpolated to the spar attachment hole centerline not including the local effect of the holes. Since each failure apparently originated at a hole, this strain appears to be the best correlating parameter. In any case, the failure loads, strains and failure modes of these five repaired panels demonstrated that it is possible to restore a badly damaged graphite structure to its original strength which is well above current design ultimate allowables.

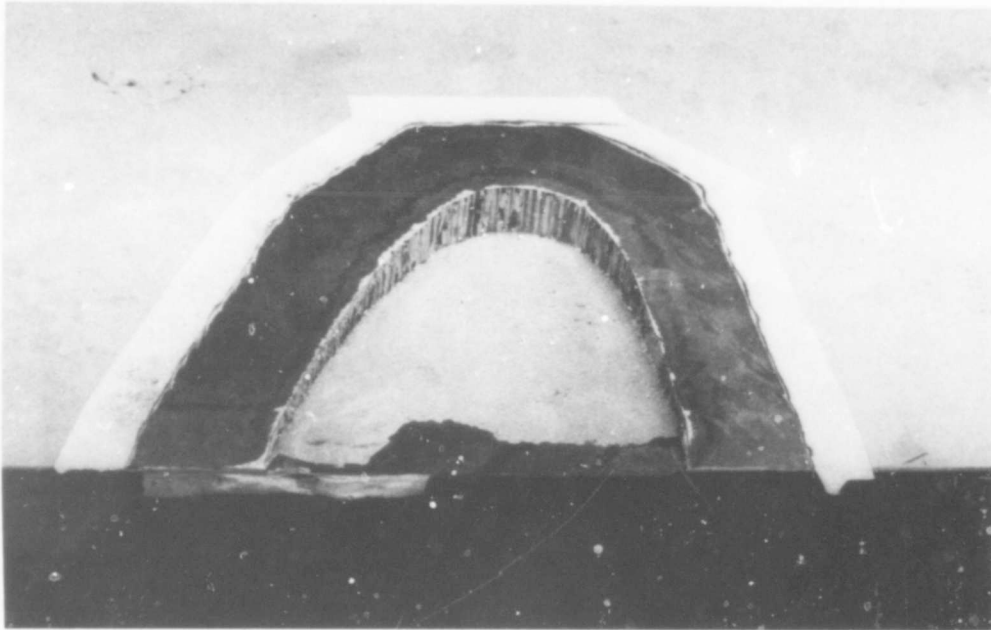
Figure 45. Repair Area on F-15 Speed Brake

when a canopy came off in flight and impacted the speed brake. The damaged speed-brake was made available to this program for use in demonstrating the application of the repair procedures on a real aircraft part. A flush repair was made and the speedbrake was proof tested to verify the quality of the repair.

At the edge of the opening which had been cut in the outer skin, the skin was scarfed over a width of less than an inch using a hand held air-driven motor with a 30-inch sanding disk, and a small belt sander. The scarfed surface was shaped to end at a scribed line on the surface. The hand held sander was controlled by the operator without using any mechanical guides. The repair area with the core removed and the scarf surface prepared is shown in Figure 45.

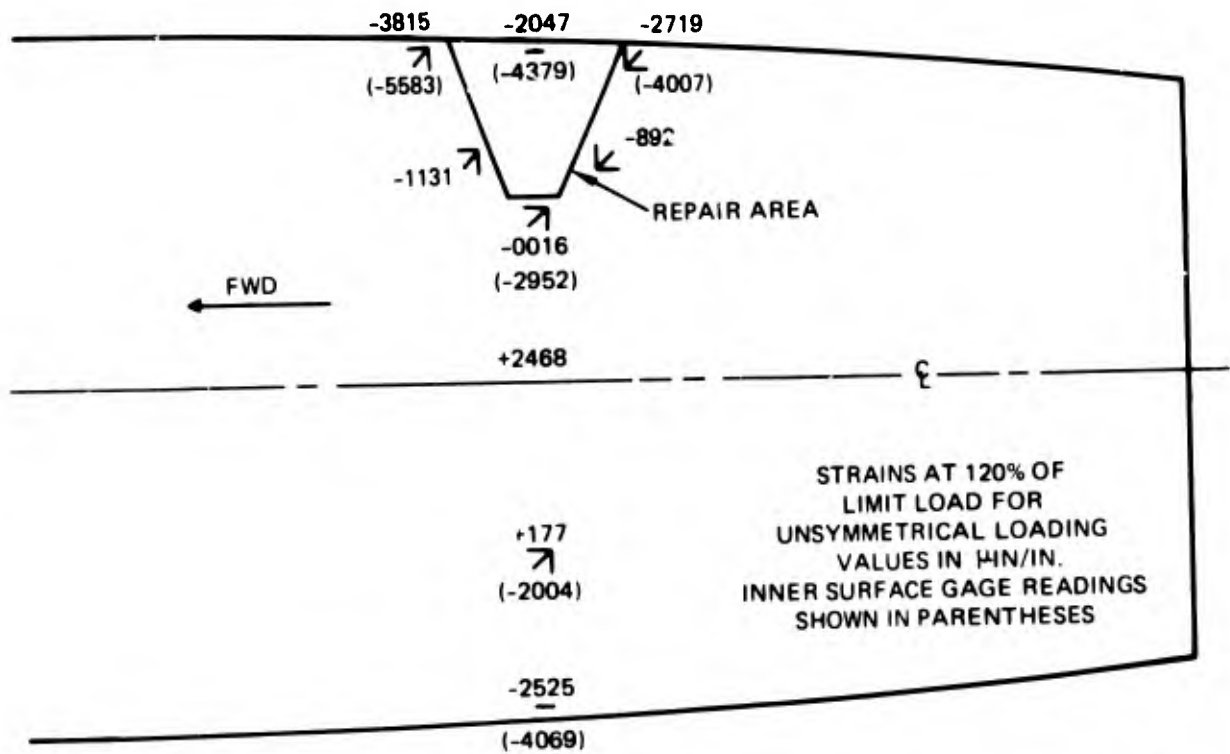
Figure 49. Strains at 120% of Limit Load During F-15 Speed Brake Proof Loading

Fifteen strain gages were used to monitor the test loading. Gage locations and strain readings at 120 percent of the limit loading shown in Figure 48 are shown in Figure 49. The peak strain shown is 5583 $\mu\text{in./in.}$ adjacent to the patch. No damage to the repaired area occurred and proof loading was terminated at 120 percent of the limit loading condition, after demonstrating that the repair was adequate.
