AFWAL-TR-89-2012

# IMPROVED FATIGUE LIFE BEARING DEVELOPMENT

June 1989

Final Report for Period September 1984 - December 1988

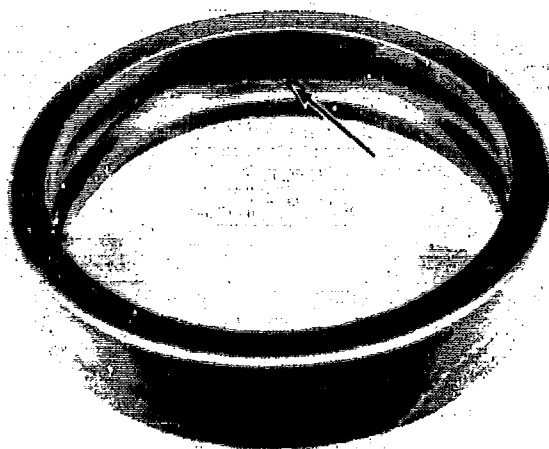
Figure 60. Localized Area of Corrosion Due to Lack of Coating.

**Outer Ring (M50NiL)** - Running track burnished, slight evidence of ring rotation on outer diameter. Cage rub indications on shoulder. TDC coating intact on all areas except one patch (see Figures 60 and 61). SEM examination of this area indicated a coating problem (peeling) presumed due to a processing anomaly.

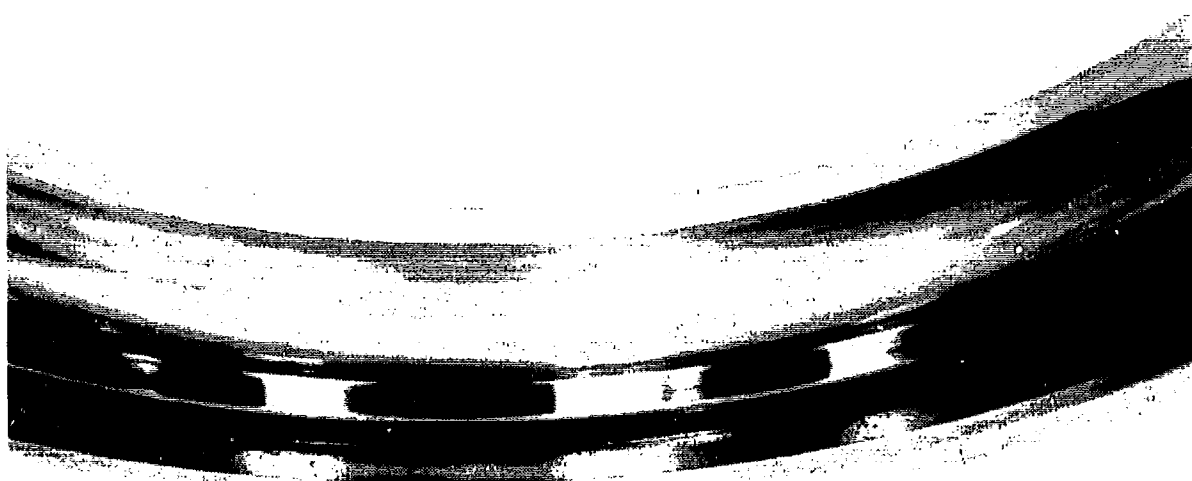
The bearing selected was a 133-mm bore mainshaft ball bearing common to the GEAE F101, F110, CFM56 family of engines. Two of these bearings were manufactured. The inner and outer rings were M50NiL, TDC coated; the balls were M50, and the cage was silver-plated 4340. To evaluate the bearing, it was run as a "slave bearing" on a two-bearing shaft component test. Initially it had only been the intention to run a continuous steady-state (constant load and speed) test for 150 hours. However, because the M50NiL bearing was "piggy backed" onto a special test cycle, the bearing actually saw a much more intensive duty cycle than had been planned. The actual test schedule is shown in Table 14. After 229.7 hours of testing, the bearing was disassembled and visually examined. As seen in Figures 74 and 75 no evidence of any distress was noted. Particularly encouraging was the fact that, similar to the 208 size bearings, no indication of coating damage was observed in the raceway, despite the fact that the bearing had experienced many shutdown and start-up cycles during the testing.

**Figure 74. Outer Raceway of 133-mm Bore Ball Bearing (TDC Coated) After Component Test.**

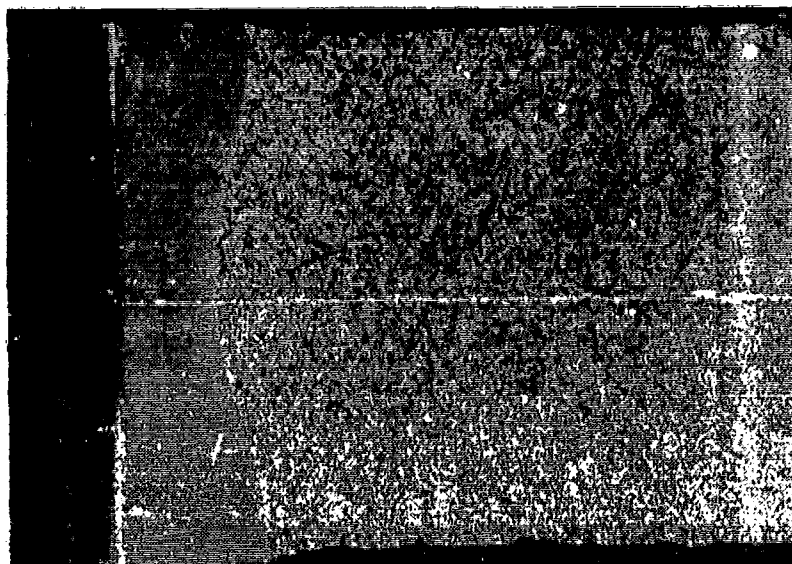
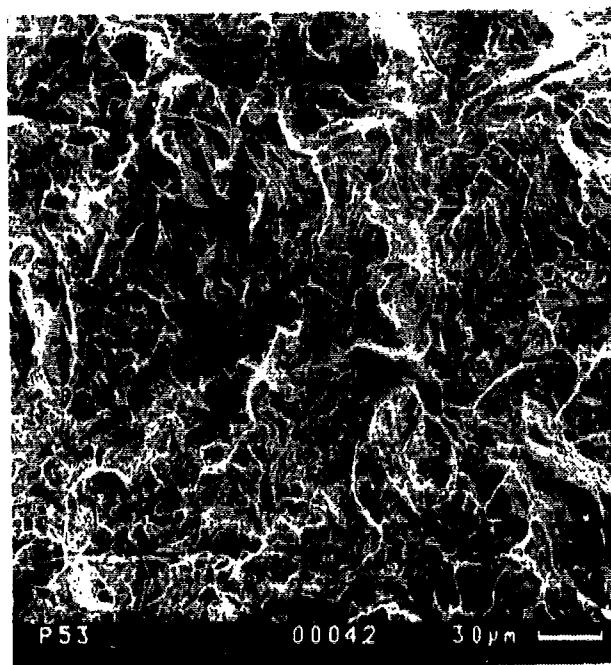
**Figure A-6. Pyrowear 53 Fracture Face ( $K_{Ic}$ ), -65°F Test.**

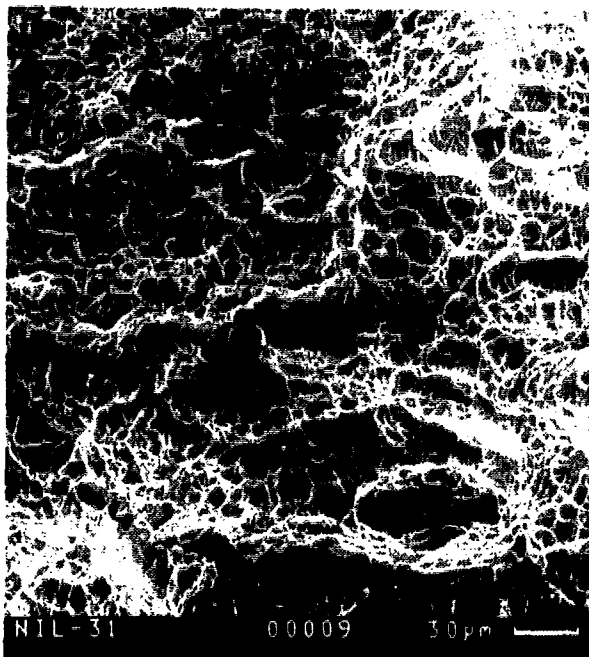
Figure A-24. M50NiL Fracture Face ( $K_{Ic}$ ), 400°F Test.

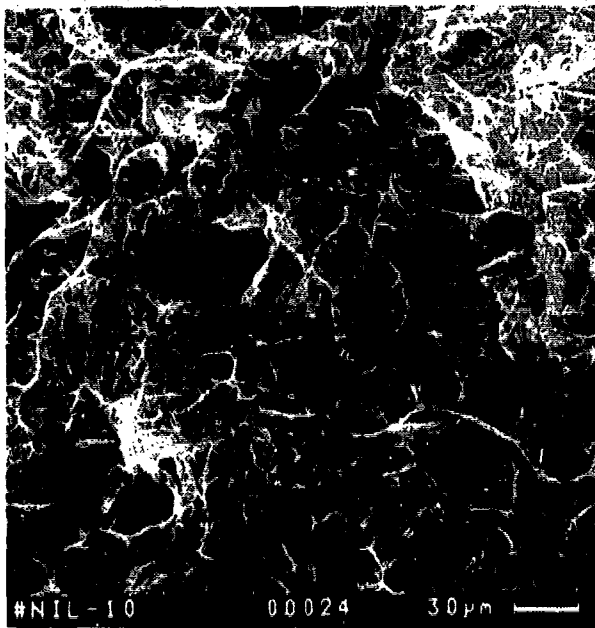
Figure A-25. M50NiL Fracture Face ( $K_{Ic}$ ), Aged 1000 Hours at 450°F, Room Temperature Test.

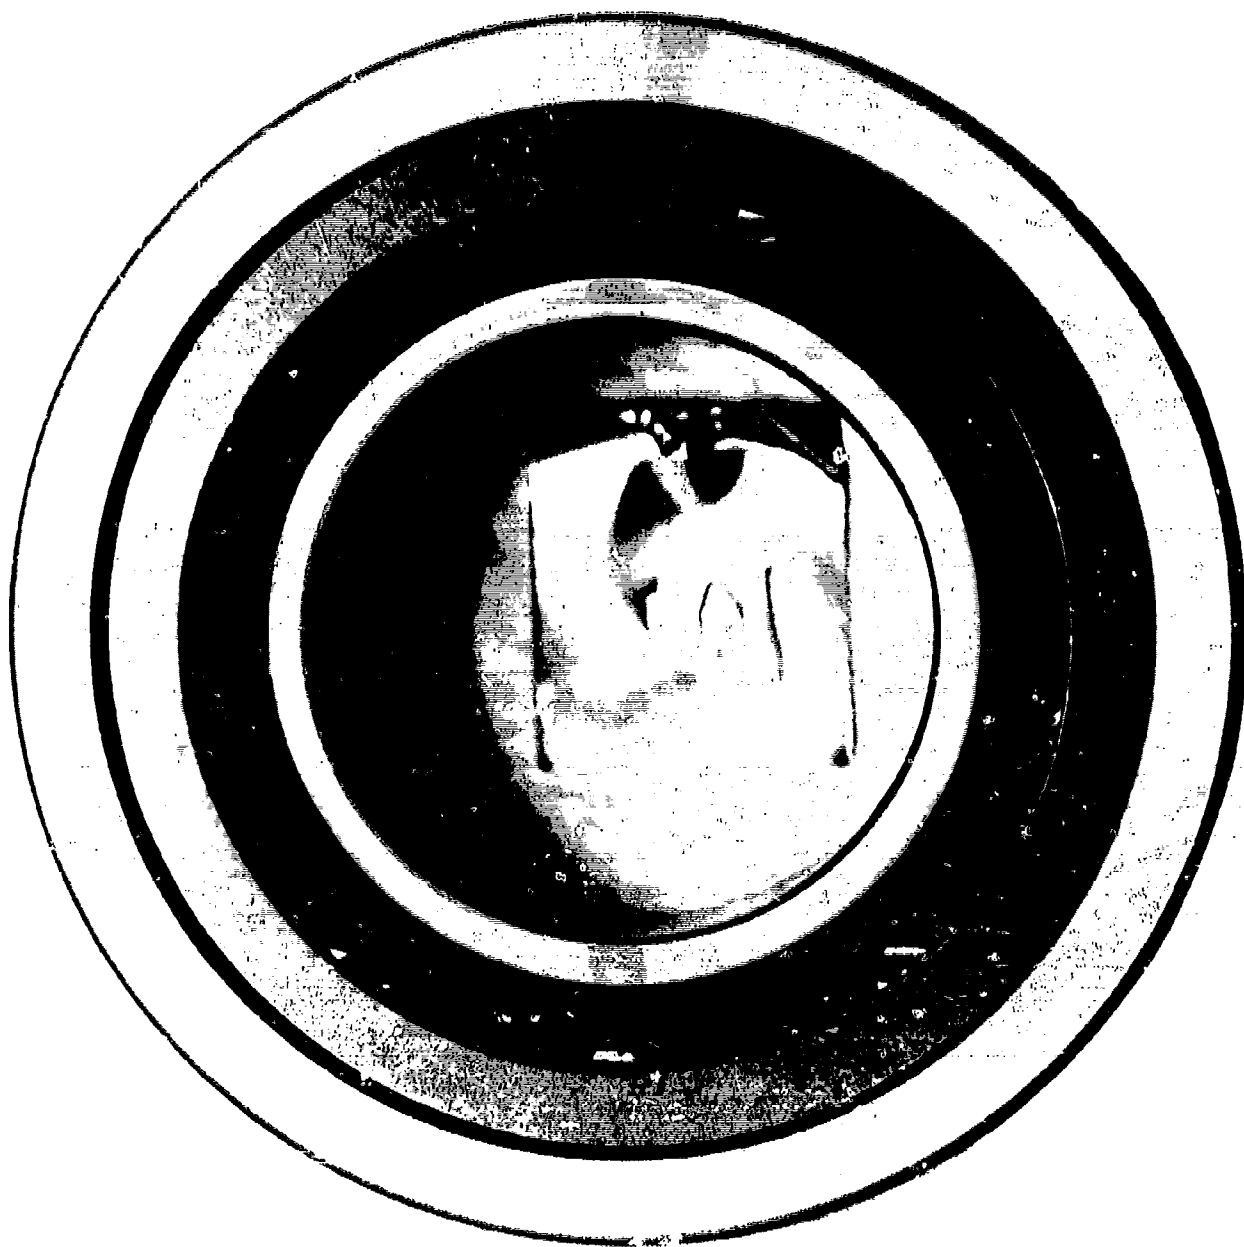
FIGURE 50  
152

#### **Bearing No. 6 – Overall photo, Figure 50.**

**Figure 50. Bearing No. 6 After Corrosion Test.**

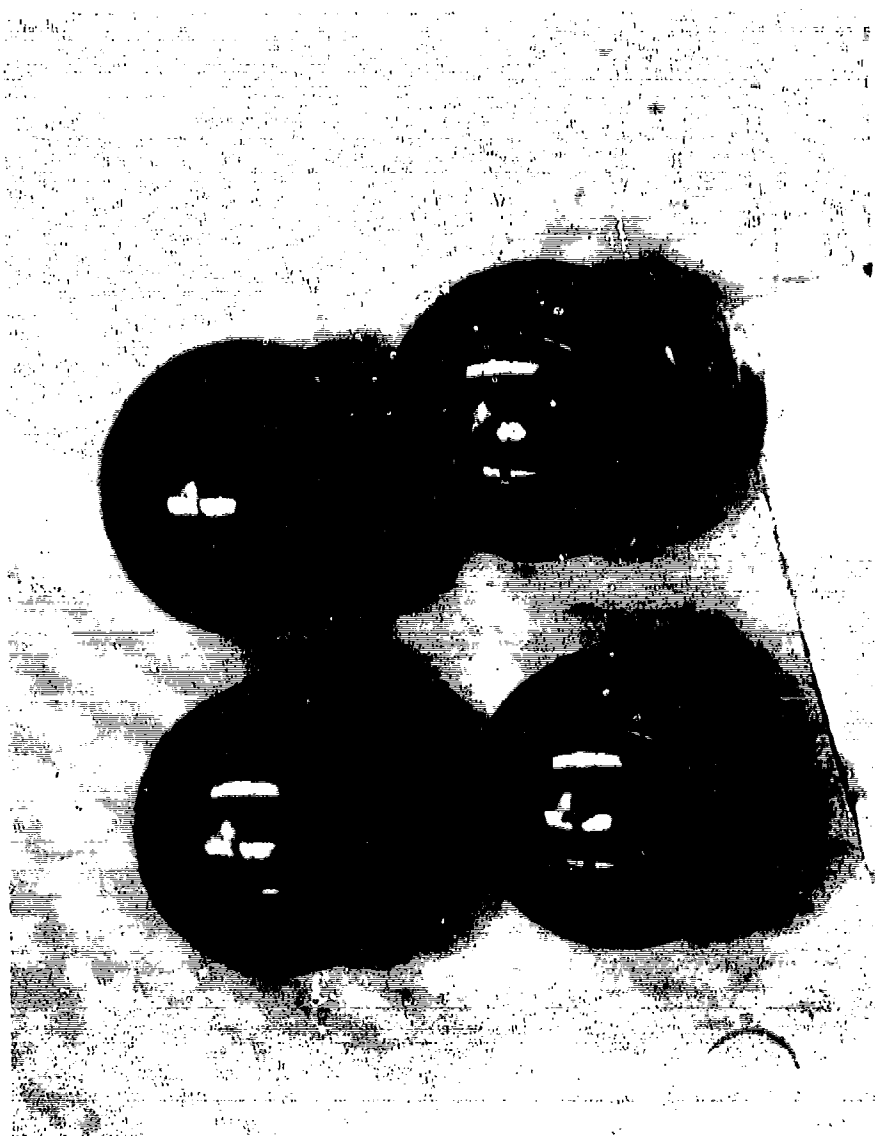
FIGURE 53  
155

**Balls (Ta<sup>+</sup> - M50)** - Localized corrosion and pitting (see Figures 53 and 54).

Figure 53. Balls from Bearing No. 6 After Corrosion Test.

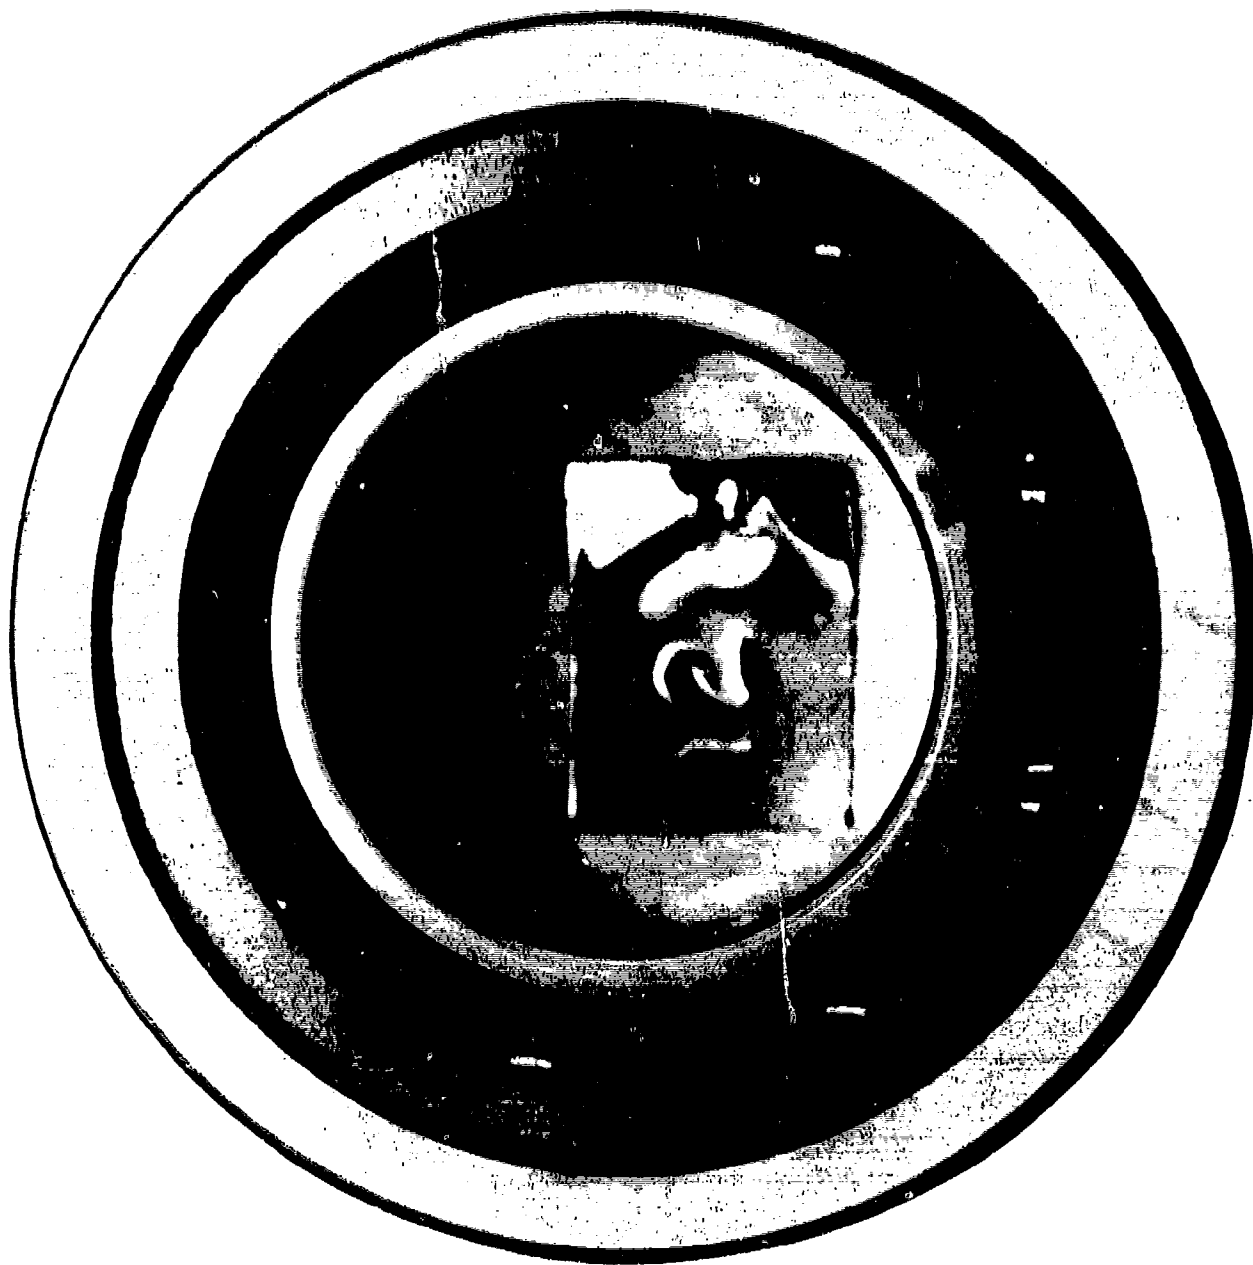
FIGURE 57

#### **Bearing No. 12 – Overall photo, Figure 57.**

**Figure 57. Bearing No. 12 After Corrosion Test.**

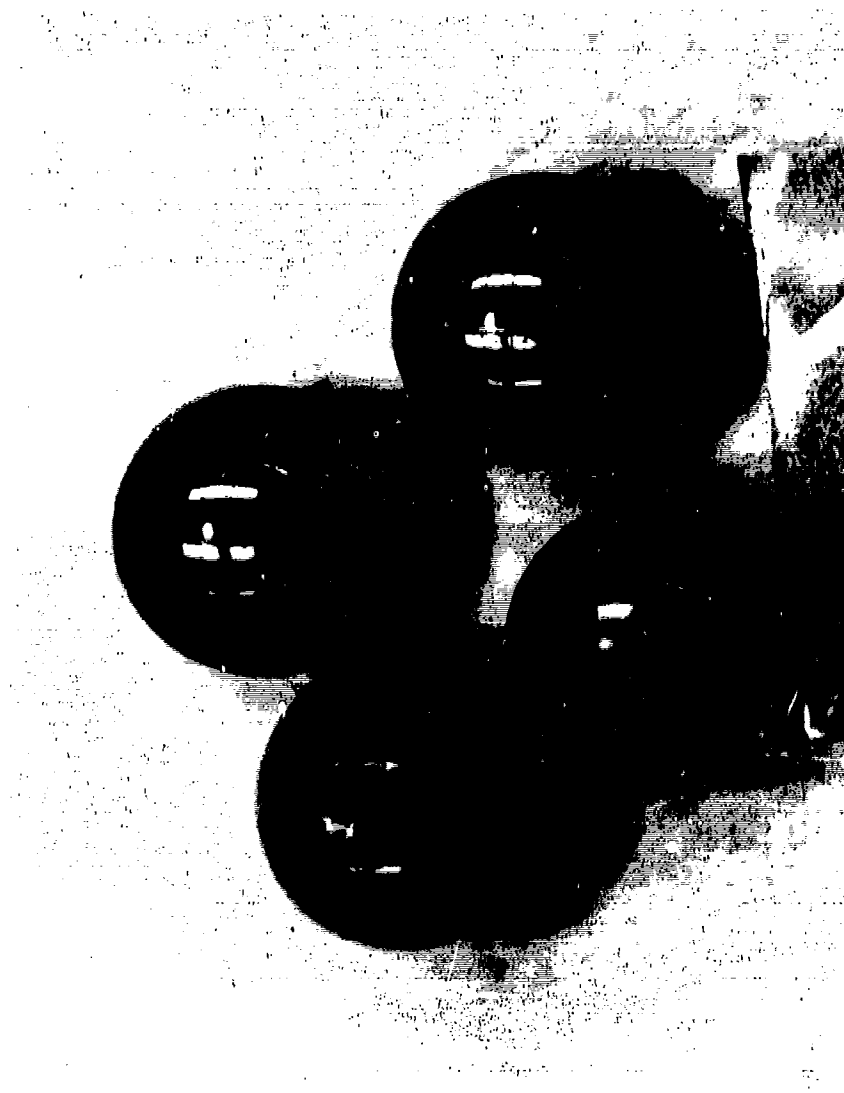
FIGURE 62

**Balls (M50)** - Evidence of corrosion and pitting. Balls were quite heavily varnished compared to the Ta<sup>+</sup> implanted balls in Bearing Nos. 6 and 9 (Figures 62 and 63).

Figure 62. Balls from Bearing No. 12 After Corrosion Test.

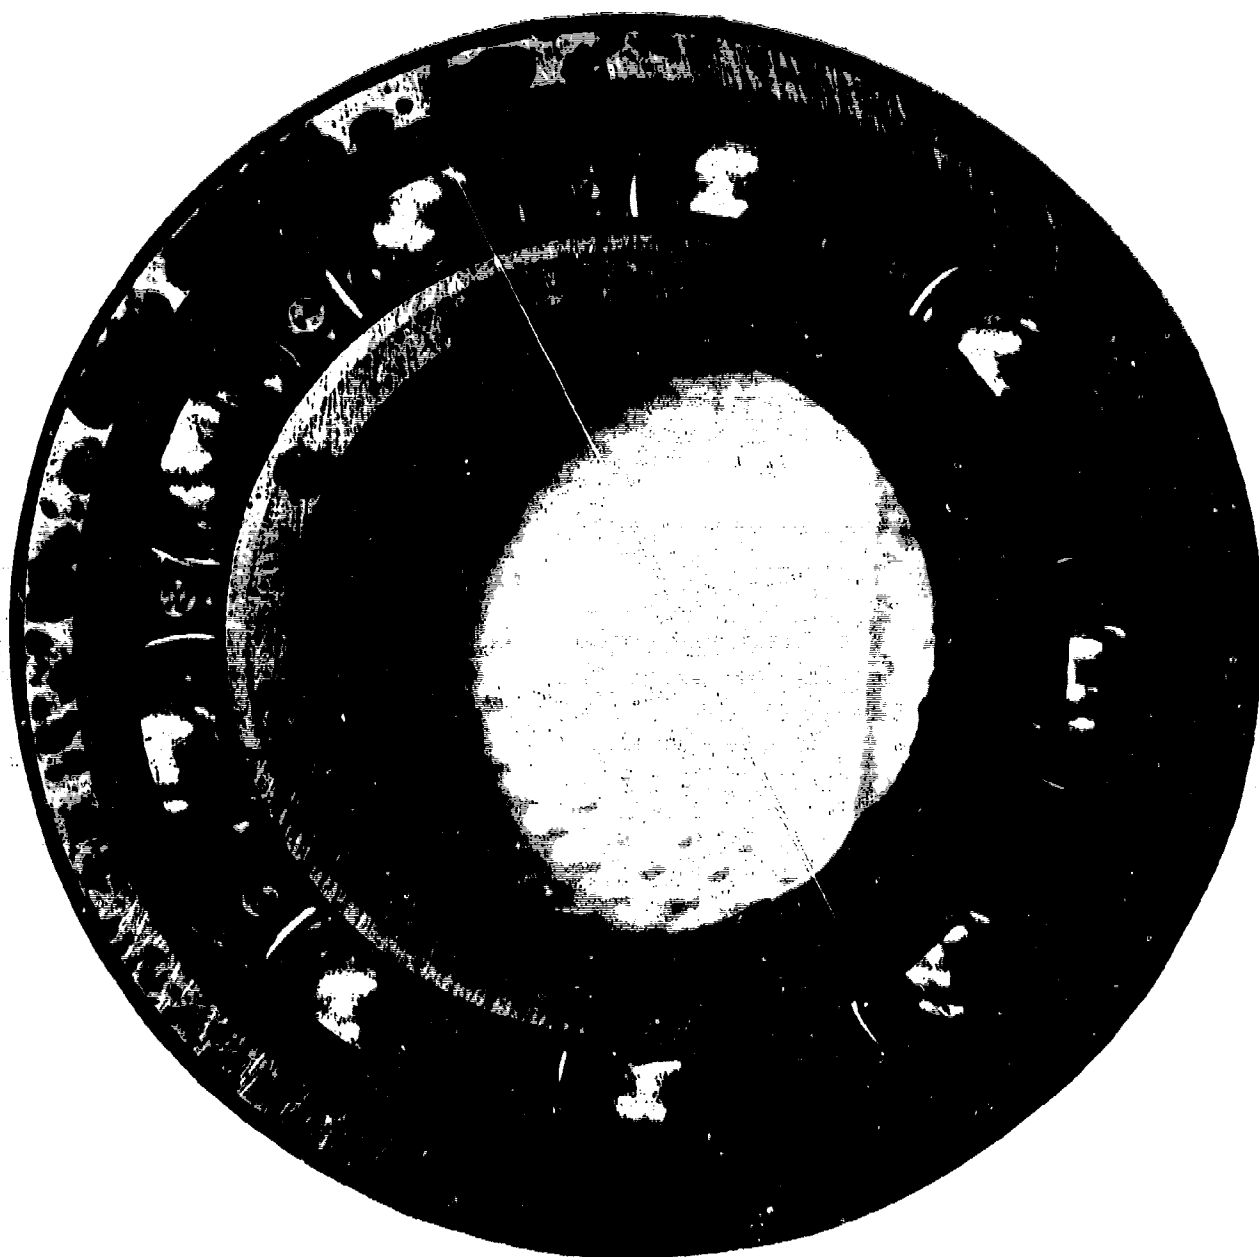
FIGURE 64

**Control Test Bearing** - Heavily corroded, see Figure 64.

Figure 64. New, Uncoated Control Bearing After Corrosion Test.
