NASA CR-72228

## 260-SL-3 MOTOR PROGRAM

VOLUME I: 260-SL-3 Motor Internal  
Insulation System

FINAL PHASE REPORT

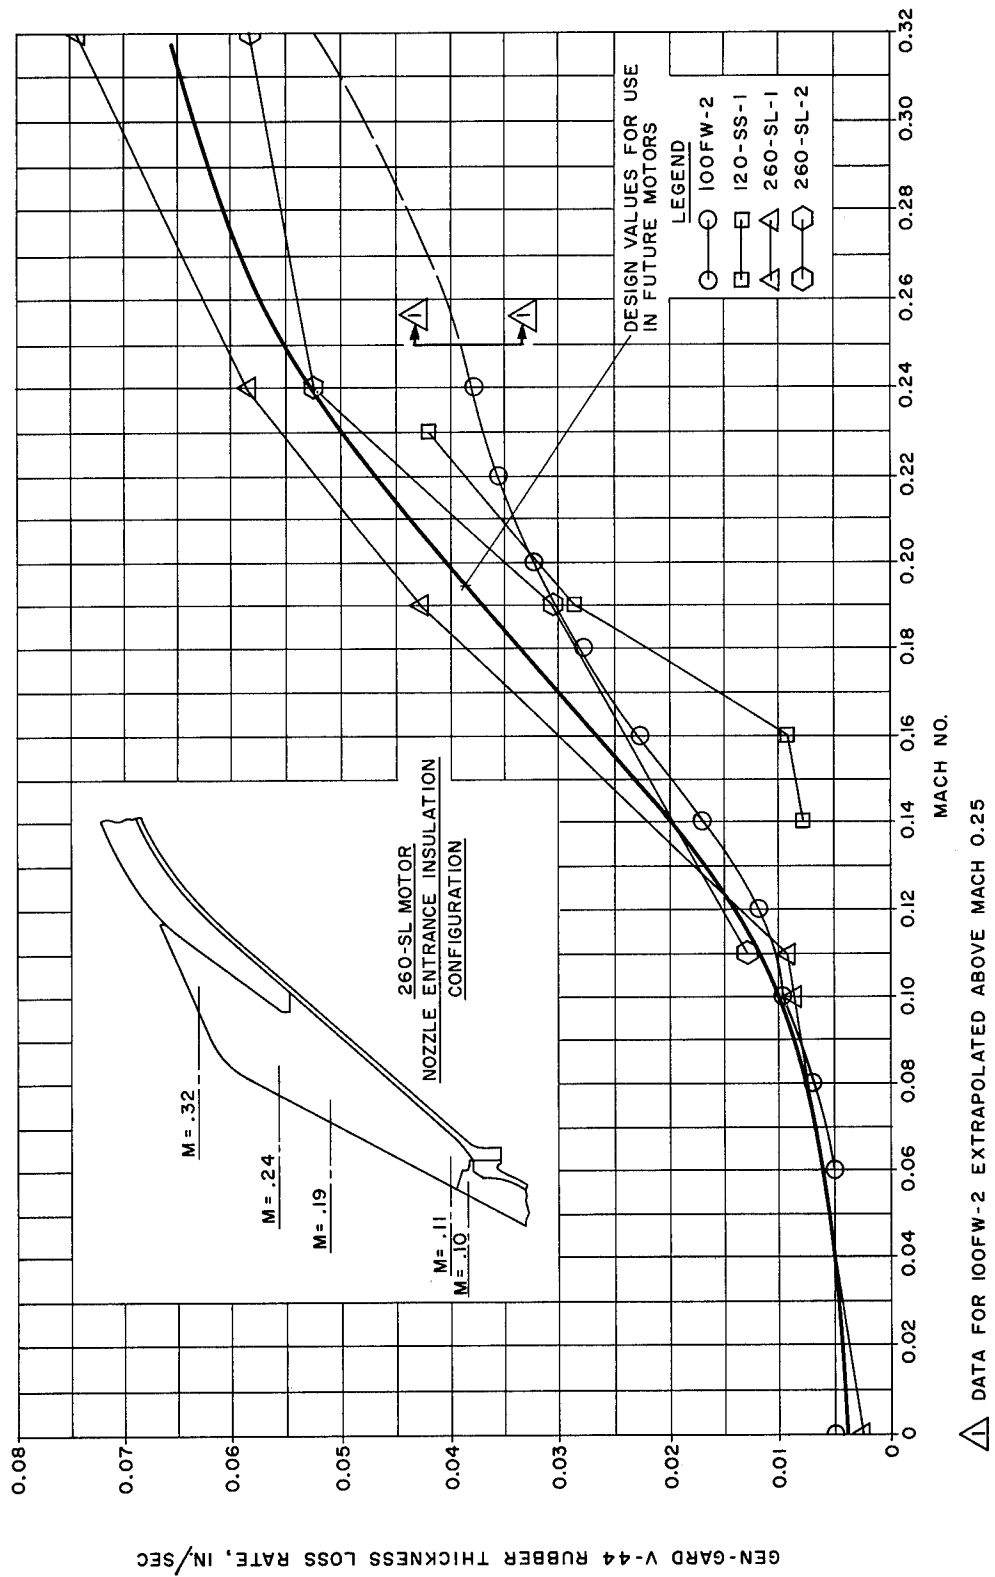
Figure 1

Thickness loss rates corresponding to the computed local Mach numbers are obtained from Figure 1. Since the nominal operating pressure for motor 260-SL-3 is not significantly different from the operating pressures of the motors used to obtain the data in Figure 1, no correction factors are required.

Gen-Gard V-44 Thickness Loss Rate Versus Gas Flow Mach Number

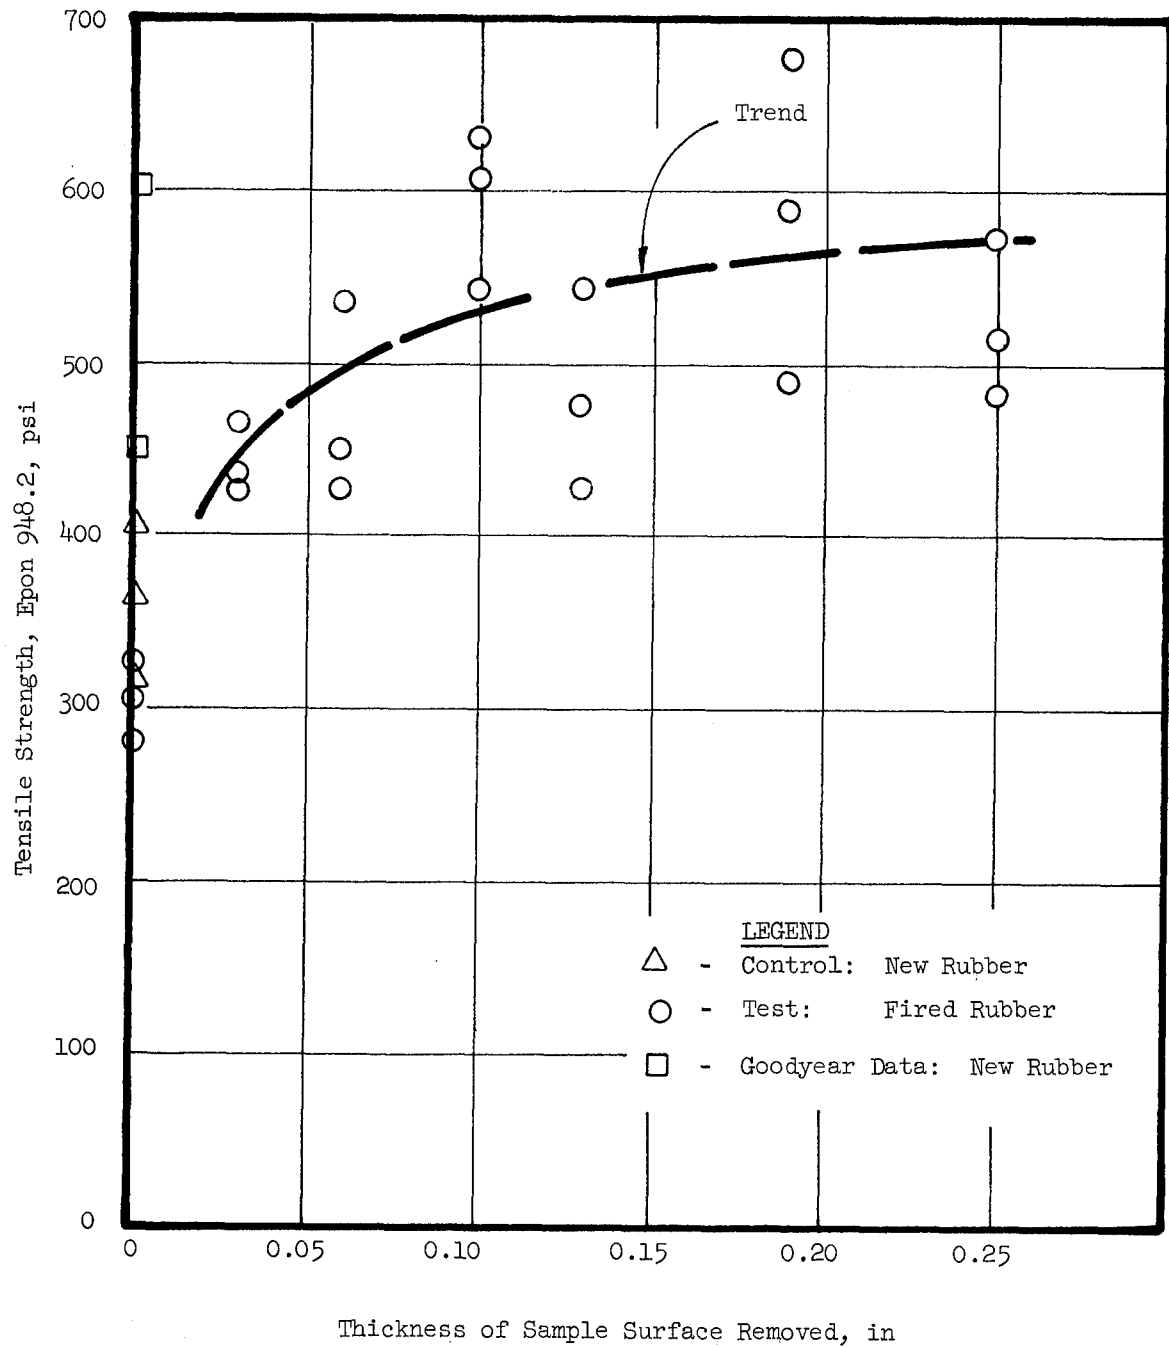
Figure 5

As shown in Figures 5 and 6, the Epon 948.2 bond-strength values for the control samples were unusually low (319 to 407 psi), and were not significantly greater than the values obtained with the essentially unabraded fired rubber specimens. However, the control samples failed in the rubber and not at the rubber-to-adhesive interface, indicating the possibility that the rubber used in the control samples tended to delaminate during the DPT test. Unfired rubber samples were obtained from the warehouse at A-DD. As a result, the

Plot of Epon 948.2 Adhesive Bond Strength as a Function of  
Fired Rubber Surface Thickness Removed

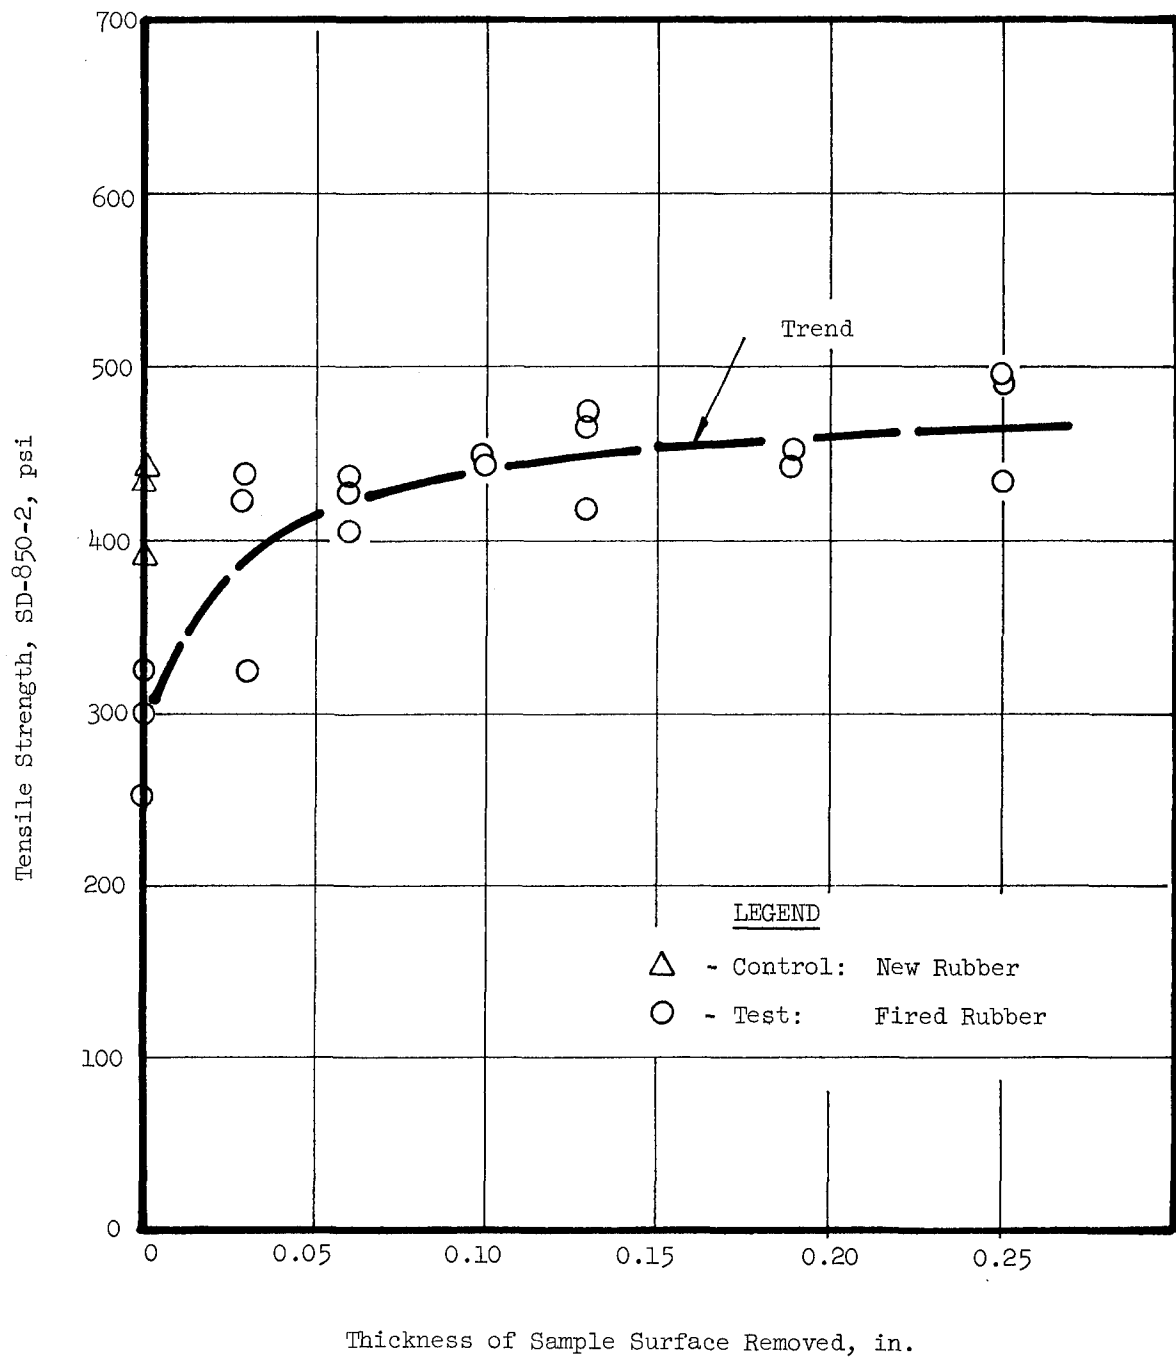
Figure 6

Plot of SD-850-2 Liner Bond Strength as a Function of  
Fired Rubber Surface Thickness Removed

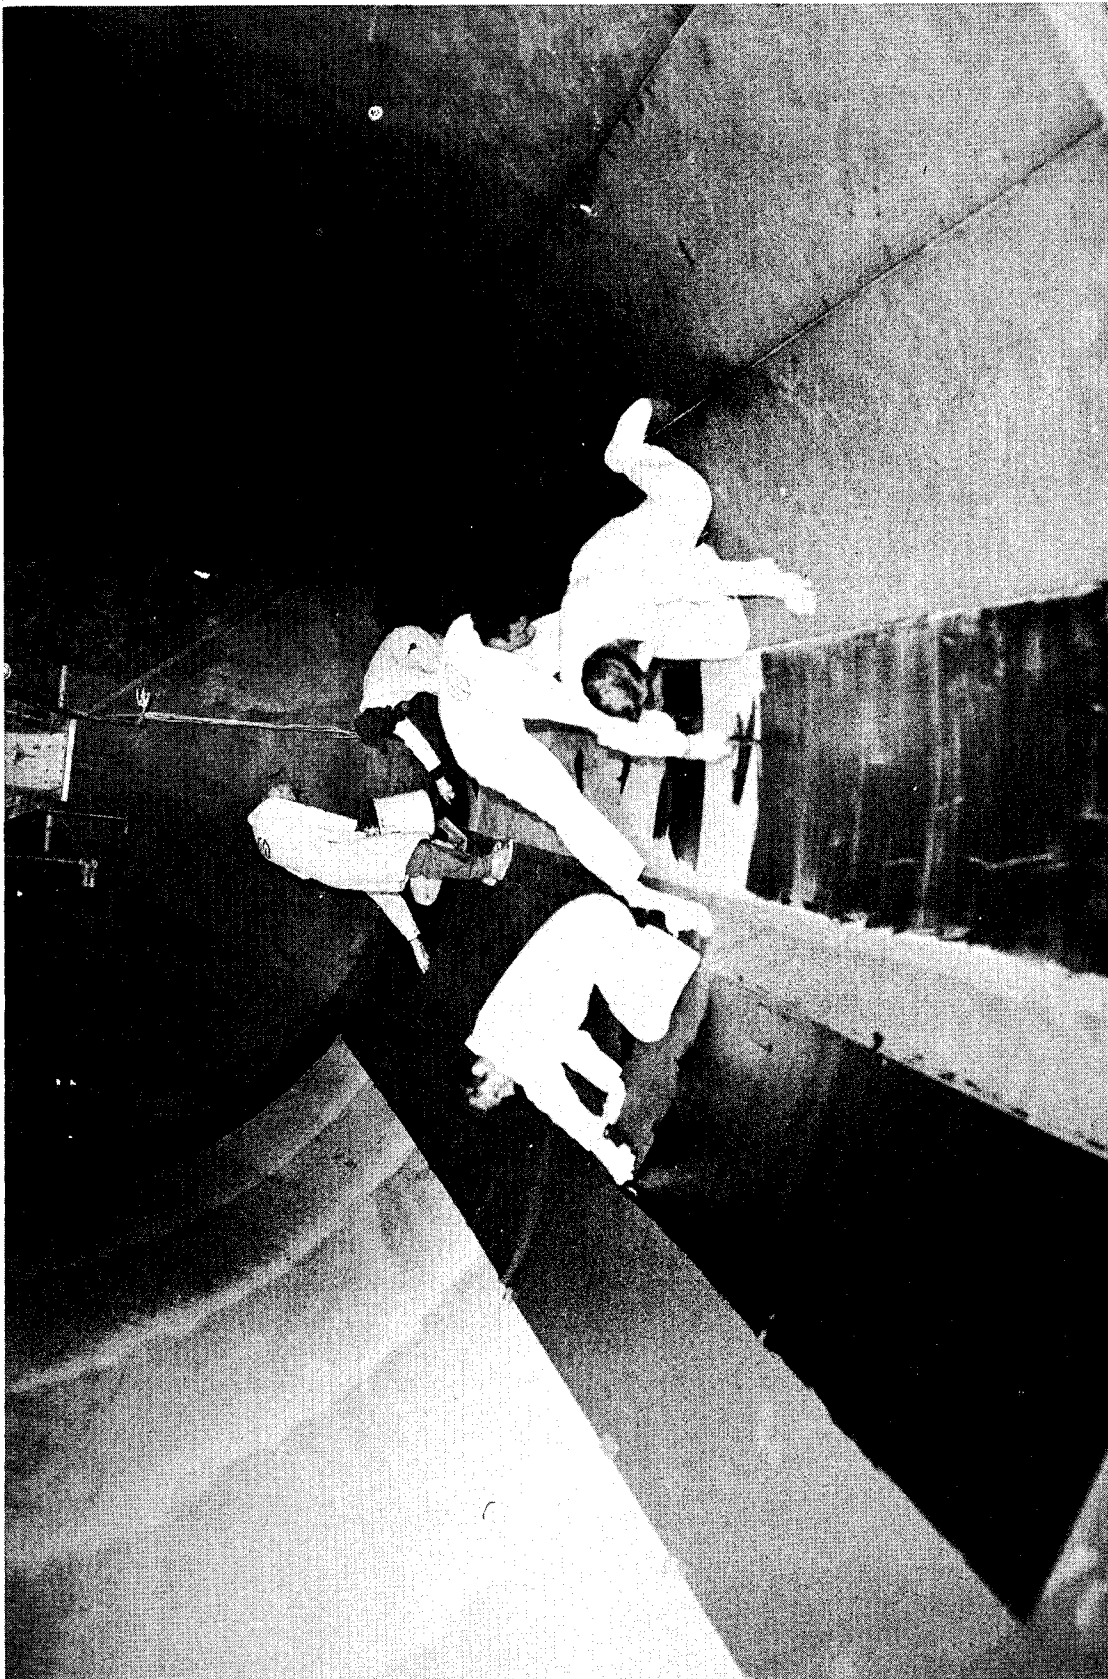
Figure 16

Adhesive Application to Cylindrical Section Rubber Strip

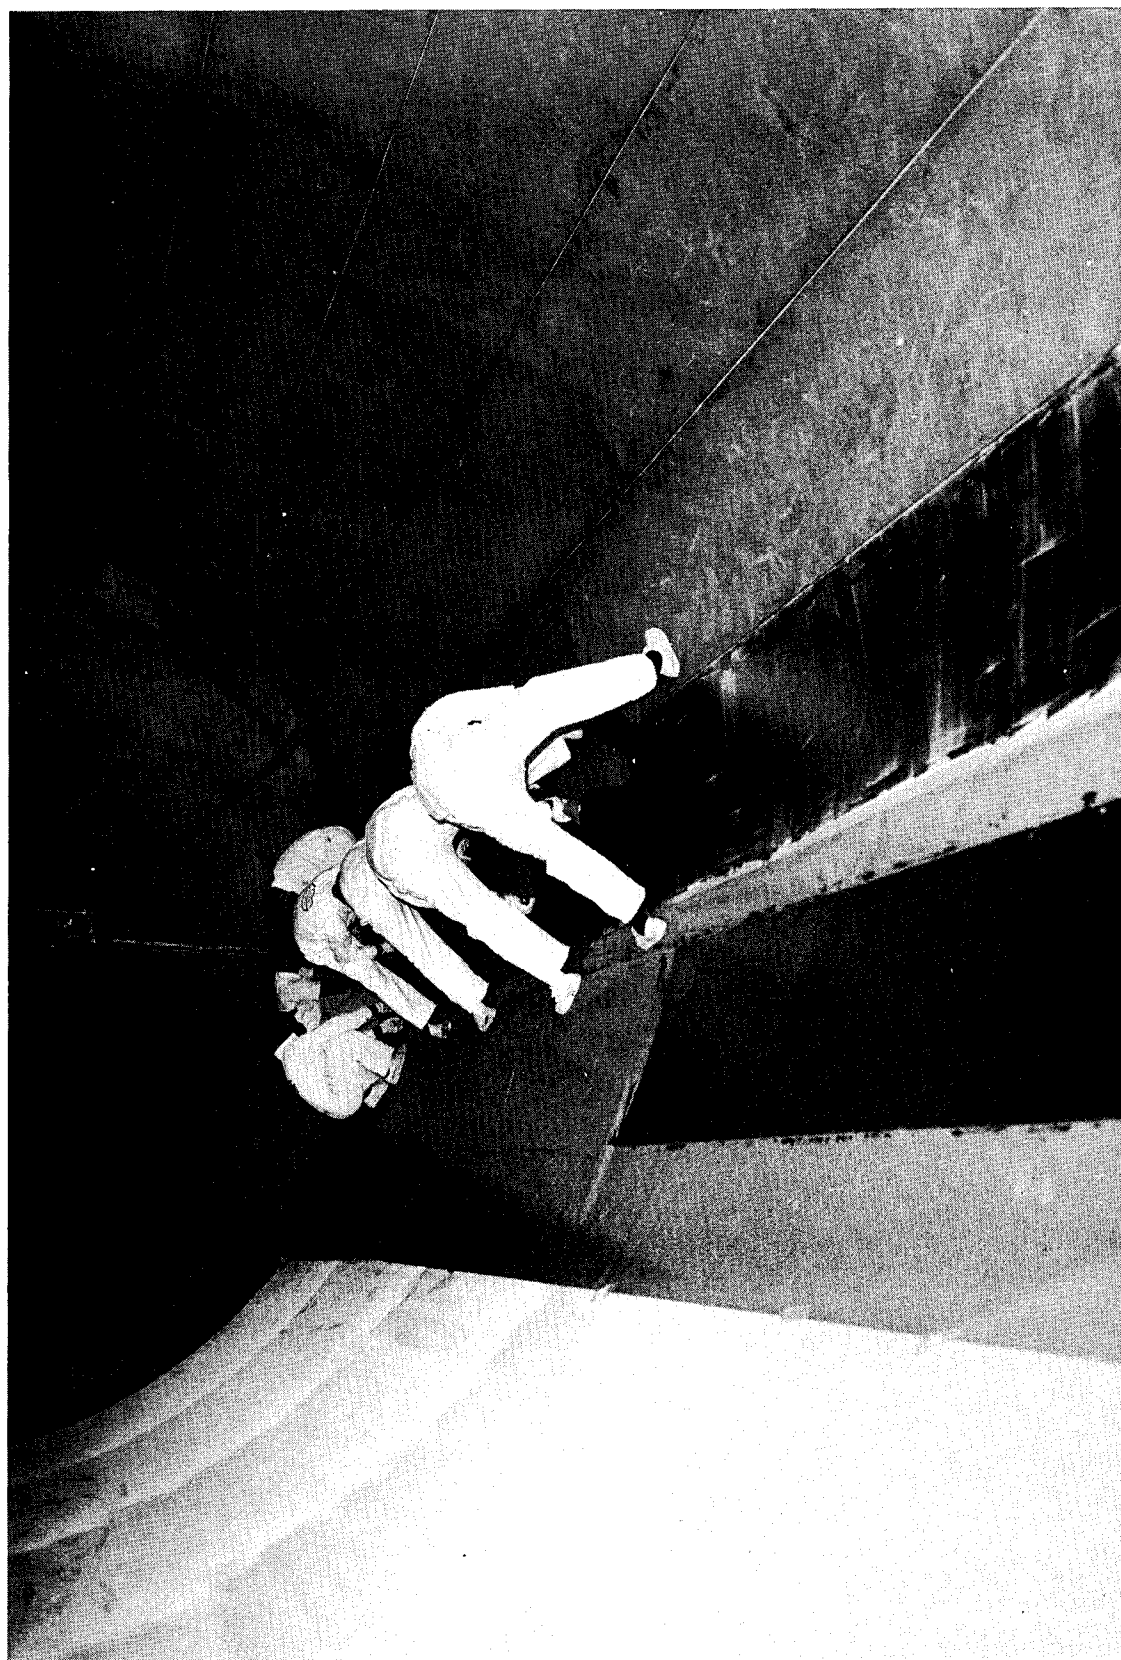
Figure 17

The first strip of the cylindrical-section insulation was aligned by using the longitudinal weld beads in the forward and aft cylindrical courses as an index. When the longitudinal guide line was established, aluminum straight edges were installed to provide a guide edge for installation of the first strip. The rubber strips were moved into the chamber, the skived edges were aligned along the aluminum straight edge, and the strips were trimmed to fit in place. After trimming, the strips were turned over, the epoxy adhesive was applied, and the strips then were installed, as shown in Figures 16 and 17. The strips were pressed into contact with the chamber by 4-in.-wide rollers as shown in Figure 18, while removing entrapped air in the process. Twenty-four full-width longitudinal strips were installed; the final strip was trimmed longitudinally

Installation of Cylindrical Section Rubber Strip

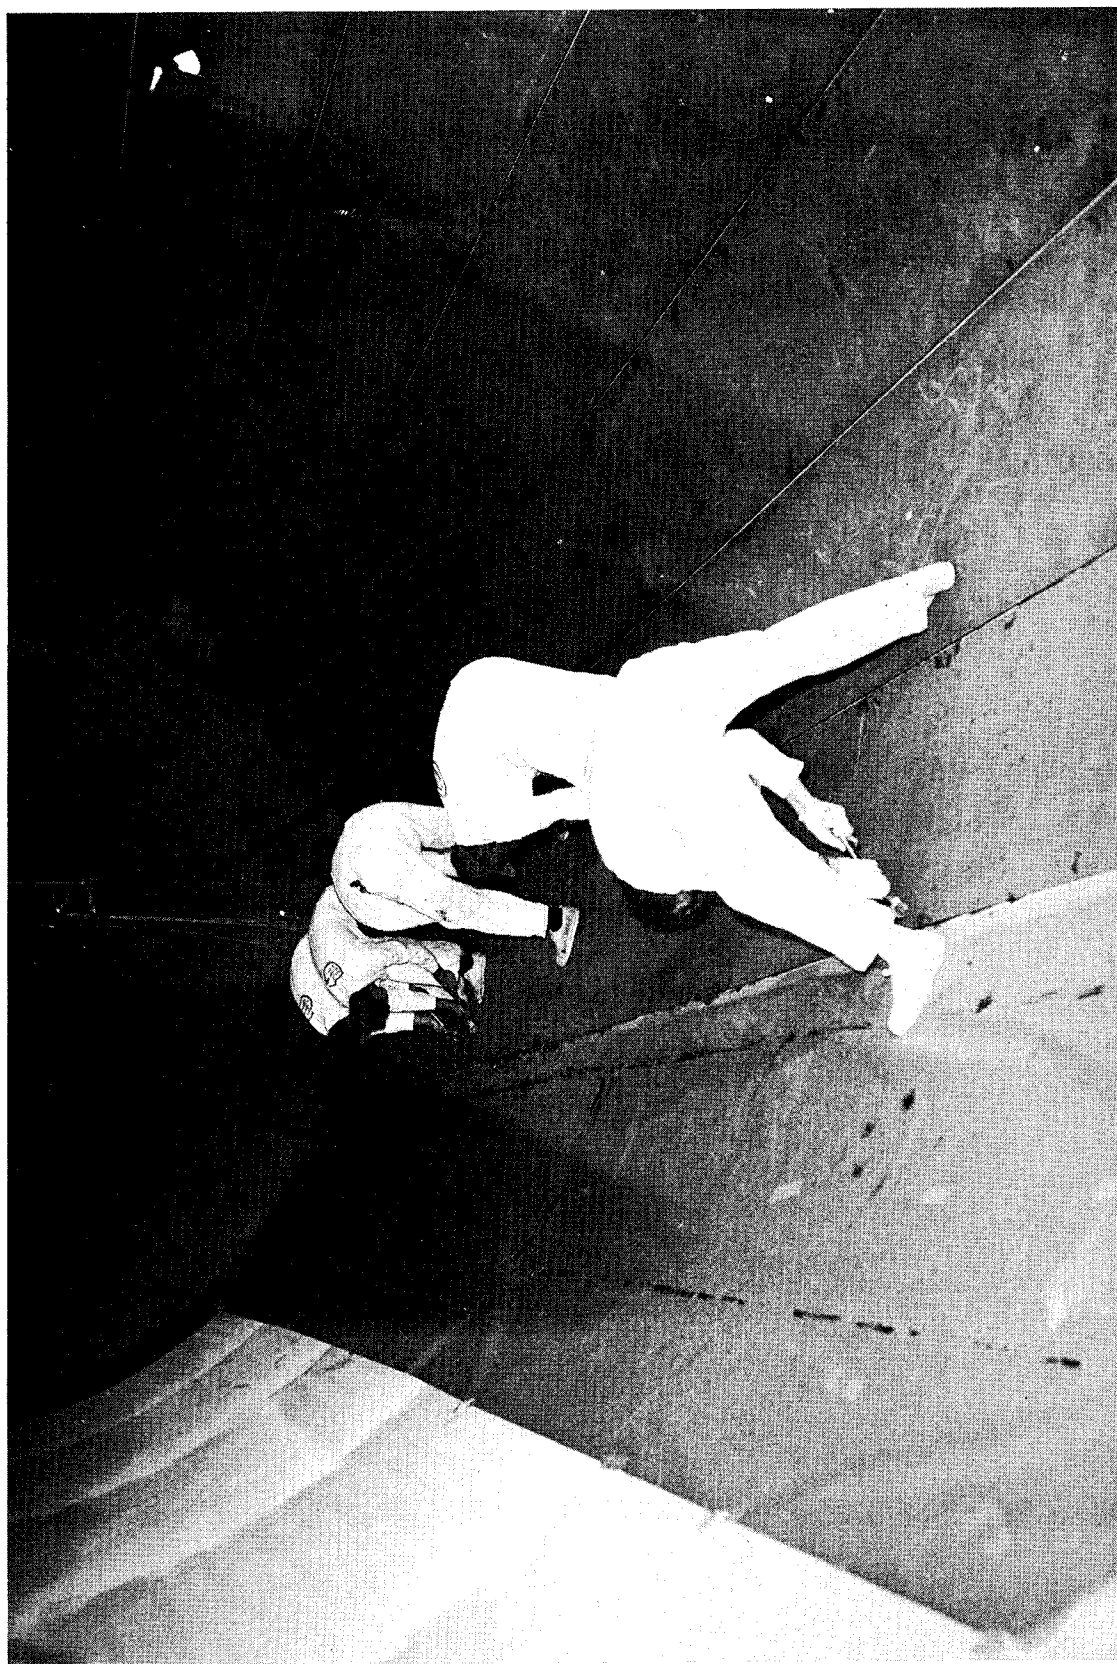
Figure 18

Stitching Cylindrical Section Insulation Strip
