# NATIONAL ADVISORY COMMITTEE FOR AERONAUTICS

No. 1095

MARINE EXPOSURE TESTS ON STAINLESS STEEL SHEET

By Willard Mutchler

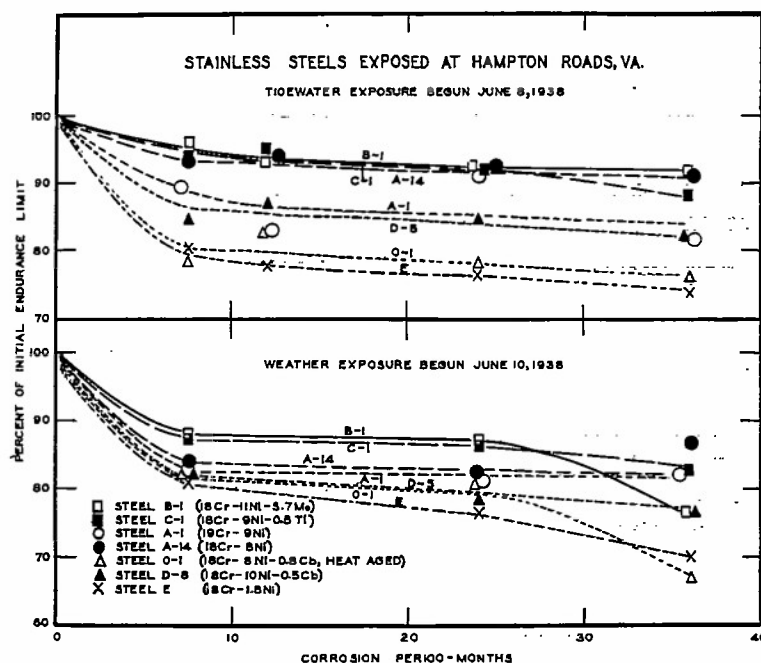
Data from the fatigue tests, plotted to permit a direct comparison of the effect of chemical compositions (fig. 18), agree in general with the results of the macrographic examinations. The steels containing molybdenum or titanium proved the most resistant to corrosion; while the straight 18:8 steels, those containing columbium (containing less columbium than is now recommended), and the one 16:1 type steel were of decreasing corrosion resistance in that order. It should also be noted that the curves for steel E are conjectural, particularly for the first 6 months of exposure, since no material was available on which to determine its fatigue limit in the initial condition. A stress value (30,000 psi) somewhat higher than determined for the other steels was assumed for calculating the percentage losses (fig. 18), because the Vickers hardness number for this steel was much higher than for any of the others.

Figure 18.- The comparative rates of corrosion for each steel exposed at the Boush Creek site, Hampton Roads, Va.

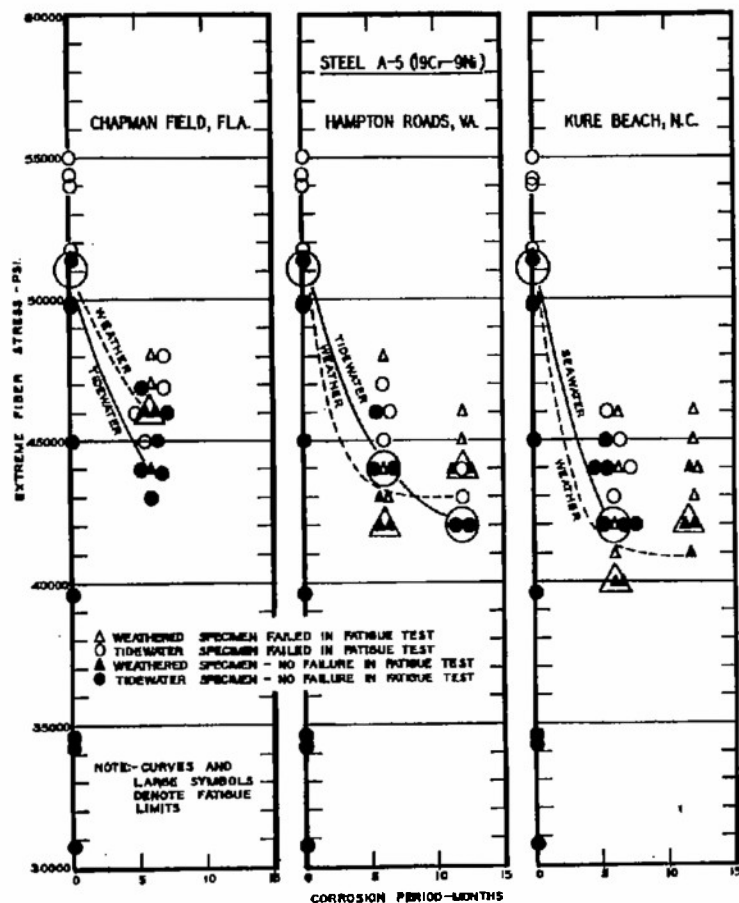
Figure 19.- Results of flexural fatigue tests on Steel A-5 exposed simultaneously at the three localities, giving the data for each specimen tested, and the approximate fatigue limits.

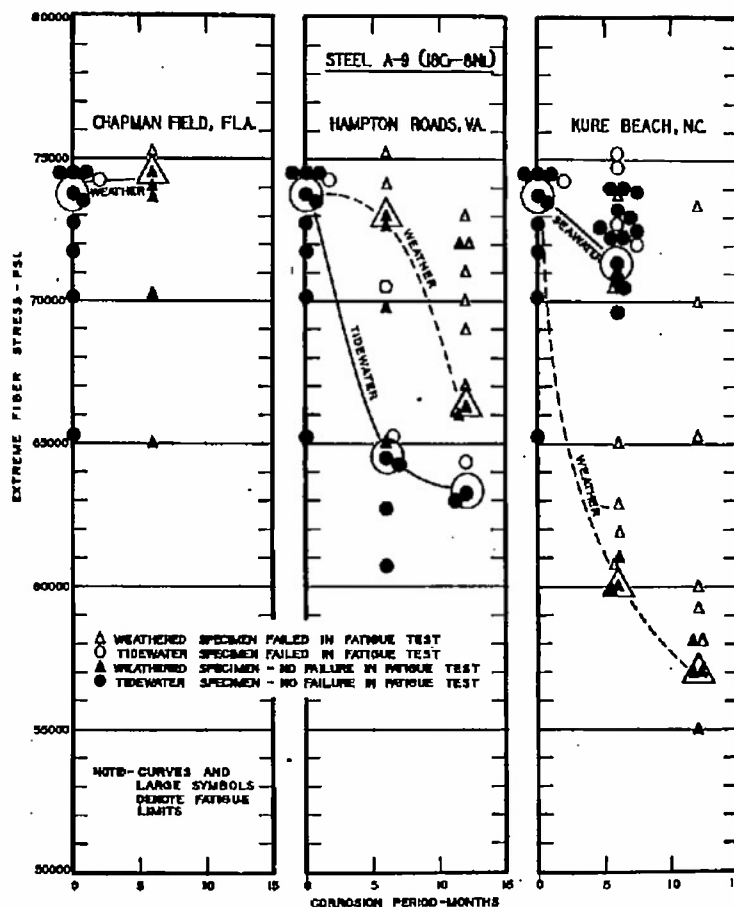
Figure 20.- Results of flexural fatigue tests on Steel A-9 exposed simultaneously at the three localities, giving the data for each specimen tested, and the approximate fatigue limits.

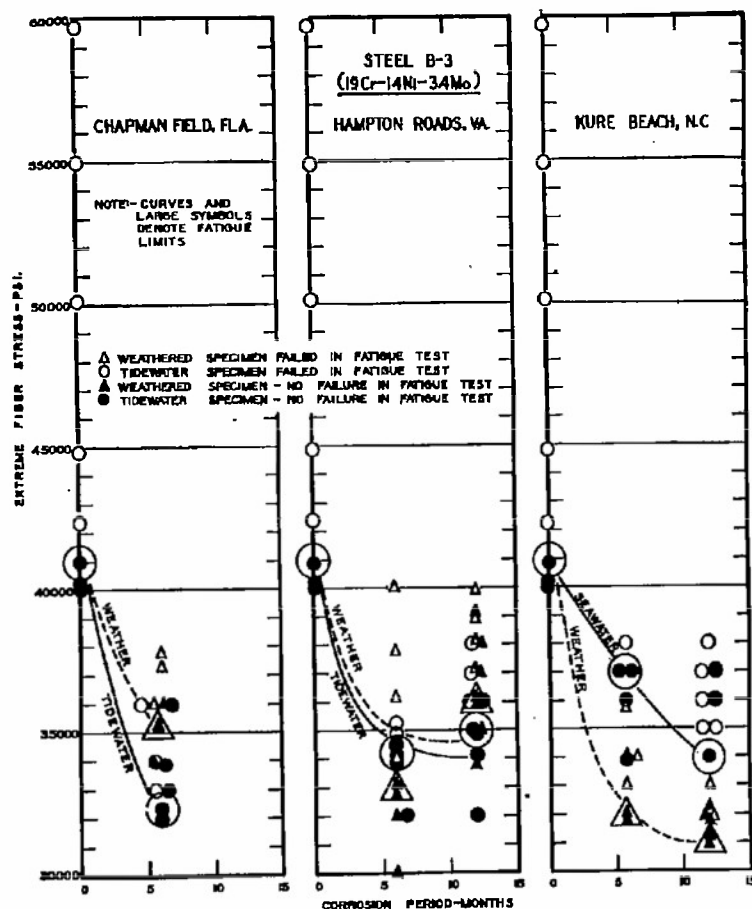
Figure 21.- Results of flexural fatigue tests on Steel B-3 exposed simultaneously at the three localities, giving the data for each specimen tested, and the approximate fatigue limits.

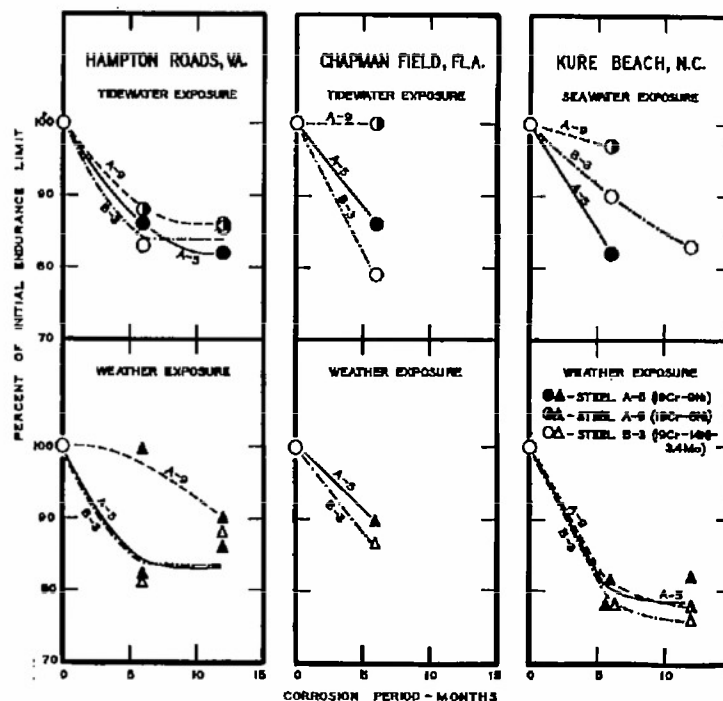
Two straight 18:8 type steels, one (A-9) with a tensile strength of 190,000 psi, and the other (A-5) with 100,000 psi, along with a 1/4-hard-rolled steel (B-3) having a tensile strength of 120,000 psi were exposed simultaneously at the three localities. The fatigue tests (fig. 22) revealed that steel A-9 usually was the least susceptible to corrosion. Steel A-5 was somewhat more resistant to corrosion than steel B-3 under all the conditions of exposure, except in the sea water at Kure Beach, N. C.

Figure 22.- The charts summarize the data for each of the steels exposed simultaneously at the three localities (figs. 19, 20 and 21), and show the loss in fatigue limits as related to the period and type of exposure.
