TITLE: The Utilization of Advanced Composites in Military Aircraft  
(L'Emploi des Matériaux Composites de Pointe pour les Avions Militaires)

FLIGHT SERVICE ENVIRONMENTAL EFFECTS  
ON COMPOSITE MATERIALS AND STRUCTURESH. Benson Dexter  
NASA Langley Research Center  
Hampton, VA USA 23665-5225

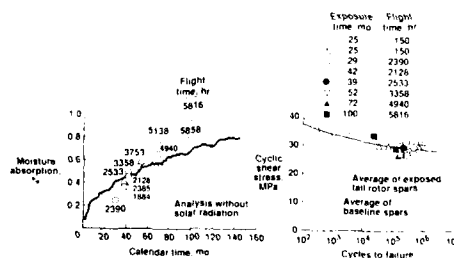
Figure 17. Moisture absorption and strength retention of AS1/6350 Sikorsky S-76 tail rotor spars.

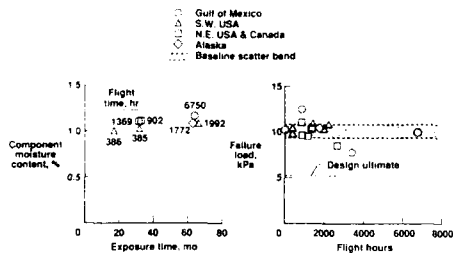
Figure 19. Moisture absorption and strength retention of T300/E-788 Bell 206L vertical fins.

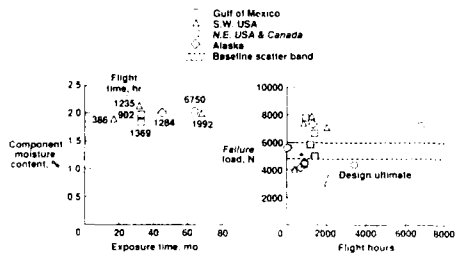
Figure 20. Moisture absorption and strength retention of Kevlar-49/F-185 Bell 206L litter doors.

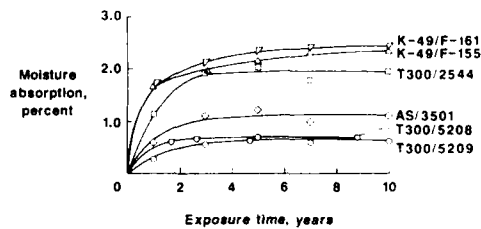
Figure 23. Moisture absorption of unpainted composite materials after worldwide outdoor exposure.

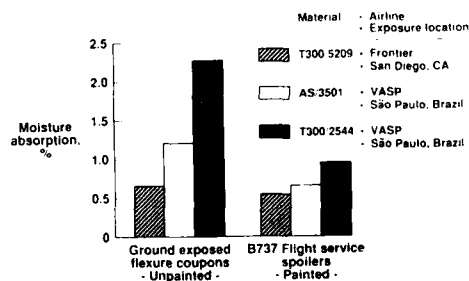
Figure 24. Moisture absorption comparison of graphite/epoxy materials after 10 years of ground and flight exposure.

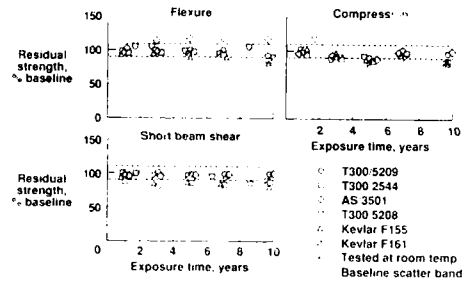
Figure 25. Residual strength of unpainted composite materials after worldwide outdoor exposure.

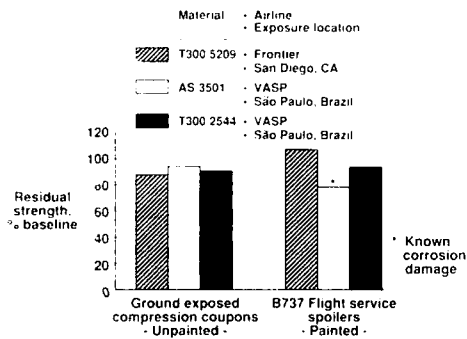
Ten year compression strength data for material coupons are compared with B737 graphite/epoxy spoiler strength data in figure 26. The strength data are for coupons and spoilers with the same exposure conditions that were discussed for the moisture comparison of figure 24. Except for one spoiler with known corrosion damage, the spoilers exhibited residual strengths that were slightly higher than the coupon residual strengths. As discussed previously, the spoiler corrosion damage is a design related problem and could be prevented through design changes. These results indicate excellent strength correlation between ground exposed coupons and flight exposed spoilers.

Figure 26. Strength comparison of graphite/epoxy materials after 10 years of ground and flight exposure.

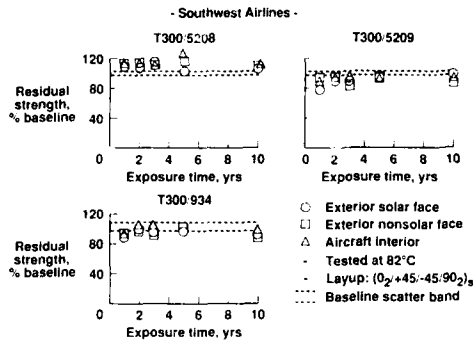
A comparison between interior and exterior aircraft exposure effects on flexure strength of three graphite/epoxy materials is shown in figure 31. The results are for coupons exposed on the upper (solar) surface and lower (nonsolar) surface of B737 flap-track fairing tailcones and in the interior of Southwest Airlines aircraft. The coupons were tested at 82°C and compared to baseline coupons tested at 82°C. A maximum strength reduction of 20 percent occurred for the T300/5209 material exposed on the upper surface of the flap-track fairing tail cone. Considering test data scatter, there is no discernible difference between the effects of solar exterior, nonsolar exterior or aircraft interior exposure.

Figure 31. Effect of interior and exterior aircraft exposure on flexure strength of painted graphite/epoxy materials.

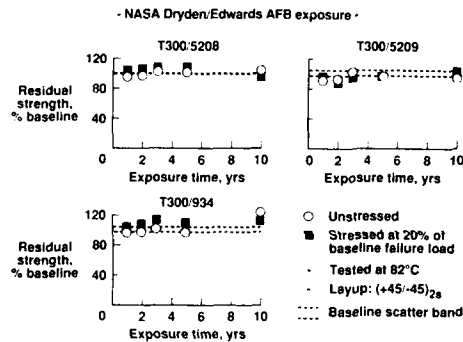
The effects of sustained stress on tensile strength of three graphite/epoxy materials exposed outdoors at the NASA Dryden Research Center in Edwards Air Force Base, CA, are shown in figure 32. The unstressed coupons are compared with coupons that were continuously stressed at 20 percent of the baseline failure stress. The tensile coupons were tested at 82°C. The test results indicate no discernible difference between the stressed and unstressed coupon data. Small variations above and below baseline values are indicated during the 10 year evaluation period. Additional details on the ground and flight exposure program are reported in reference 16.

Figure 32. Effect of sustained stress on tensile strength of painted graphite/epoxy materials after outdoor exposure.

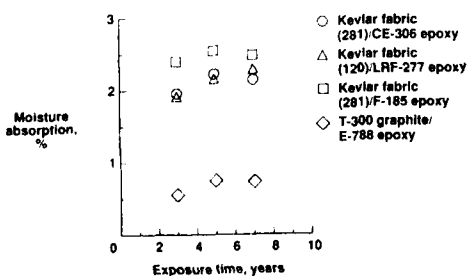
Moisture absorption data for three Kevlar/epoxy fabrics and one graphite/epoxy tape material are shown in figure 33. The painted T300/E-788 graphite/epoxy material absorbed about 0.7 percent moisture, whereas the painted Kevlar/epoxy materials absorbed about 2.5 percent moisture, as expected. The average residual strengths for four Bell 206L composite materials after outdoor exposure at five exposure sites discussed previously are shown in figure 34. In the summer of 1985

Figure 33. Moisture absorption of Bell 206L painted composite materials after outdoor exposure.

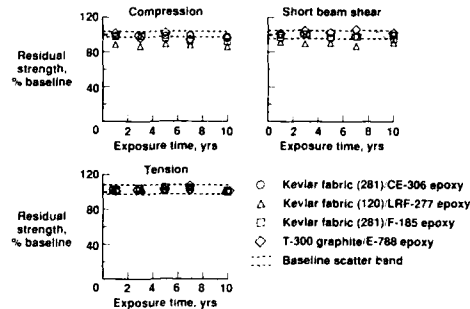
Figure 34. Residual strength of Bell 206L painted composite materials after outdoor exposure.

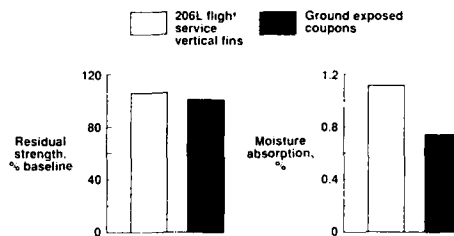
Figure 35 compares strength retention and moisture absorption data for T300/E-788 composite coupons with corresponding data from Bell 206L vertical fins after 5 years of flight service. The vertical fins absorbed about 1.1 percent moisture, whereas the 5 year ground exposed coupons absorbed about 0.7 percent moisture. The fin moisture content includes moisture absorbed by paint, sealer, primer, graphite/epoxy skins, and honeycomb core. Strength retention for compression coupons and vertical fins was near 100 percent. These results indicate that ground-based coupon strength data are representative of strength retention results expected from flight service components. Additional details on the test program and test results are reported in reference 15.

Figure 35. Strength retention and moisture absorption of T300/E-788 after 5 years of ground and flight exposure.

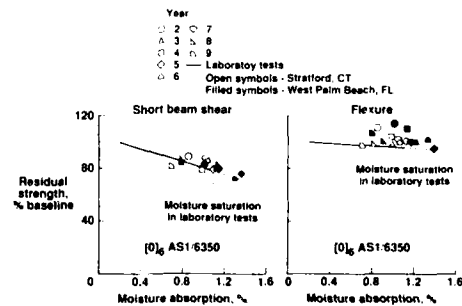
As discussed previously, Sikorsky conducted accelerated laboratory conditioning tests to develop environmental factors that account for anticipated strength reduction as a function of absorbed moisture. These tests were conducted at 87 percent relative humidity and 88°C. To establish a correlation between realtime outdoor exposure and accelerated laboratory exposure, composite panels were exposed for 9 years in outdoor racks located at Stratford, CT and West Palm Beach, FL. Results for 6-ply ASI/6350 short beam shear and flexure coupons machined from the panels are shown in figure 36. Residual strength is plotted as a function of absorbed moisture and the results indicate that the matrix dependent short beam shear strength is affected more than the fiber dependent flexure strength. The accelerated laboratory conditioning tests indicated moisture saturation for the 6-ply laminates at about 1.1 percent. The panels exposed at Stratford, CT absorbed a maximum of 1.13 percent moisture, however, the panels exposed at West Palm Beach, FL absorbed a maximum of 1.40 percent moisture. The results are inconsistent in that the 5 year panels absorbed the most moisture, whereas the 9 year panels absorbed the least amount of moisture. These results are probably affected by local weather conditions at the time of panel removal.

Figure 36. Effect of moisture on the residual strength of Sikorsky S-76 graphite/epoxy laminates.
