- *Title:* Technology Showcase: Integrated Monitoring, Diagnostics and Failure Prevention.  
Proceedings of a Joint Conference, Mobile, Alabama, April 22-26, 1996.

# PREVENTION OF CRANKCASE EXPLOSIONS IN RECIPROCATING COMPRESSORS

V. A. Cox

Shell Research Ltd  
Thornton Research Centre  
P.O. Box 1  
Chester CH1 3SH  
United Kingdom

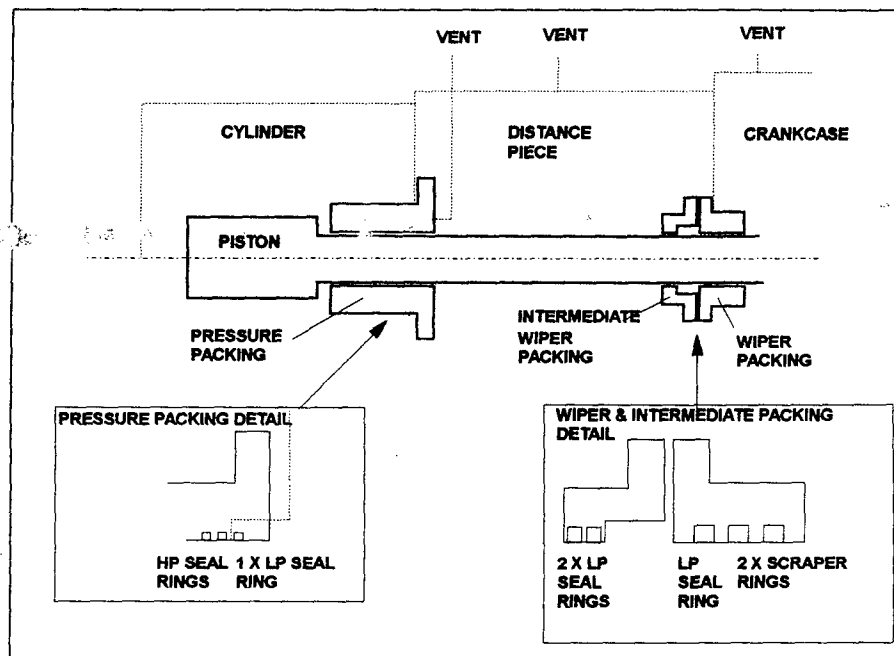
Figure 1. Arrangement of sealing components

The original layout of sealing and venting components of the four compressors is shown in Figure 1.

The source of gas within the distance piece and crankcase was considered to be inefficiency of the low-pressure (LP) axial seals. All four LP seals fitted in the locations shown in Figure 1 were of the type shown in Figure 4(a).

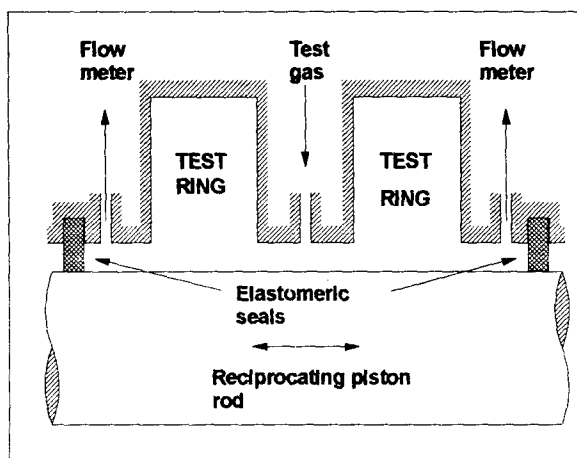
Figure 5. Low pressure seal test rig arrangement

A test rig was constructed for the purpose of measuring typical leakage of gases. The rig, shown in Figure 5, comprised two seal containers mounted back-to-back, with a gas entry port between them. Leakage past the seals was directed to passages equipped with Rotameter flow measurement meters. Elastomeric seals fitted outboard of the containers provided leak-free sealing and were replaced after each test. The piston rod used for this work was of 50 mm diameter and its stroke rate was 300 per minute, identical with that of the compressors.
