TECHNICAL PAPER No. 4

Scale Model Igloo Magazine Explosion Tests

Naval Proving Ground, Arco, Idaho

August 1946

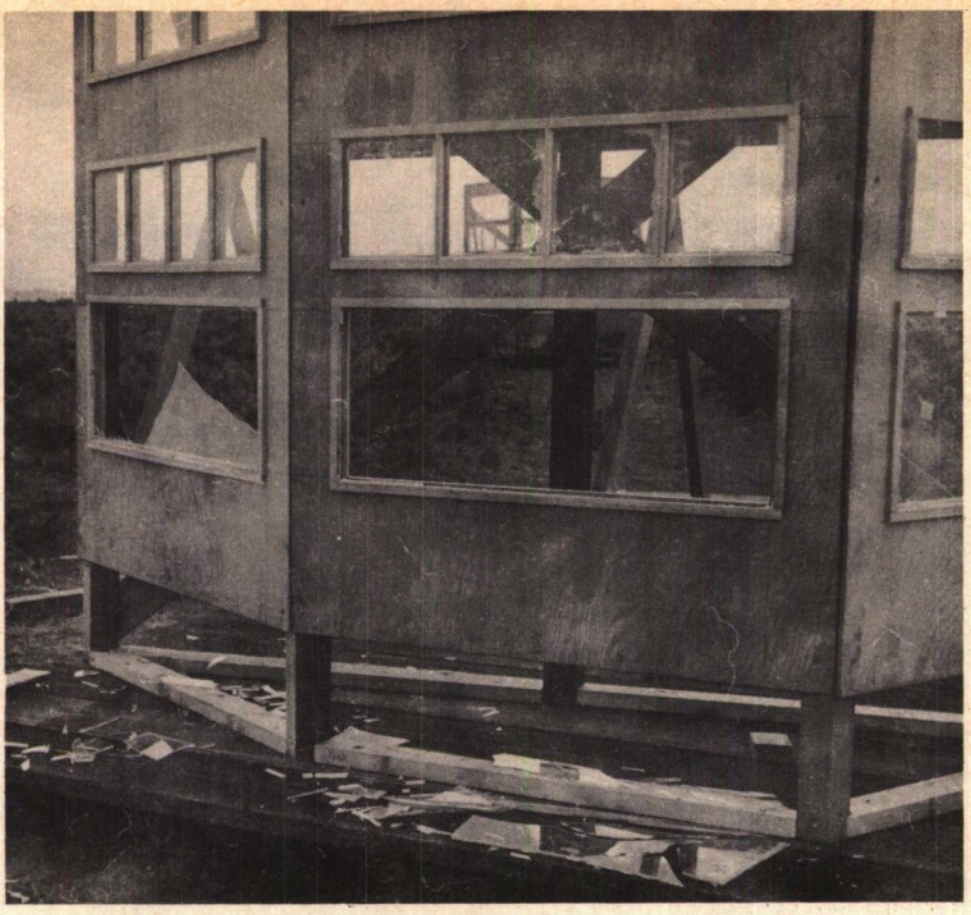
Figure 23. Glass breakage, glass test panel assembly No. 1, Test 1.

E. Glass Breakage.—Two lower large panes broke in the nearest (215 ft.) glass test panel assembly, one in the panel oriented 90° to the line from the explosion to the panel, or facing the explosion, and the other in the panel oriented at 60°. No other glass breakage occurred. Figure 23 is a photograph of the lower portion of the glass test panel assembly, illustrating the breakage. The field notes, which graphically portray the breakage, are included in appendix A of this report. The fragments fell out toward the explosion and were found on the front part of the platform; there was evidently no "flying glass."

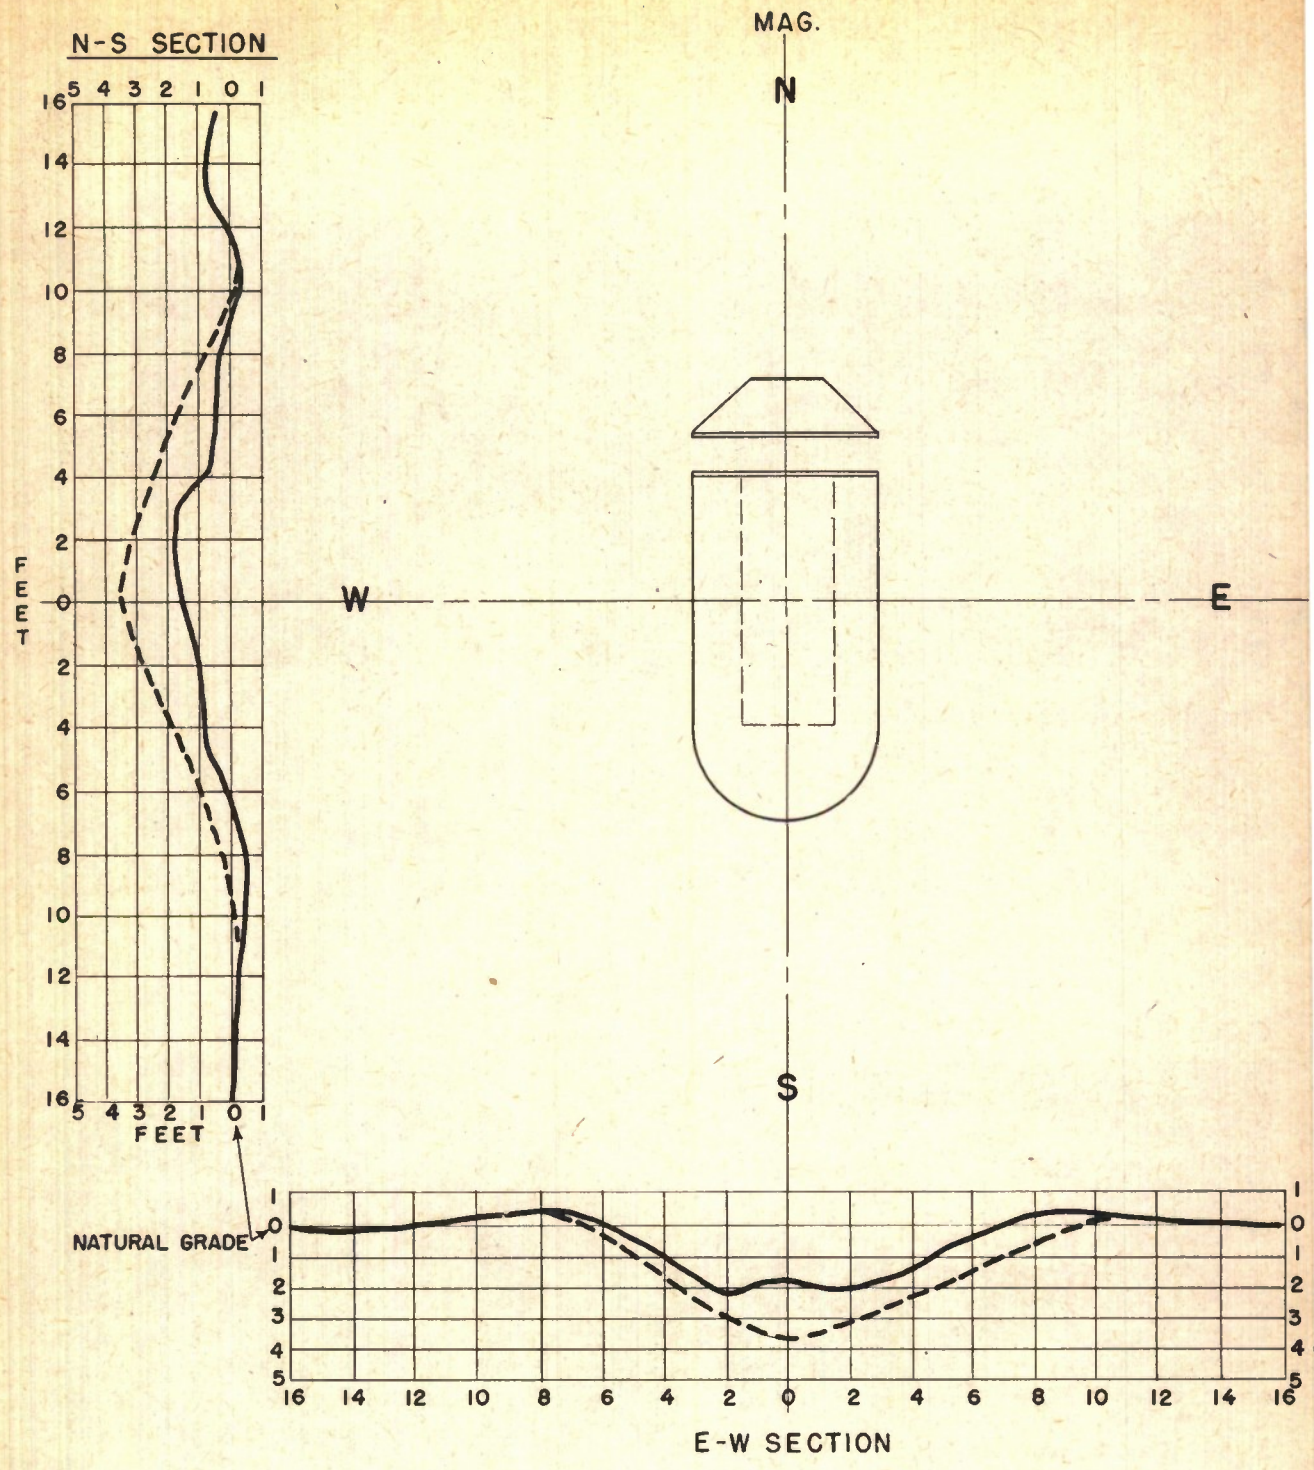
Figure 28. Crater, Test 2.

C. Crater. The diameter was 16.1 feet transversely to the igloo (east-west) and 12.0 feet longitudinally (north-south). Its apparent depth was 2.2 feet and it was 3.5 feet deep to sound bottom. The crater was not benched as in Shot 1, but graded nearly uniformly from lip to the deepest point. Figure 28 is a picture of this crater, and figure 29 shows its profiles.

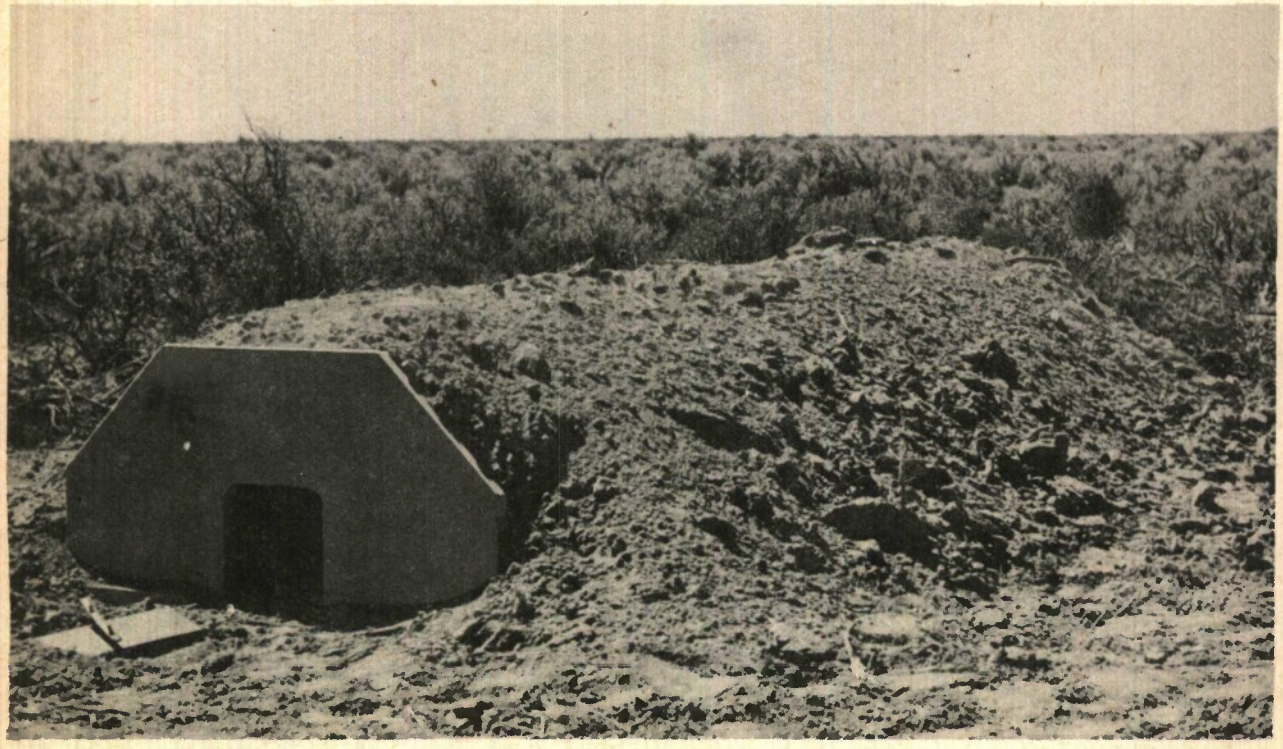
Figure 36. Target igloo after shot, Test 3.

E. Damage to Target Igloo. The earth cover was very disheveled. The front end wall was blown completely off the arch barrel, and was found badly cracked and lying face down 2½ feet in front of the igloo. This is illustrated by the photographs,

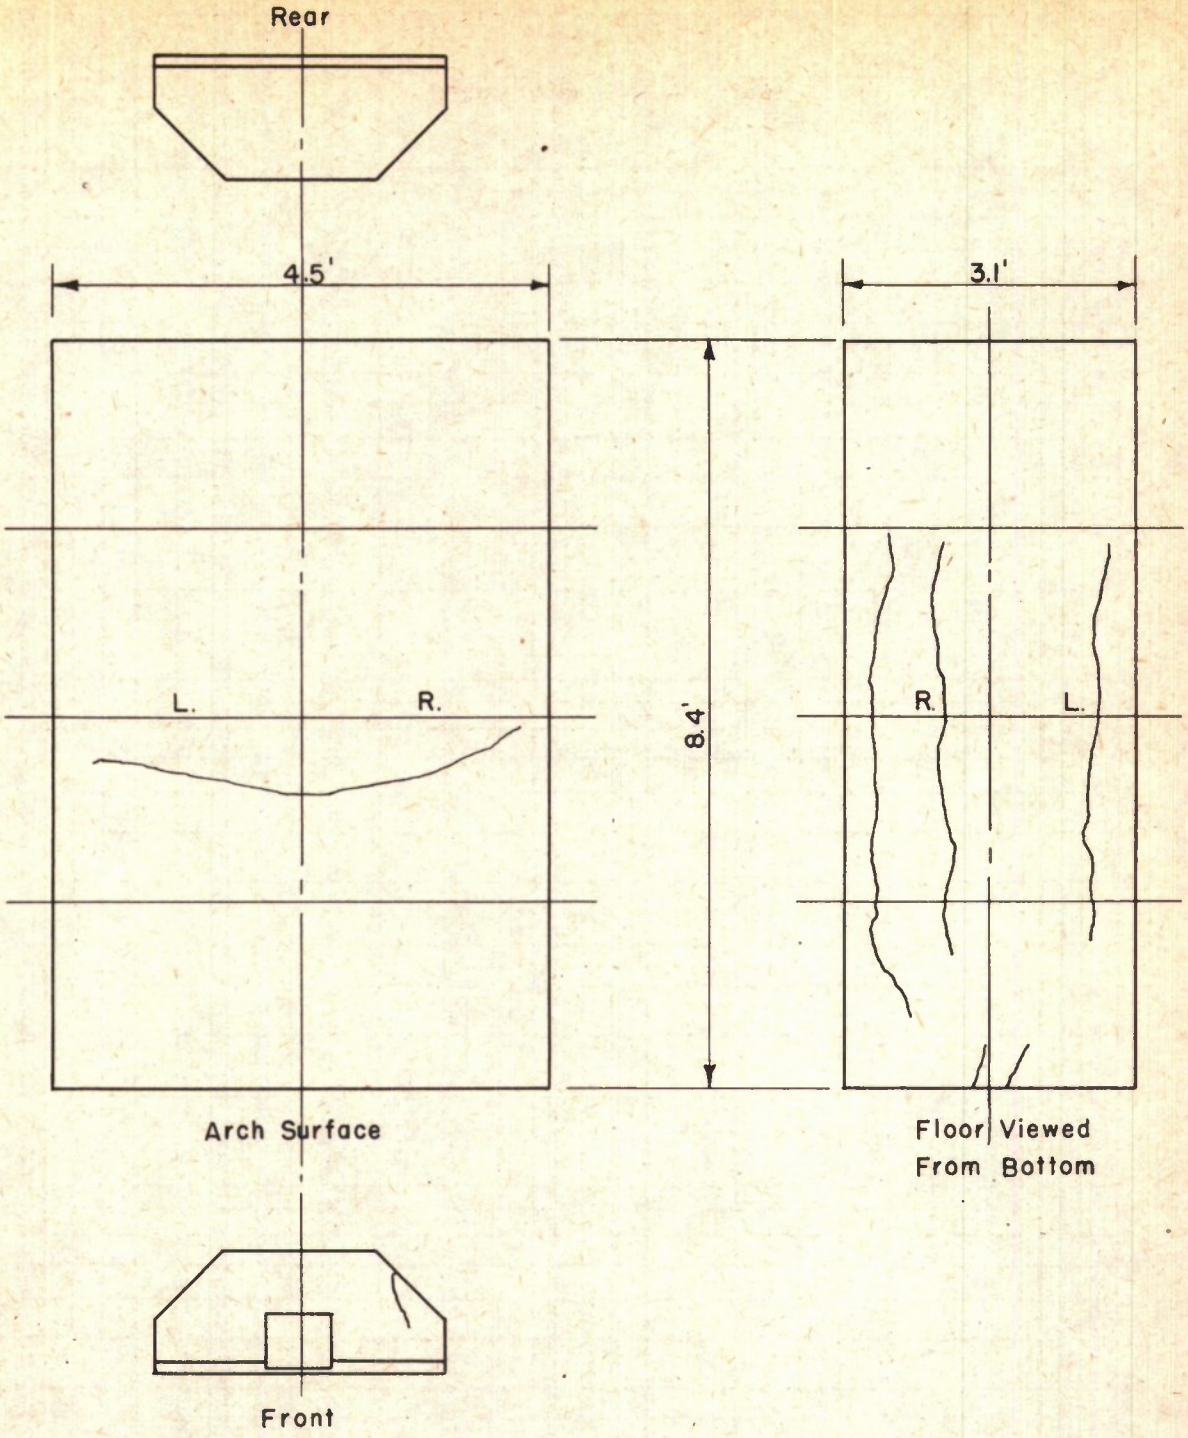
FIG.37
DIAGRAM OF CRACKING
TARGET IGLOO
Model Test No.3

The near side of the next-in-line target igloo sustained considerable damage involving diagonal and longitudinal cracking and an inward deflection of ⅞ inch in test No. 3. The front end wall was badly cracked and separated from the arch. The rear wall was separated at the base. Obviously, air blast had a hand in causing this damage. When the shot was repeated in Test No. 4, using the damaged igloo as target, the damage was increased. Peak air blast pressures recorded by instruments were greater than in Tests No. 1 and No. 2. These tests clearly demonstrated the effectiveness of the earth-covered igloo in minimizing damage by air blast to nearby structures when explosives within the igloo are detonated.

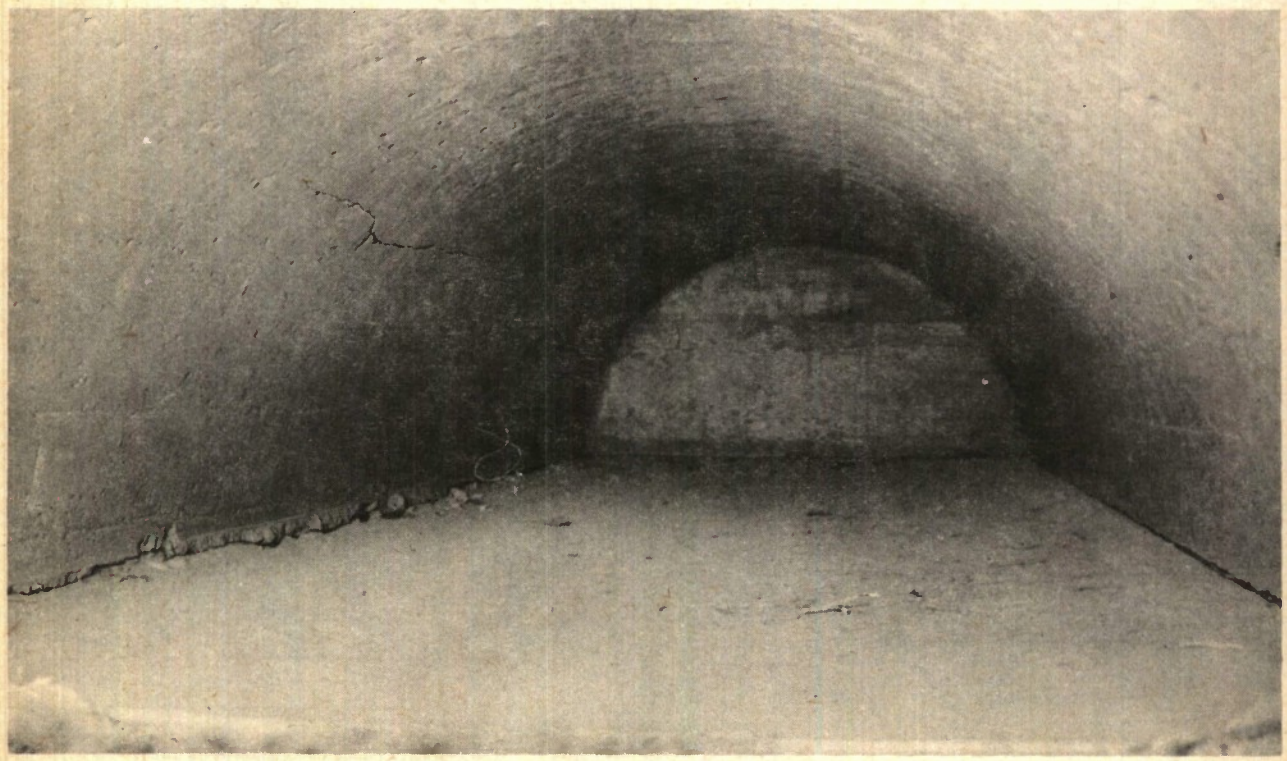
Figure 44. Interior of target igloo after shot, Test 4.

figures 42 and 43. The door was found underneath the end wall, the latchbar badly bent. The wire reinforcement which had passed from the arch into the end wall was pulled out of the end section and was left protruding from the arch. The barrel was cracked away from the floor slab from the front all the way to the rear end wall on the near side, and the junction was also broken on the far side to a point a little beyond half-way back. See the photograph of the interior of the igloo taken through the broken front end, figure 44. A network of cracks appeared on the near side of arch barrel, extending 7 feet back from the front and from 4 to 12 inches above the floor slab. This network consisted of three main longitudinal cracks interconnected by frequent diagonals. A central longitudinal crack appeared at the crown, extending nearly the entire length of the barrel, and two other longitudinal cracks appeared at approximately one-third and two-thirds the distance up the arch, respectively, on the far side of the barrel. The floor slab sustained a network of severe cracks. The cracking is illustrated by the sketch, figure 45. The rear end wall was not damaged. The dummy charge in this igloo was badly jostled, practically all the channels on the upper layer having been overturned and the aisle space was filled with fallen channels.

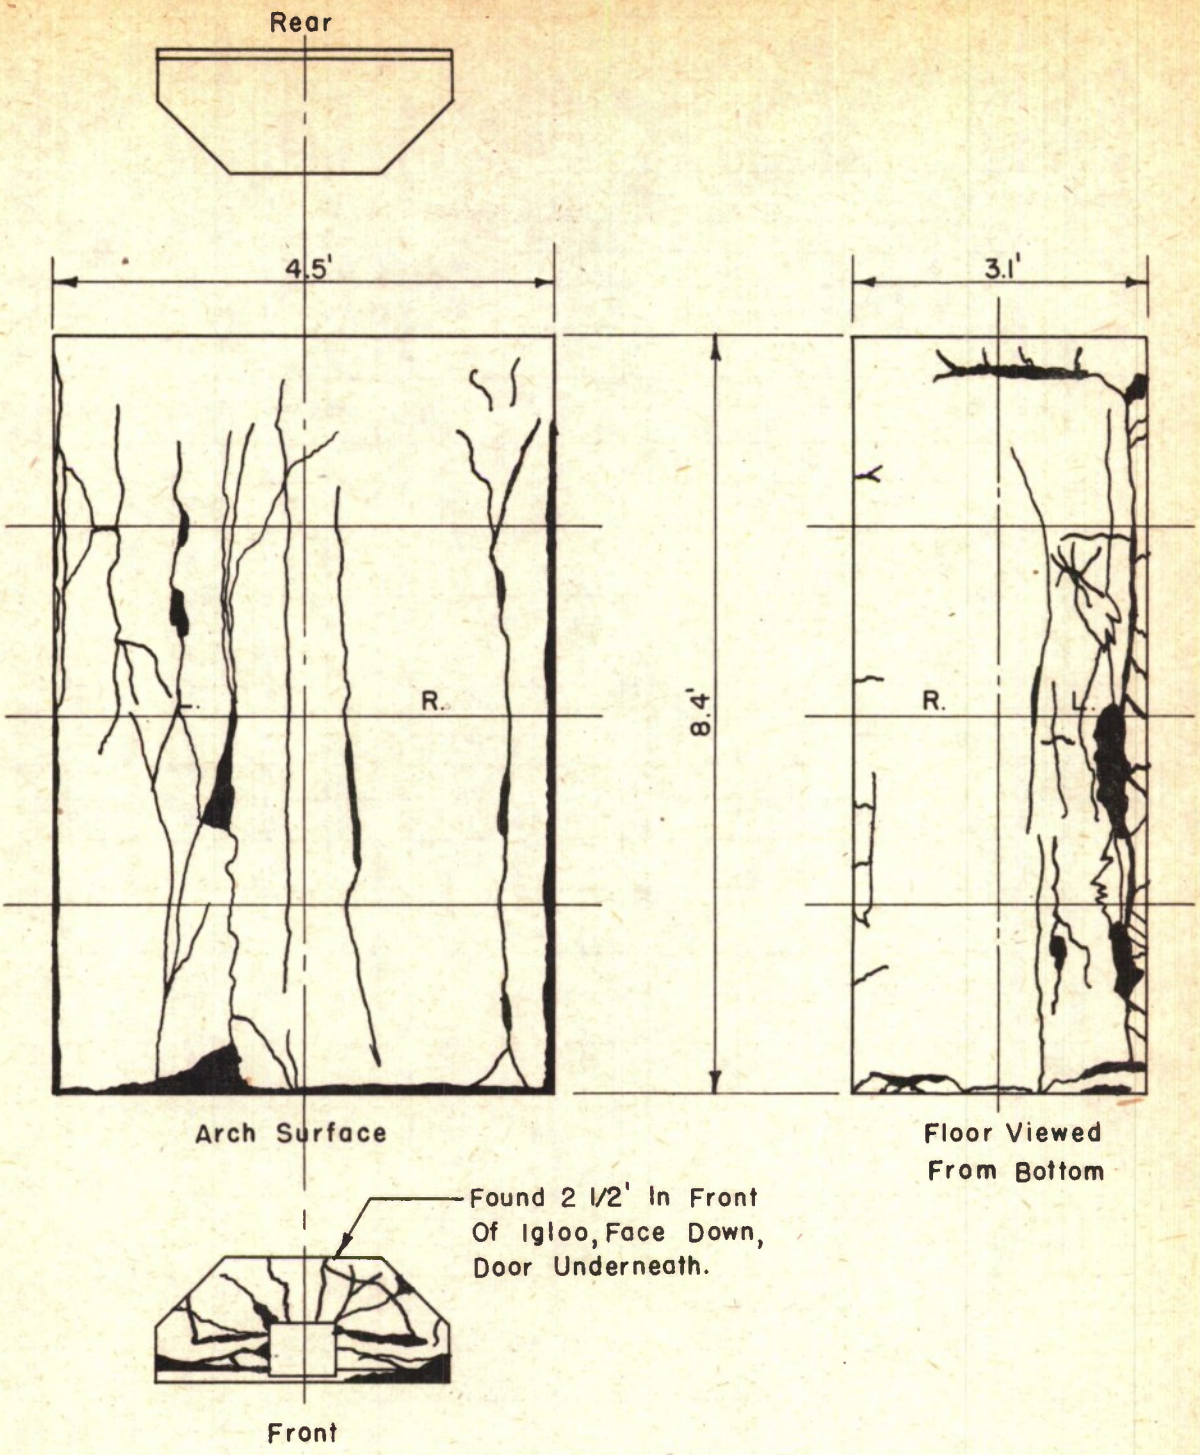
FIG. 45
DIAGRAM OF CRACKING
TARGET IGLOO
Model Test No.4

Shape I Earth Cover On Primary Igloo
Charge Weight 500#

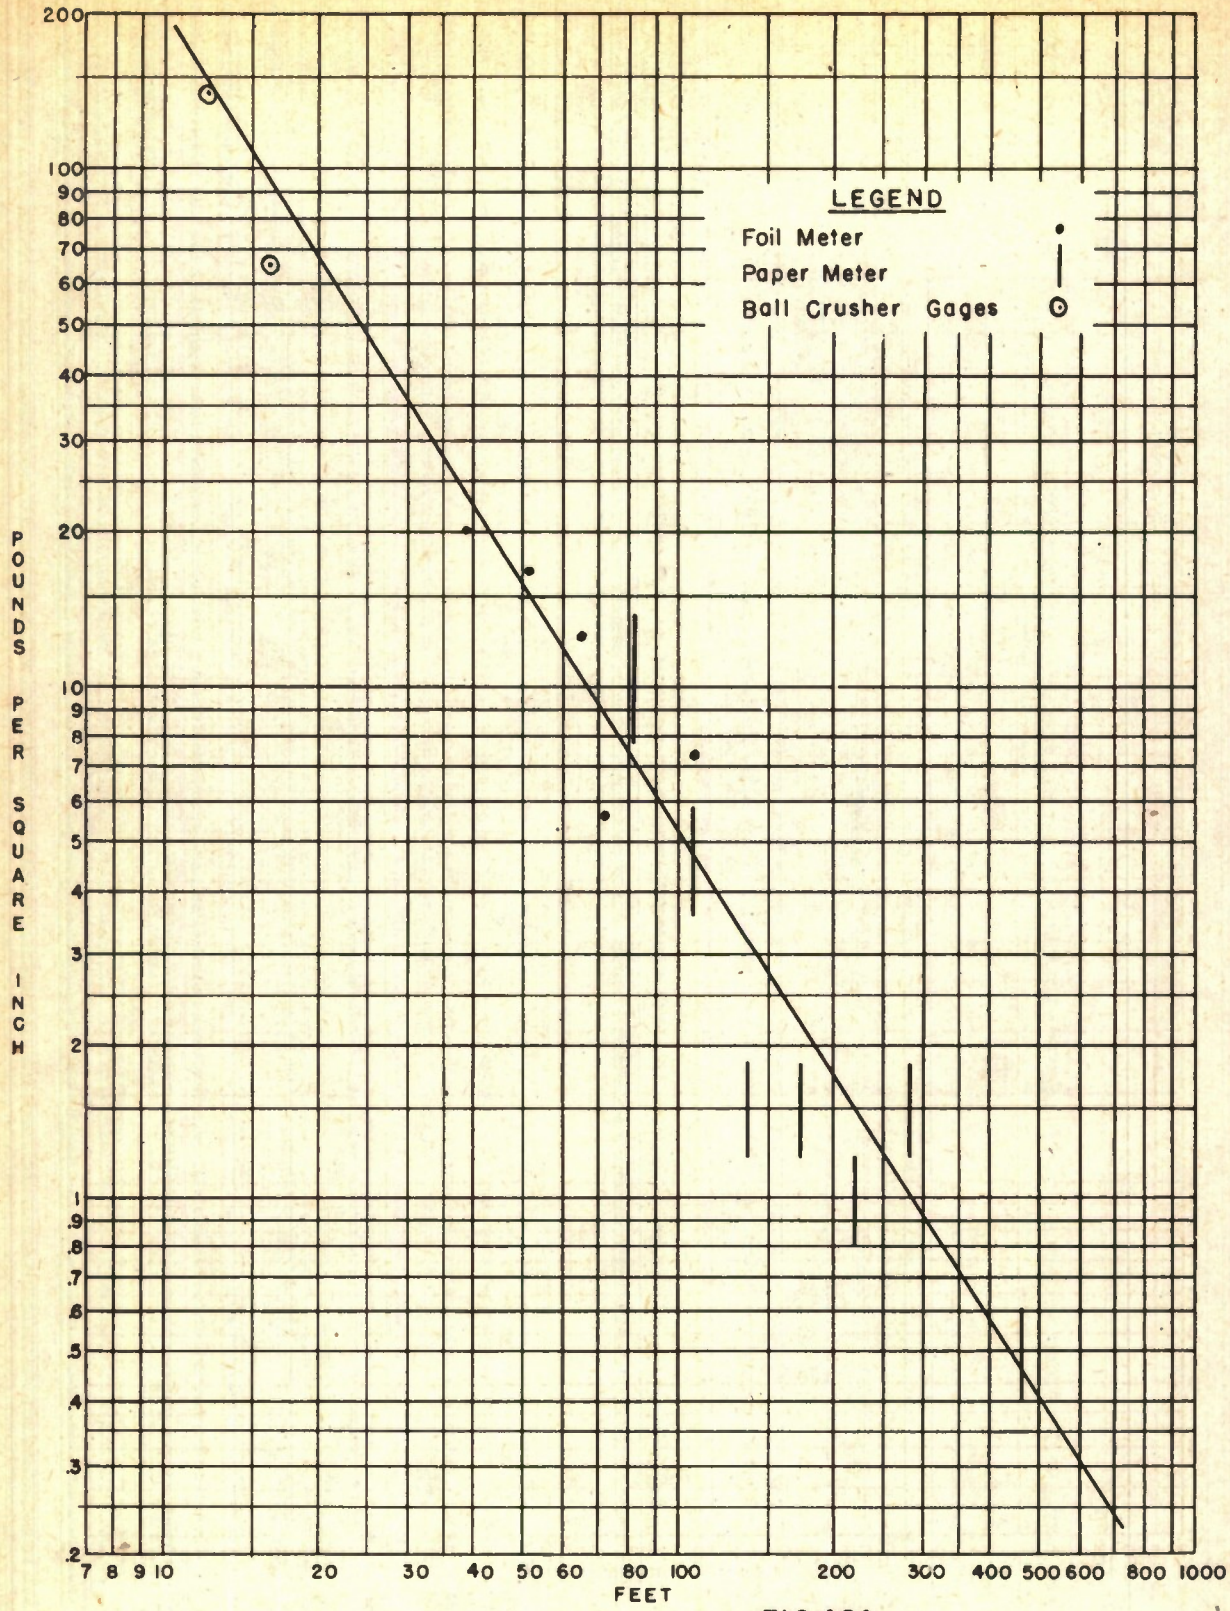
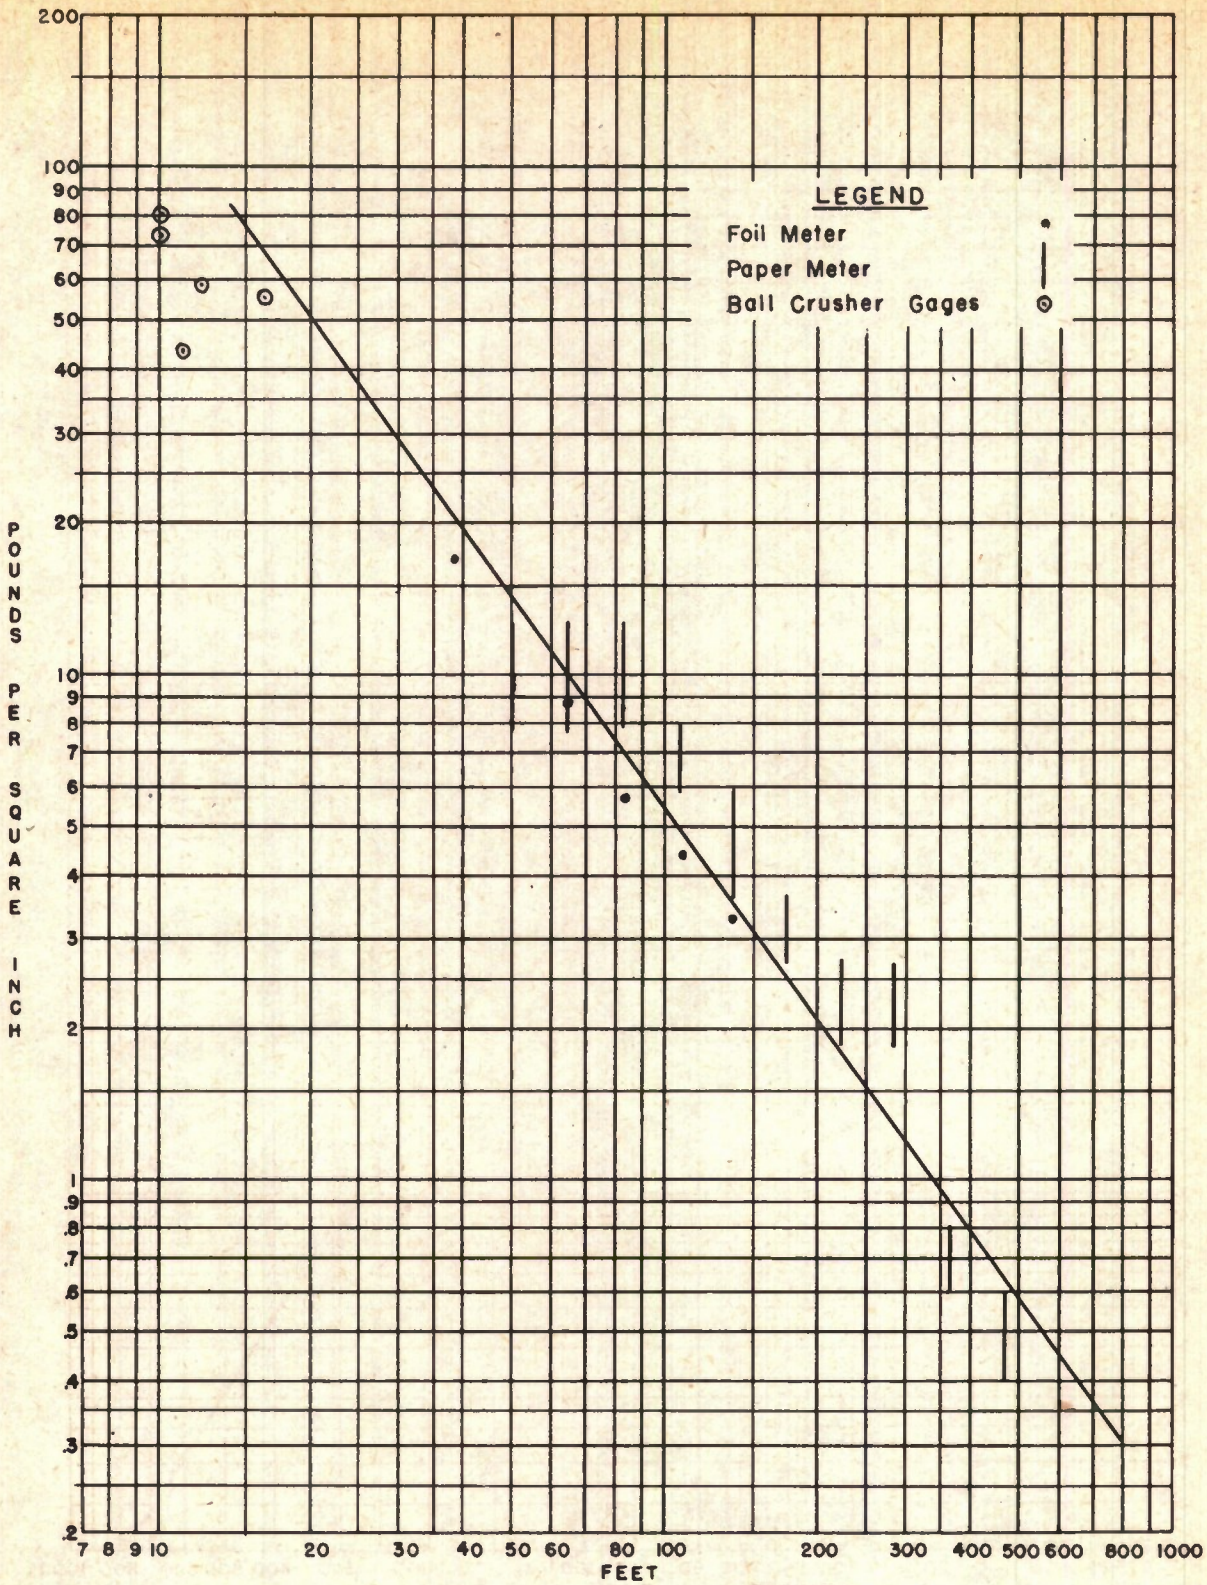
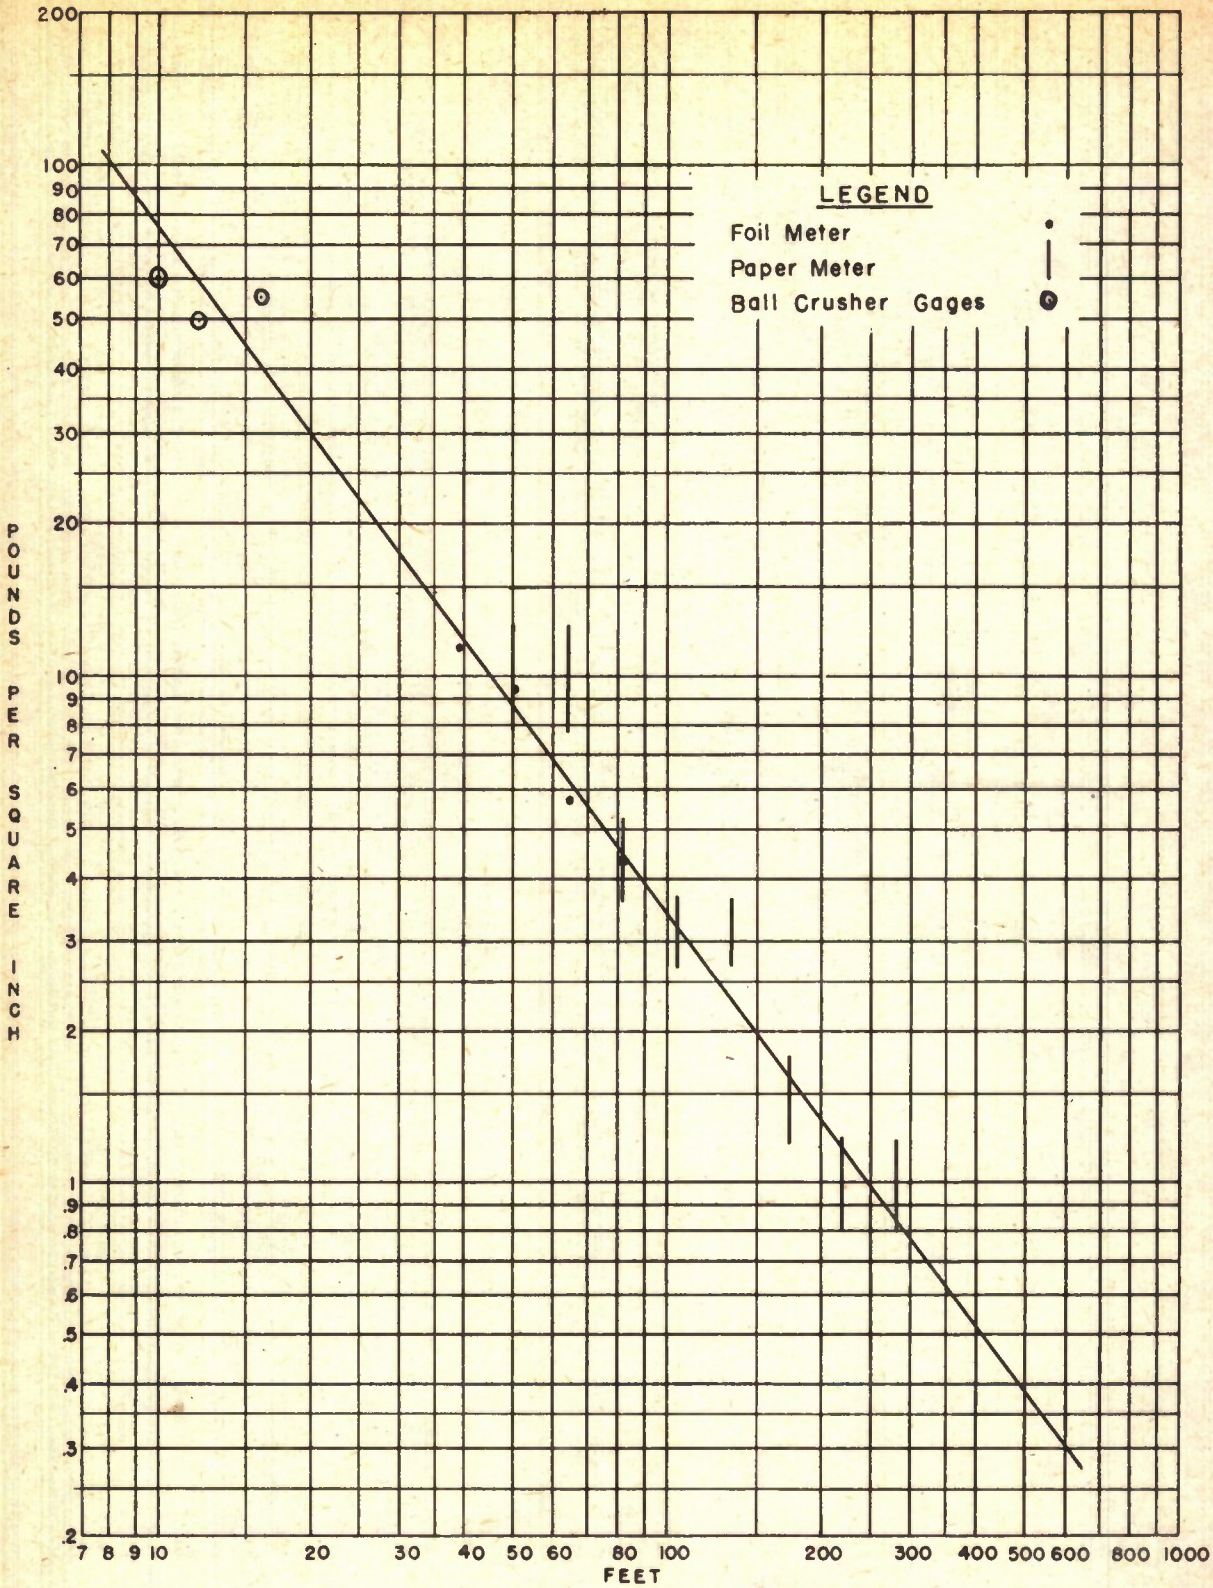
FIG.46A

H. Air Blast. The Aberdeen paper blast meters and the aluminum foil gages registered much greater peak pressures than in the 250-pound test series, about 73 p. s. i. being obtained at 15 feet and 0.8 p. s. i. at 400 feet off the side of the primary igloo. The NOL ball crusher gages were used again in this test, but the pressure values obtained are inconsistent. The pressure data are given in table XIV and plotted on logarithmic paper in figure 46.

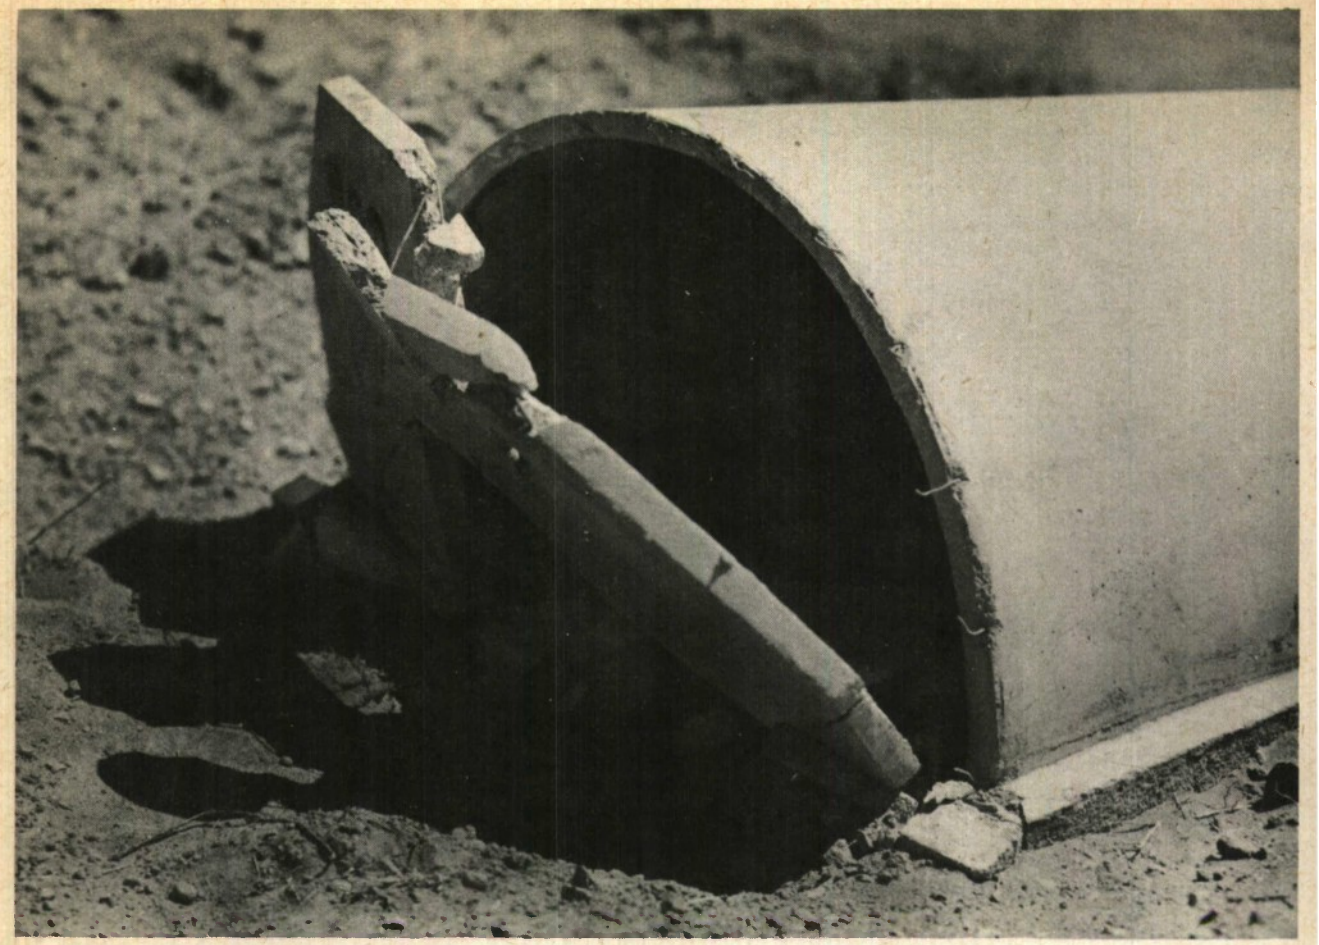
Figure 50. Front of target igloo, after shot, Test 5.

E. Damage to Target Igloo. The earth cover was roughened and considerably deformed. The front end wall sustained several severe cracks and was loosened from the base slab. The arch sustained two longitudinal cracks about half the length of the barrel, one in the upper part of the near side and one at the crown. It also suffered a transverse crack starting at the base on the near side, running over the crown and nearly down to the base on the far side, located just back of the front end wall. Two other transverse cracks appeared near the middle of the barrel, one running almost

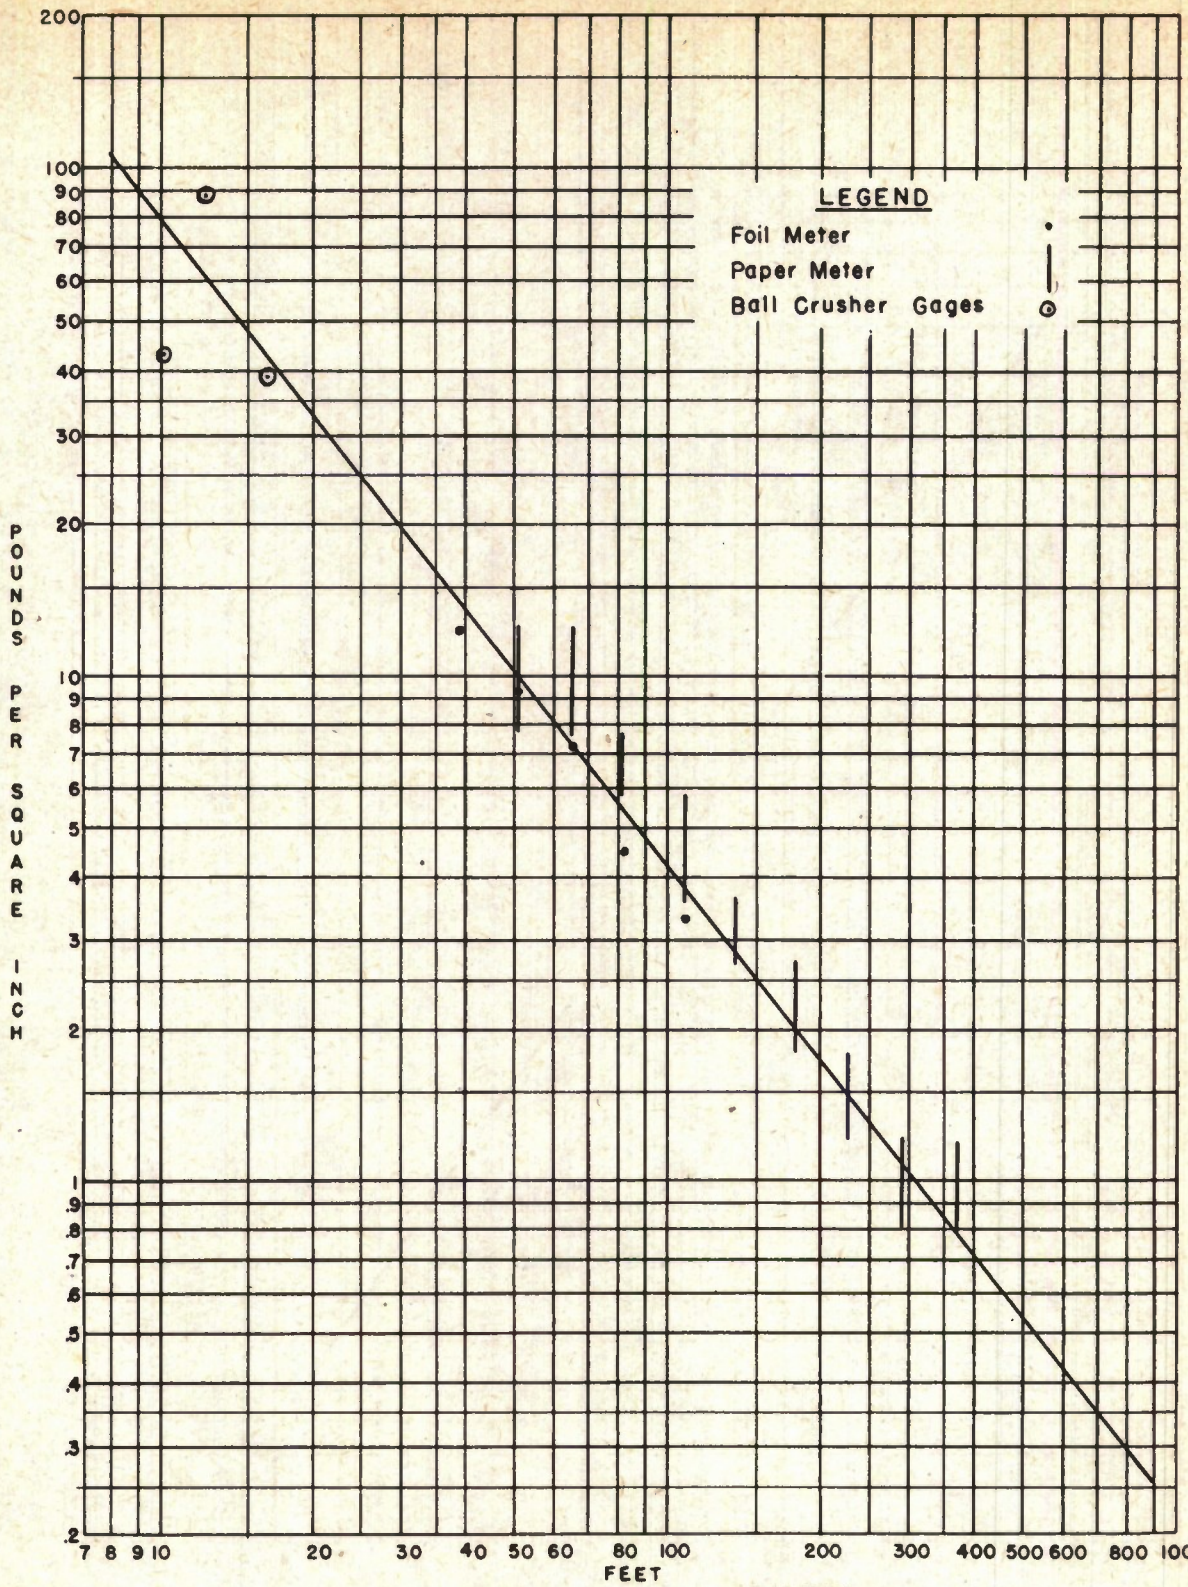
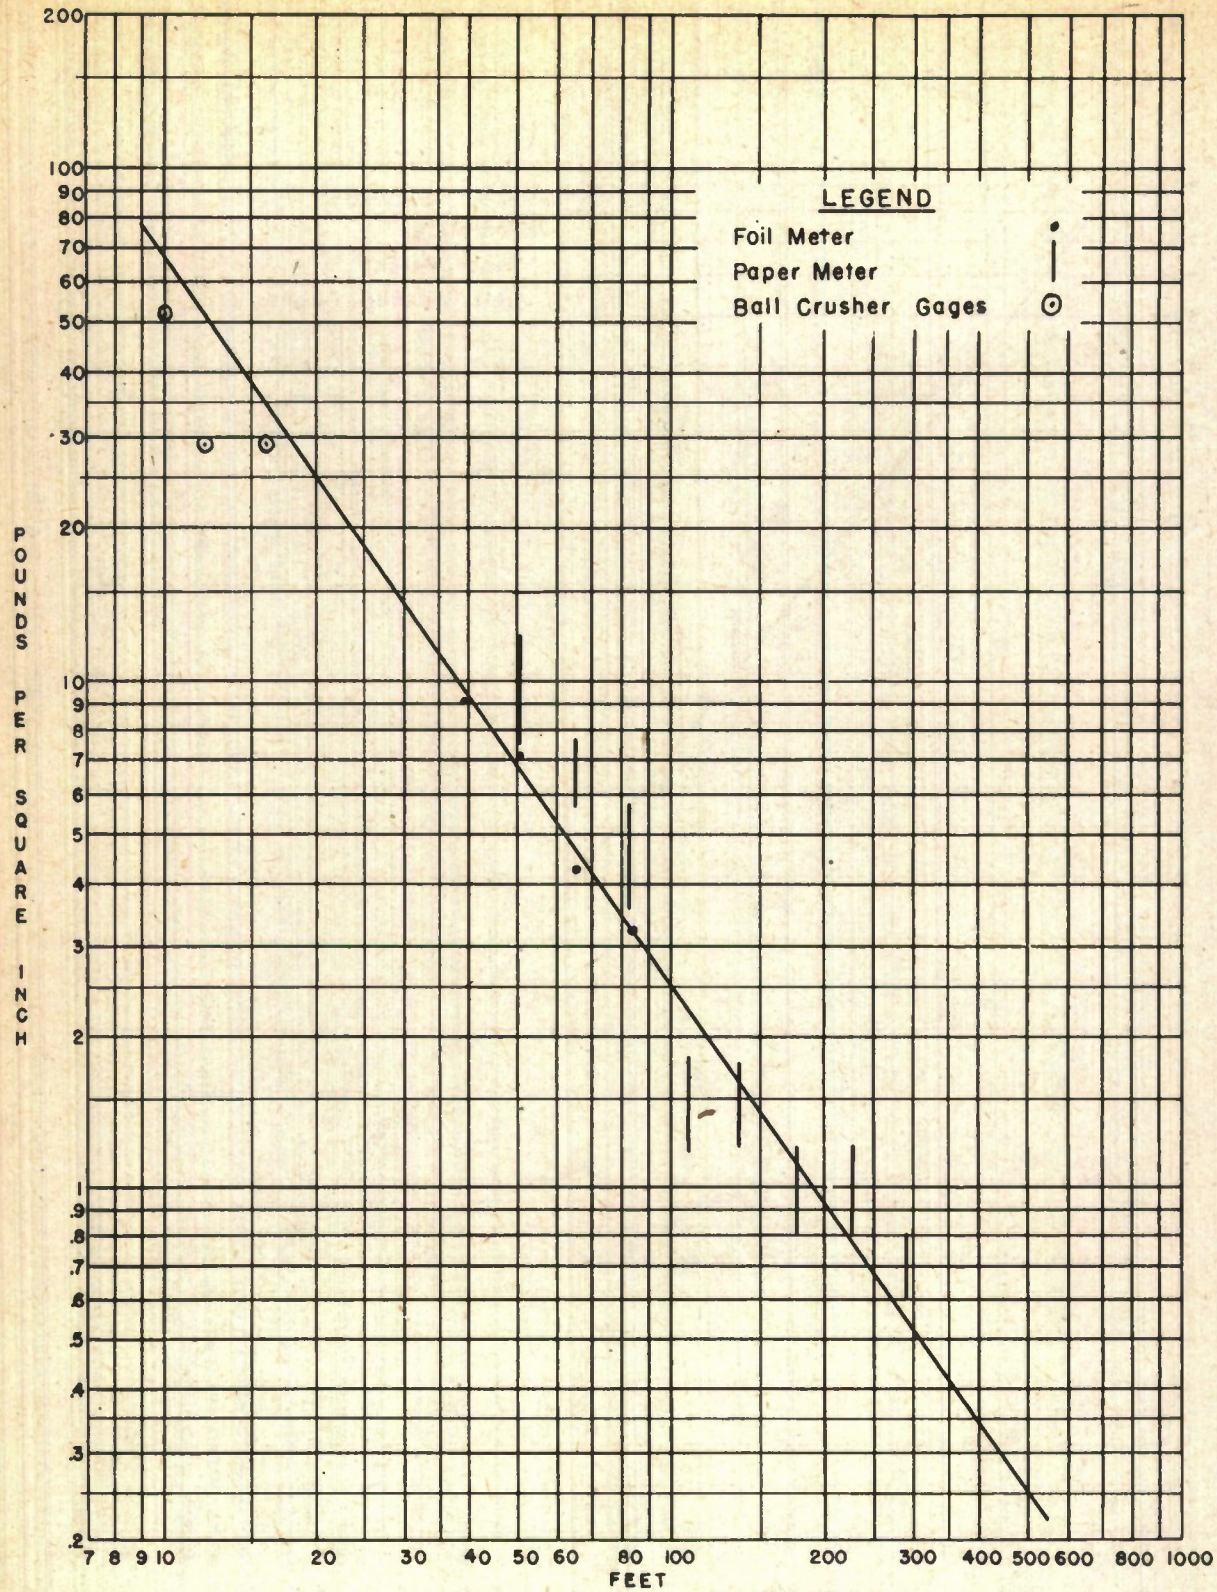
FIG.53A

H. Air Blast. The paper meters and aluminum foil gages gave consistent readings and the pressures are about the same as those obtained in Shot 4. The ball crusher gages afforded some readings but they varied widely. The pressure values from the three types of gages are tabulated in table XVI and plotted on figure 53.

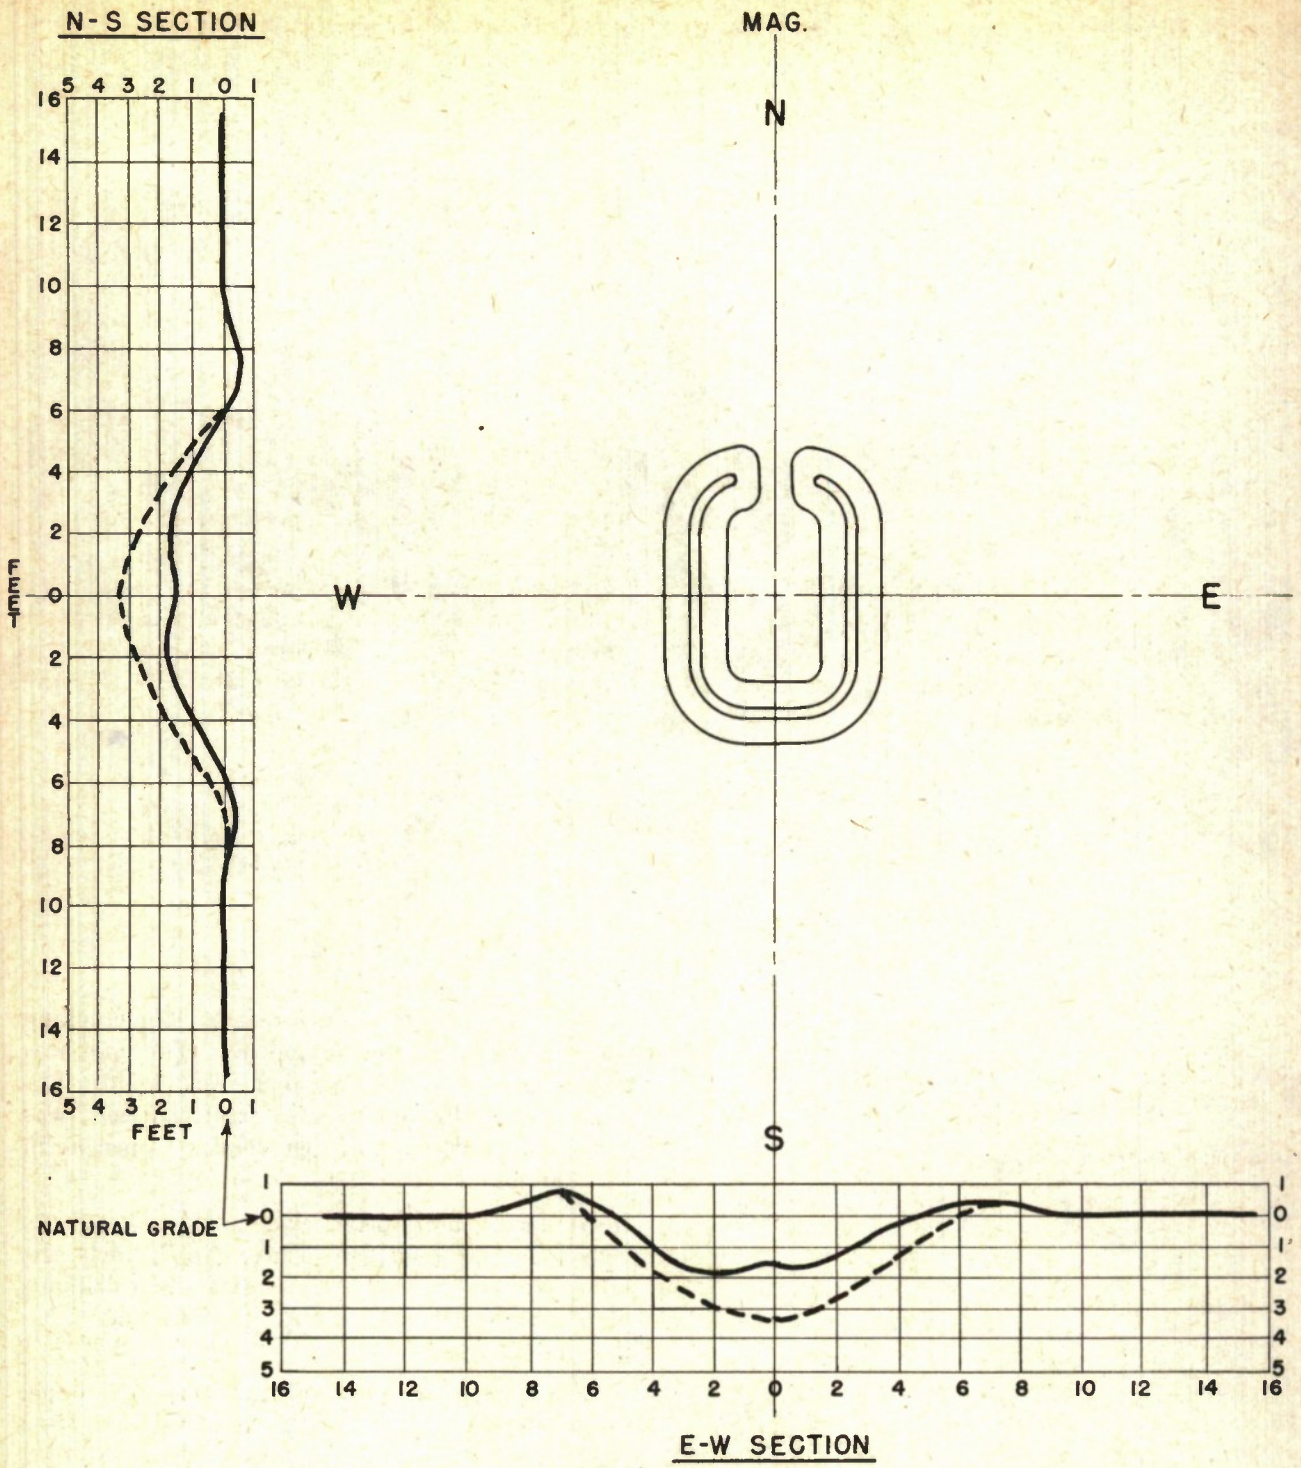
Figure 56. Target igloo after shot, Test 6.

all the way over the arch and the other running somewhat beyond halfway over the arch. One of these had existed prior to the shot, and was made worse. A longitudinal crack occurred in the floor slab, about 4 inches in from the near edge, running about three-quarters of the length of the igloo. A crack appeared at the junction of the rear end wall with the base slab, running halfway across from the near edge. The cracking is illustrated in figures 56 and 57. The door was undamaged but its latchbar was bent. The dummy charge, consisting of steel channels, was shaken up but was not disturbed as much as in the 500-pound tests.
