TECHNICAL PAPER No. 4

Scale Model Igloo Magazine Explosion Tests

Naval Proving Ground, Arco, Idaho

August 1946

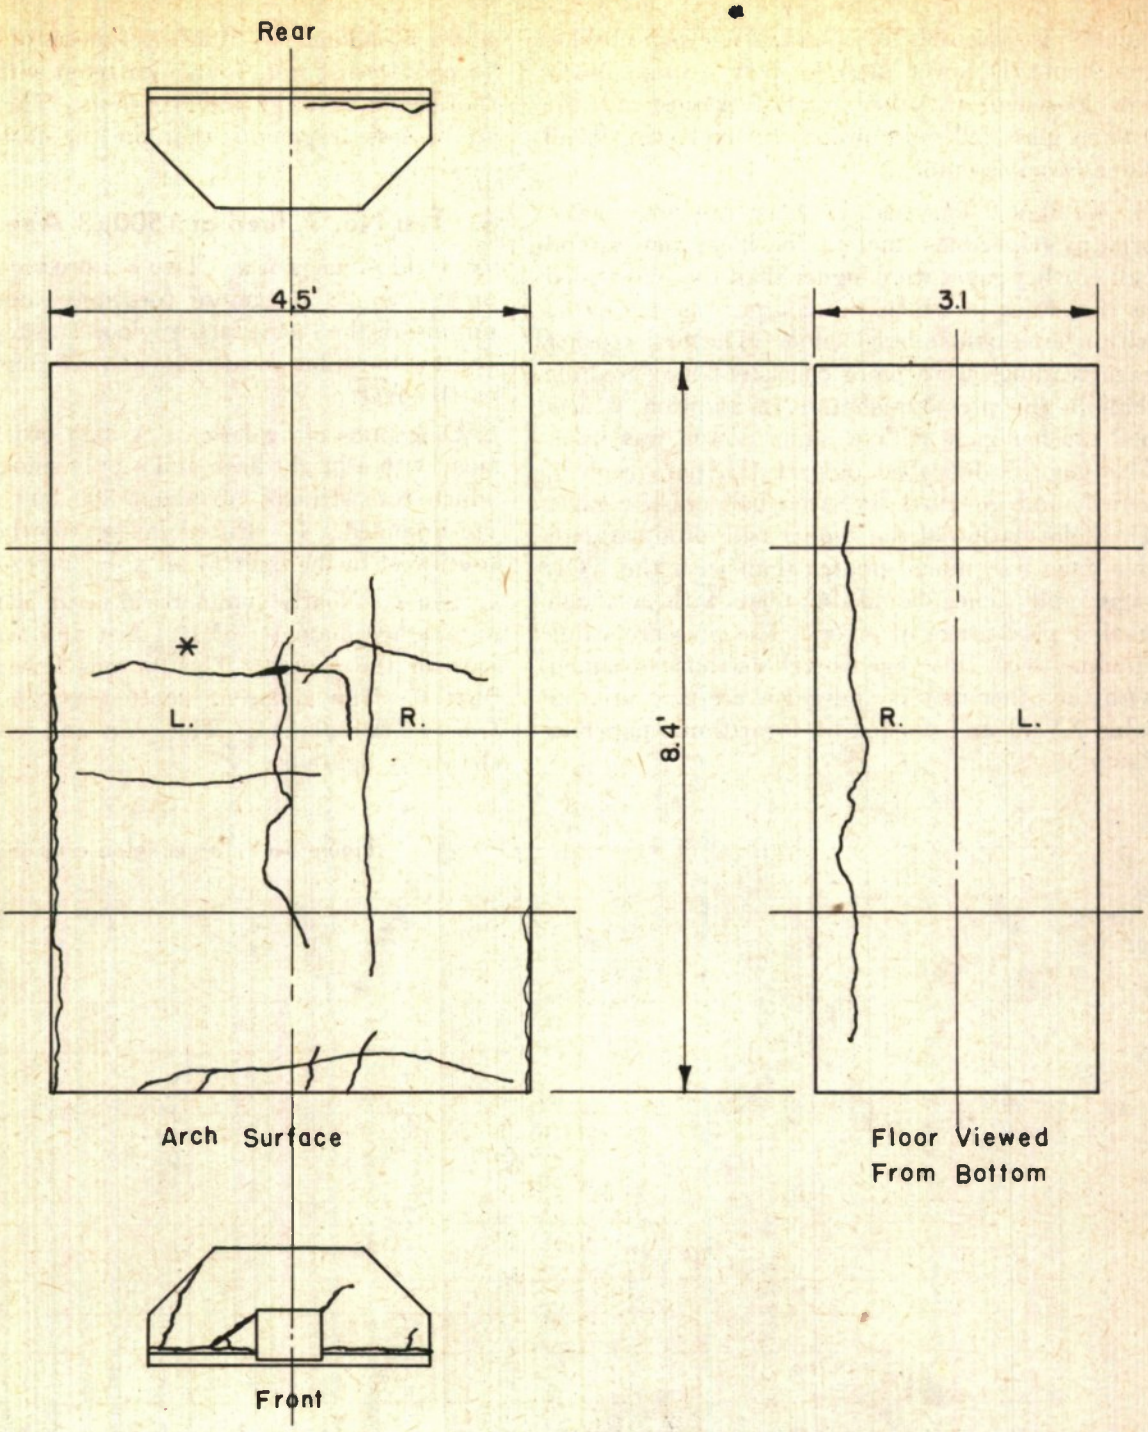
FIG.57
DIAGRAM OF CRACKING
TARGET IGLOO
Model Test No.6

* Existed Before Test & Made Worse
Charge Weight 250# In Revetment

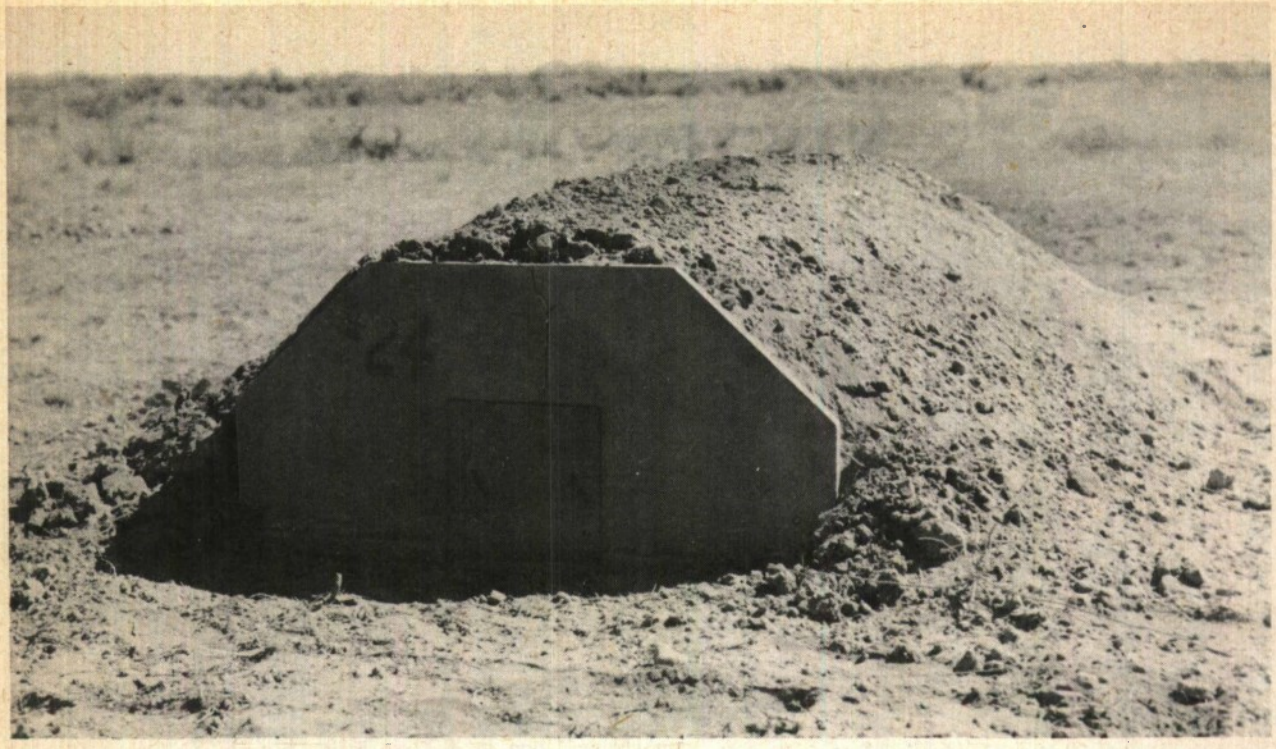
Figure 59. Target igloo after shot, Test 7.

E. Damage to Target Igloo. The earth cover was partly blasted away and left considerably deformed. The front end wall suffered a number of severe cracks and a small piece was blown off over the door. The arch barrel sustained three long longitudinal cracks running about two-thirds of the length of the igloo, two on the near side and one just over the crown on the far side. Two transverse cracks appeared about 2½ feet from the front end, one on the near side of the arch and one on the far side, each being limited to its own side. A longitudinal crack about 18 inches long crossed the transverse crack on the far side near

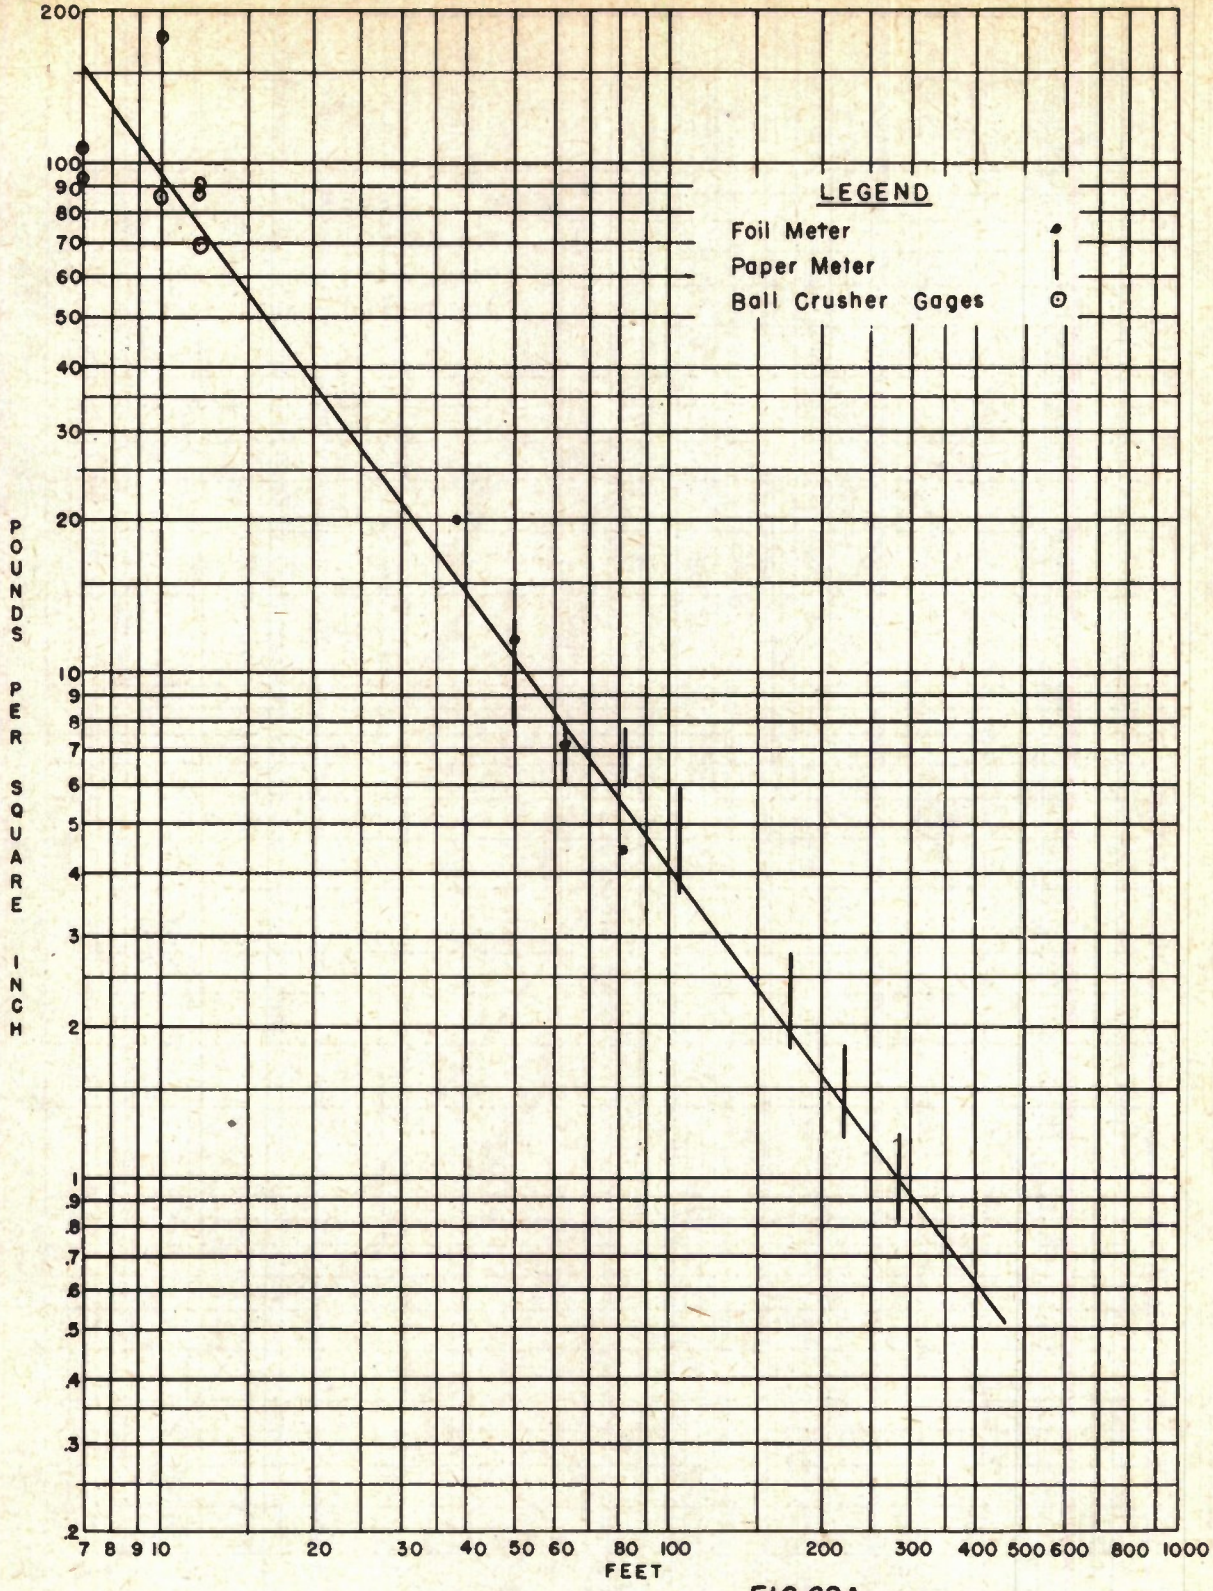
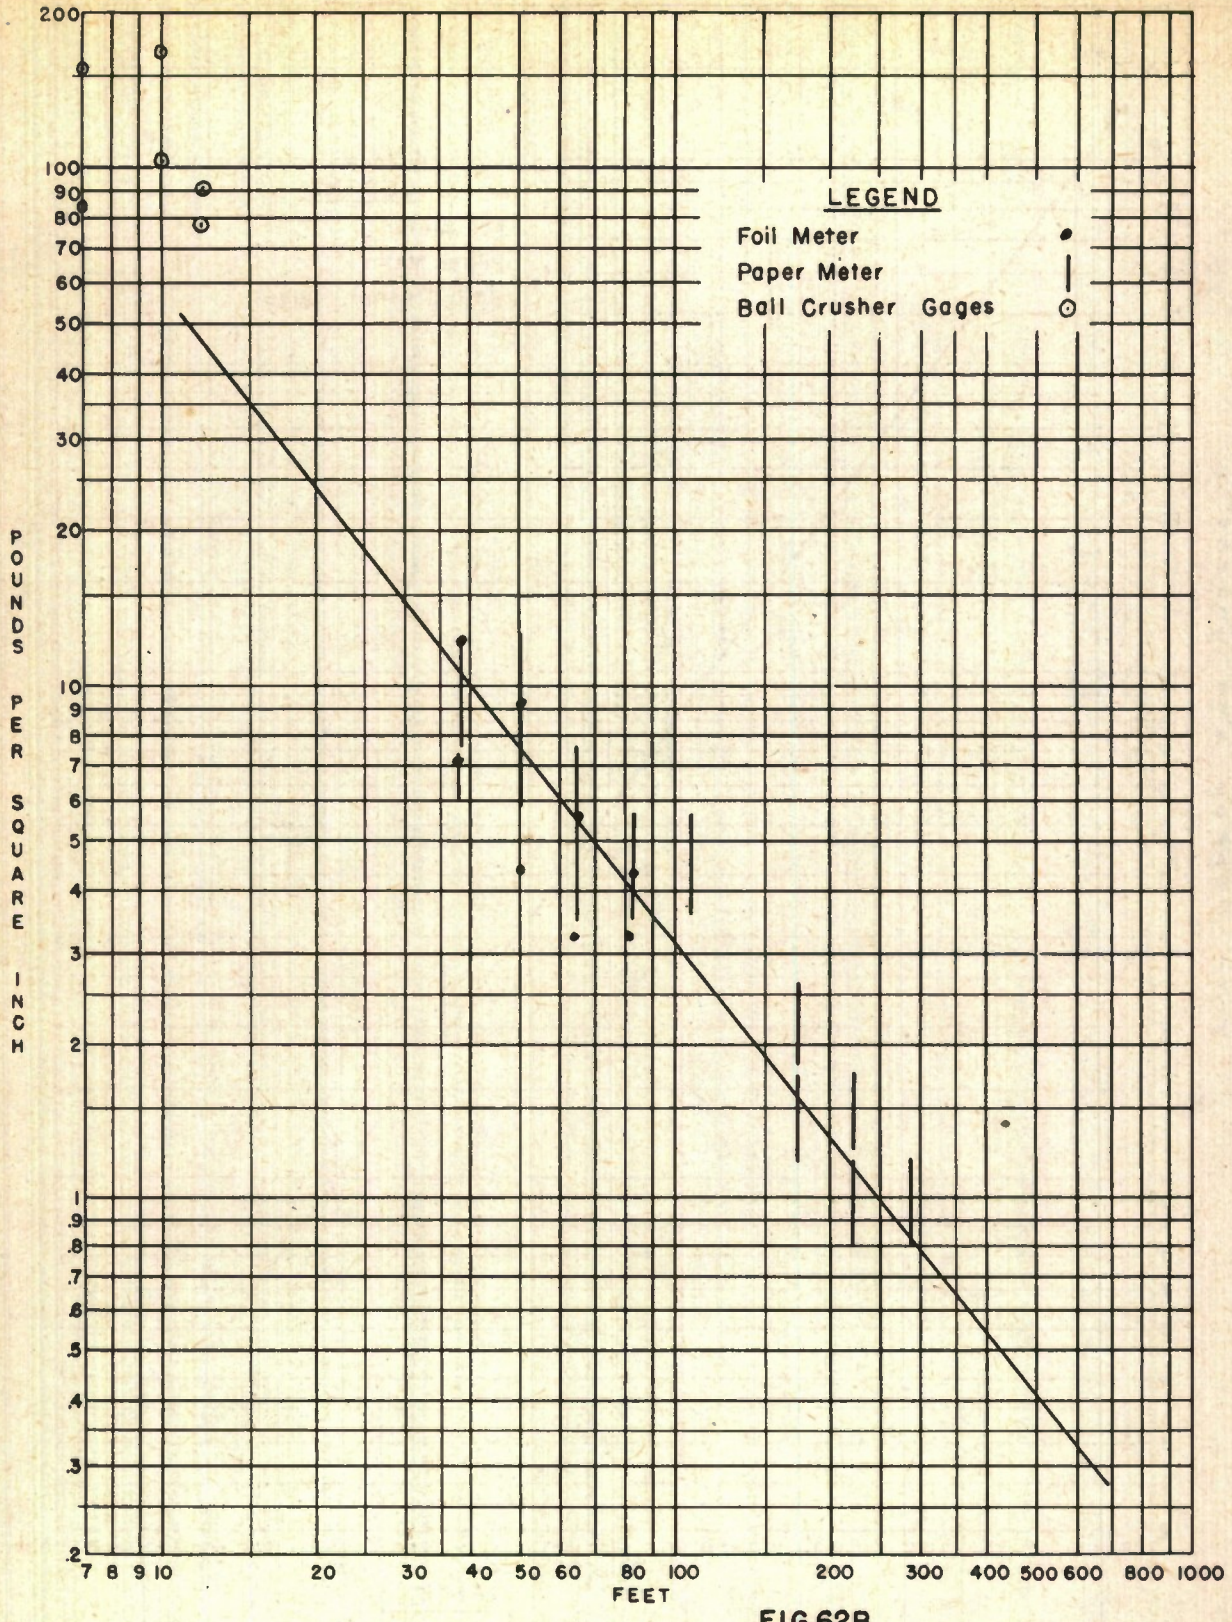
FIG.62A

H. Air Blast. The pressure values obtained with the paper and foil meters, and the NOL and Arco ball crusher gages, are tabulated in table XX and plotted in figure 62. The average line is slightly higher than that of Shot 6.

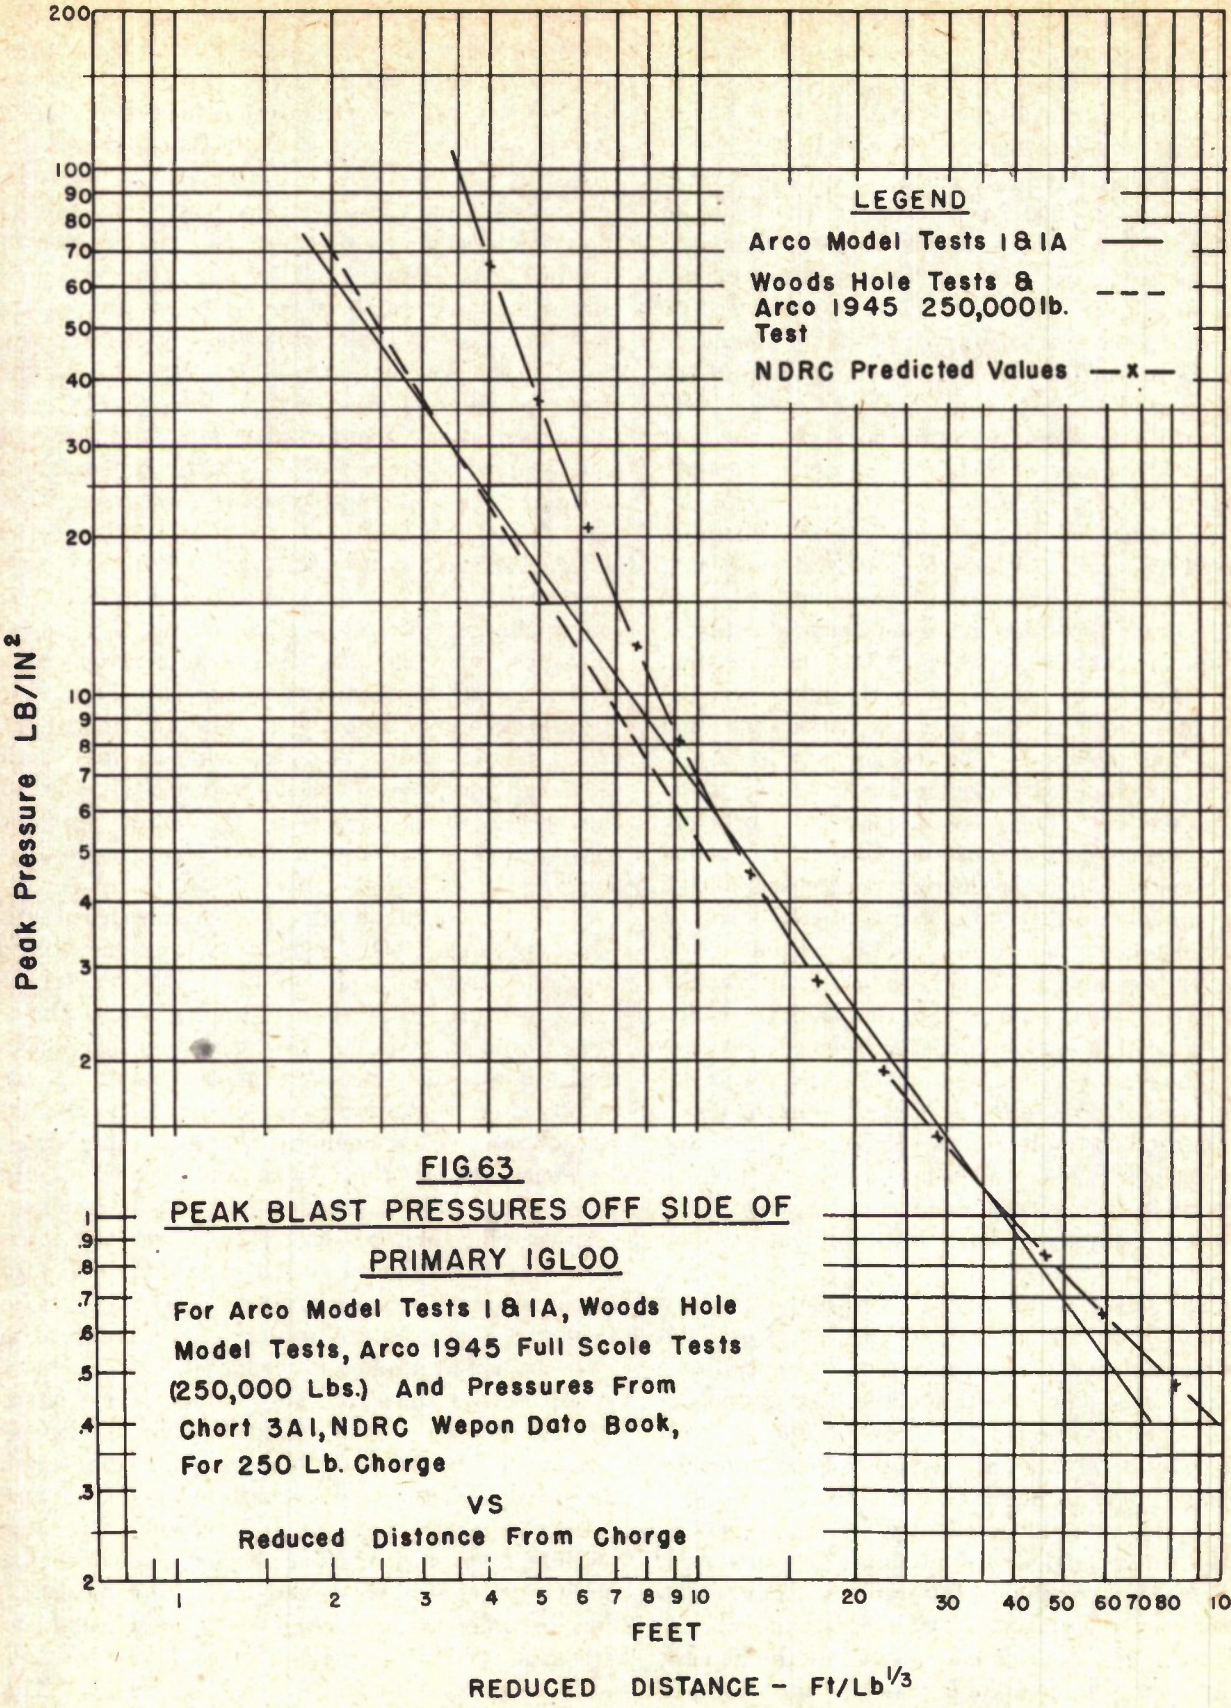
FIG. 63

(B) Comparison with 1945 Arco and Camp Edwards Tests. In figure 63 peak pressures obtained off the sides of the primary igloo in Tests 1 and 1–A are plotted against reduced distance (distance divided by cube root of charge weight) on logarithmic paper along with the line obtained in the 1945 Arco and the Camp Edwards tests, as reported by reference 4, part VII. Through the center of the coincident range the two lines agree closely but as the slopes are not the same there is divergence near the ends. (The slope of the line drawn for these model tests is determined from data over a greater range of distances.) However, it appears that there is sufficiently close agreement to warrant a statement that the blast pressures followed the model law.

(C) Comparison with Peak Pressure Values Determined from NDRC Nomograph. Chart 3A1 of reference 9, part VII predicts values which agree quite well with those obtained in these tests in the lower ranges of pressure, but are much higher in the upper ranges. This is shown by figure 63, on which the NDRC values for a 250-pound charge are plotted against reduced distance along with the line for Arco model tests 1 and 1–A. The NDRC line is concave upwards rather than a straight line, and indicates pressure increasing at a much greater

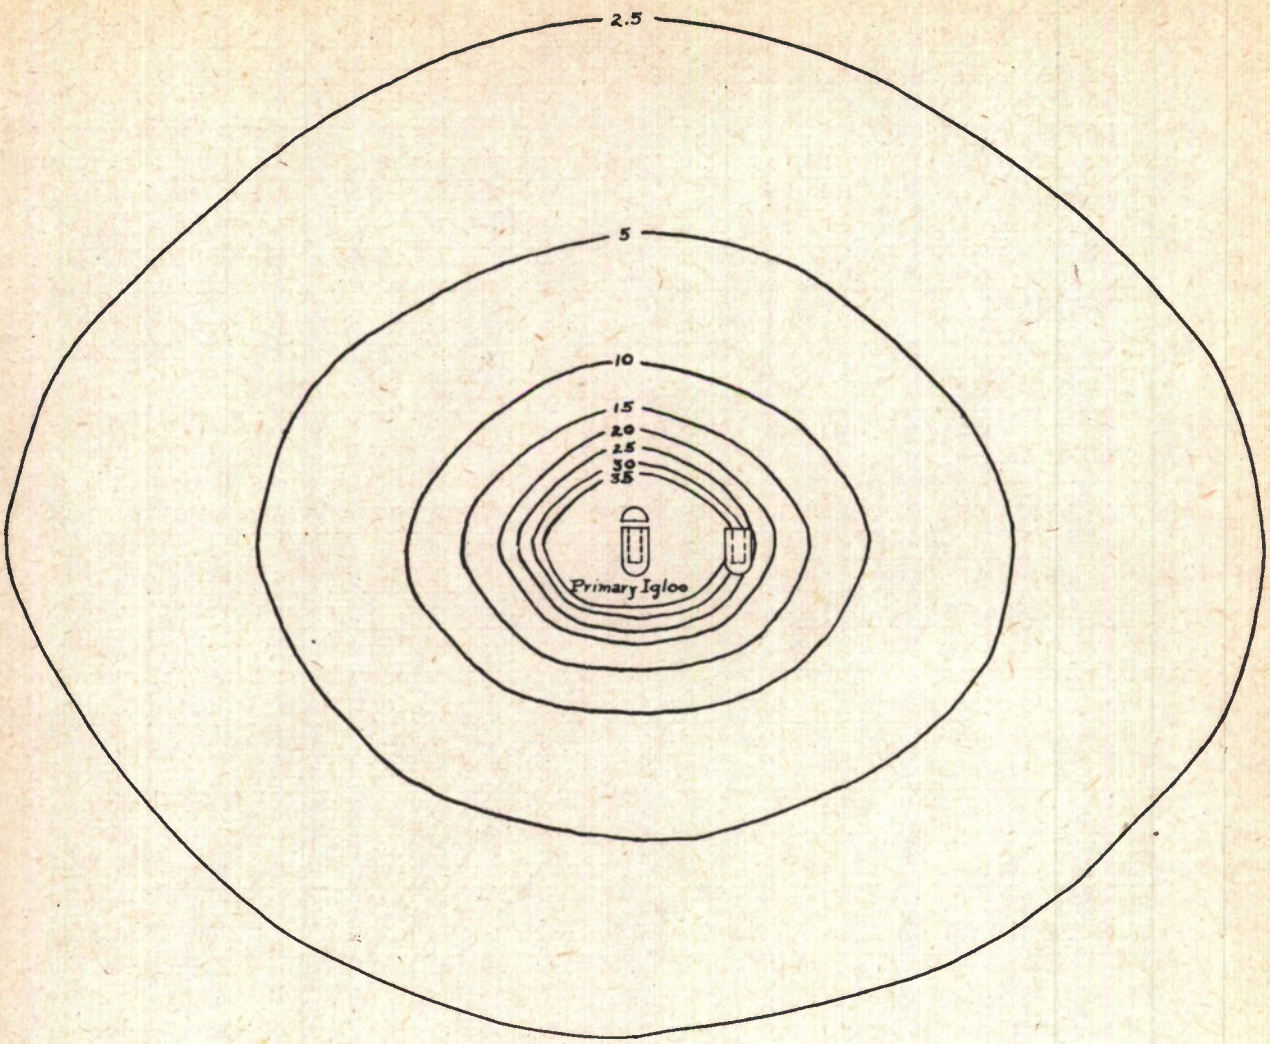
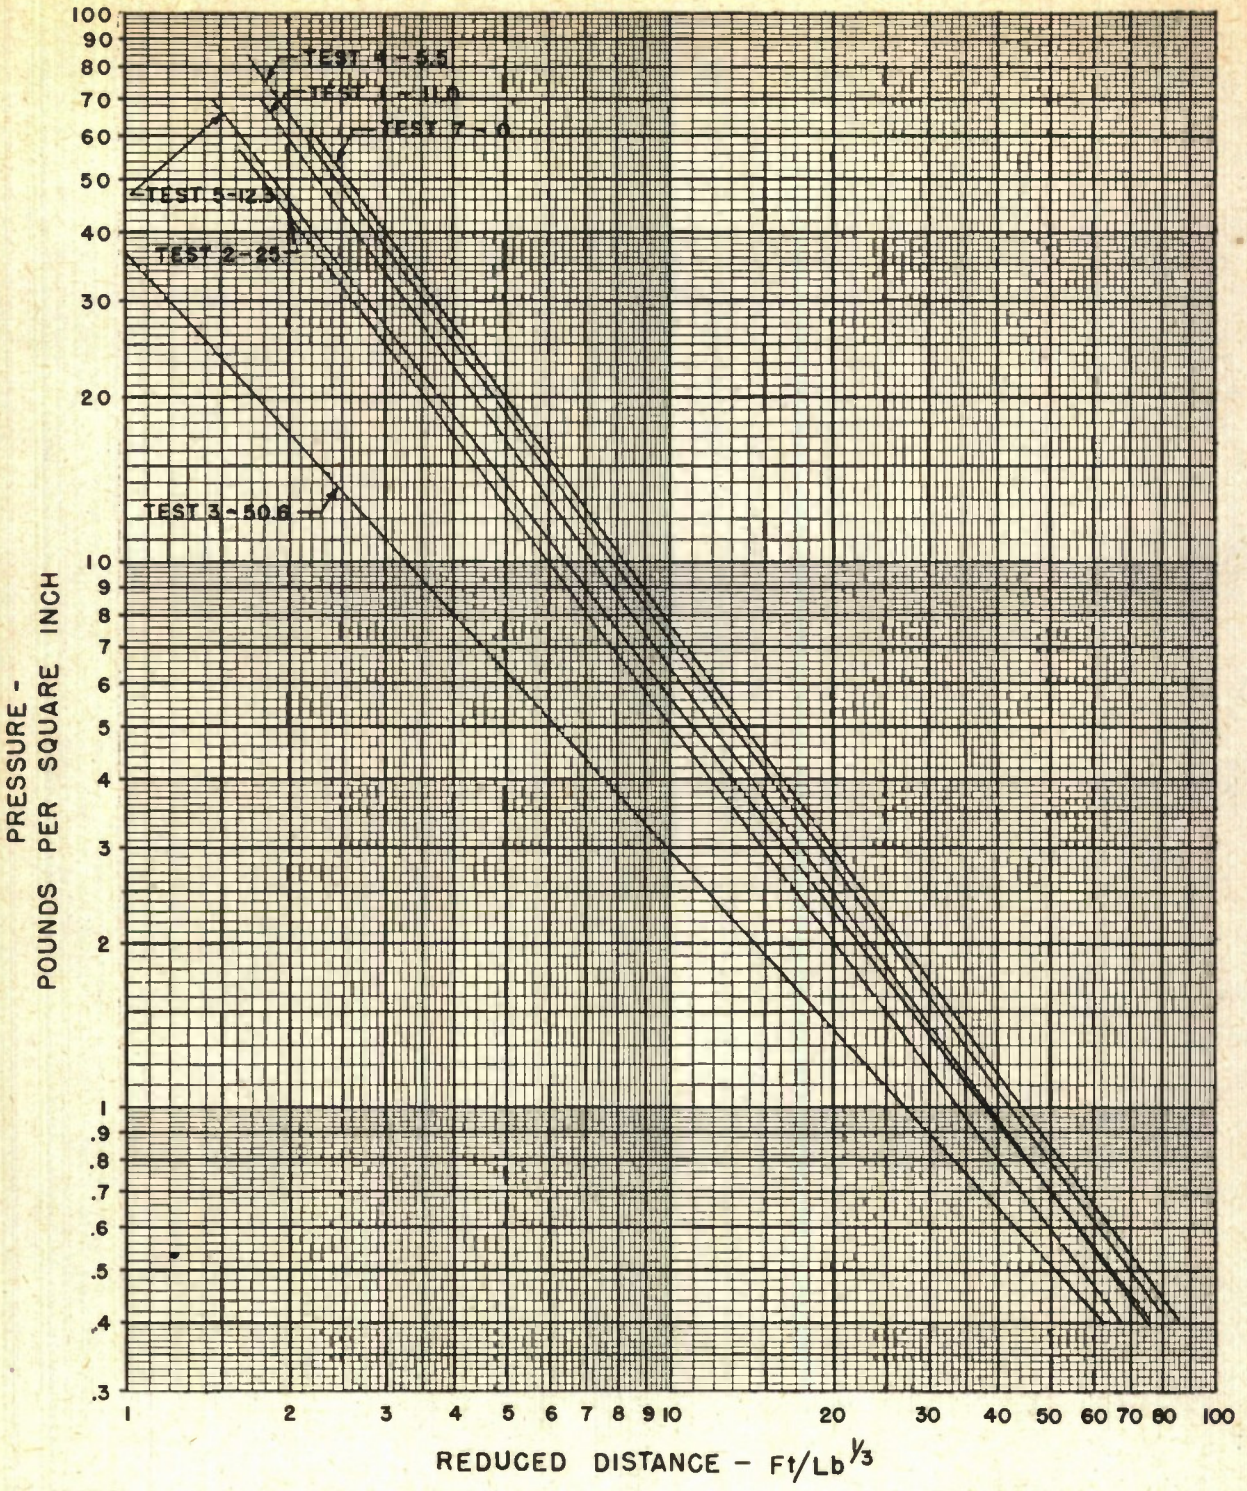
FIG.64

(D) Asymmetry of Blast. Figure 64, on which are plotted pressure contours for model tests 1 and 1–A, illustrates the asymmetry of blast pressure with respect to direction in the horizontal plane. The maximum pressures occur along the extension of the transverse center-line of the igloo, and the minimum occur to the rear on the longitudinal center-line extended. The pressures in front and off the quarters of the igloo are in between the extreme values. The ratio of side to rear pressure at a distance of 20 feet is about 1.5 to 1. As distance increases, the eccentricity decreases; at 100 feet, the side-to-rear ratio is about 1.4 to 1. At great distances the contours will approach circles. Greater pressure off the side than off the front or rear of the igloo would be expected from the shape of the pile of bangalore torpedoes, since experience has shown that rectangular stacks of high explosives generate greater blast intensities in the direction normal to the long axis. In Test 1, the shape of the crater, which had benched sides with steep faces in front and rear, and comparatively long gouged-out slopes on both sides, indicated much greater lateral pressure.

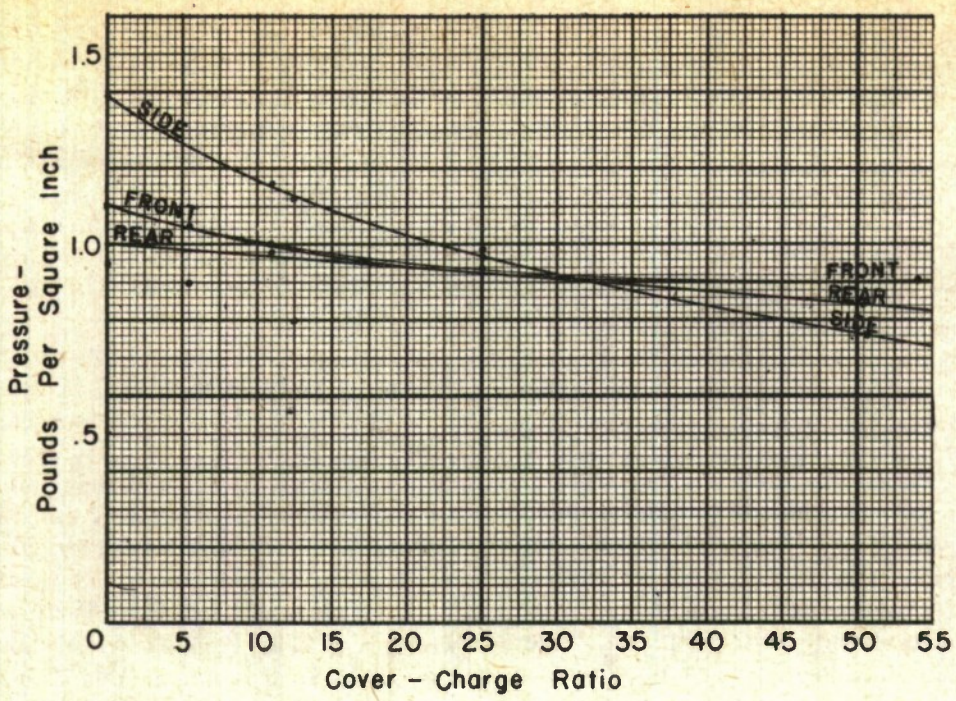
FIG. 66
BLAST PRESSURE Vs COVER-CHARGE RATIO
FOR A REDUCED DISTANCE OF 35 FT./LB.$^{1/3}$

(E) Effect of Augmented Earth Cover. The pressure data conclusively show a decrease in blast intensity as earth cover is increased. Figure 65 is a plot of pressures vs. reduced distance for various cover-charge ratios, and figure 66 shows pressure as a function of cover-charge ratio at a constant value of reduced distance, 35 ft./lb.$^{1/3}$. Some of the lines in figure 65 are inconsistent but the general trend seems unmistakable, and in drawing the curves of figure 66 the out-of-line points have been disregarded. Side pressure declines most markedly, while front and rear pressures decrease less rapidly as the earth-cover is increased. At a cover-charge ratio of about 30, the pressures are equal in all directions. Beyond this value, side pressure becomes less than front or rear pressure, and the eccentricity of contours which existed in figure 64 is reversed. This might be expected since increased earth cover offers greater lateral resistance, partially diverting the explosive energy toward the weaker parts of the structure. The front pressure is greater than that to the rear, inasmuch as the front wall is not earth-covered but at most is protected by a barricade across an air-gap. The average pressure decreases from about 1.0 p. s. i. at a cover-charge ratio of 12 (standard earth cover) to about 0.85 p. s. i. at a cover-charge ratio of 4.8. A graph of pressure vs. cover-charge ratio at a small value of reduced distance, such as 3.5, would exhibit the same general relationships between side, front, and rear pressures, and a decrease in pressure from about 25 p. s. i. to about 13 p. s. i. when normal earth cover is quadrupled. At short distances, a given increase in earth cover evidently causes a greater proportionate decrease in blast pressure than at long distances.

It is believed that figures 65 and 66 offer a clue to a more rational evaluation of the effect of earth cover which, when corroborated by more complete and accurately instrumented investigations may enable future selection of safety distances on the basis of closely known reduction in ability to cause damage for a given quantity of explosives placed in a given earth barricaded or covered storage. From the information given in figures 65 and 66, and from the model law, a graph has been constructed (figure 67) showing peak pressure off the side of the exploding igloo as a function of distance simultaneously for various charge weights from 50,000 to 500,000 pounds, and for 250,000 pounds under earth-covered igloos with cover-charge ratios up to 50. (These curves have been adjusted slightly from those plotted direct in order to get rid of irregularities in spacing and slope. The adjustments were all made in a direction to give more conservative results.) The curves show that, for a constant distance, a considerable decrease in quantity from a 250,000-pound uncovered charge would be necessary to effect the same reduction in peak blast pressure as a given increase in cover-charge ratio or a 250,000-pound charge; and also, for a constant pressure, placing additional earth

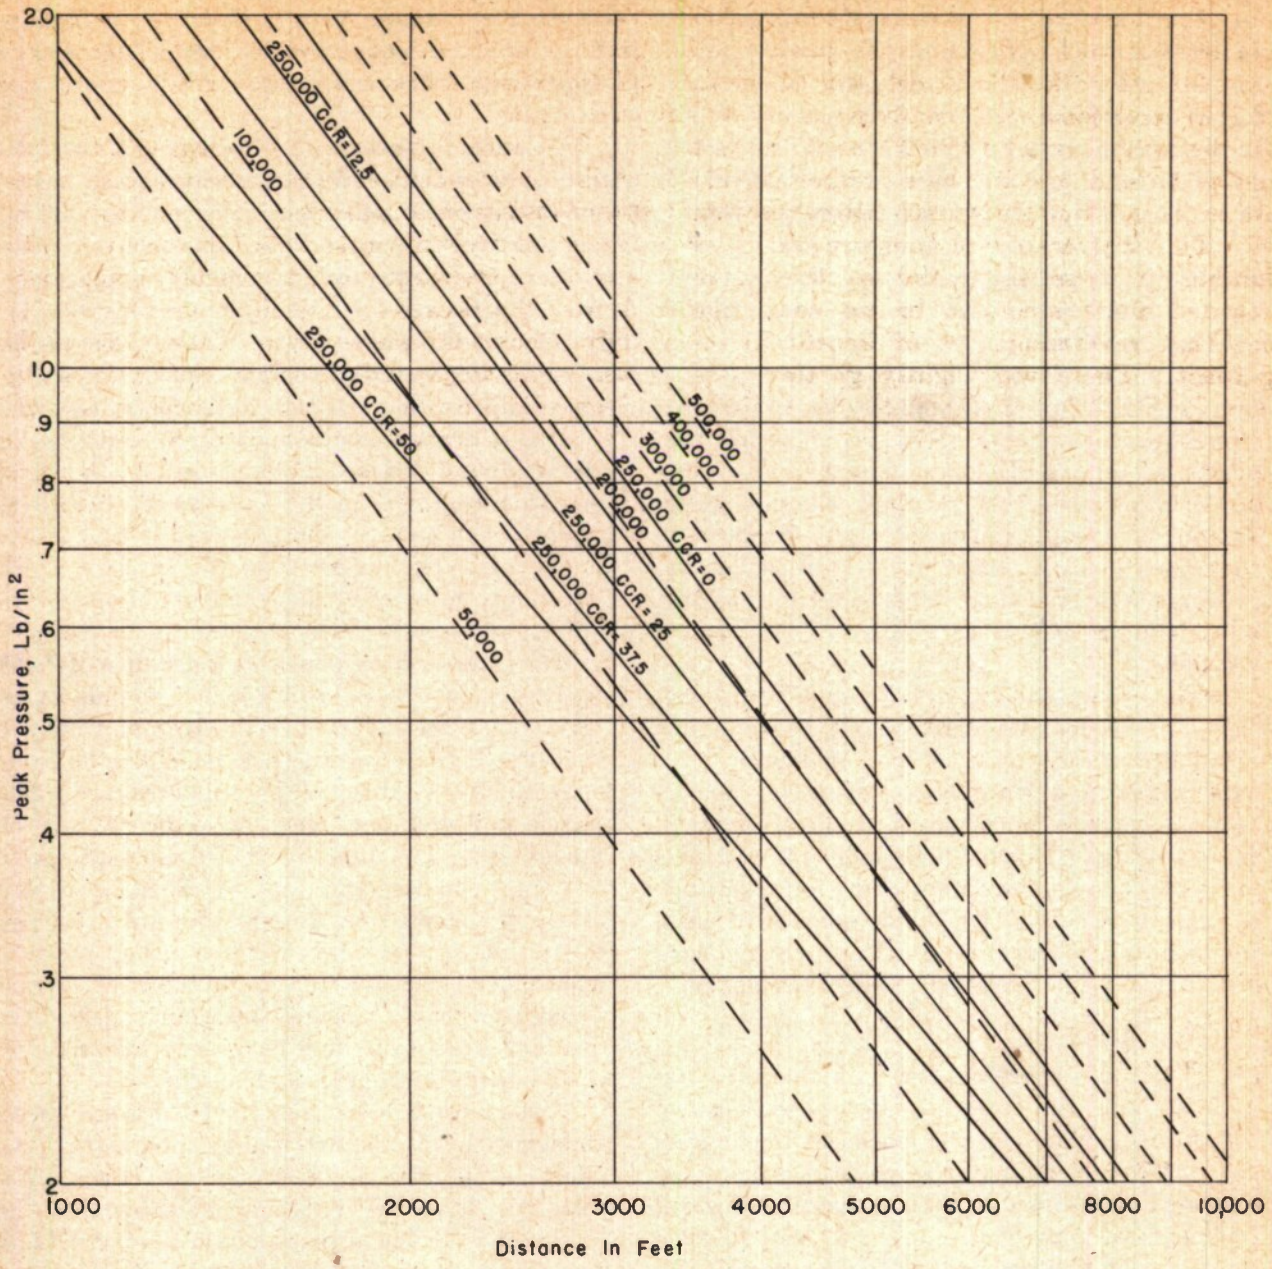
FIG. 67

It is emphasized that the foregoing pressures and distances are approximate, and are derived by up-scaling the results of the model tests. Figure 67 is not recommended for actual use, but it qualitatively illustrates trends which are believed to exist. Further studies should be

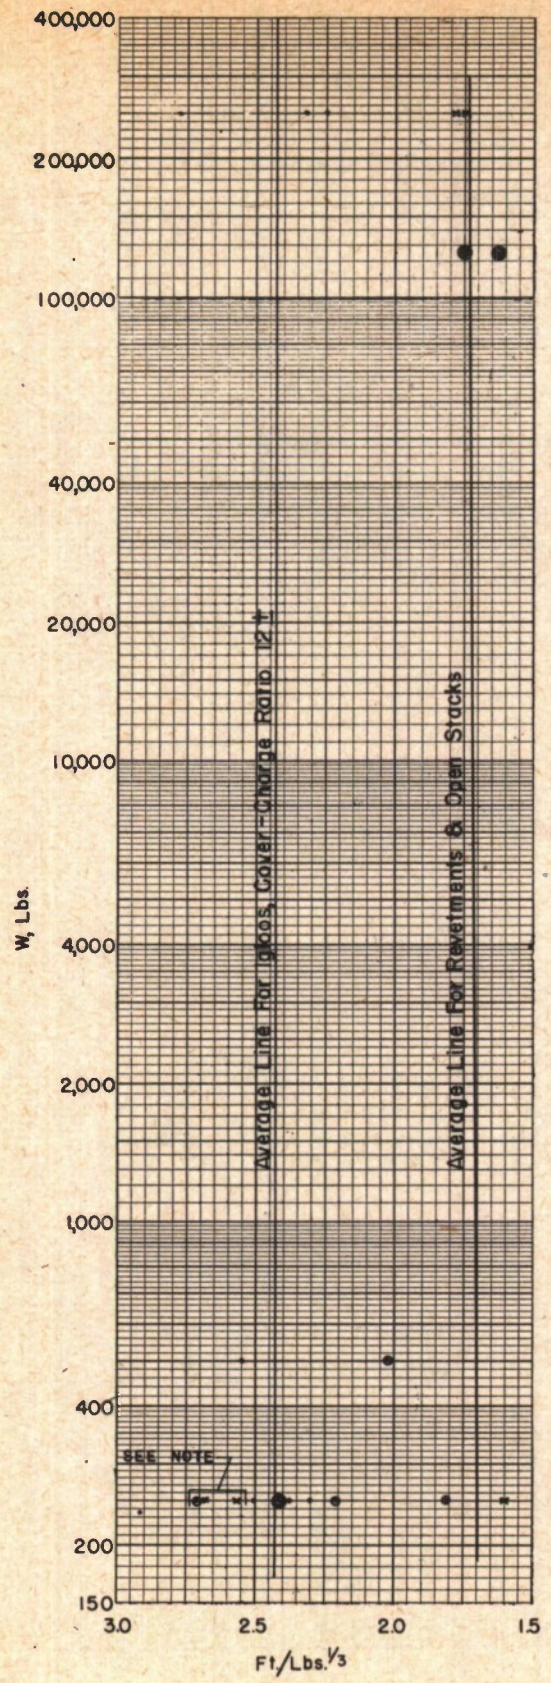
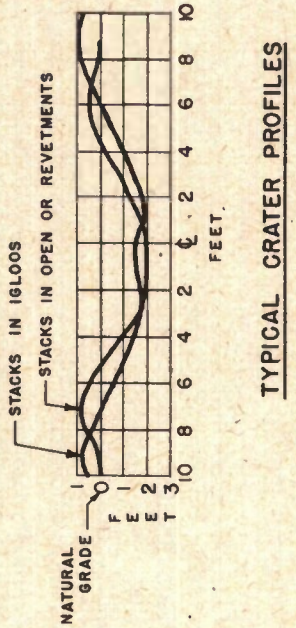
FIG. 68

(D) Effect of Augmented Earth Cover on Craters. Neither table XXIV nor figure 68 show any consistent tendency of increased earth cover on igloos to affect the crater diameters, but the table shows a small increase in depth. This is regarded with suspicion in view of the small number of tests. There is a decisive increase of about 40 percent in diameters from explosions within earth-covered igloos as compared with explosions in revetments or in the open, but crater depths are about the same in either case and vary considerably from test to test. Crater volumes when earth-covered igloos are used are considerably greater than volumes obtained from open explosions. These general relationships should hold true in any relatively homogeneous granular soil of sufficient depth over bedrock.

The values of $d/W^{1/3}$ are plotted against charge weight in figure 68. It may be seen from the above table that crater *diameters* scale reasonably well for similar explosions, but crater *depths* do not, consequently volumes do not. For example, to be true to scale the depth in Arco Model Test No. 1 should be only 1.2 feet (average depth from Arco Nos. 1, 3, and 5), whereas it is actually 2.1 feet or 75 percent greater.

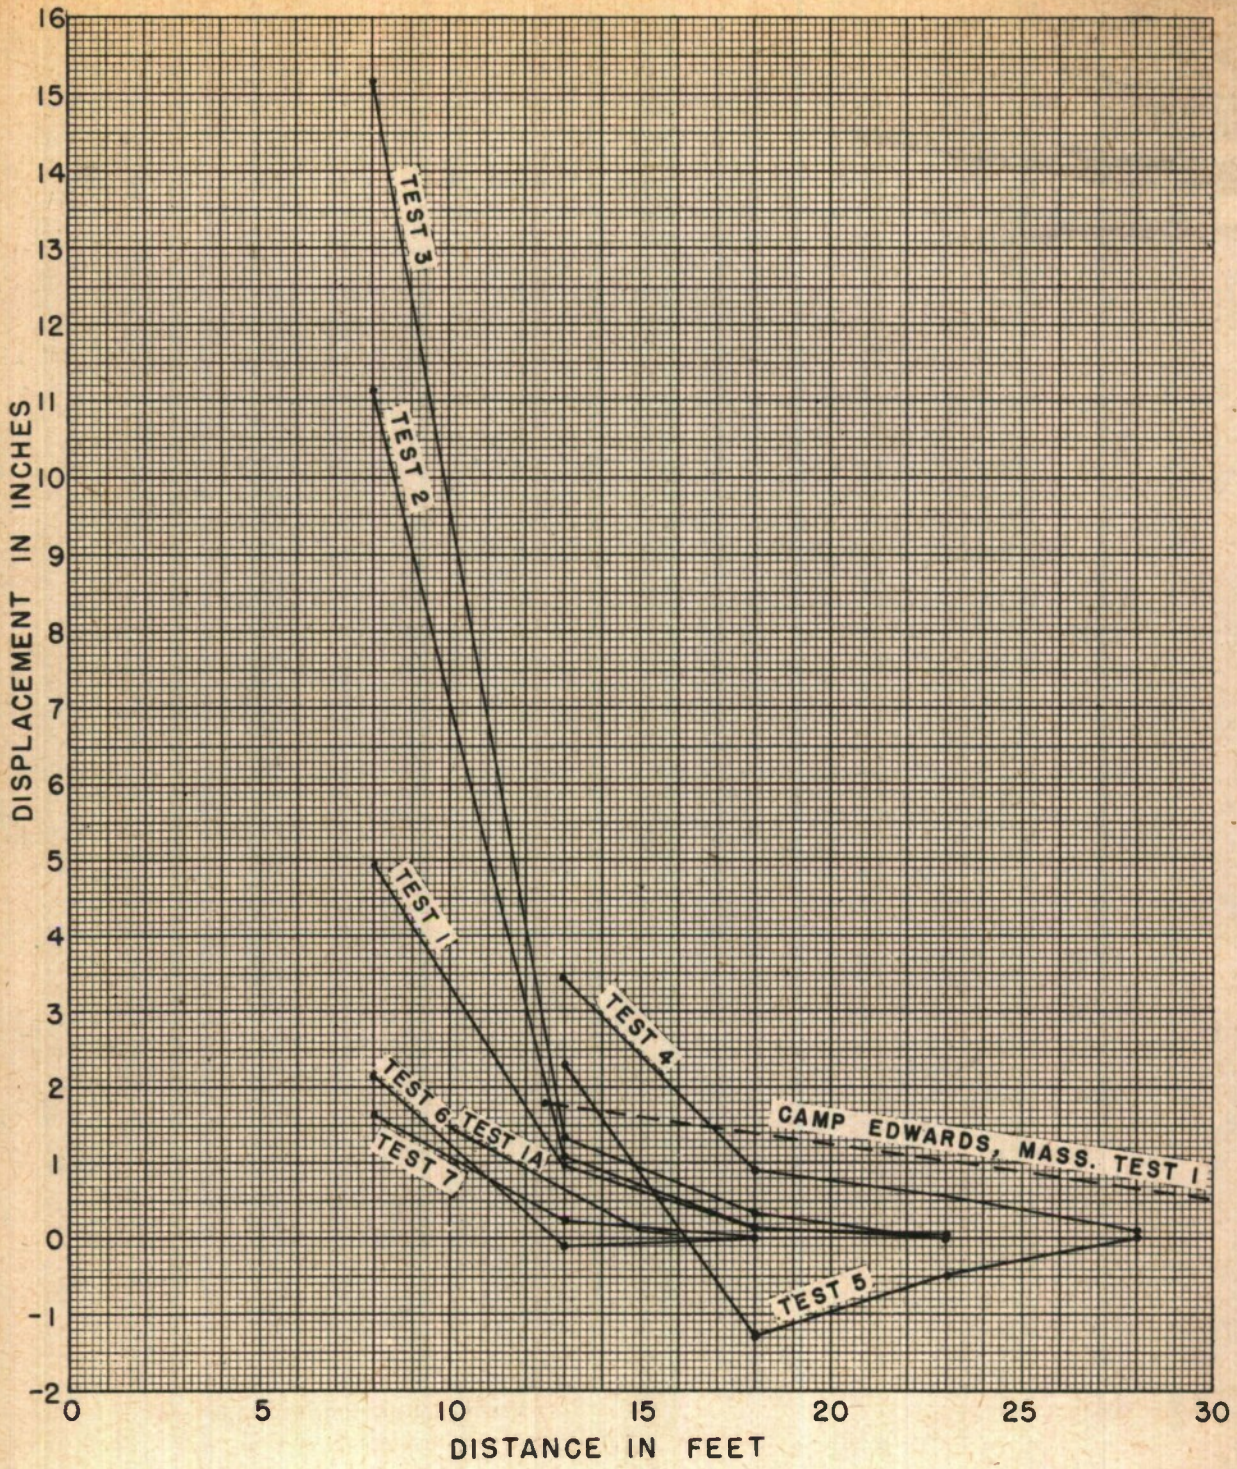
FIG.69

(A) General. Figures 69 and 70 are graphs of permanent horizontal and vertical earth displacement as a function of distance from the center of the crater for each of the model tests. The graphs, which are drawn as straight lines connecting the plotted points, would resemble hyperbolas if drawn as curves, with outward displacements very high close to the crater and decreasing rapidly with distance.
