REPORT OF PROJECT NR AVN 2656  
EFFECT OF WING-TIP VORTICES AND SONIC SHOCK  
ON ARMY AIRCRAFT IN FLIGHT

May 1957

UNITED STATES ARMY AVIATION BOARD  
Fort Rucker, Alabama

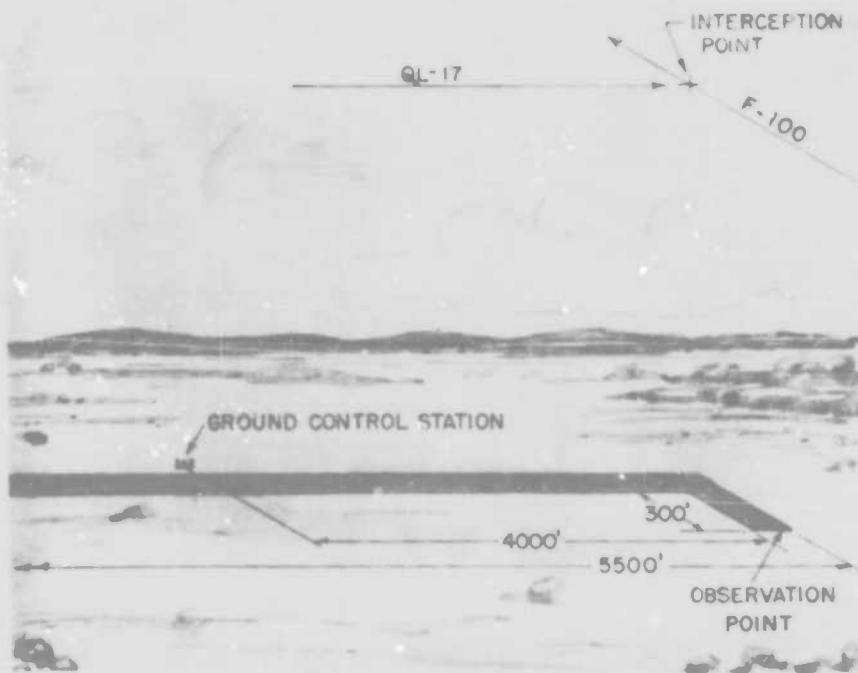
Figure 8.  
Test Site

feet south of the intercept point. A second station with observers, camera crews, and a communications vehicle was established approximately 300 feet to the right of the intercept point. Aerial observation and motion pictures were taken from a helicopter which flew near the intercept point.

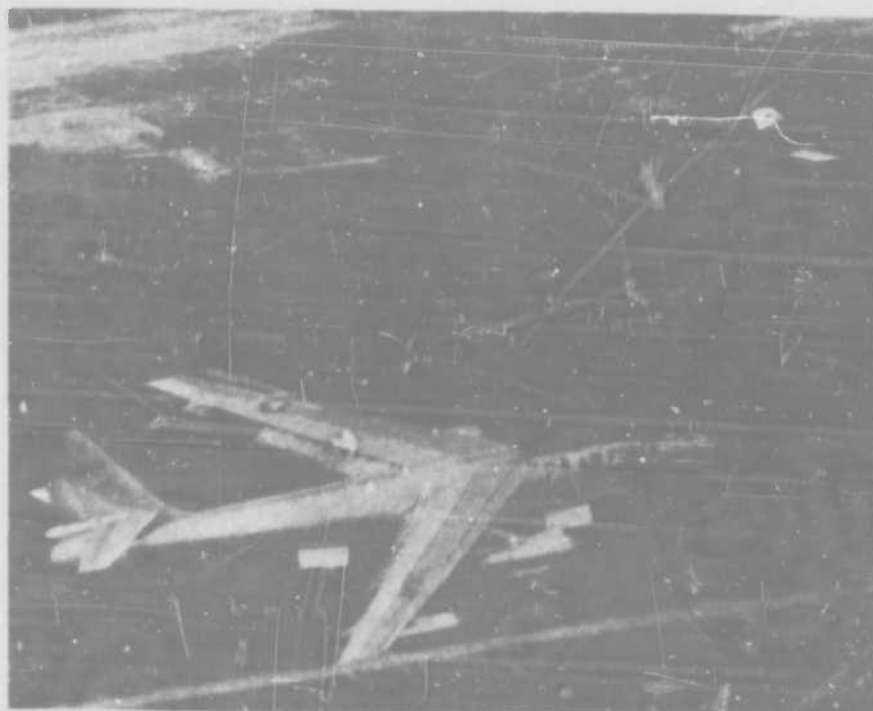
(1) To study the effect of wing-tip vortices on lightly wing-loaded aircraft, a QL-17 was used to intercept the vortex disturbances generated by F-100 and B-47 aircraft.

Figure 10.  
E-47 Passing  
Under QL-17

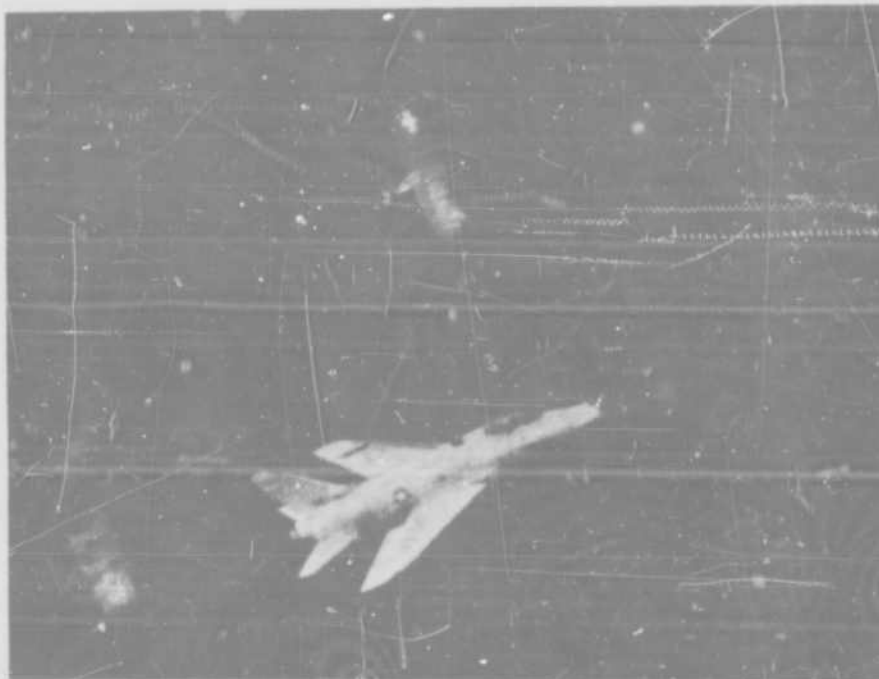
b. Piloted Penetrations. Two flights were made in which a piloted L-19, flying at 90 miles per hour, attempted to penetrate the F-100 vortices. The F-100 was flown at an airspeed of 200 knots in landing configuration at an altitude of 6,000 feet. The F-100 dispensed smoke on each of the attempted intercepts.

Figure 12. F-100 Passing Under L-19

The smoke marking the vortices dissipated after 30 seconds, and there was no way to determine if the center of the disturbed area was penetrated. Only mild turbulence was encountered when entering the supposed area of turbulence 45 to 90 seconds after the passage of the F-100. At 45 seconds one sharp gust was felt. Letting down into the vortex 30 seconds after the F-100 had passed, the right wing of the L-19 dropped and the aircraft yawed to the right. Full left rudder and left stick were applied. The right wing nevertheless dropped approximately 50 degrees and the airplane yawed 30 degrees to the right. The pilot was unable to hold the airplane in the vortex. On other intercepts, at

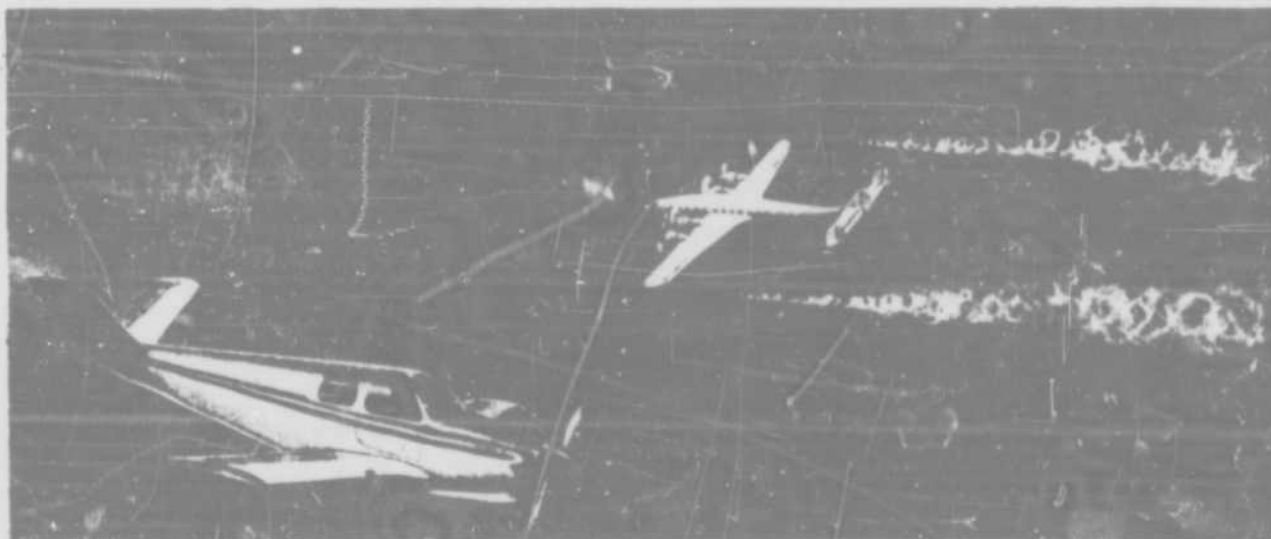
Figure 1

This figure shows the tip vortexes and swirling propeller wash trailing behind a large aircraft on its landing approach and a plane in the downwind leg of the traffic pattern.

What Causes This Hazard? Basically it is (a) the wing tip vortexes and (b) the swirling propeller wash of large aircraft that creates a turbulence which can upset another aircraft, as indicated in Figures 1 through 5 of this bulletin.

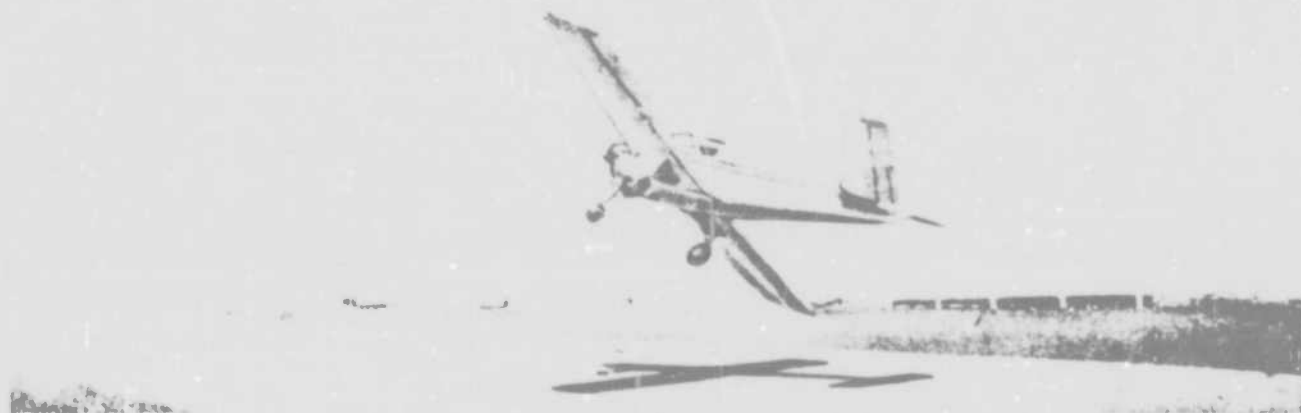
Figure 3

This figure shows the landing airplane being upset by the turbulence.
